WILD TROUT TRUST

**River Arrow**

Spennall, Warwickshire

September 2023

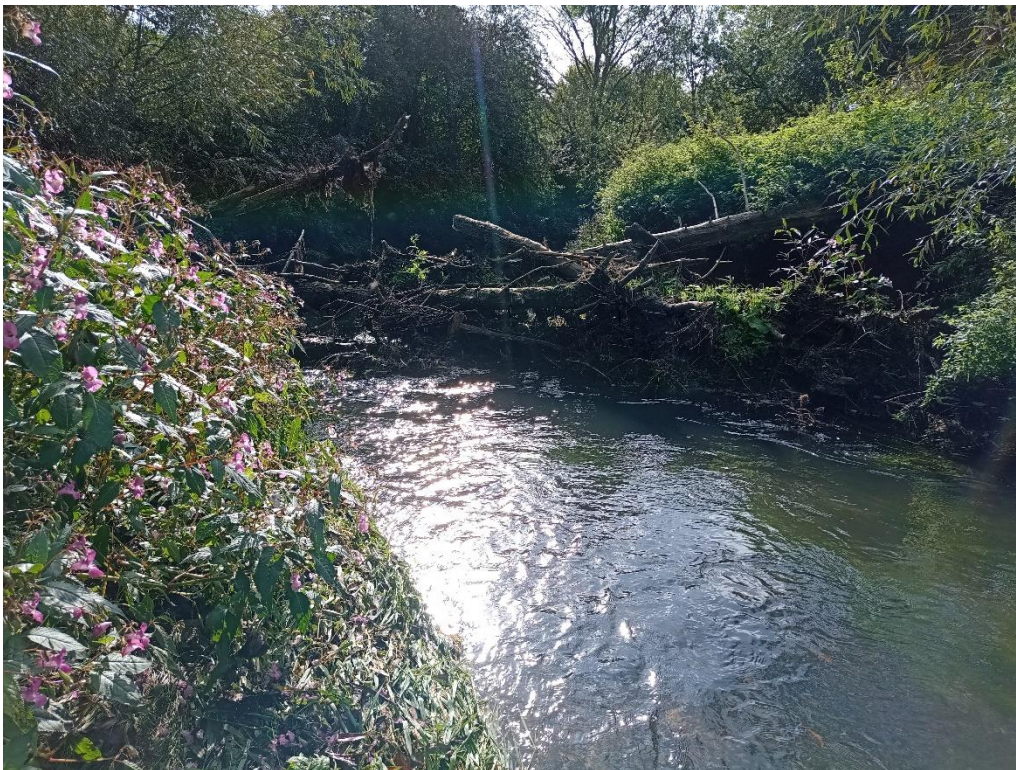
*Figure 1 (downstream view; 52.253787, -1.875045). An accumulation of large woody material (LWM) at the downstream end of the reach inspected. These structures enhance stream habitat by creating localised scour which sorts and cleans gravels (improving their quality for fish spawning). They also provide excellent refuge for fish from predators such as cormorants and otters, in addition to trapping leaf litter, aquatic weed, etc. which is food for invertebrates and subsequently fish.*

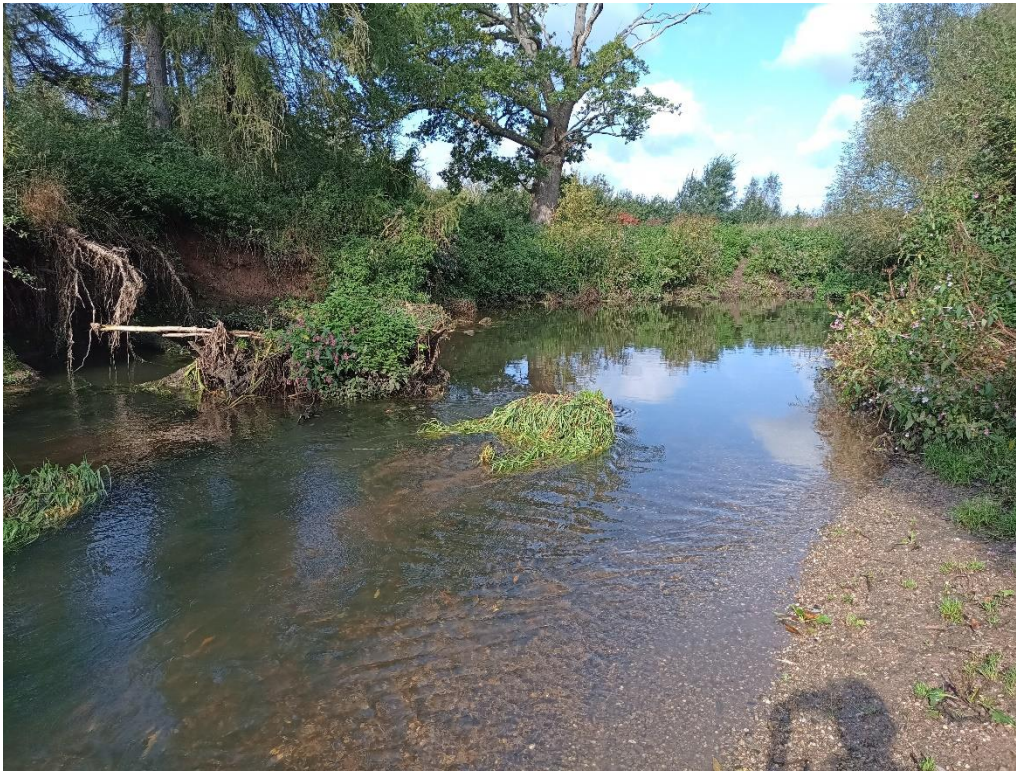
*Figure 2 (upstream view; 52.253787, -1.875045). The meandering planform of the river creates deep pools on the outside of bends with steep-sided (or vertical) banks – river cliffs. On the inside of the bend is a shallow gravel point bar. These dynamic processes of erosion and deposition create the natural features and habitat of the river. The rate at which the processes occur depends on a number of factors, one of which is riparian vegetation and its influence on bank stability. Mature trees increase the stability of banks, binding them with their roots, so having native woodland creation as the main land use on the right bank is a big plus.*

*Different tree species provide differing stability and here shallow-rooted conifers are being undermined by erosion. This is not necessarily a bad thing – it is providing a supply of LWM to the river – but planting more deep-rooted tree species further back from the river would be beneficial in the long-term.*

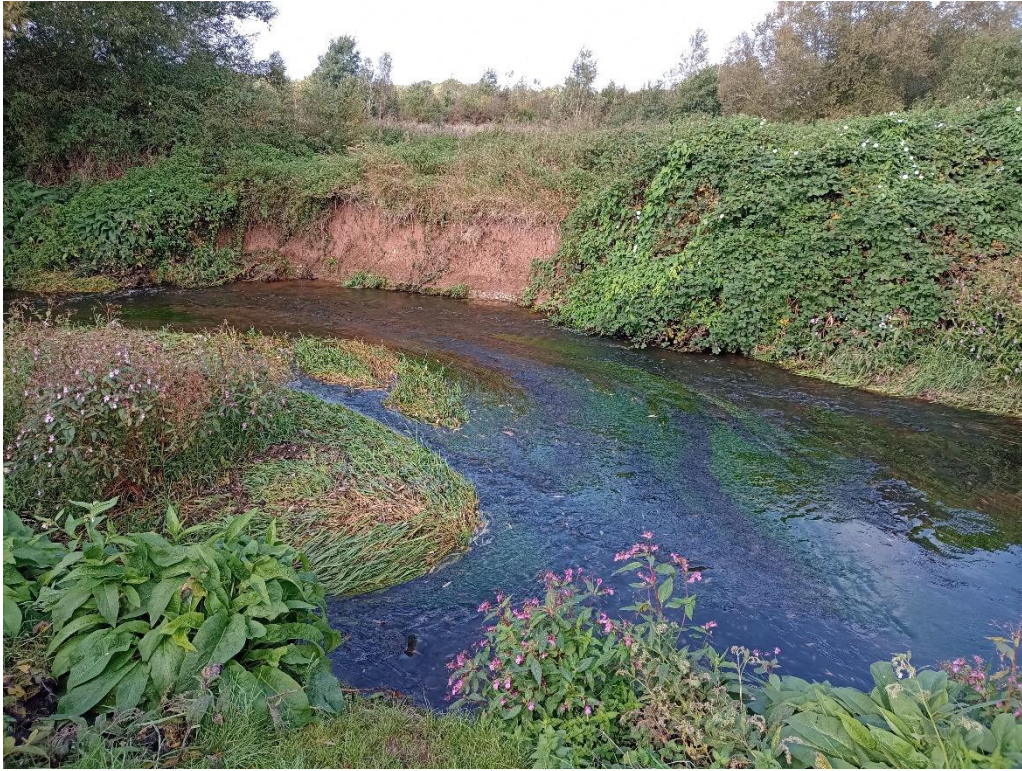
*Figure 3. (downstream view; 52.254262, -1.874497) A shallow gravel riffle supporting beds of water crowfoot (*Ranunculus* sp.). However, this plant was only present in very limited areas, with the majority of rooted aquatic weed observed being fennel pondweed (*Potamogeton pectinatus*), a species which is characteristic of polluted, oxygen poor waters with high nitrate and/or phosphate levels, but which becomes less competitive at low phosphate levels (*Marine Biological Association*).*

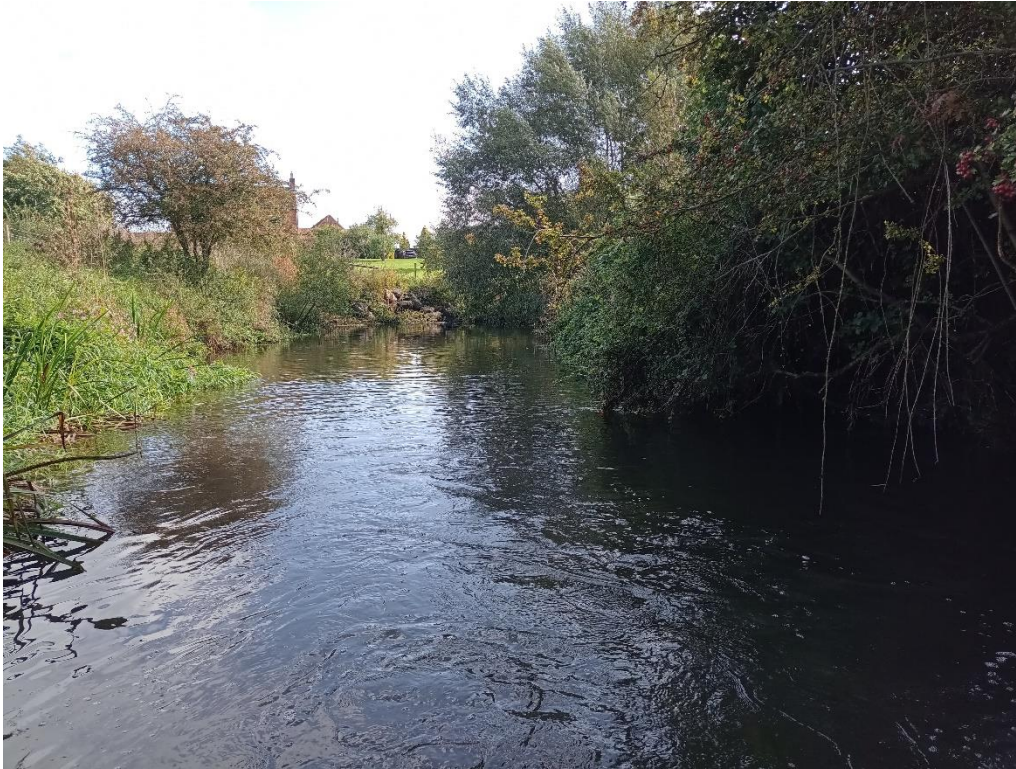
*Figure 4 (downstream view; 52.254672, -1.874790). The pool downstream of the footbridge. The meander bend at the downstream end of the pool has been protected with boulder rip-rap. This arrests erosion in the localised area, but can lead to a transfer of energy, shear stress and increased rates of erosion at the boundaries of the reinforcement. Natural approaches to reducing erosion rates are preferable from a river habitat perspective, such as protection with brushwood, establishment of trees on the riverbank and exclusion of livestock.*

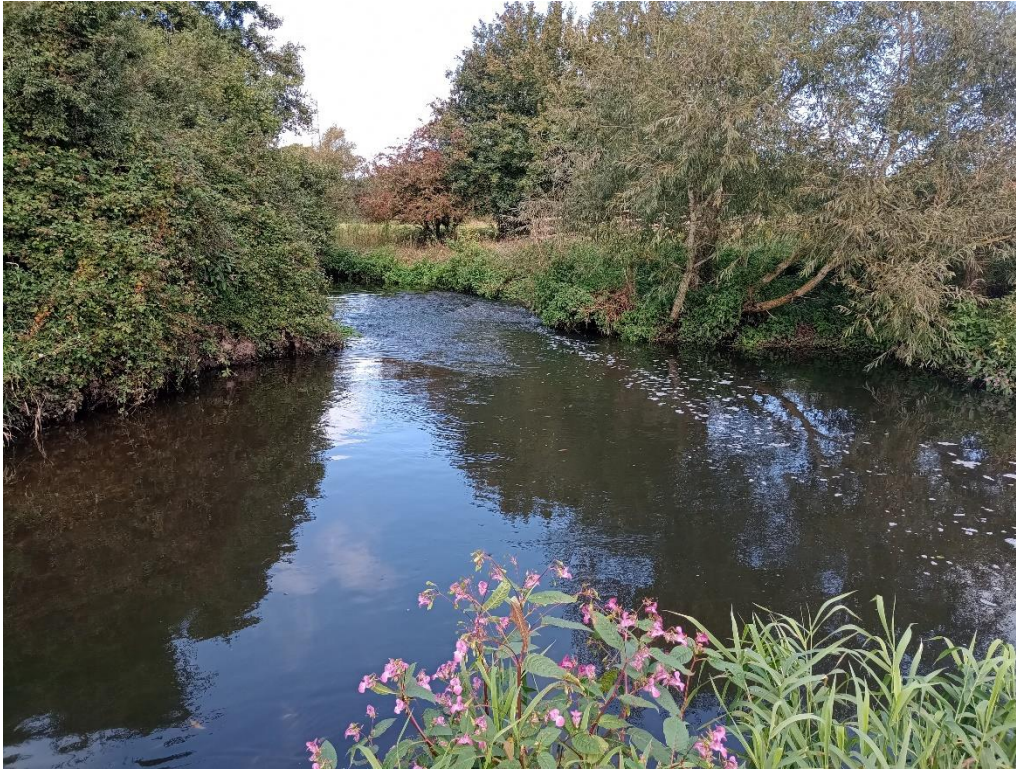
*Figure 5. (upstream view; 52.255660, -1.875571) A wide pool below a steep riffle forms a nice variety of habitats. A large fallen willow was removed from the left side (right of shot) of the channel recently to improve angling access. There is a balance to be struck between access and habitat features – removing features which provide fish cover is often counter-productive, as the fish move elsewhere or are more easily predated.*

*Note the presence of Himalayan balsam which is common throughout the reach. This non-native invasive annual plant species is detrimental to habitat by shading out native plant species before dying back in winter to leave bare banks more vulnerable to erosion. The invertebrate fauna supported by balsam is impoverished compared to typical native plant assemblages. Ideally, balsam should be controlled by hand pulling or strimming/cutting below the first node of the stem, before it flowers and sets seed in mid to late summer. The seed bank is relatively short-lived (c. 3 years), so the benefit of control measures can be seen within that timescale, although downstream drift of seed will take place from uncontrolled areas higher up the catchment.*

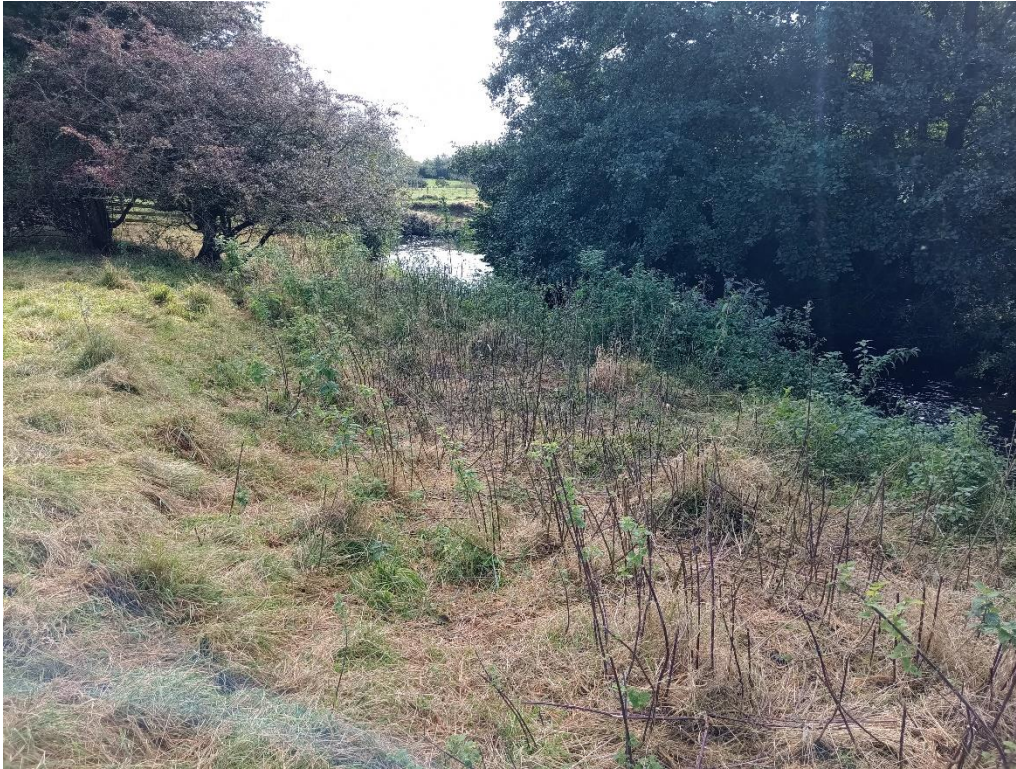
*Figure 6. (downstream view; 52.256029, -1.875986) Livestock (sheep) access to the bank here has a noticeable impact on riparian vegetation. Grazing prevents tree succession which has long term implications for bank stability and habitat. Ideally, the livestock fencing on the downstream end of the inspected reach should be extended to exclude livestock entirely.*

- Maintain the livestock fence on the left bank and consider extending it further upstream on the neighbouring landholding. Continue the light-touch maintenance for access with the strimmed path set well back from the river.
- Consider a rotational coppice of the dense tree regrowth on the upper part of the reach inspected, in order to promote a diversity of tree sizes and shading.
- Control Himalayan balsam by hand-pulling or strimming before it sets seed.
- Install some small flow deflectors on the shallow gravel riffle areas to promote localised scour and gravel sorting. This will produce patches of cleaned gravel which fish will seek out for spawning and will hopefully result in increased egg survival rates (*Figure 9* -Figure 11).

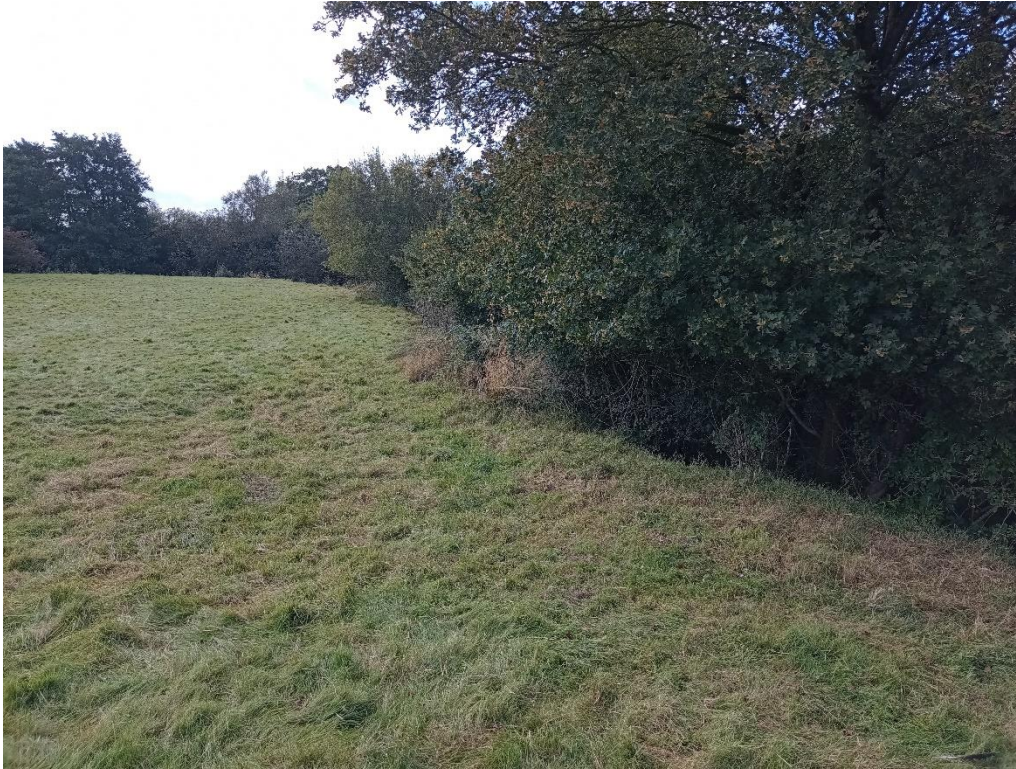
*Figure 7 (downstream view; 52.256528, -1.875667) Grazing has restricted trees to the fall of the bank here, making them more vulnerable to wash-out and also restricting access to the river for angling. It appears the trees along this section have been previously coppiced and the re-growth has formed a dense, uniform 'hedge'. A staggered, rotational annual coppice of say 1 in 7 trees (whilst leaving some trees untouched to mature) would produce varied stages and sizes of regrowth and benefit habitat diversity, with larger trees naturally suppressing growth in other areas, to return a more naturally balanced canopy. Fencing out a buffer strip would also allow tree succession and improve long term bank stability.*

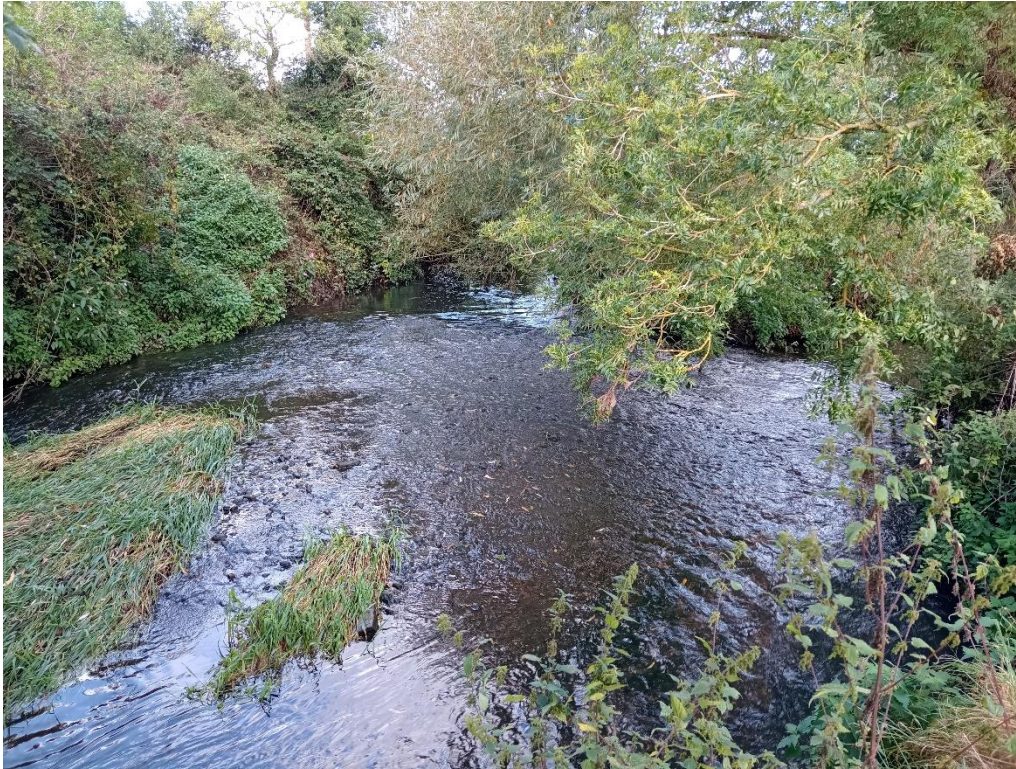
*Figure 8. (upstream view; 52.257851, -1.875905). Riffle at the upstream extent of the reach inspected, just downstream of Spernal Lane. The wide river channel here has promoted coarse sediment deposition, creating a riffle and vegetated shoals, with some nice stream habitat features now developing.*

*A brief inspection of the underside of stones and algae indicated an invertebrate community characteristic of organic pollution, with abundant hog louse (*Asellus aquaticus*), blackfly larvae (*Simulium* sp.) and freshwater sponge and an absence of the pollution sensitive taxa that should be dominant in a stream of this character.*

*The gravels here contained large amounts of fine sediment and would benefit from structures to create localised scour to improve fish spawning potential.*

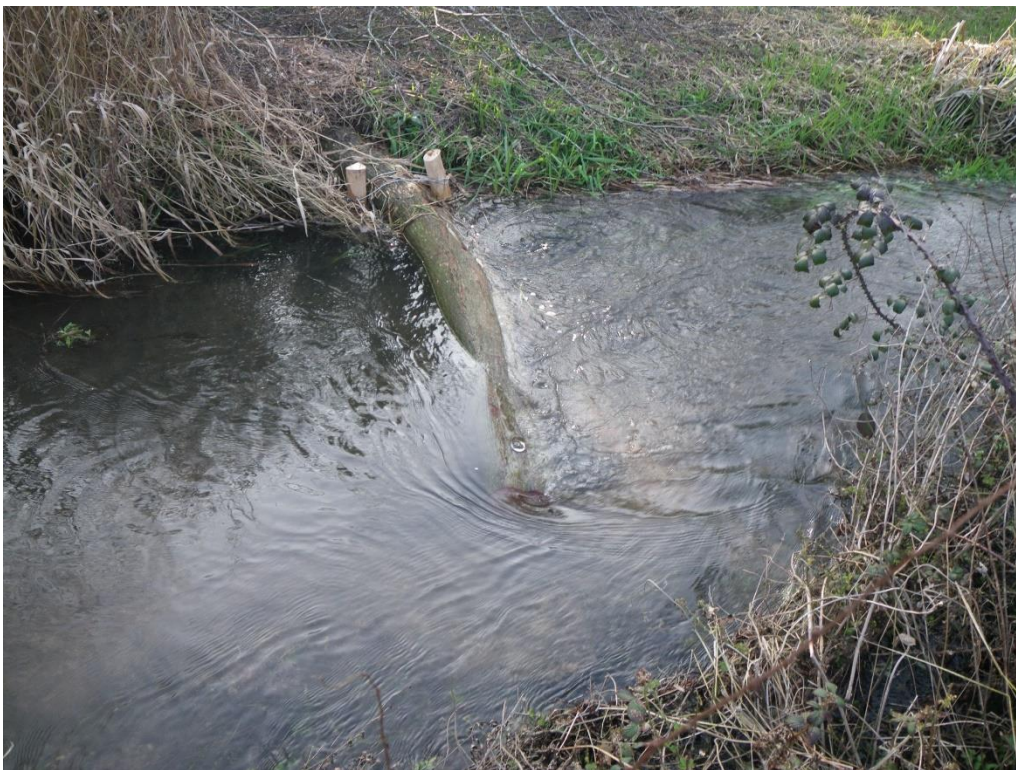
*Figure 9 A log flow deflector set perpendicular to the flow and secured in place with chestnut posts and wire (bank end) and rebar pinned to the bed. Both overshoot and undershot flows will locally scour and clean gravel downstream of the structure.*

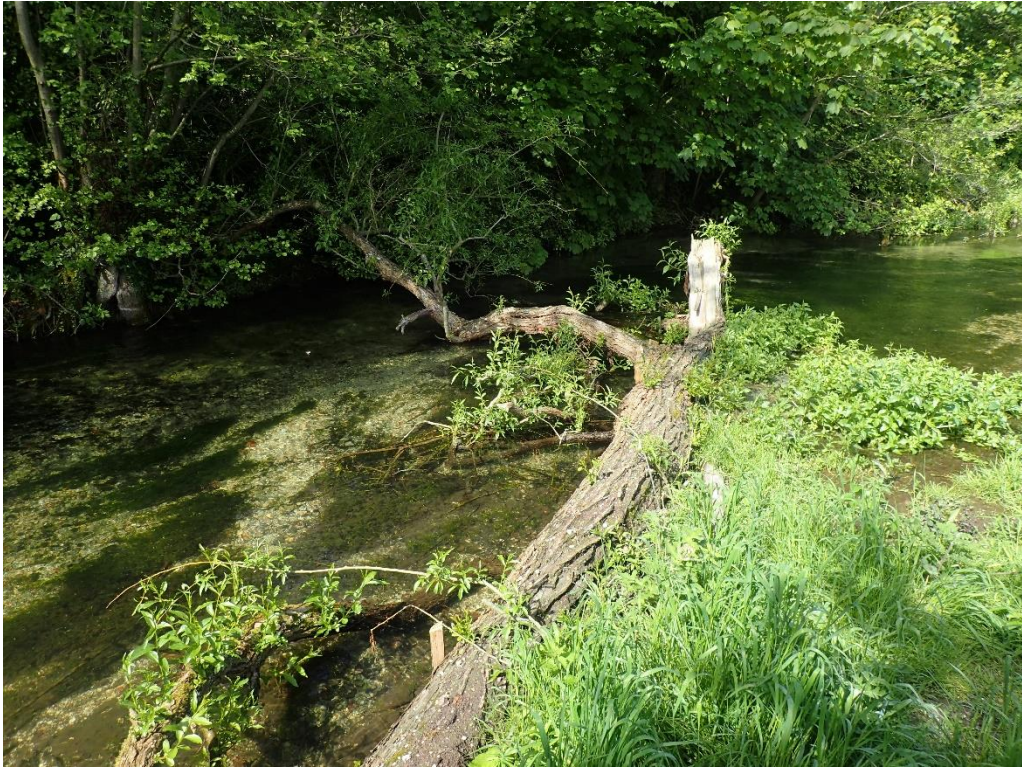
*Figure 10 A willow limb hinged over and pinned in place to create gravel scour; one year after placement.*

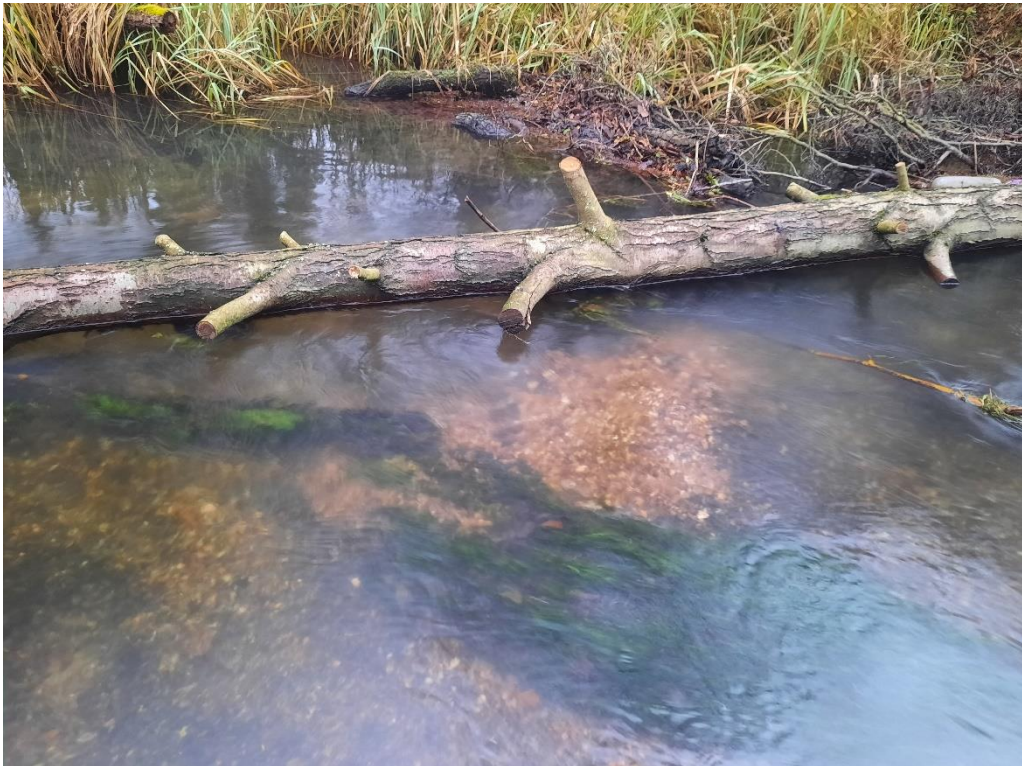
*Figure 11 A felled and secured alder trunk in the River Mimram, Herts., which has attracted trout to cut a redd (spawning 'nest' – the hollow and ramp of clean gravel visible in centre of shot) in the scoured gravels downstream.*
