WILD TROUT TRUST

**River Bain**

(River Witham Catchment)

October 2023

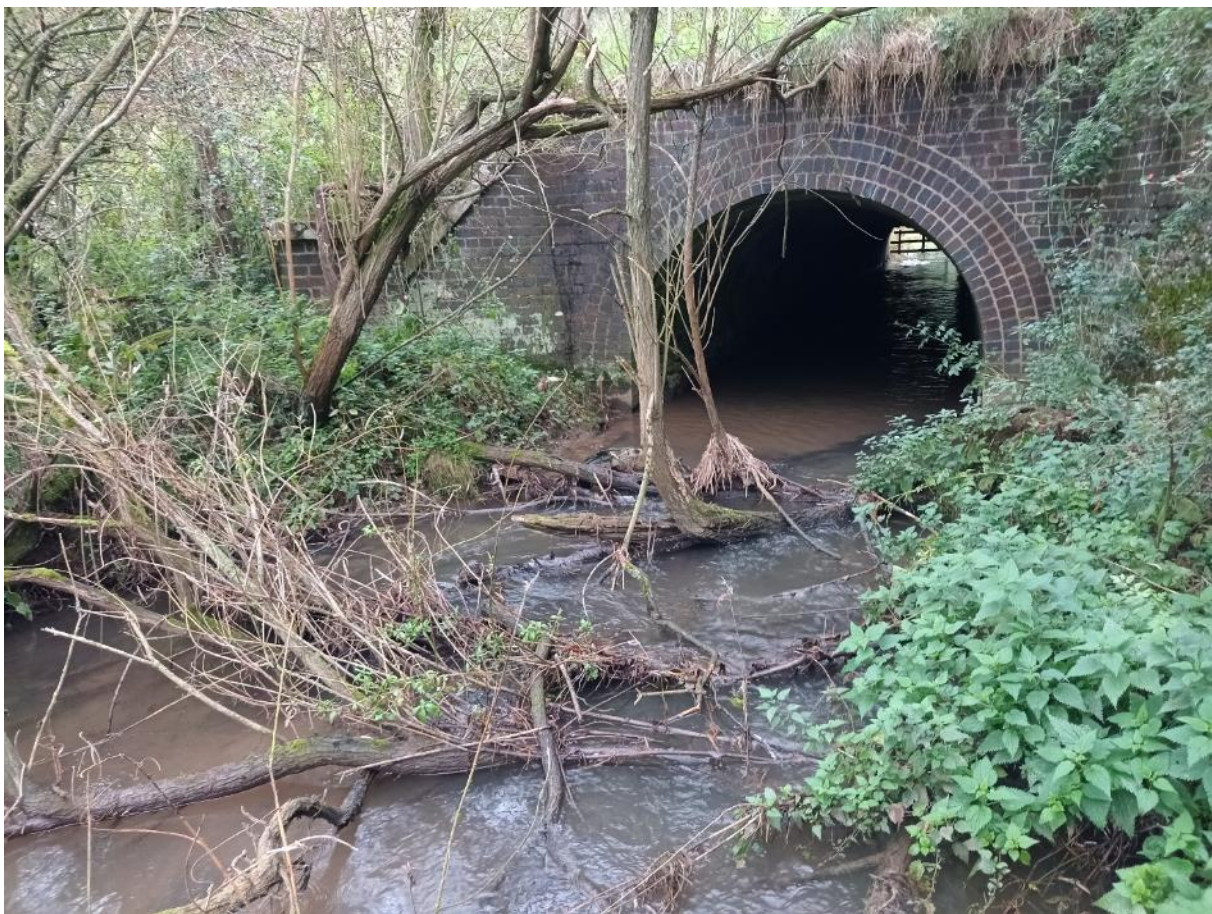
*Figure 2. (53.32262, -0.1517844) The culvert beneath the disused railway line has a natural bed gradient and does not present any barrier to the free movement of aquatic organisms nor sediment transport. Woody material within the river channel provides good in-stream habitat.*

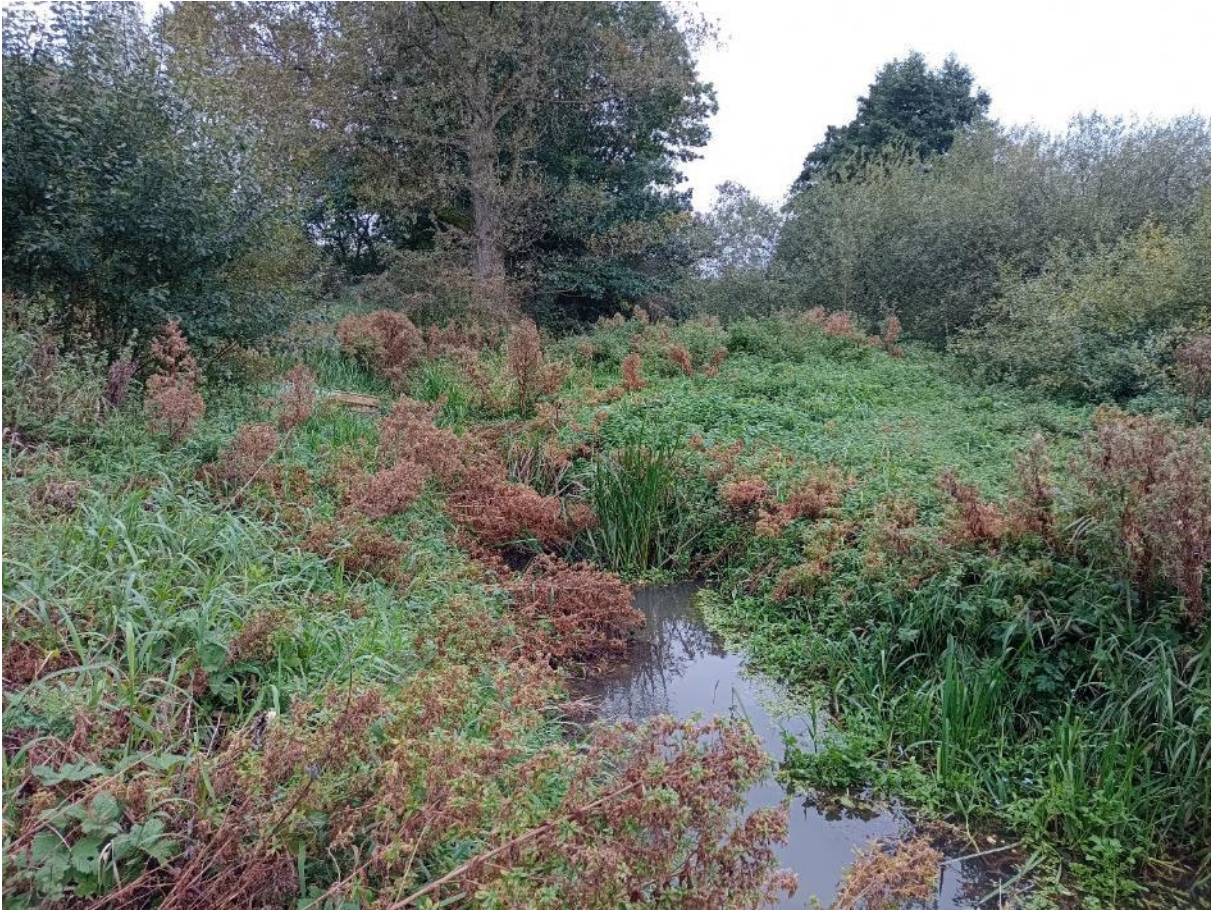
*Figure 3.(53.322598, -0.151713) Downstream of the railway line the river borders a lake on the LB. The lake is offline, with a controlled inflow and overspill from the river. The planform of the river is meandering and does not appear to have been modified by the creation of the lake. Alongside the lake the river flows through a corridor of wet floodplain with aquatic vegetation and mainly willows and salallows. Where tree shading is denser, the channel is more open, whereas less shaded areas have more emergent aquatic vegetation (reeds, rushes).*

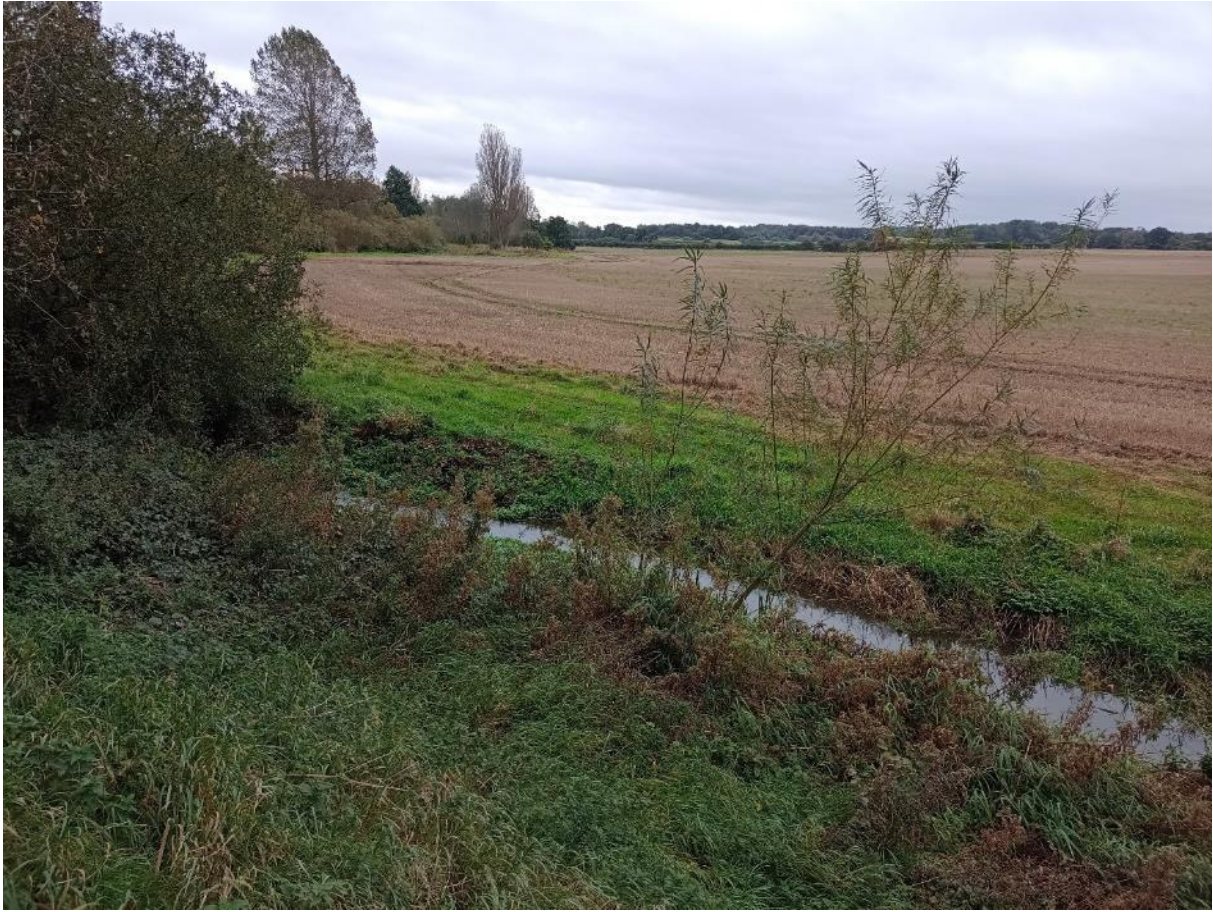
*Figure 4. (53.32119, -0.1508911) Looking west from the lake embankment across the river. The land on the RB of the river (different ownership) is used for arable agriculture, with a grass buffer alongside the river (the land is under Entry Level plus Higher Level Stewardship, ([magic.defra.gov.uk](https://magic.defra.gov.uk))).*

*Although the river within this reach is not entirely straight, it is less meandering than adjacent stretches and it is probable that it has been altered in the past for land drainage. This is likely to have involved dredging to deepen the river channel and provide outfall for drains. Dredging has a detrimental impact on river and floodplain habitat by removing the pool-riffle sequence, lowering the adjacent water table and drying of the land, and disconnecting the river from its floodplain. Where adjacent land is in agricultural use, and the land drainage function is still required, this may be a constraint on river and floodplain restoration.*

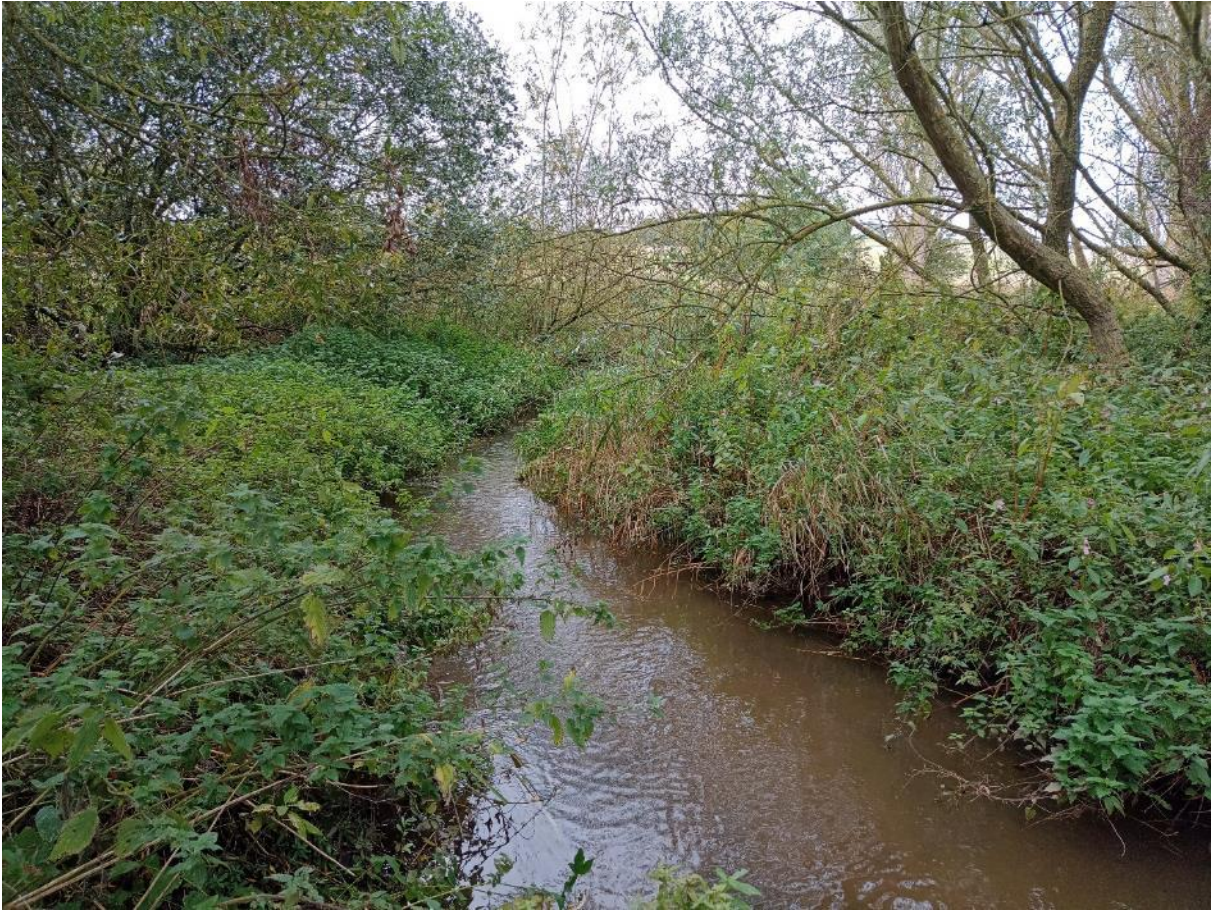
*Figure 5.( 53.317703, -0.148828) Not all this reach is bordered by agricultural land, with some meandering sections contained within a corridor of natural vegetation providing good riparian habitat. The in-stream habitat however remains poor quality, comprising uniform channel dimensions, flow pattern (glide) and a dominance of unsorted, fine sediments.*

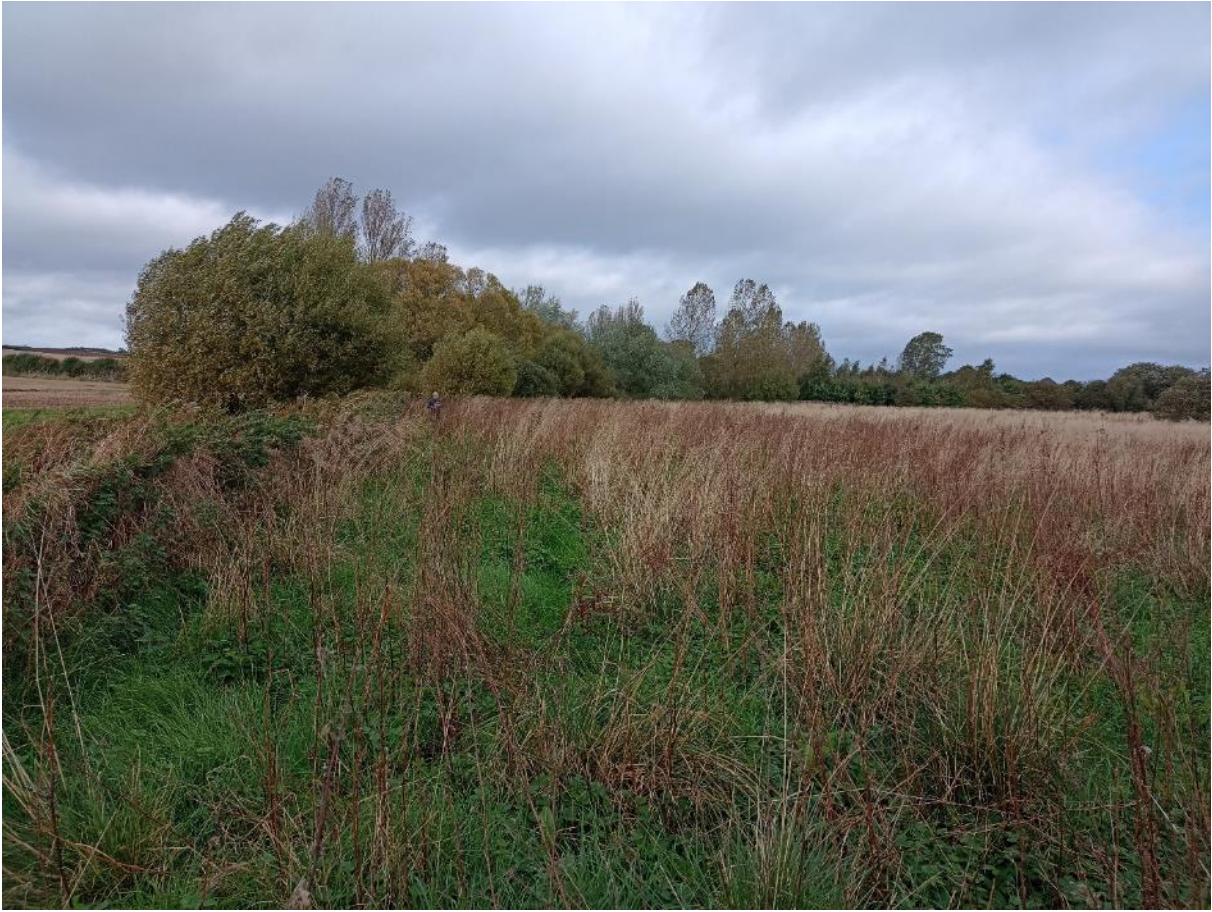
*Figure 6. (53.316837, -0.148170) Land use on the east bank of the river is low intensity compared to the west bank (below). The quality of in-channel river habitat here is poor - incised, straight and full of emergent vegetation, suggesting past modification.*

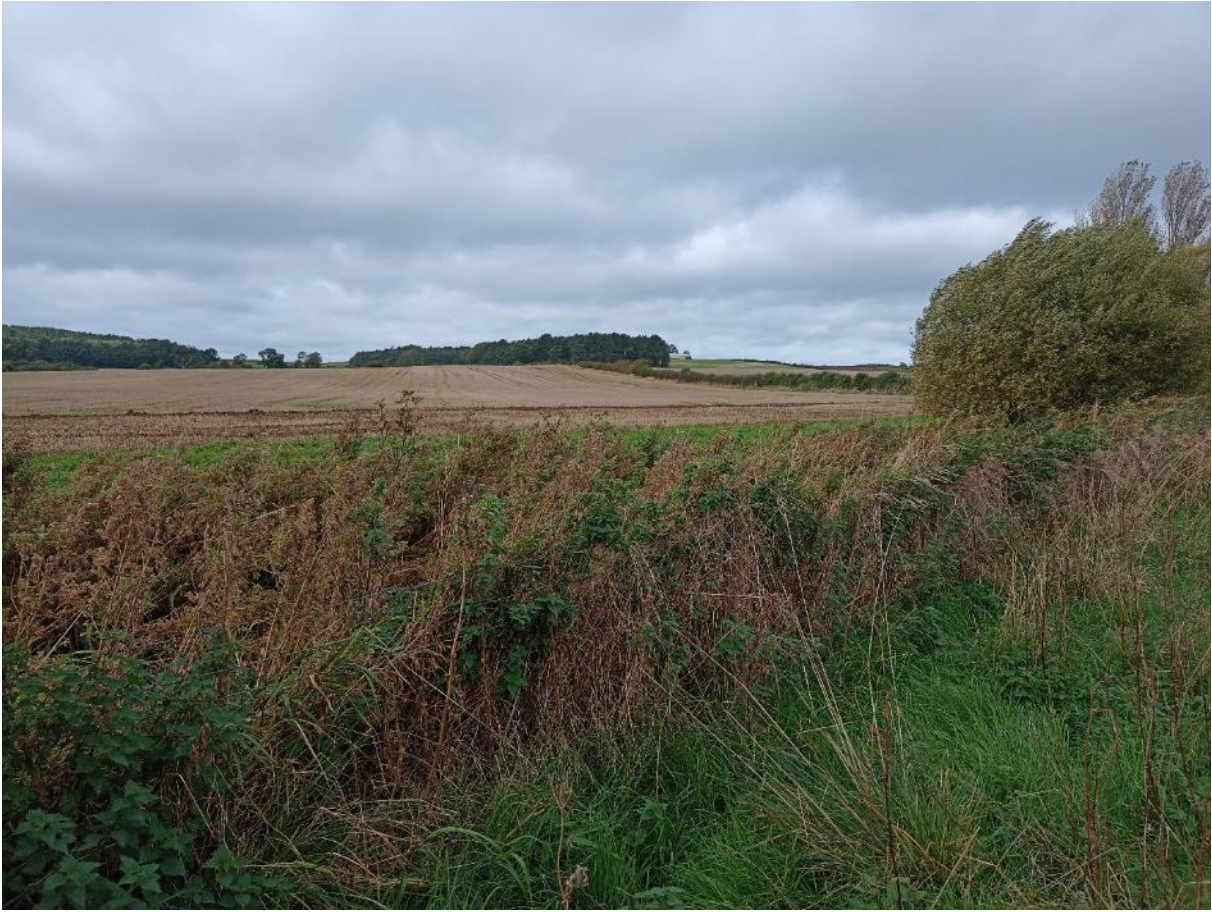
*Figure 7.( 53.316837, -0.148170) A view across the river to the west where land use is arable agriculture.*

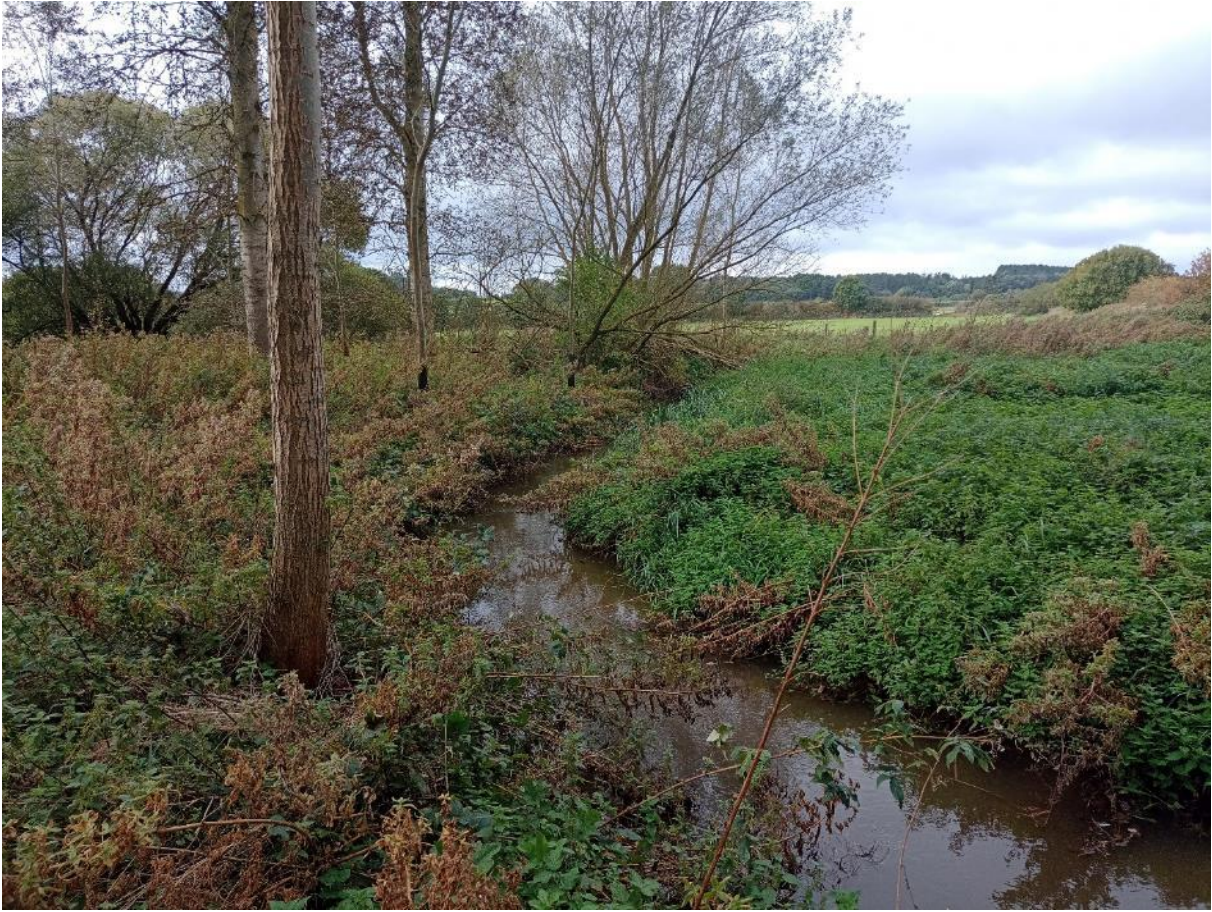
*Figure 8 (53.315968, -0.146902). Near the public footpath crossing (Viking Way) the river has a more meandering planform and the floodplain headlands have been planted with cricket bat willows.*

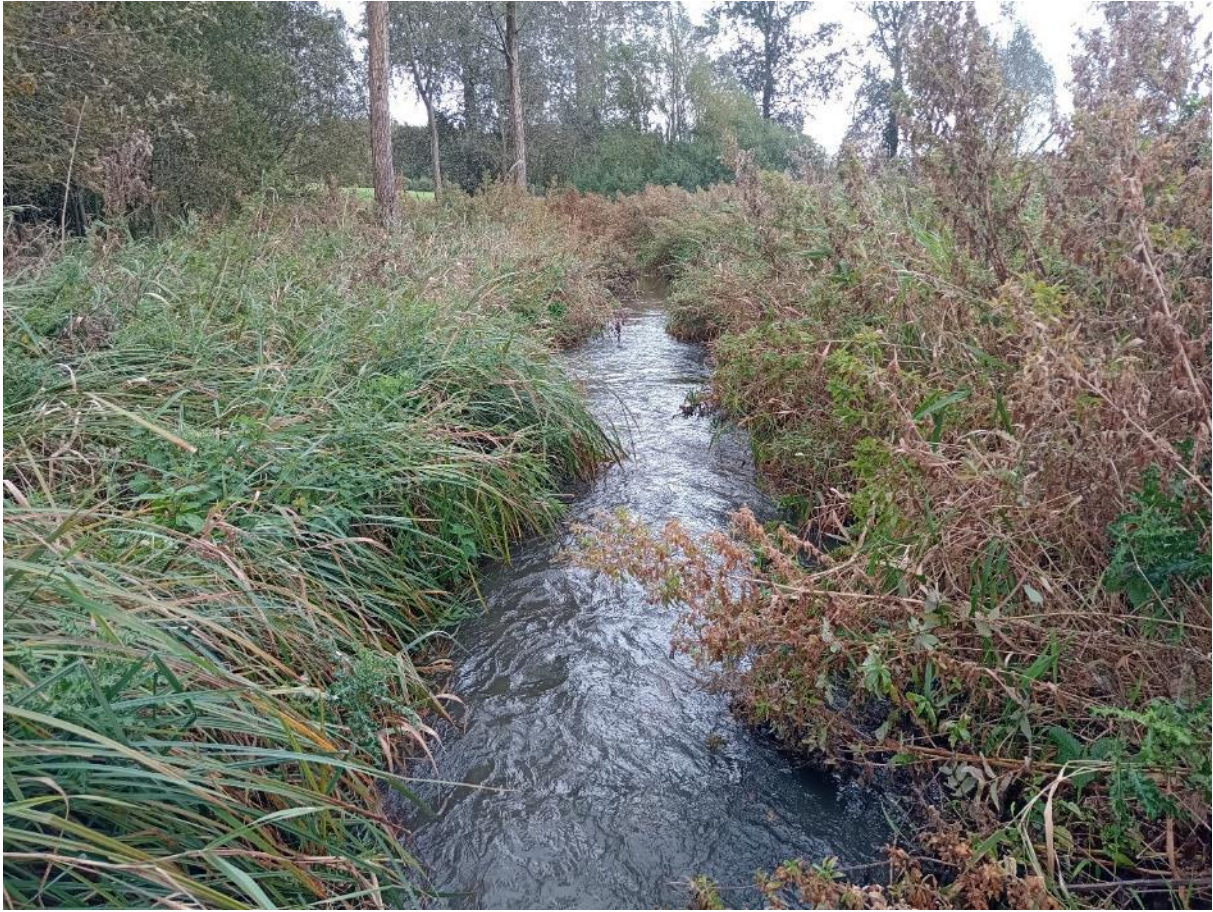
*Figure 9. (53.315510, -0.147480) More varied flow patterns are evident here where the channel appears to have a steeper gradient. There were some larger stones on the river bed here (cobble-size and larger) – larger than would be expected to occur naturally, possibly the remains of a man-made structure (weir or ford?). The riparian habitat here is excellent, with thick beds of sedge overhanging the margins.*

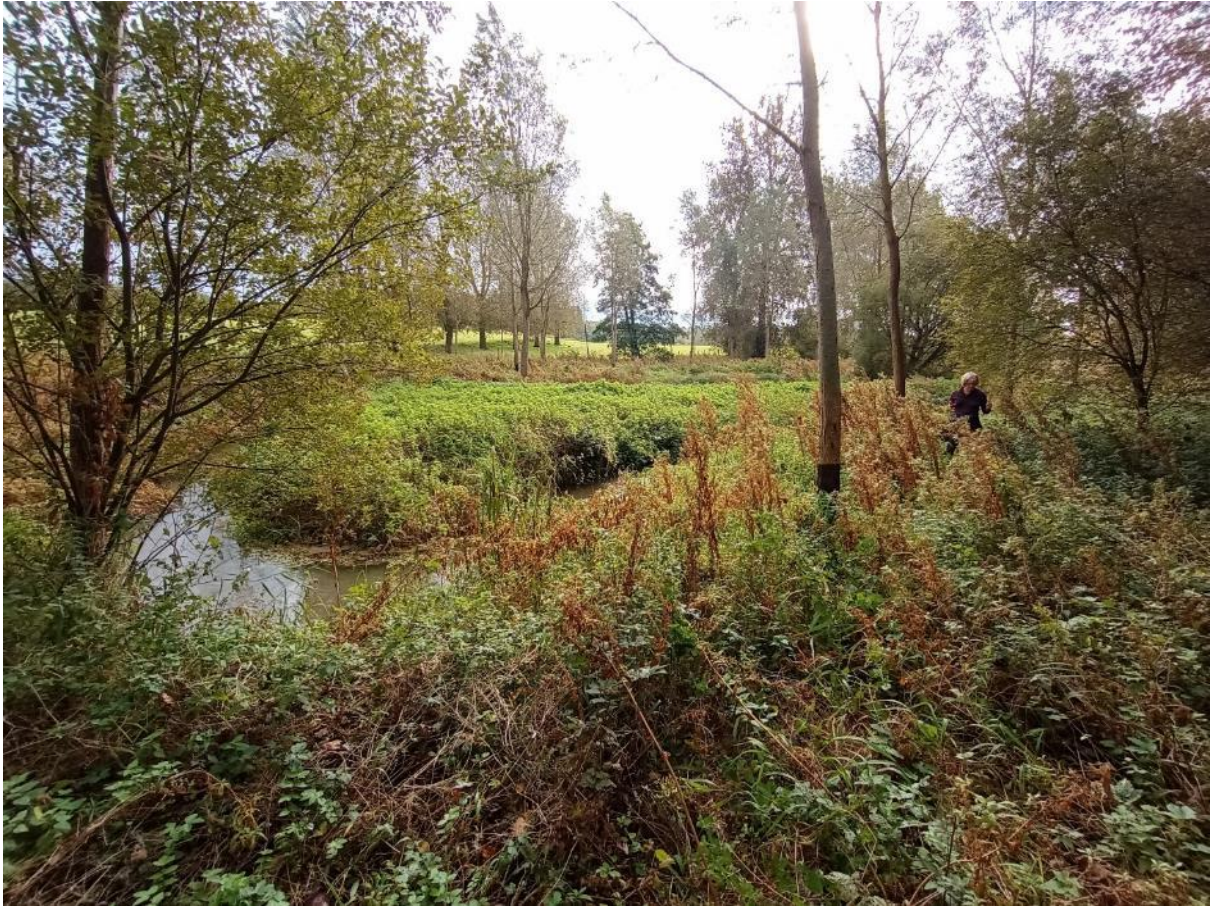
*Figure 10 (53.315743, -0.146742) A sinous section of river downstream of the faster section in Figure 9.*

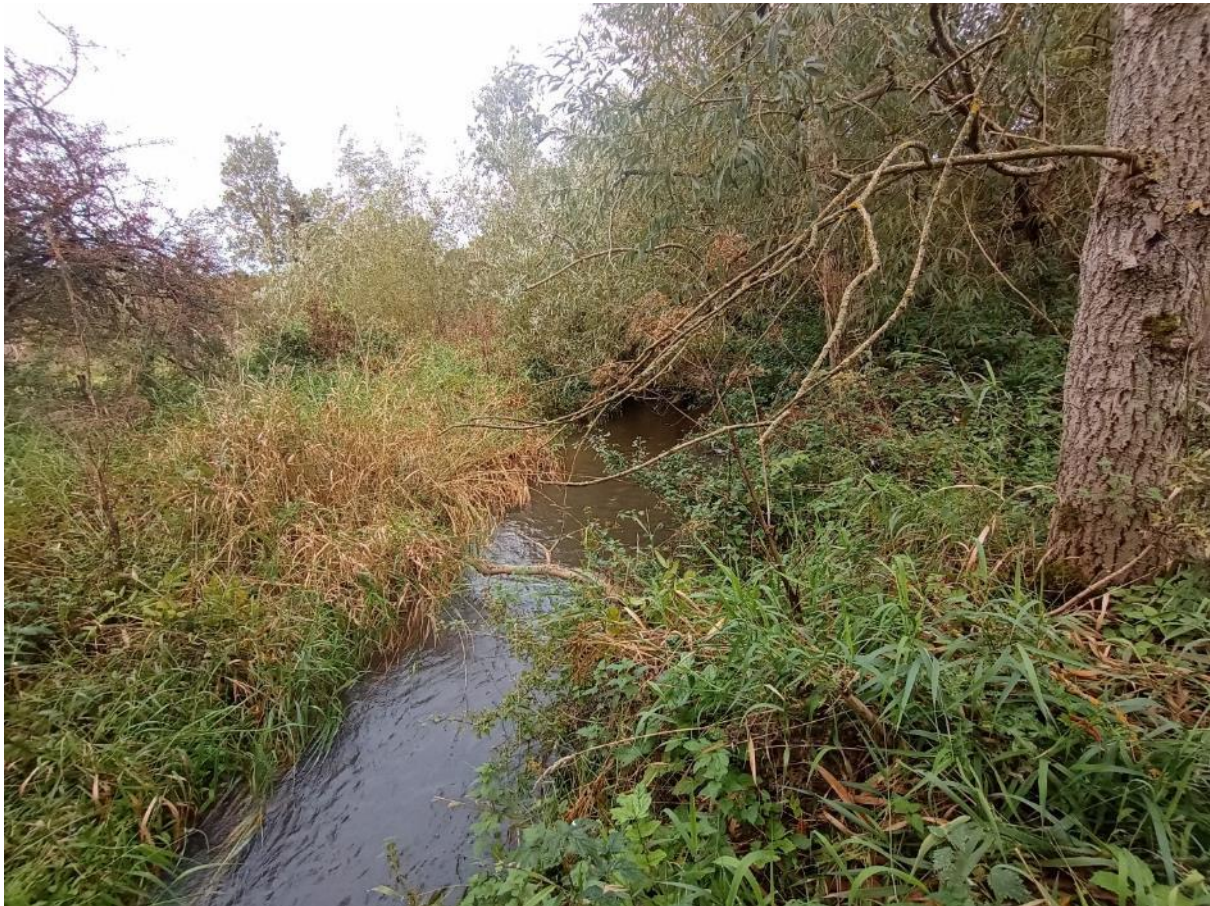
*Figure 11. (53.30895, -0.1434275) A typical view towards the upstream extent inspected – a wildness rarely seen on a lowland river in the UK, and an example of some excellent habitat.*

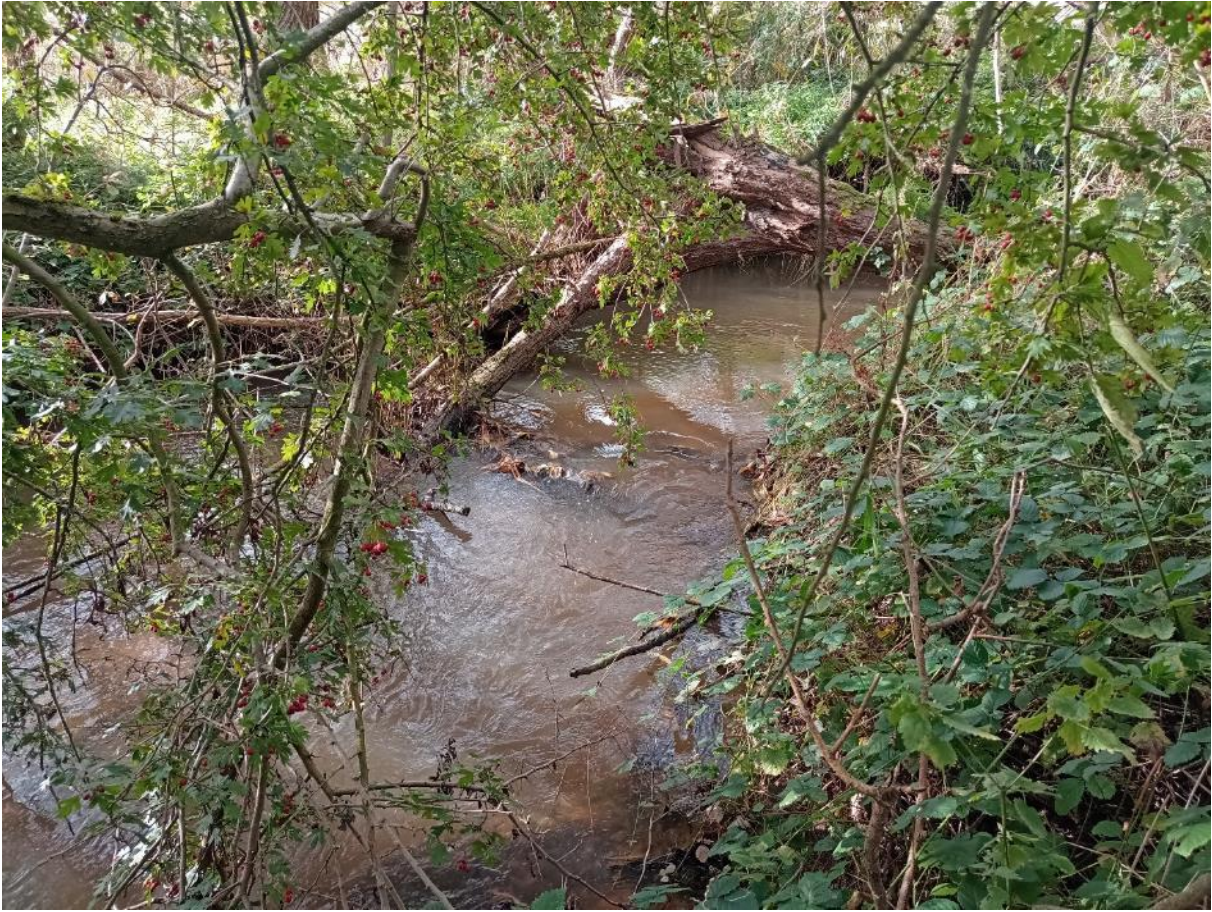
*Figure 12. (53.308800, -0.143635) Fallen wood occurs regularly within the channel and contributes to the good habitat seen. It provides numerous benefits including diversifying flow patterns and sorting of sediments, and trapping leaf and weed litter; this provides habitat niches for various invertebrates and spawning opportunities for fish.*

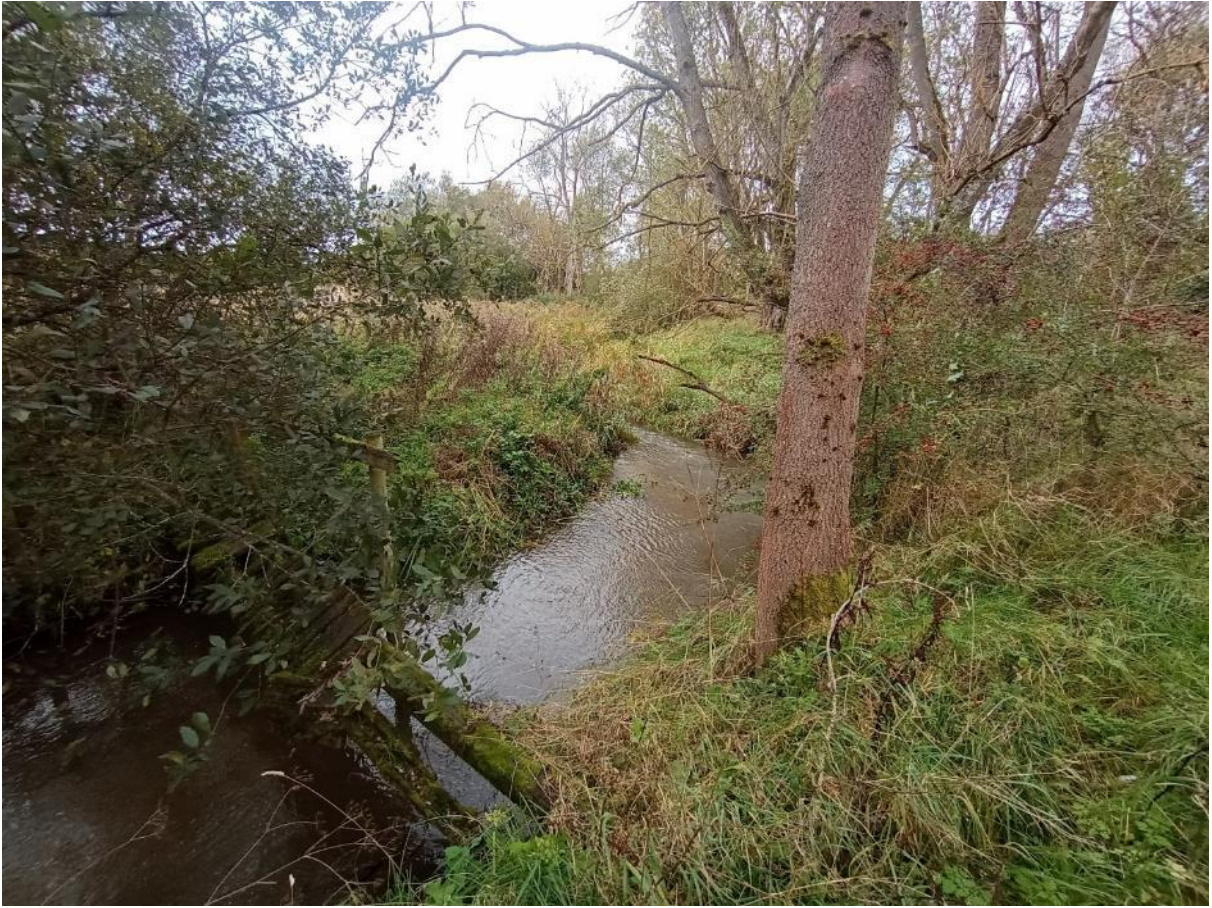
*Figure 13. (53.308483, -0.142557) The river channel becomes more incised with downstream progress, indicating some modification has occurred in the past.*

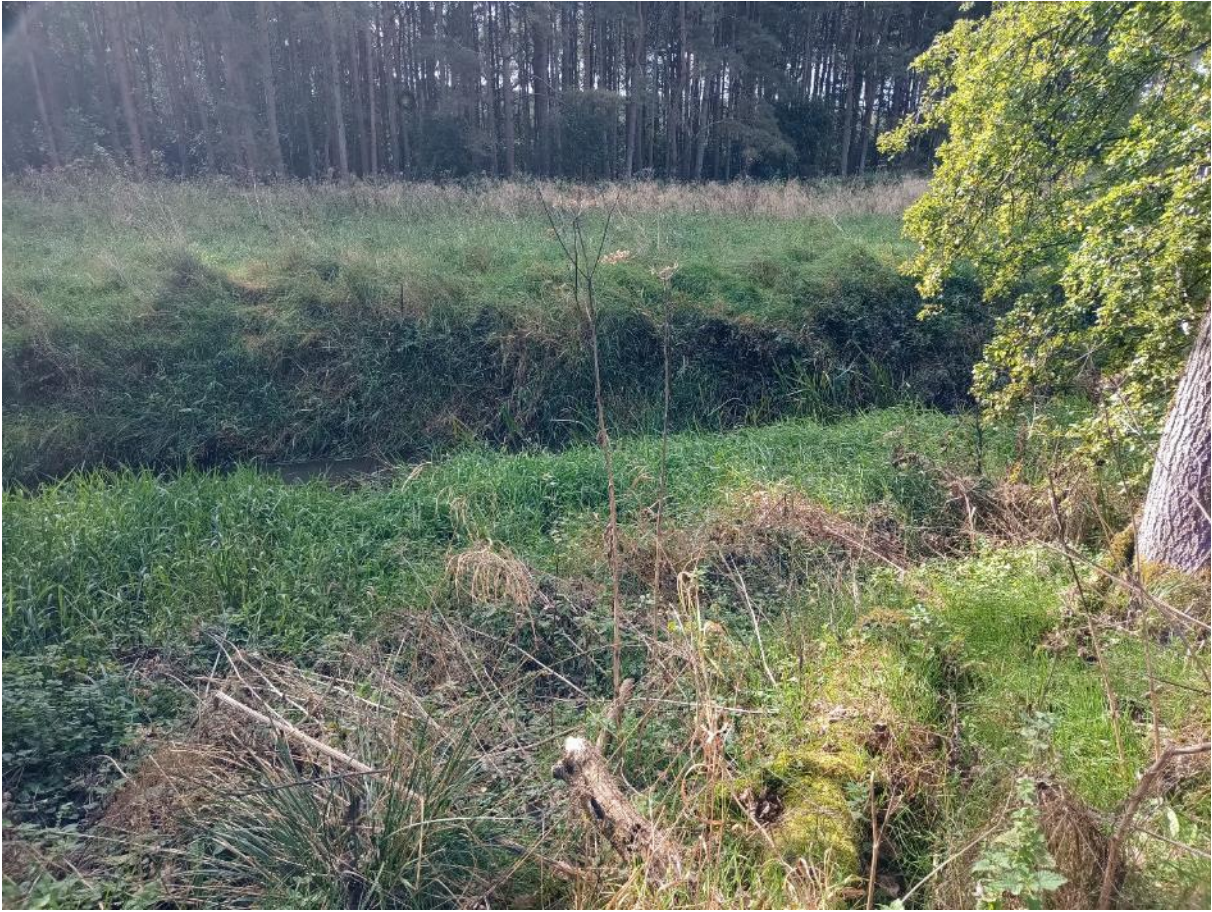
*Figure 14. (53.30766, -0.1413704) As above – note the high RH bank.*

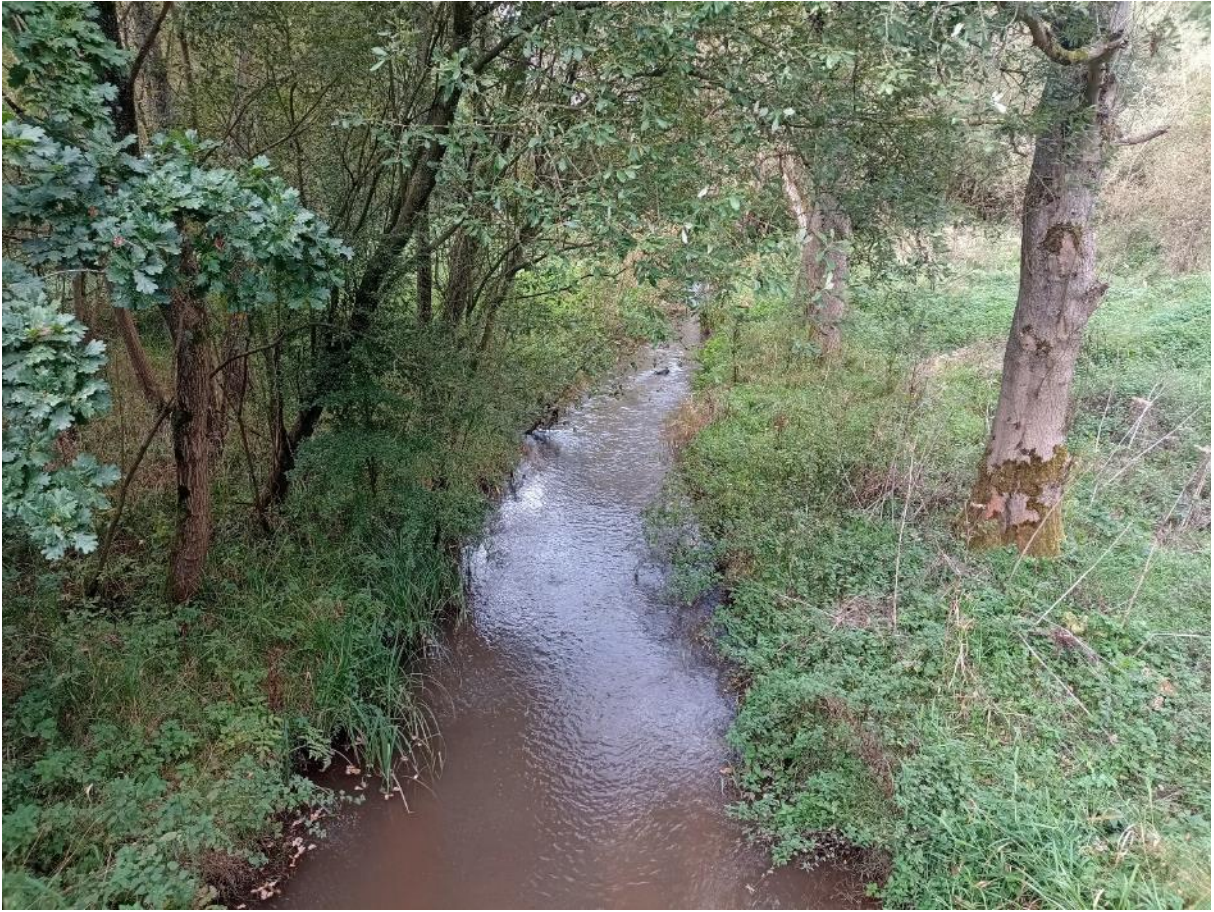
*Figure 15 (53.30710, -0.1405909) A view upstream from the road bridge shows more uniform channel dimensions.*

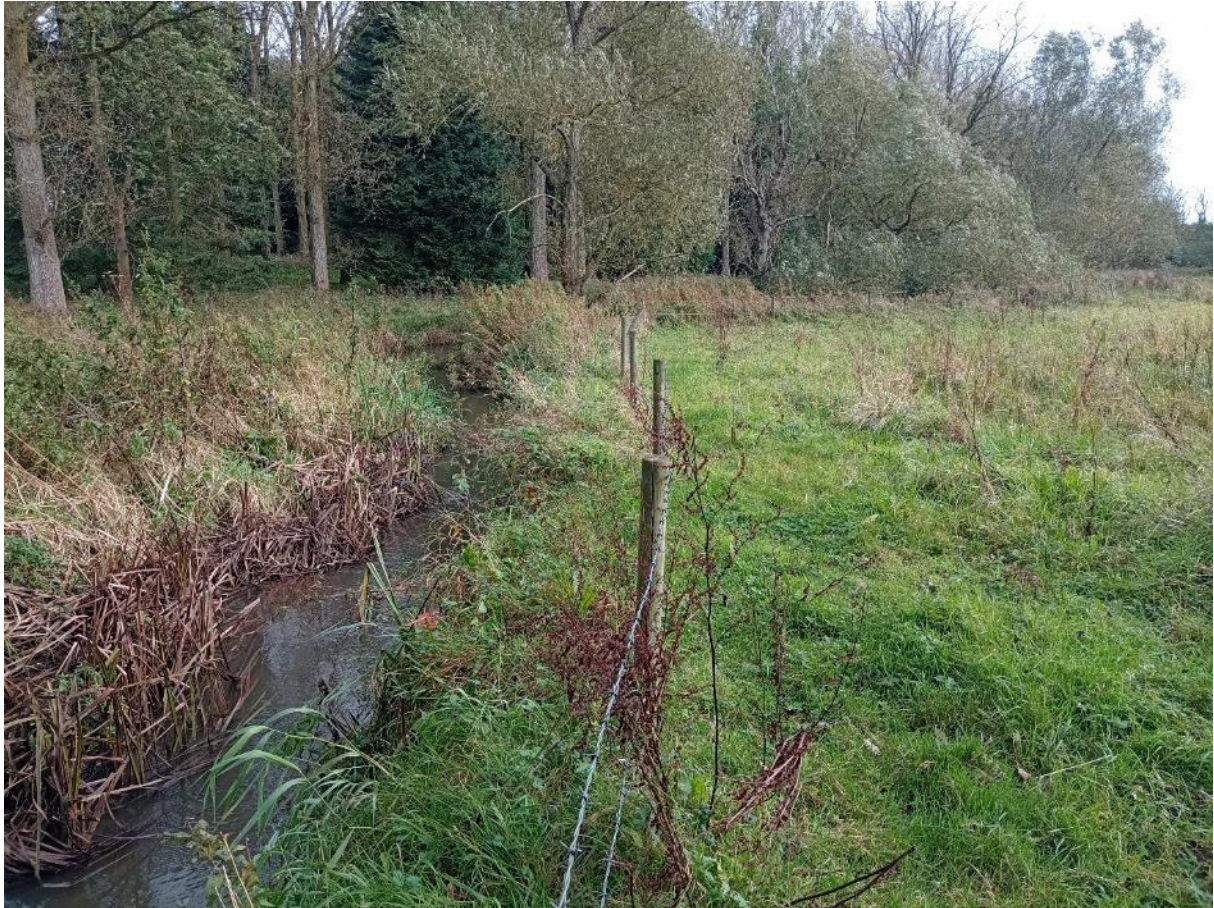
*Figure 16. (53.306950, -0.140100) Downstream of the road bridge the river is bordered by a poplar plantation on the left bank and land used for grazing on the right bank. The river channel is quite incised, potentially indicating past drainage works.*

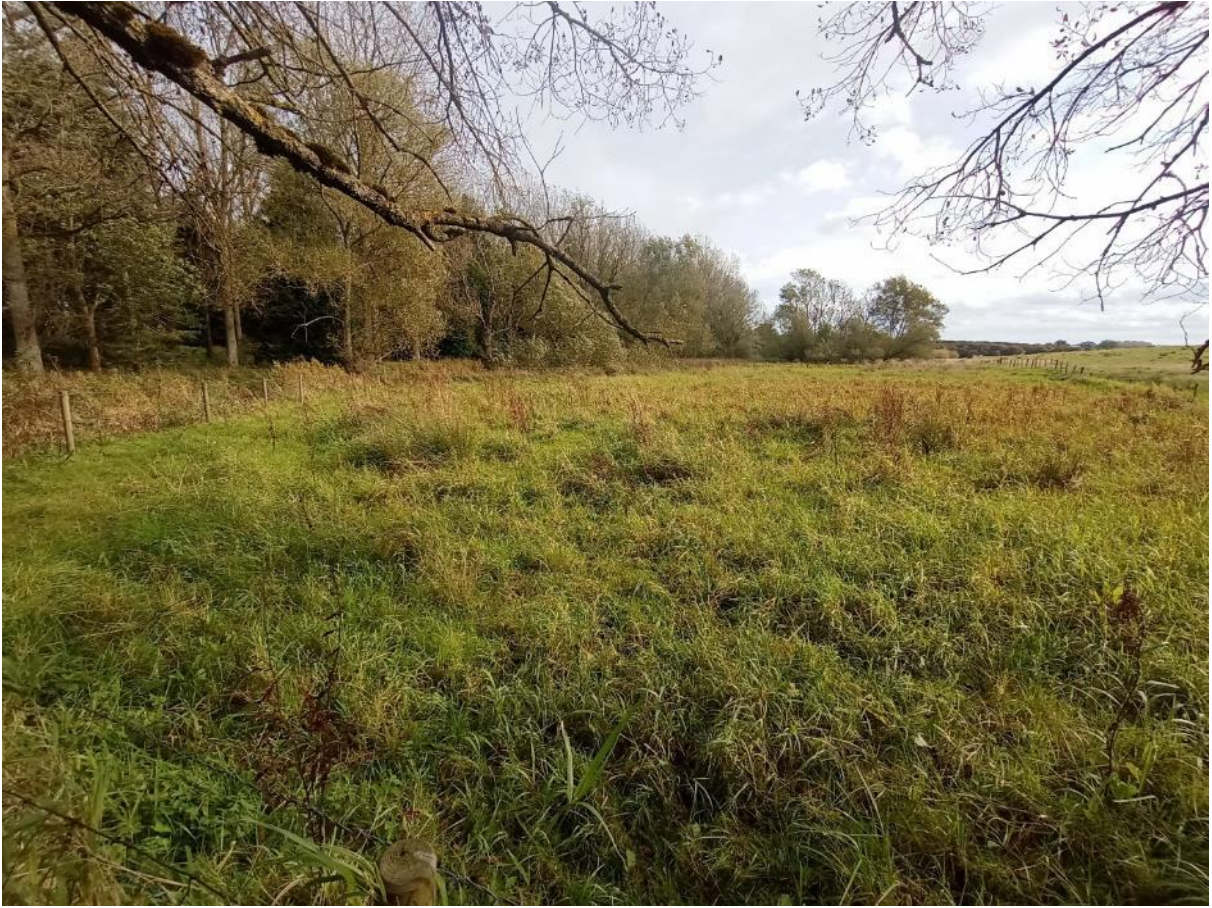
*Figure 17 (53.30674, -0.1398493) A wider view from the same perspective as Figure 16. The flood plain here is wet, although this may be from seepage from the base of the valley side rather than the river.*

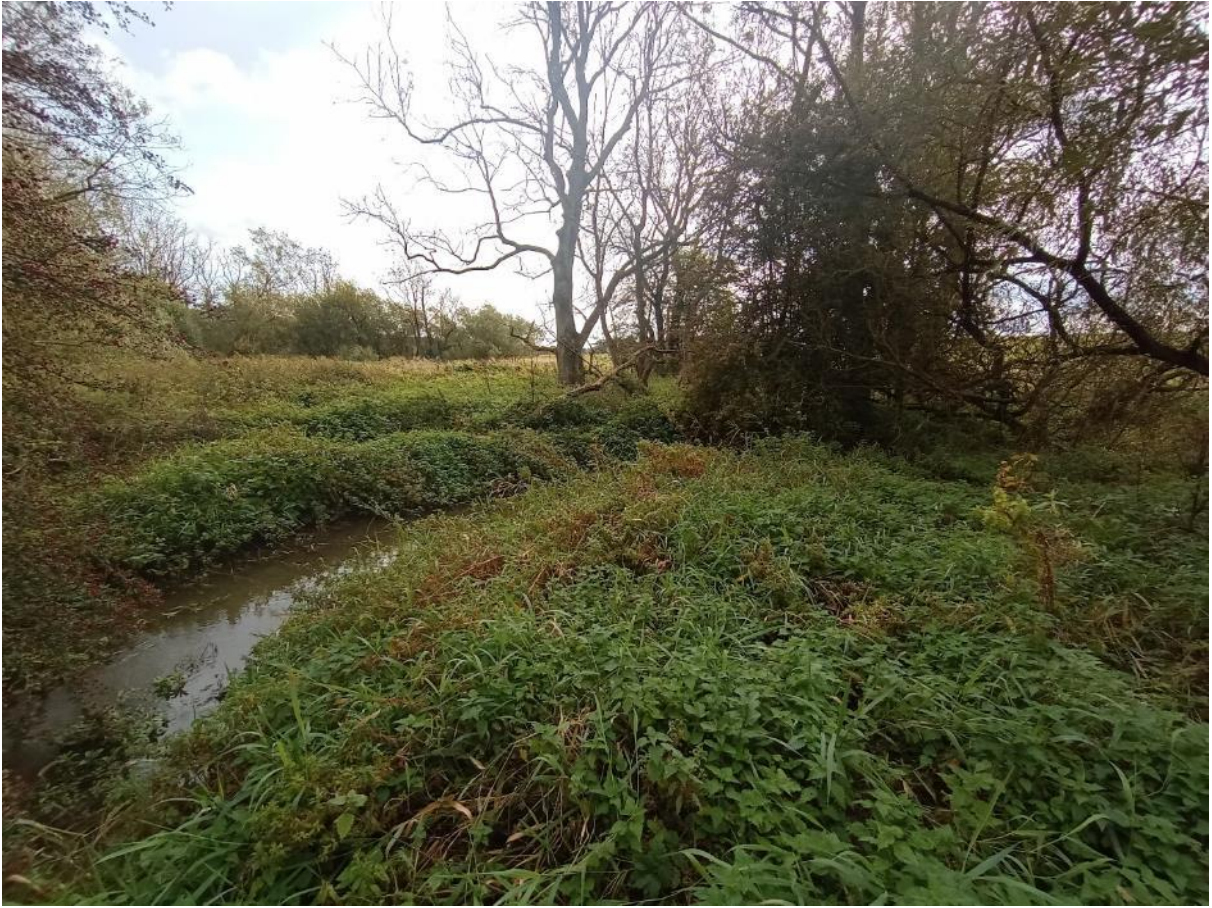
*Figure 18.(53.306389, -0.138788) Meander bend at the downstream end of the plantation, downstream view.*

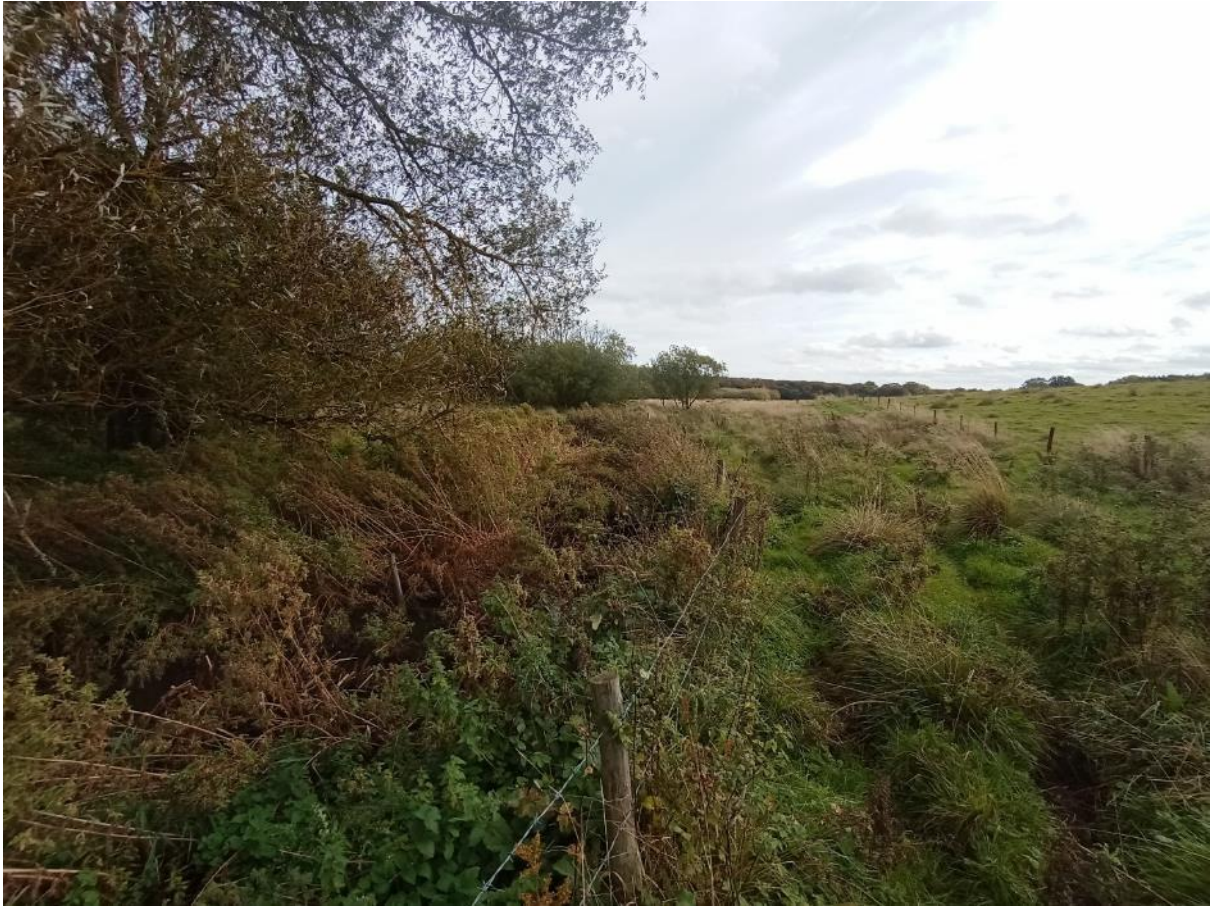
*Figure 19. (53.30592, -0.1388630) View down the valley from the meander bend in Figure 18.*

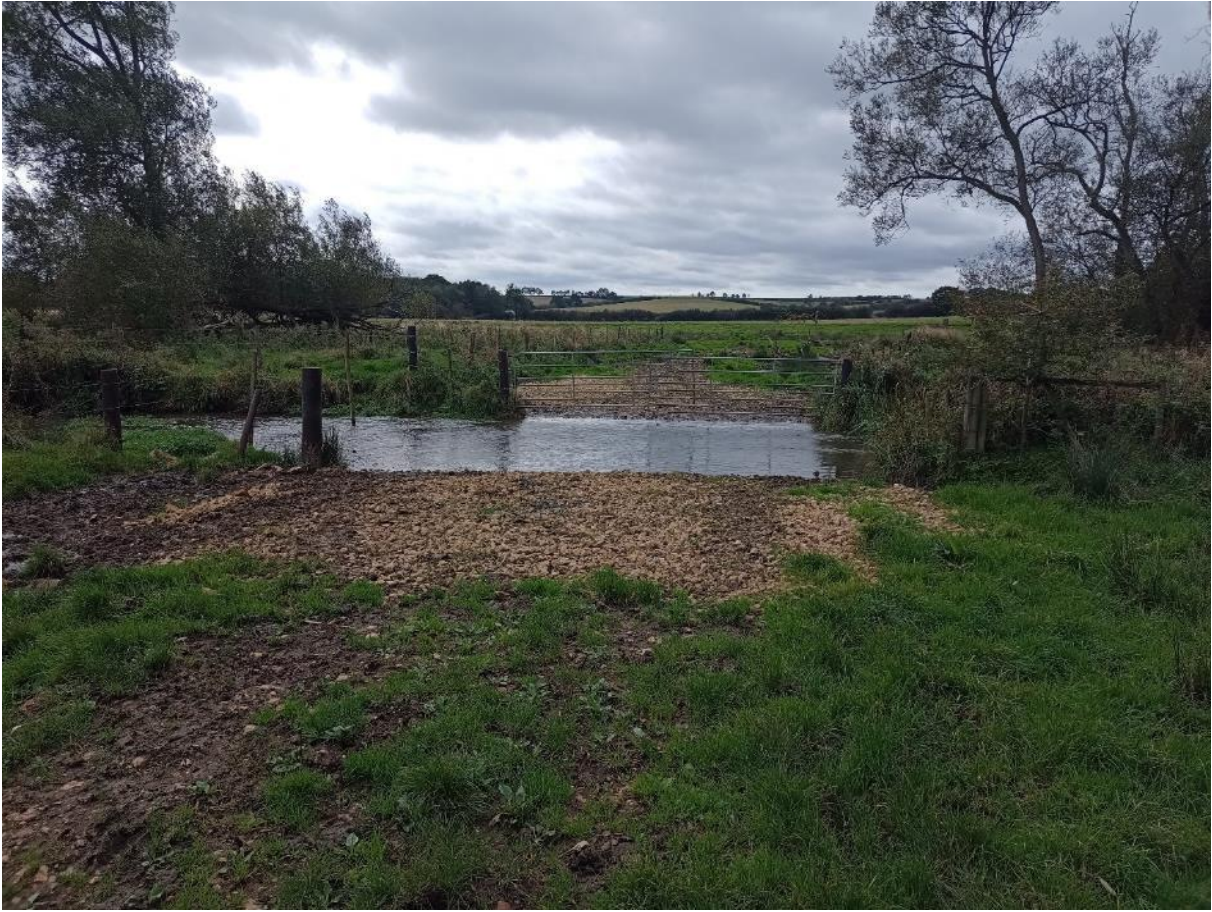
*Figure 20. (53.30546, -0.1364610) Ford crossing at downstream end of plantation, just downstream of the Stenigot Beck confluence; view to the west. The use of crushed aggregate is good practice, helping to limit the input of fine sediment to the river.*
