WILD TROUT TRUST

**River Bain**

(River Witham Catchment)

October 2023

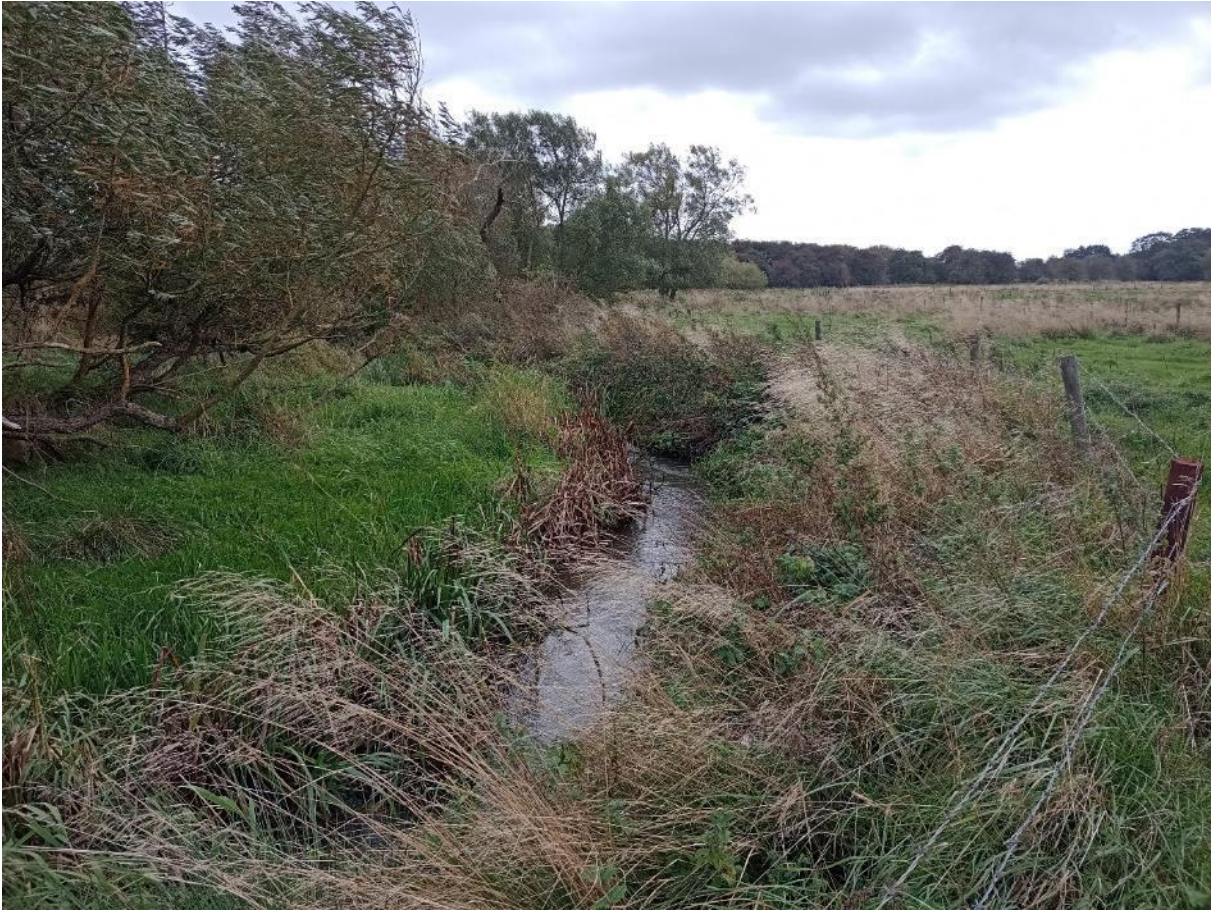
*Figure 21. (53.305191, -0.136772) Downstream of the ford, showing the low, well-connected floodplain area on the left bank.*

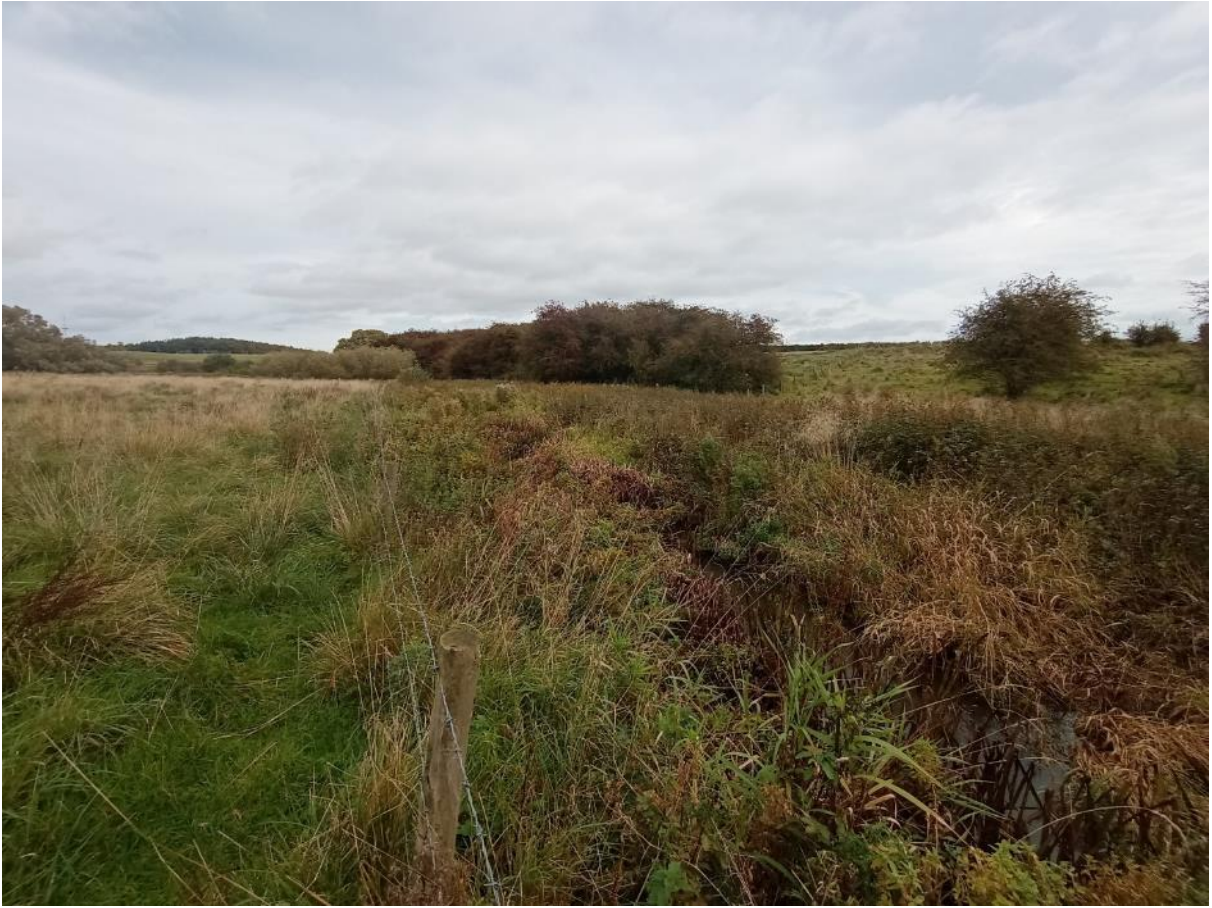
*Figure 22 (53.302975, -0.136690). View upstream along the artificially straight section of channel between the ford and the downstream boundary. The river channel here is over-wide, incised and disconnected from its floodplain. This section may present an opportunity for a river and floodplain restoration project. See also Figure 31.*

The area which seems to have the most potential for habitat improvement is the section of straightened river and floodplain towards the downstream end of the Bain (Figure 31). It appears the land on either side of the river is within the ownership of Stenigot Estate, and land use is low intensity cattle grazing. There is a reasonably wide floodplain here that extends up to the road bridge and is already quite wet in places, so there may be potential for restoration works to encompass a wider area of floodplain than just the section alongside the straightened channel.

The aims of restoration work here would be to increase the connectivity between river and floodplain (aiming for the river to exceed bankfull and spill onto the floodplain at a return period of around 1-in-2 years), and to increase the diversity of channel habitats. Techniques to achieve this include:

- Raising the river bed level by introduction of gravels (of appropriate size and local provenance) and large woody structures.
- Removal or lowering of bunds/levees alongside the river channel at strategic points to encourage higher flows onto the floodplain.
- Introduction of large woody structures to the floodplain to diversify flow and channel patterns.
- Excavation of features within or alongside the river channel, for example meanders (along the straightened section), bank reprofiling, channel widening, backwater creation.
- Breaking of land drains within the floodplain (if present).

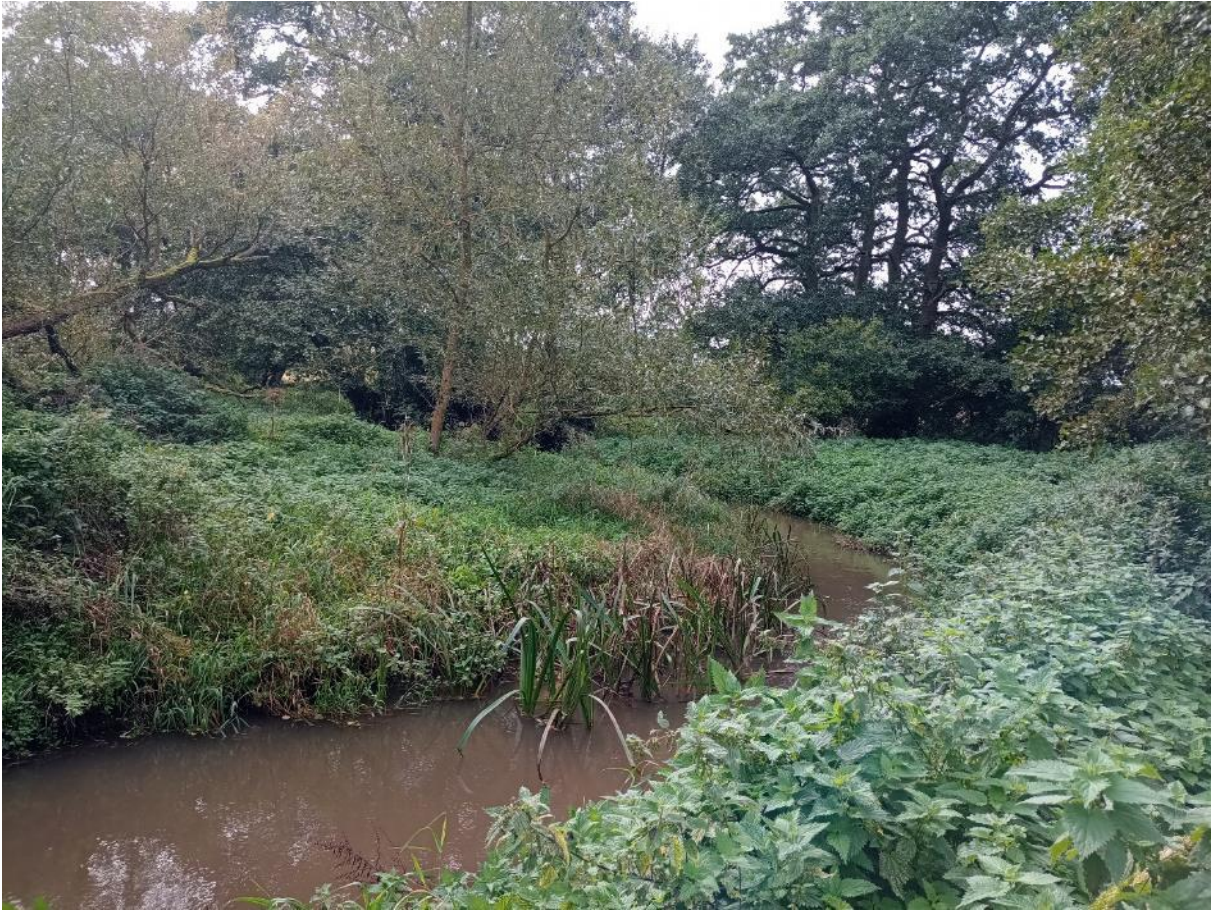
*Figure 23 (53.302528, -0.137655). The bend at the downstream end of the section of river in Figure 22.*

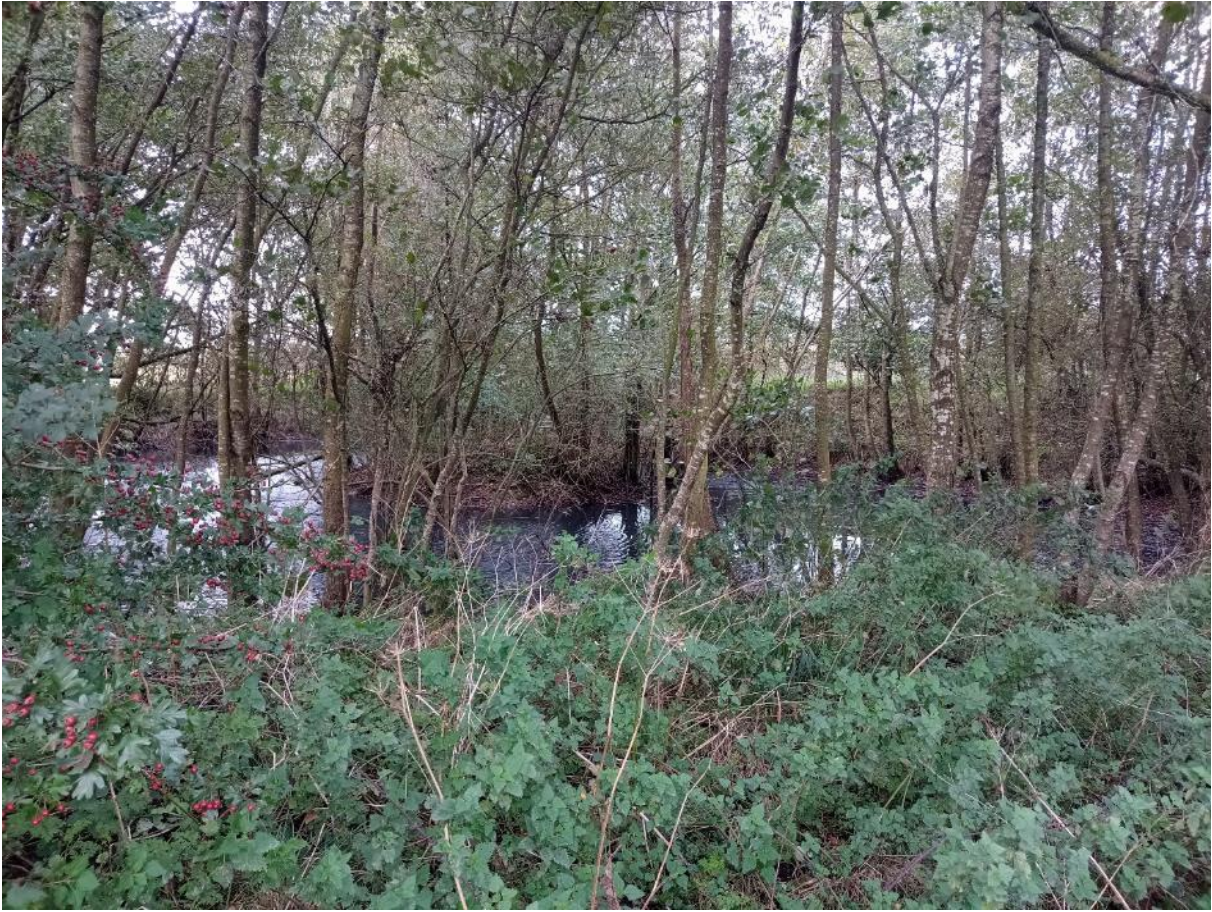
*Figure 24. (53.30267, -0.1380627) A pond adjacent to the river in Figure 23. This has evidently been created by excavation with the spoil used to form the island and bund surrounding the pond.*

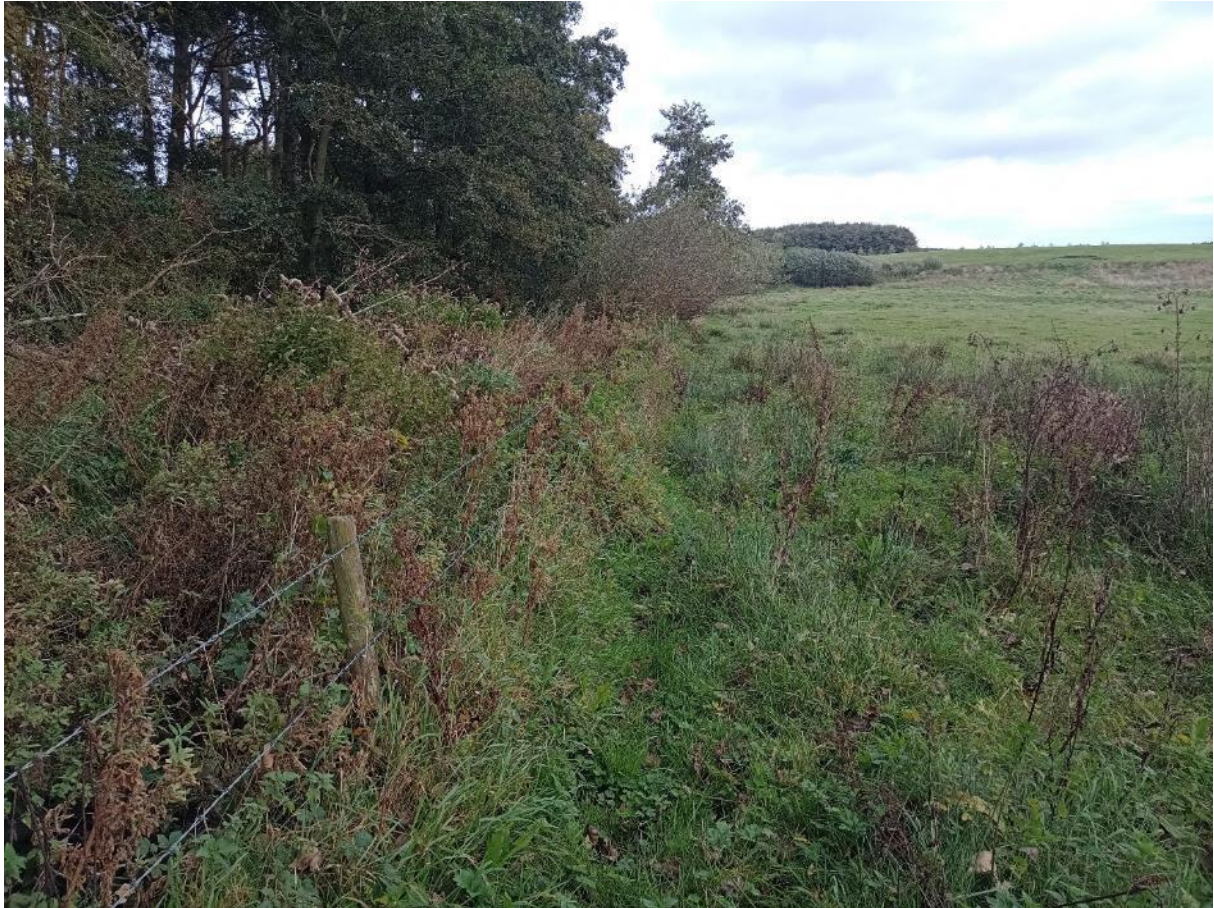
*Figure 25 (53.30566, -0.1366430) The downstream end of the Beck follows a straight course along the south-eastern edge of the plantation to join the Bain just upstream of the ford in Figure 20. The beck is fenced from livestock and bordered by dense vegetation growth.*

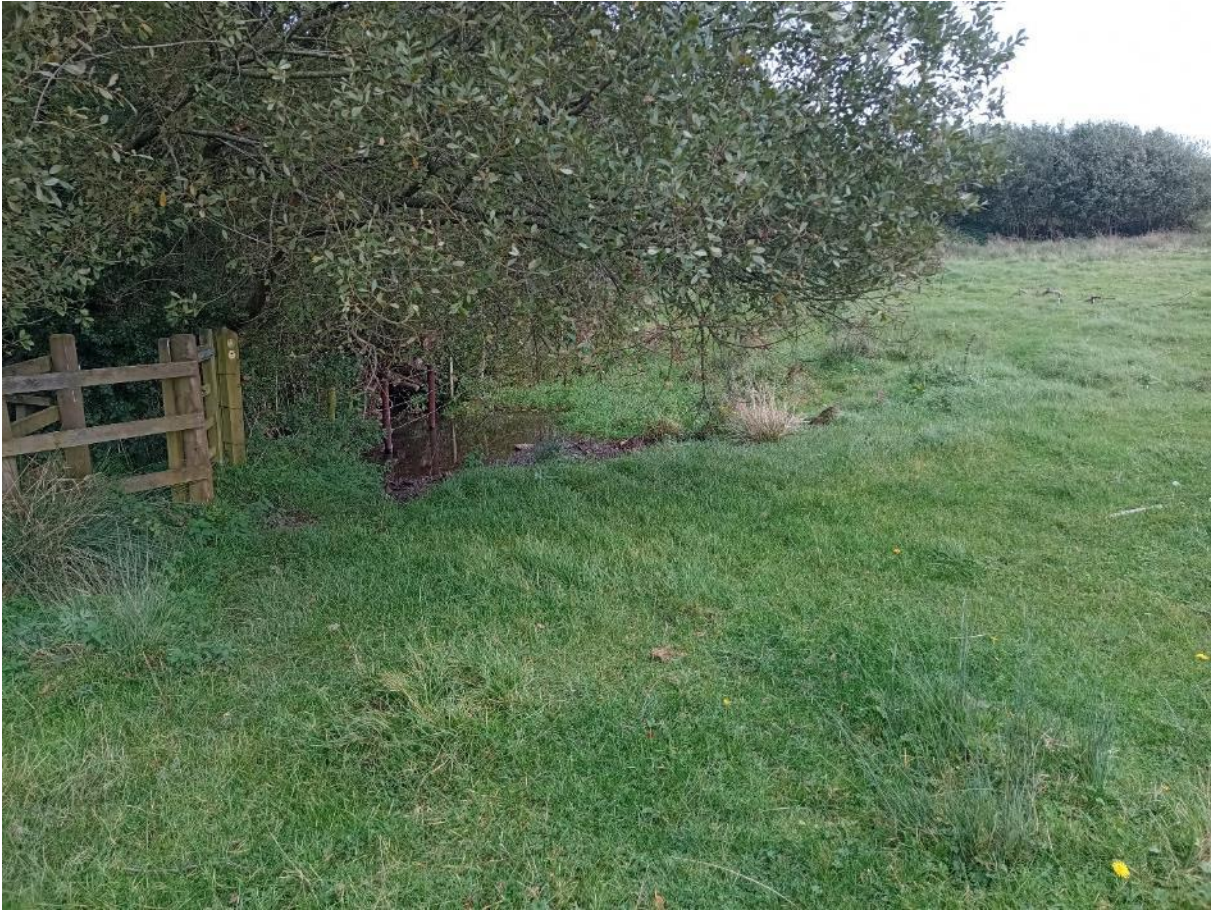
*Figure 26 (53.306191, -0.135572) The lower section of the beck is largely confined to a straight channel indicating it may have been ditched in the past. There are a few small areas where the banks are lower and wetter, possibly developed through livestock poaching. Grazing pressure generally appears to be low and livestock do not have access to the beck channel.*

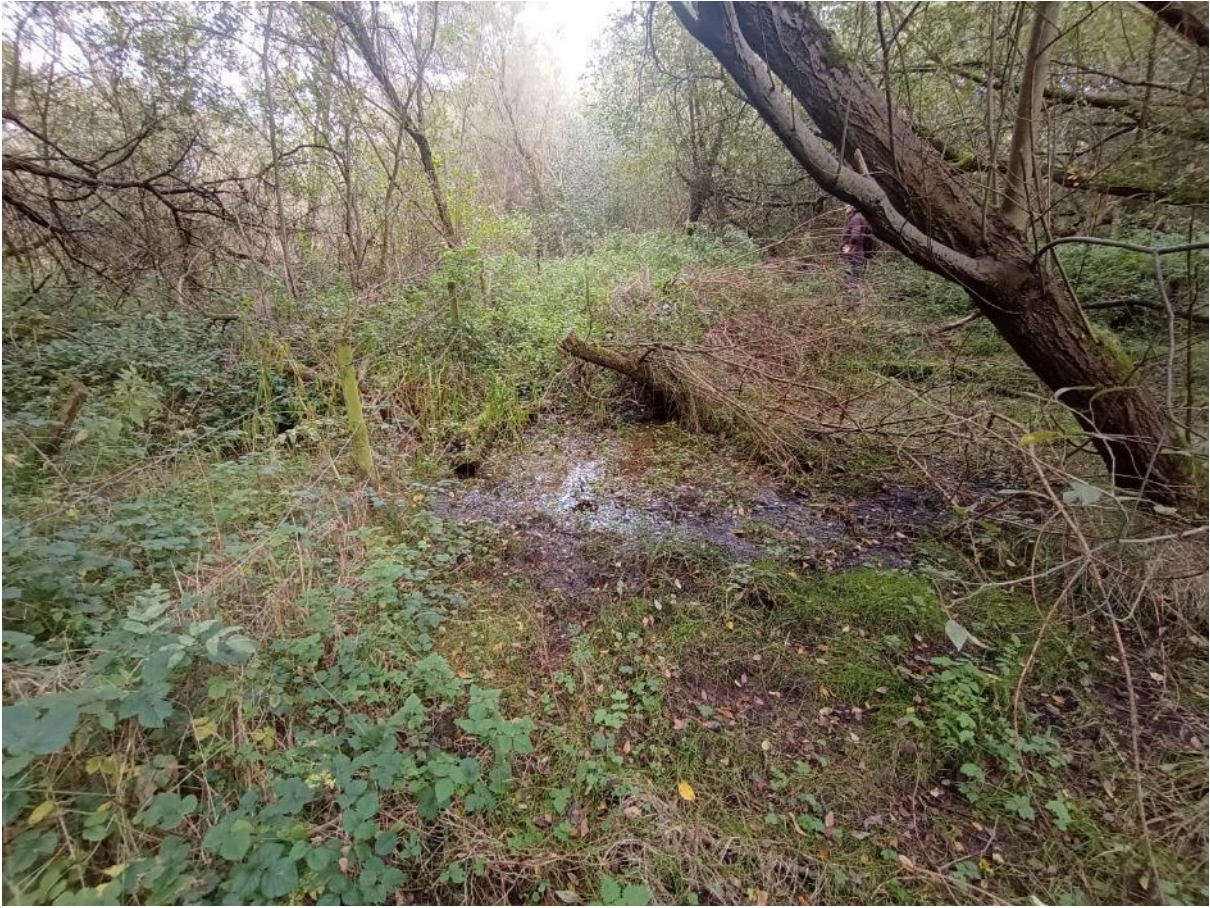
*Figure 27 (53.306576, -0.134673) Further upstream there are wet flushes draining to the beck providing some good habitat.*

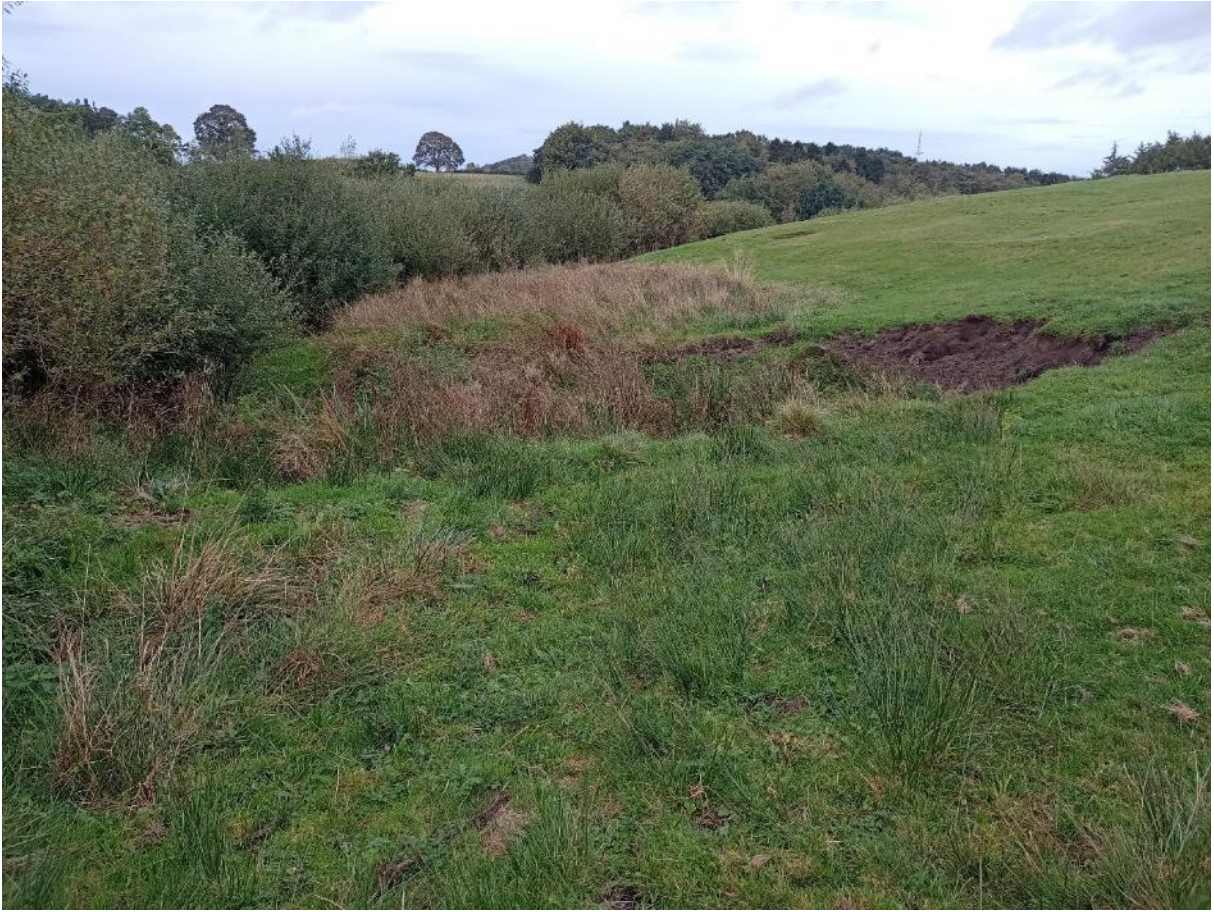
*Figure 28 (53.306736, -0.133728) The southern valley side of the beck showing the transition from grazed pasture to rough grassland, to willow (behind a livestock fence).*

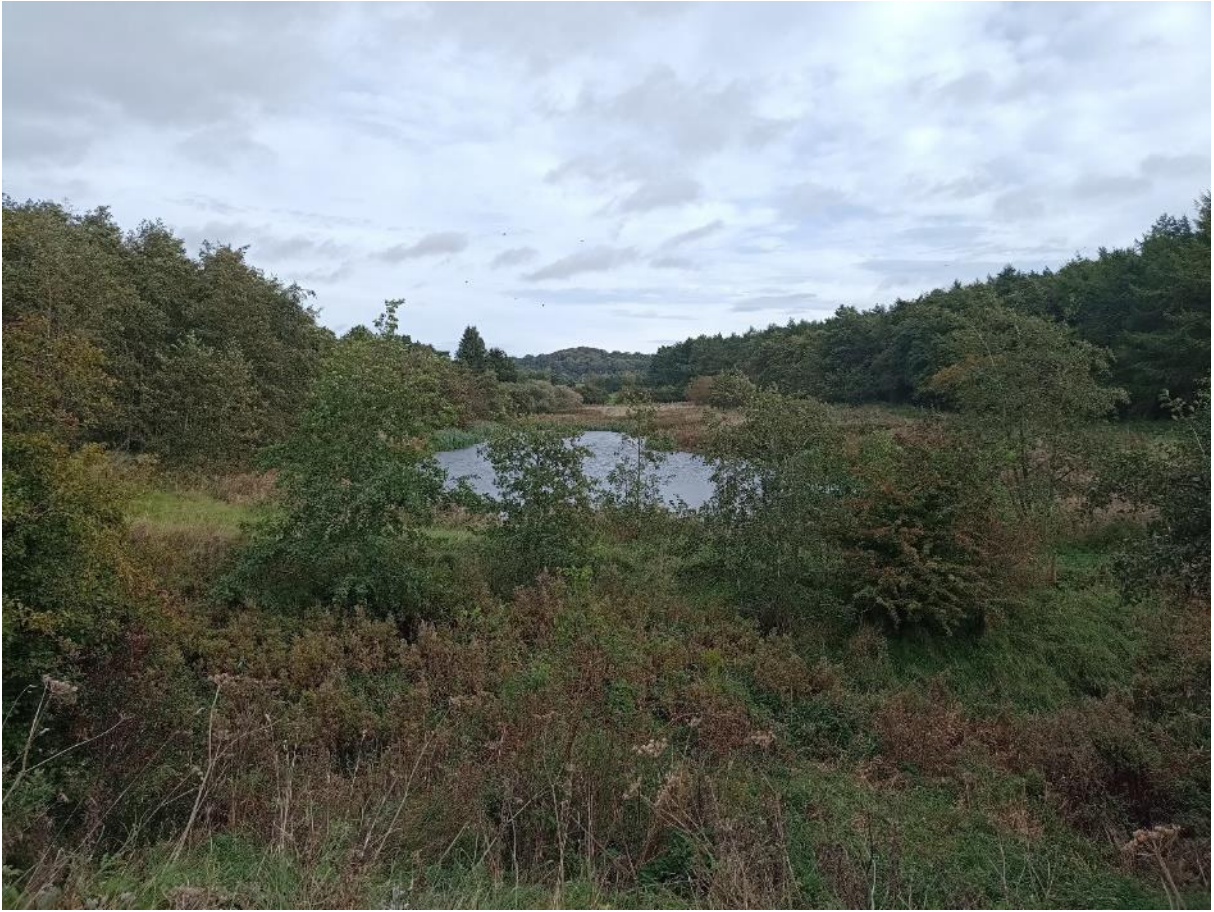
*Figure 29 (53.30846, -0.1322346) The online lake formed by damming the valley approximately halfway between the Bain confluence and Moses Farm; view upstream from the dam. There is another lake just west of this point, perched at a higher elevation on the valley side.*

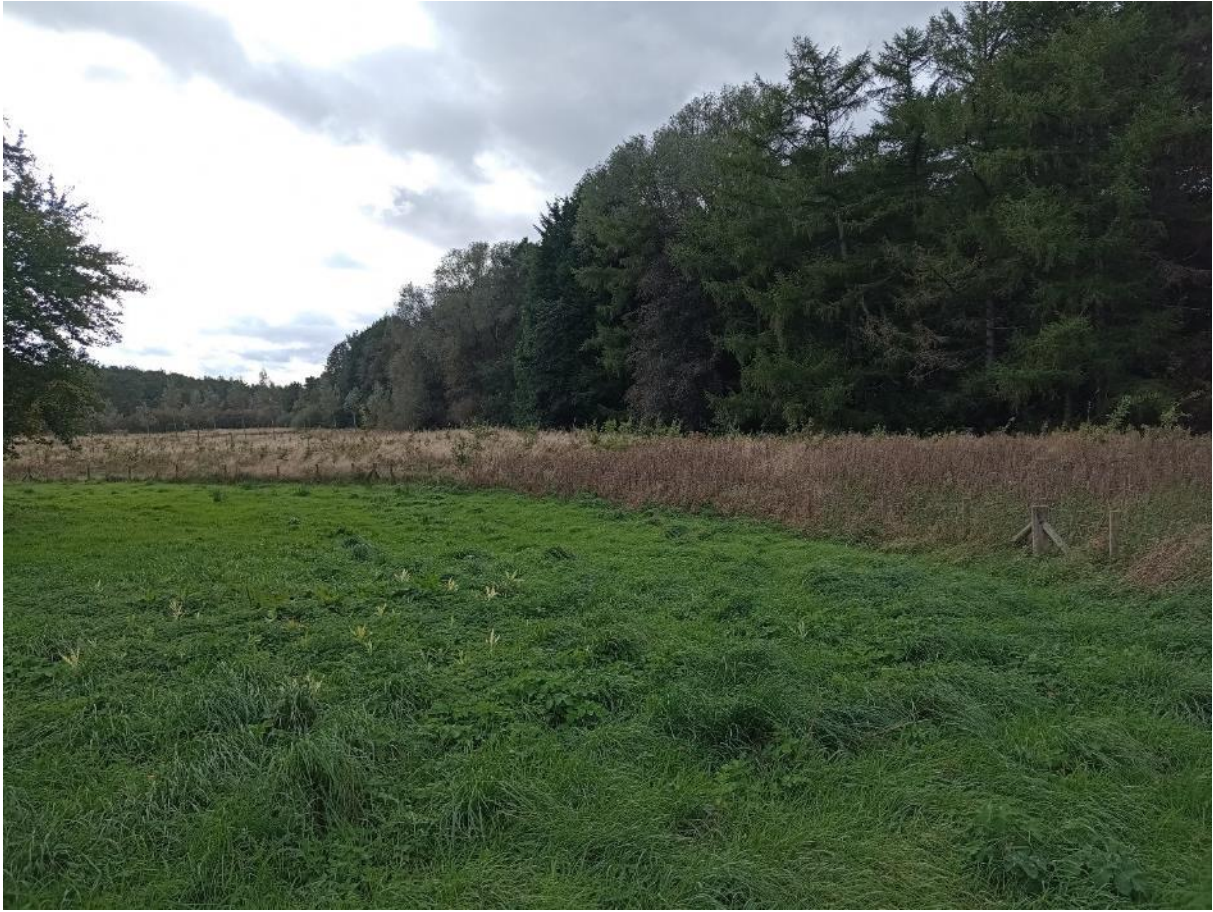
*Figure 30 (53.311733, -0.125865) View down the valley of the Stenigot Beck from the field adjacent to Moses Farm. The beck channel here is straight and bordered by dense vegetation. There may be opportunity here for channel and floodplain restoration works.*

The section of the Stenigot Beck between Moses Farm and the lake was not inspected but could also be a candidate area for restoration works.

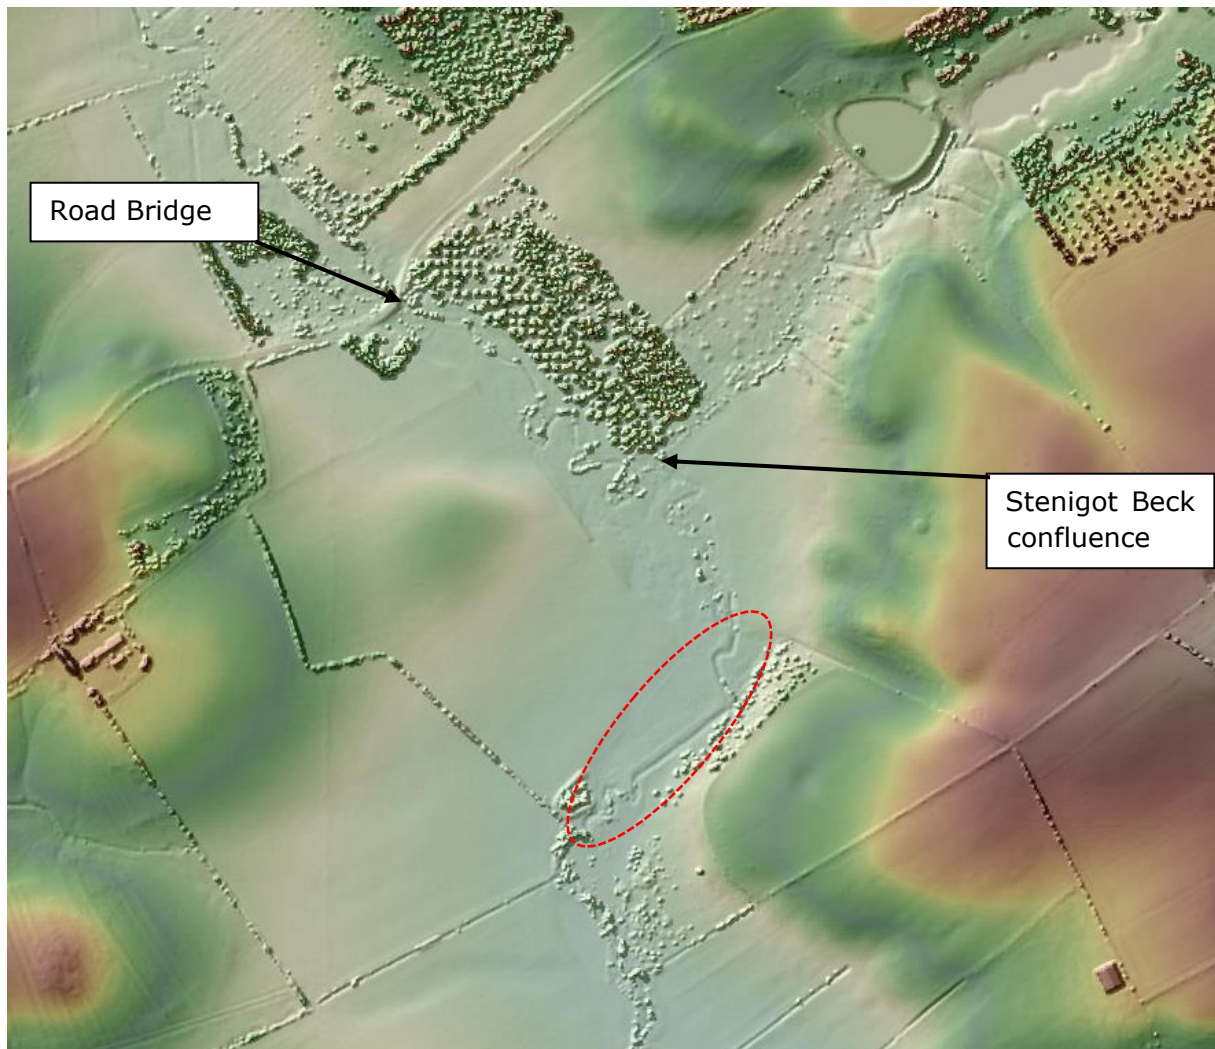
*Figure 31 LiDAR map showing the straightened and incised section of channel (red ellipse) and adjacent floodplain that is a potential candidate for a restoration project. The low-lying floodplain and low intensity land use in the valley bottom here may give scope to extend such a project upstream towards the road bridge and/or the lower reaches of the Stenigot Beck.*

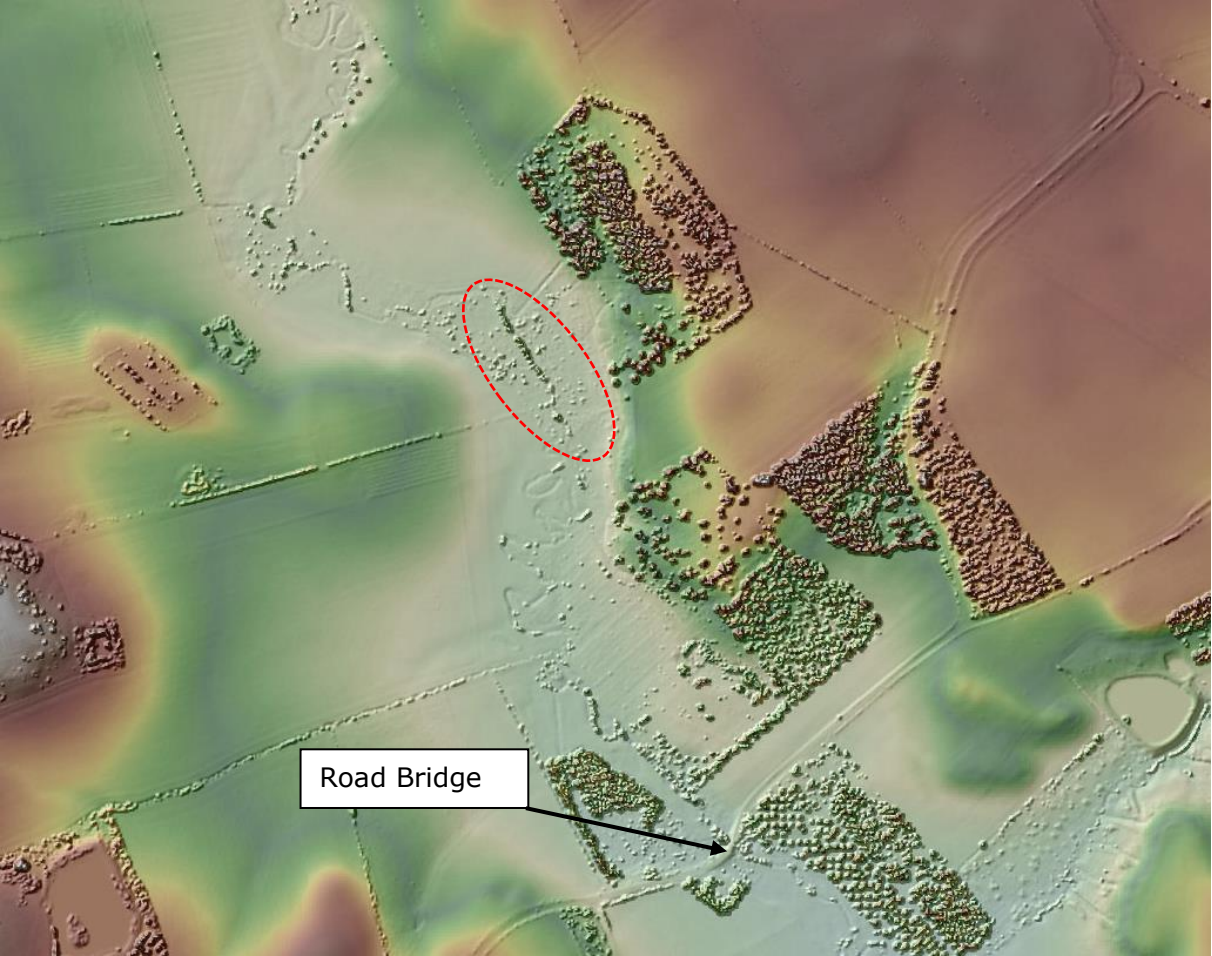
*Figure 35 Another section of the Bain (red ellipse) which appears to have been straightened and is possibly a candidate area for restoration.*

Similar restoration works would be appropriate on other sections of the Bain inspected, but there may be more constraints, for example single-bank ownership; arable land-use adjacent to the river; existing tree plantations. Also, some sections could not be reached or fully appraised due to dense vegetation, but may have potential (e.g. Figure 35). A further site visit in late winter is recommended when vegetation has died down.
