WILD TROUT TRUST
wildtrout.org

Advisory Walkover, Nov 2023

R Aire (Newfield): [GB104027063100](https://www.gov.uk/land-registry/GB104027063100)

Prof J Grey (jgrey@wildtrout.org)

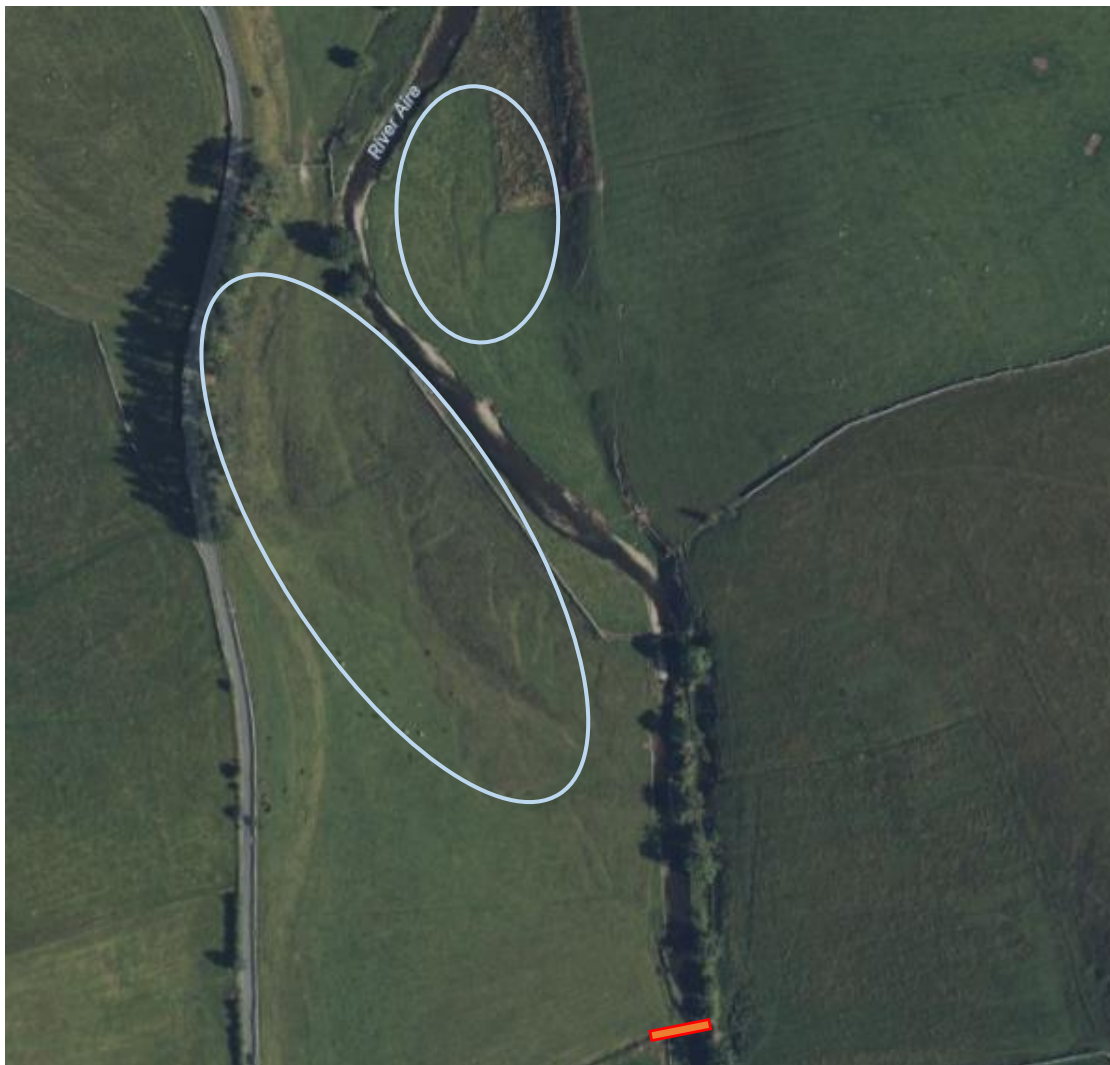
Starting at the lower limit and working u/s, the channel has been severely straightened and realigned to the eastern side of the valley where it was pinned out of position to ultimately provide a head of water at the Bell Busk weir ~425m d/s on Coniston Hall Estate. The field to the RB contains many paleochannels, the ghosts of former courses of the Aire prior to it being moved, visible to the naked eye and hinting at how sinuous a course it should have naturally (Fig 1).

Fig 1. D/s limit of the beat (red bar), the extant Aire channel was shunted in straightened sections through the floodplain and then pinned against the eastern side to provide head at a weir d/s. Note in contrast, the sinuosity of the paleochannels in the floodplain (ringed). The deposition bars of exposed cobble, maintained bare by livestock, were also obvious from this perspective.

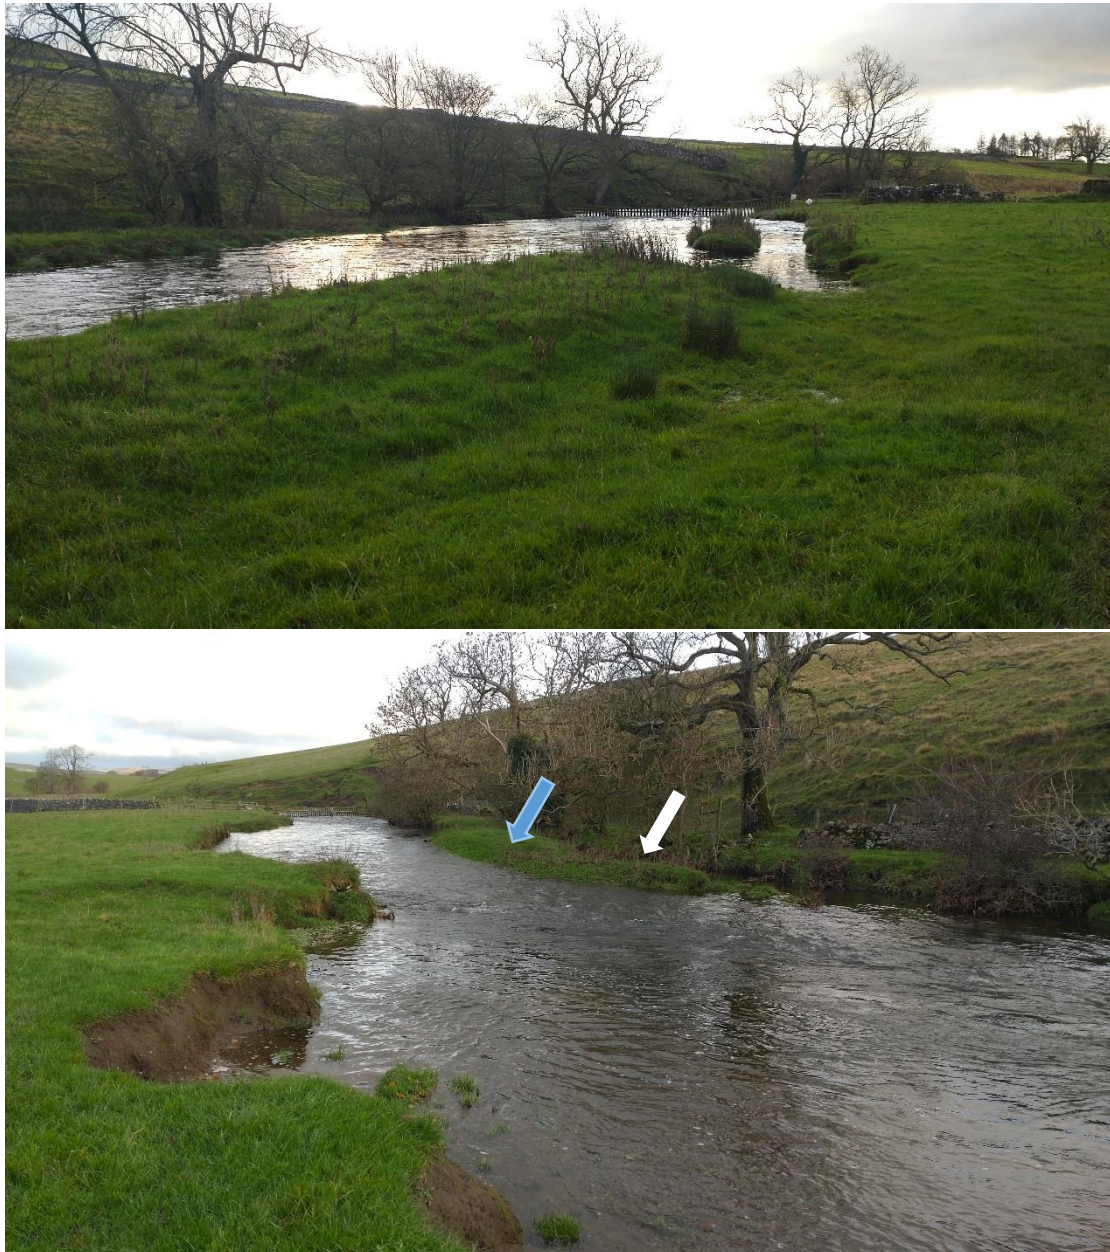
There was limited low cover provided by thorn trees on the LB of the first field; because the channel was pinned against the valley side, the LB was slightly steeper, discouraging livestock and allowing a line

of trees to cling on (Fig 2). Several were mature ash exhibiting *Chalara* (ash dieback) infection, and hence unlikely to survive for much longer, so could be proactively felled and tethered or lodged to provide habitat benefits. With continued livestock access, there was scant evidence of self-set trees regenerating and ensuring succession when the mature trees ultimately are lost.

Fig 2. Remnants of a tree line along the LB, but the mature specimens were ash that will soon be lost. They could be used proactively to provide localised habitat, rather than falling and being washed away. In several places, the river had managed to undermine the boulder revetment to the RB (exacerbated by livestock) and was trying to return to a more natural position within the floodplain – note the nascent reconnection with a paleochannel in the upper panel. A point bar (blue arrow) had developed parallel to the LB and created a smaller side channel (white arrow) which would provide flow refugia for weaker swimming fauna.

There was also evidence of the channel trying to renaturalise, breaking through some of the old boulder revetment especially where it blocked old paleochannels (eg Fig 2 upper panel). A point bar had

also developed adjacent to the LB and had caused some slight pinching and focus of flow. Between the bar and the LB, a small side channel provided some flow refuge for fry and invertebrates.

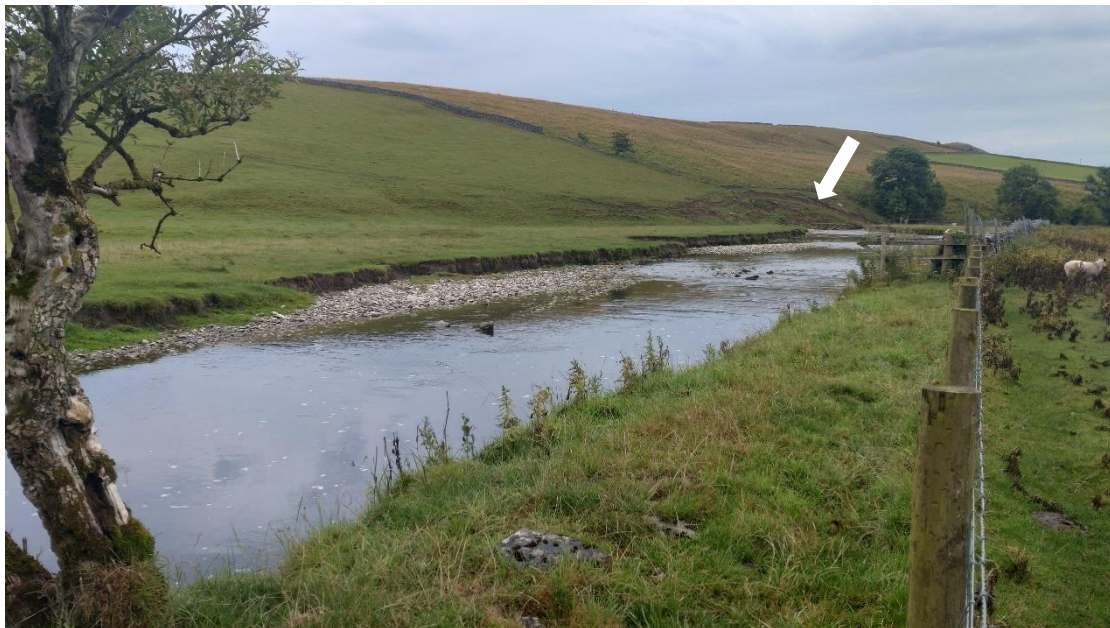
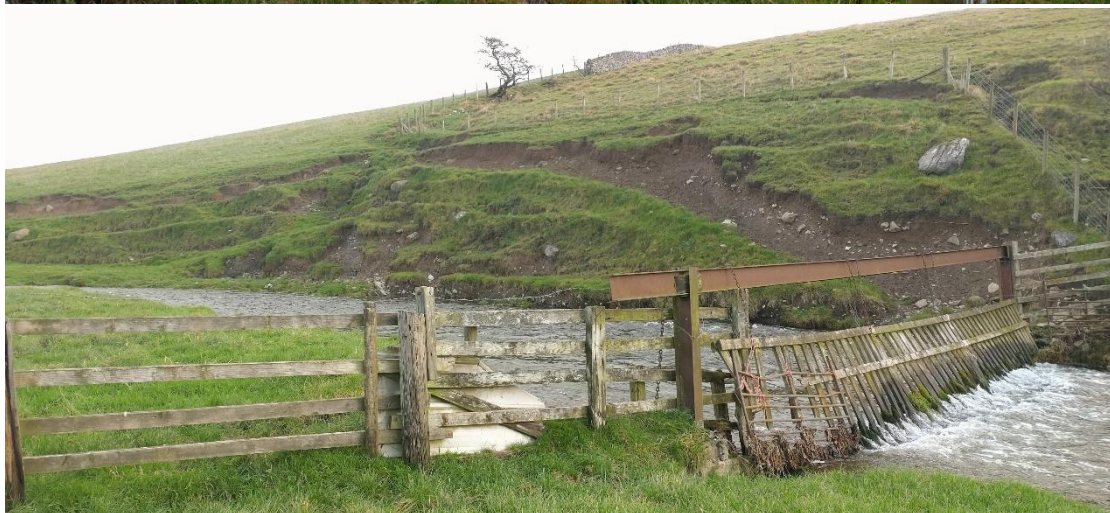
Managed as pasture for both cattle and sheep with unfettered access, most of the first two fields were devoid of any riparian zone cover, and the channel was suffering from excessive lateral erosion caused by poaching and trampling of the banks, and continuous grazing reducing the root matrix in the soil, hence reducing resilience (Fig 3).

Fig 3. Looking back d/s along a straightened section forced diagonally across the floodplain: overly wide and very exposed. Stock access both banks during low flows. The white arrow identifies the area highlighted in the lower panel where livestock had eroded the hillslope into terraces and bare earth.

Consequently, the channel was consistently overly wide and uniform in cross-sectional profile, shallow, and dominated by riffle. Without any cover, fish are susceptible to predation and warming of the water. There were nascent cobble deposition bars where the channel was

trying to readjust to a more natural width for the flow regime (Fig 3). These should evolve slowly into more stable structures as plants colonise and help to bind the matrix of substrate together. However, again with livestock access, constant disturbance from trampling or grazing maintained the bars as unconsolidated material. Bare rock also warms and conducts heat more efficiently than plant material so the fringe of cobble to either side exacerbates the water temperature issues.

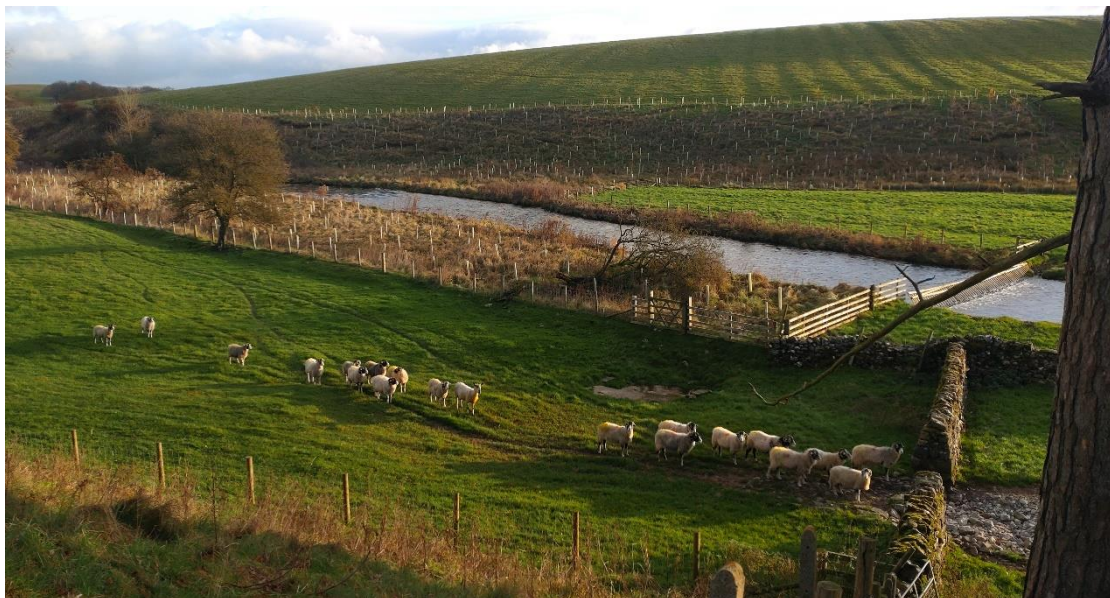
A fine contrast was provided by the restoration scheme undertaken by the Upper Aire Project to exclude livestock from 350m of the channel (continuing a further 300m along the steep slope of the eastern side of the valley). Fencing and watergates with augmented tree planting have transformed the riparian buffer (Fig 4). A diverse, shaggy herb flora now extends from the channel edge across the floodplain, imparting hydraulic roughness to slow the flow which is incredibly important not only for weak swimming fry to find refugia to the sides of the channel but also to slow the flow across the floodplain when the river is in full spate. The floral diversity also begets invertebrate diversity, a proportion of which may end up in the river to become fish food.

Fig 4. Clear evidence of the impact of livestock on the landscape on either side of the buffer fence. The (now protected) slope in the background used to look like that in Fig 3; indeed, it is part of the same field.

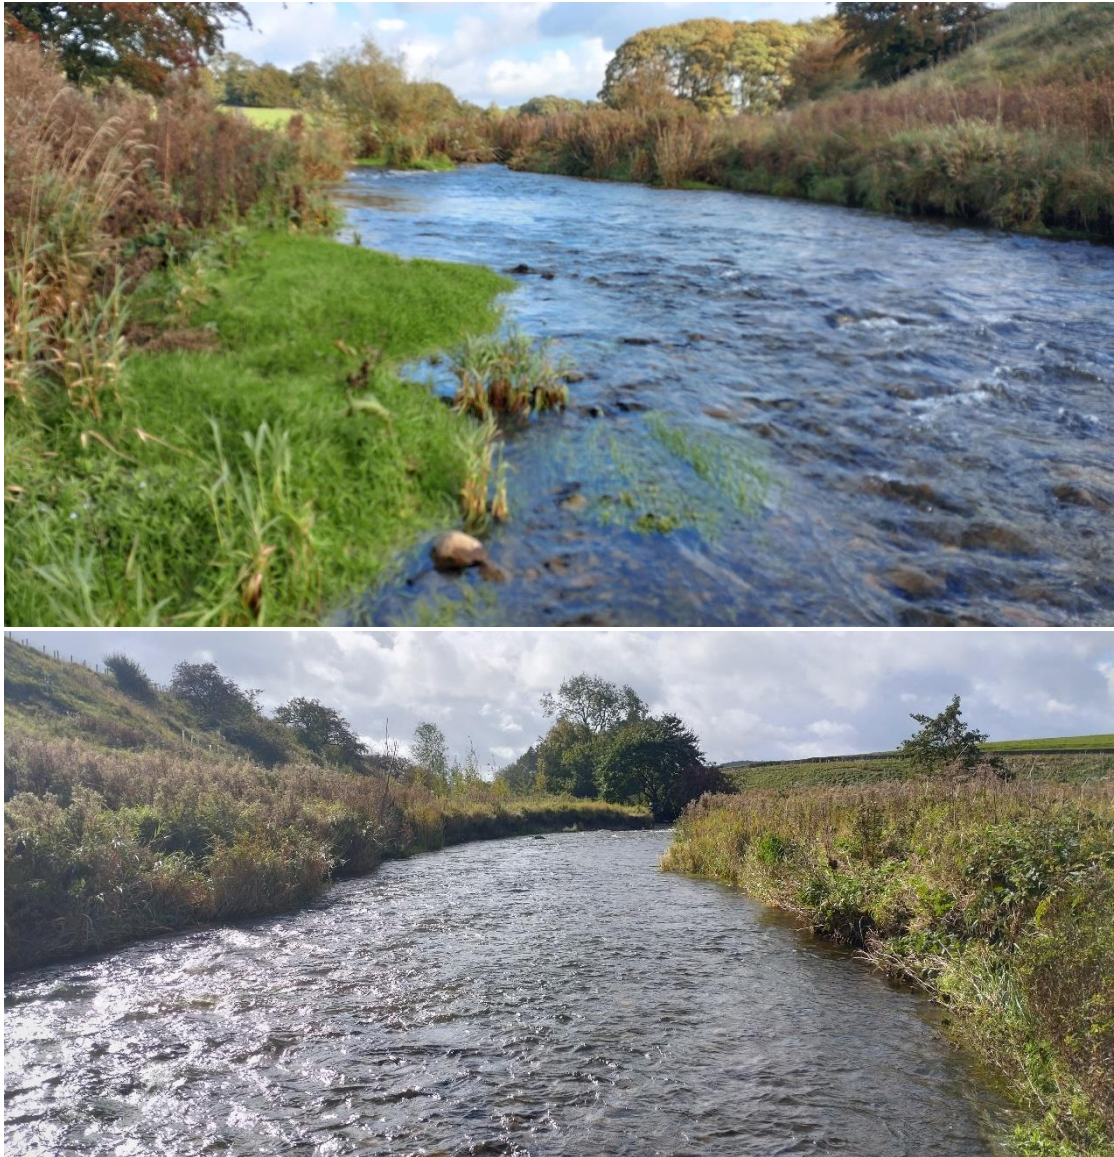
It was also notable in this protected reach that deposition bars of cobble to the sides of the channel were vegetated, unlike the ones outside the buffer fence, and were already providing greater ecological benefit by focussing the flow and trapping further fine sediment in their lee.

Fig 5. In stark contrast to the bare, grazed banks d/s (Fig 3), the herb flora within the buffer fencing was lush and species-rich, with lots of 'shagginess' at the edges. Where cobble deposition bars had formed, plants had colonised them and were beginning to stabilise them, thereby pinching the width of the wetted channel.

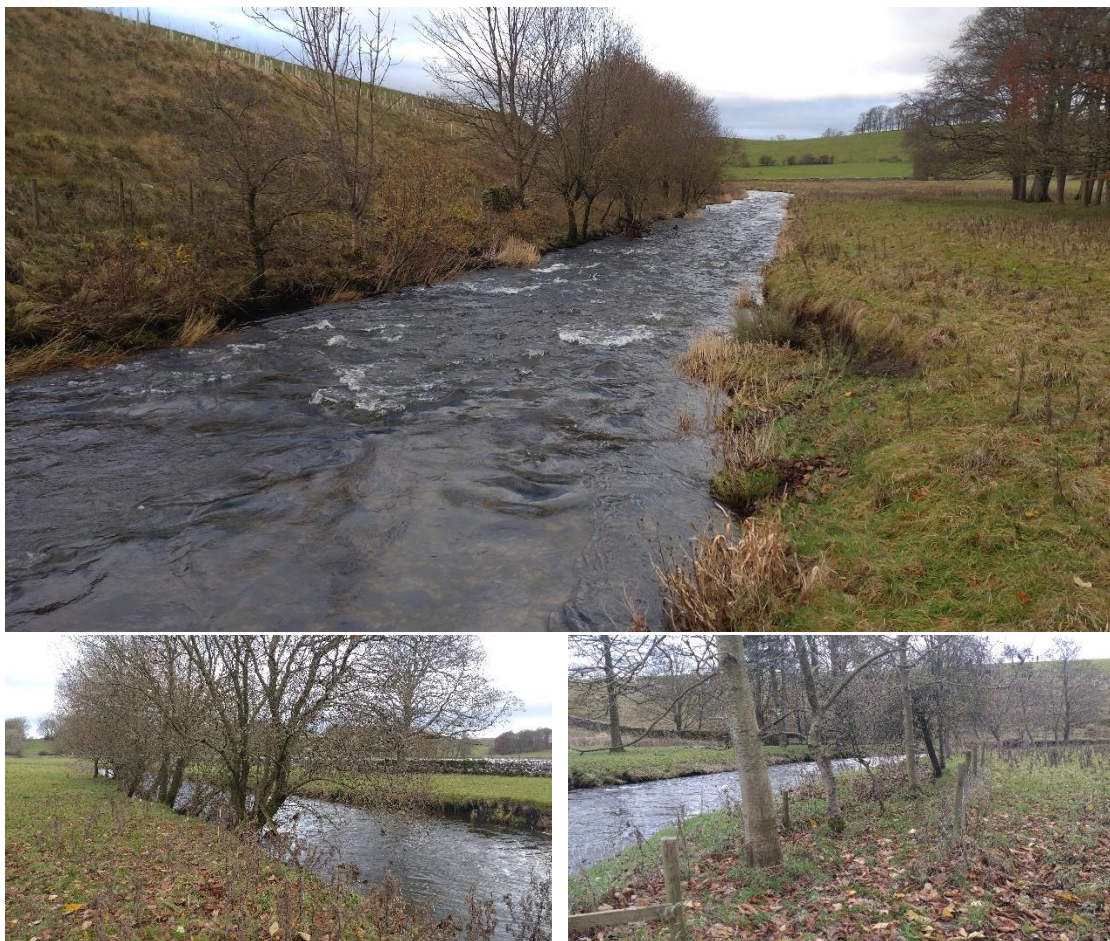
The next straightened section of channel up to the footbridge was relatively featureless because of that historic modification (Fig 6 upper panel). The club had historically inserted some 'low water cills' which have all since failed. With the benefit of hindsight, it is now widely recognised that the costs to habitat far outweigh the benefits of these structures for fisheries. The boulders used, which are now scattered within the channel, could be rearranged to better effect on one side or the other to induce some channel sinuosity and focus of deeper water under low-flow conditions.

Both u/s and d/s of the footbridge, there were short sections of tree planting instigated by the club, but the fencing has not been maintained (Fig 6). A clear browse line was evident on most trees,

reducing the low cover aspect that would be more beneficial. The trees were sufficiently large so that some of the trunks could be used for habitat works, especially in conjunction with the rearrangement of boulders. Either hinging and laying, or felling and lodging/tethering selected stems into the channel would create low cover and flow diversity in an otherwise relatively featureless reach. The coppiced stumps would be retained alive with reinvigorated low growth. U/s of the footbridge, there were several short stands of predominantly willow from which one or two pliant stems should be simply hinged and laid at a d/s angle to increase cover (Fig 6). It would be worth trying to replenish the fences.

Fig 6. Upper panel – the straightened reach immediately d/s of the footbridge. All panels exemplify short lines of trees planted by BGFA. The original fencing had not been maintained and while the established trees provided certain benefits, the full potential (eg ongoing protection for natural regeneration and succession, low branches for cover) had not been realised. However, the trees could be managed to enhance habitat – see text.

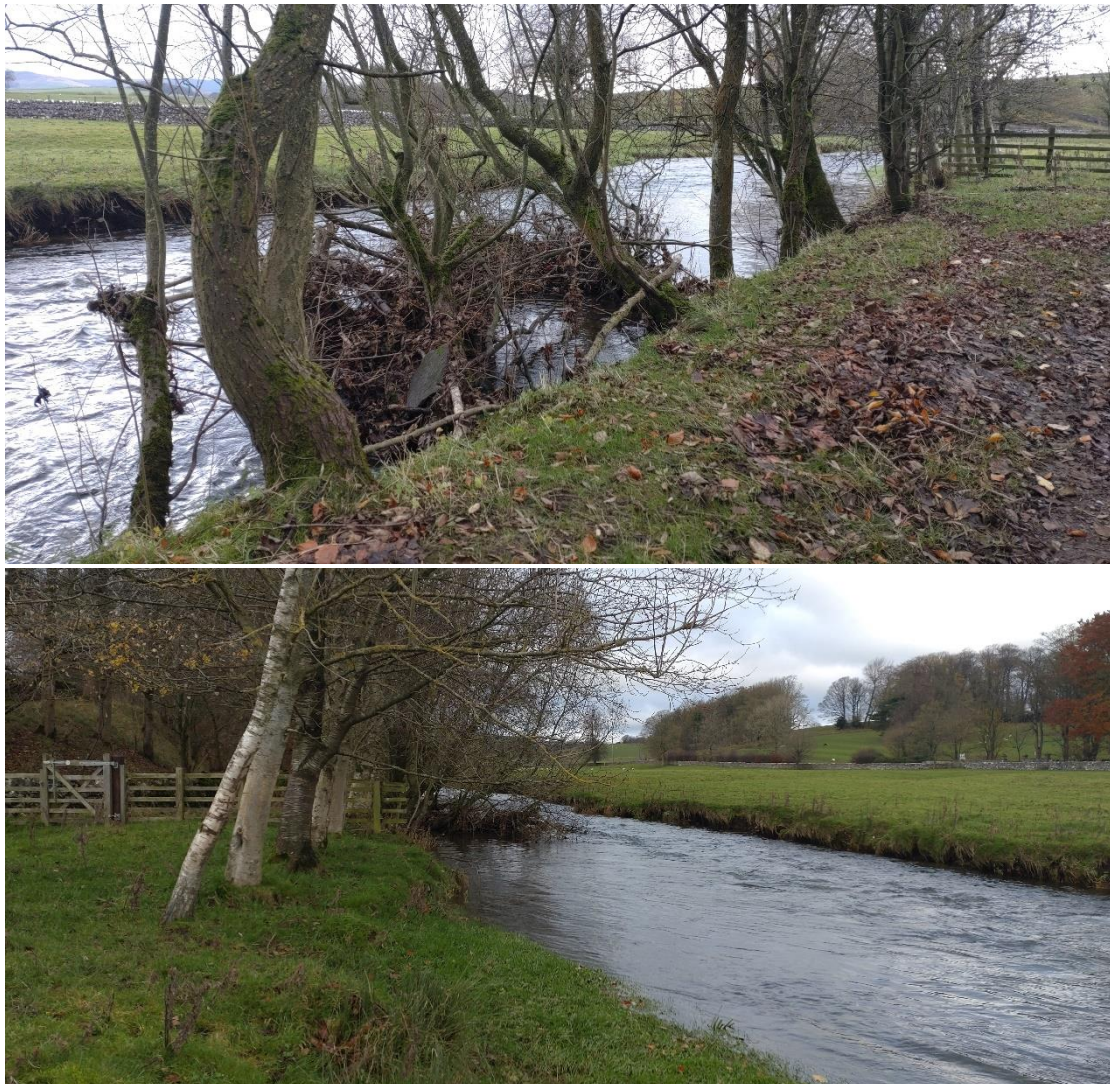
Where the trees were better protected, low branches trailing onto and submerged within the channel were providing multiple benefits (Fig 7). Trapping of fine debris 'little and often' prevents all that material accumulating en masse at man-made pinchpoints like bridges and weirs where it might cause flooding issues. That trapped material provides resource (food and shelter) *in situ* for many aquatic

invertebrates, as well as diversifying channel morphology and flow patterns, in this case creating a slackwater refuge on the d/s side evident in Fig 7 (lower panel).

Fig 7. Upper - fine debris trapped in the trailing and submerged stems of willow and alder. When viewed from d/s (lower), the slack water refuge was clear to see. Note the clear browse line on the trees in the field exposed to livestock (lower panel).

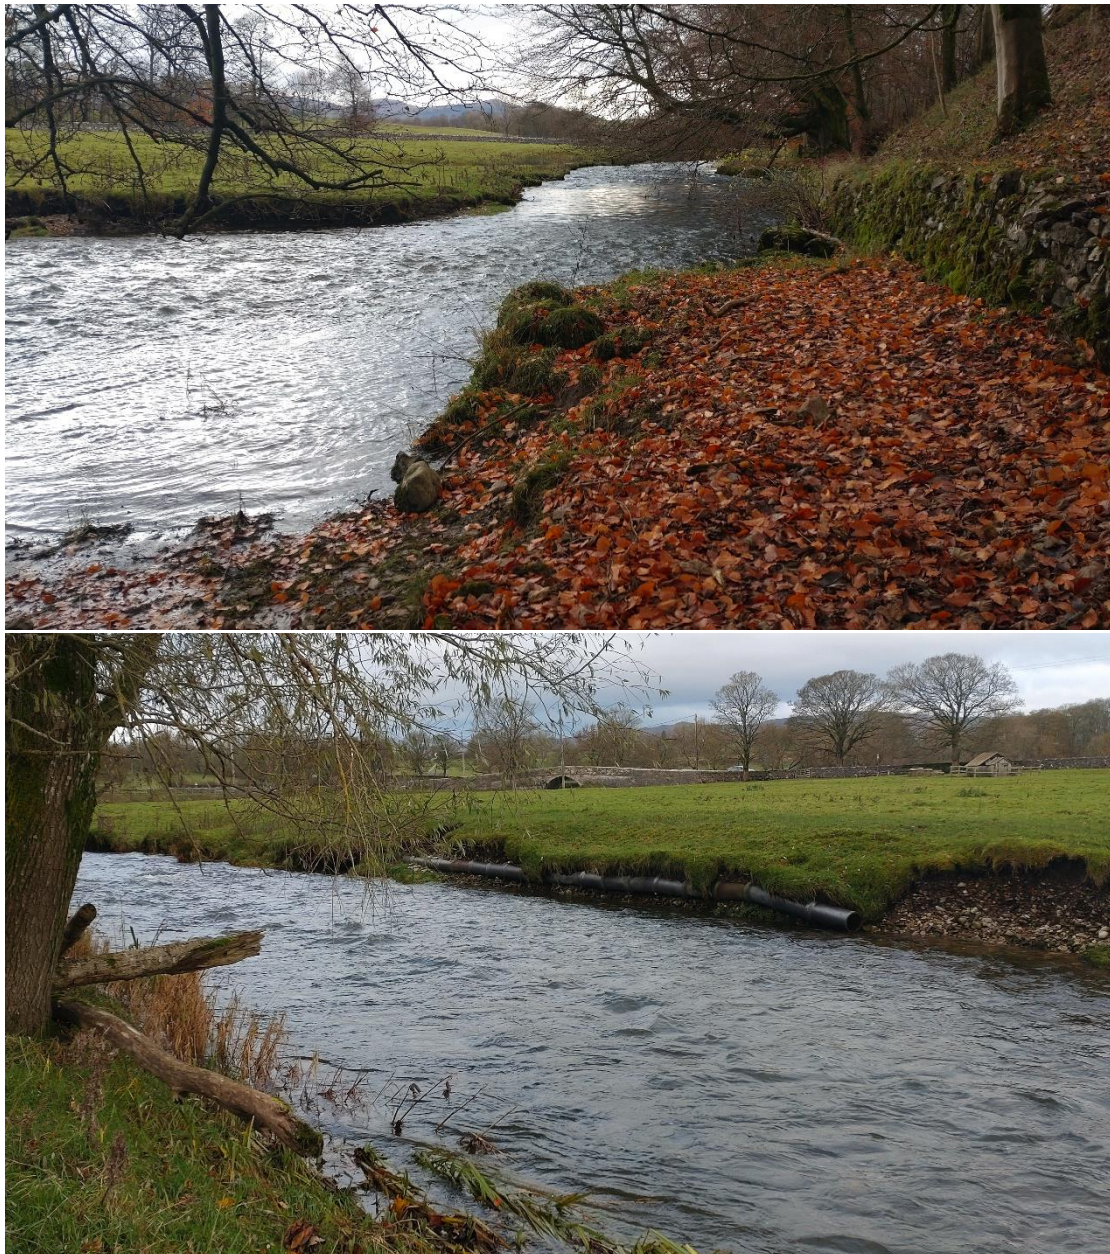
Unfortunately, the long field up to Newfield Bridge experiences heavy grazing pressure and the banks were bare and subject to erosional stress. Numerous paleochannels wend across the wide floodplain at this point, but the extant channel has been pinned into place at various junctures by boulder revetment and by redundant pipework left over from the old pumphouse that used to supply water to Newfield Hall (Fig 8, 10 & 11). Gold standard restoration of the channel would involve unshackling the channel, allowing it to access the floodplain more freely and returning to a dynamic, sinuous course evidenced by the paleochannels. This is an aspiration of the Upper Aire Project but would obviously involve considerable buy-in from the tenant farmer.

Fig 8. Constraints on the channel. Upper – walling to the RB to accommodate the Pennine Way, and lower – pipework from the pumphouse infrastructure (just visible top right) buried in former alluvial substrate within the LB and now eroding into the channel.

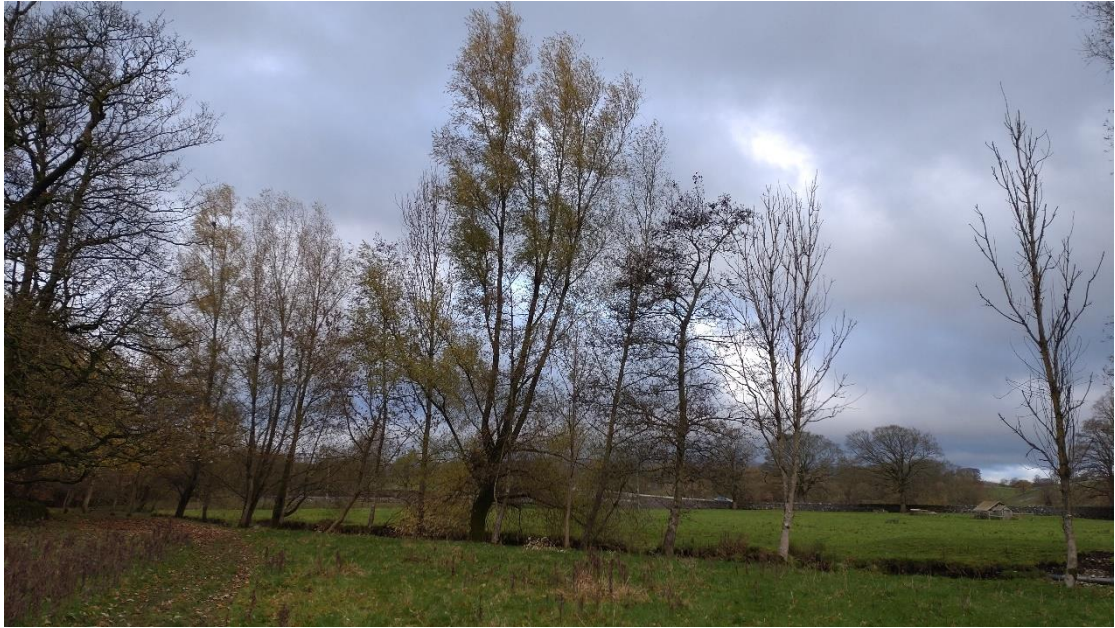
More cills were installed into this reach, but the majority were degraded to such an extent that they do not cause major issues anymore. Again, some judicious rearrangement of the boulders to accentuate sinuosity, rather than rob the river of gradient, would be beneficial. Several crack willow were reaching considerable height, and showed evidence of historic pollarding; similar management would relieve the crown burden whilst also providing tree-kicker material to lay into the channel (Fig 9).

Fig 9. Potential tree management below Newfield Bridge. Tall crack willows could be hinged or pollarded, as appears to have been done historically to at least the large specimen in the centre of shot. The large stems arising could be tethered in the channel using the remaining living trees as anchors. The ash to the right of shot were suffering from *Chalara* and could also be proactively felled and used for habitat.

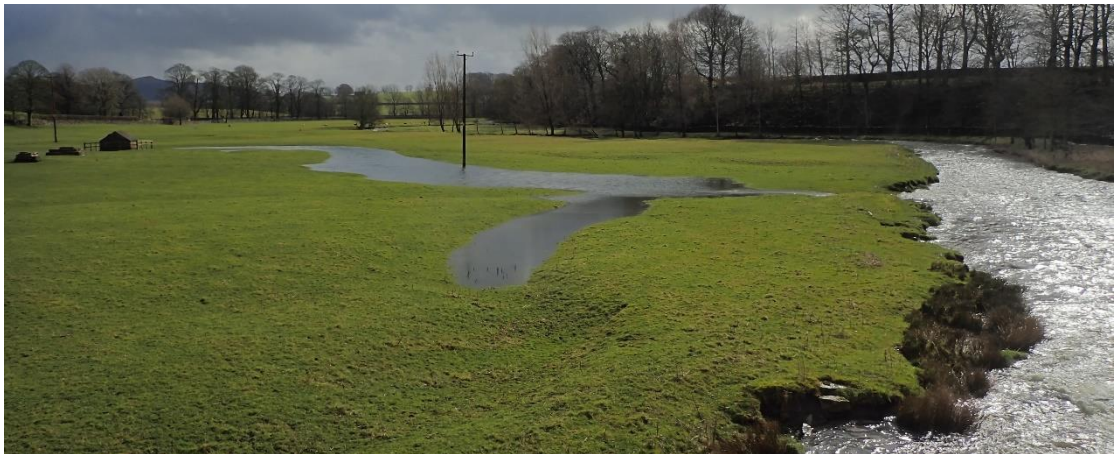
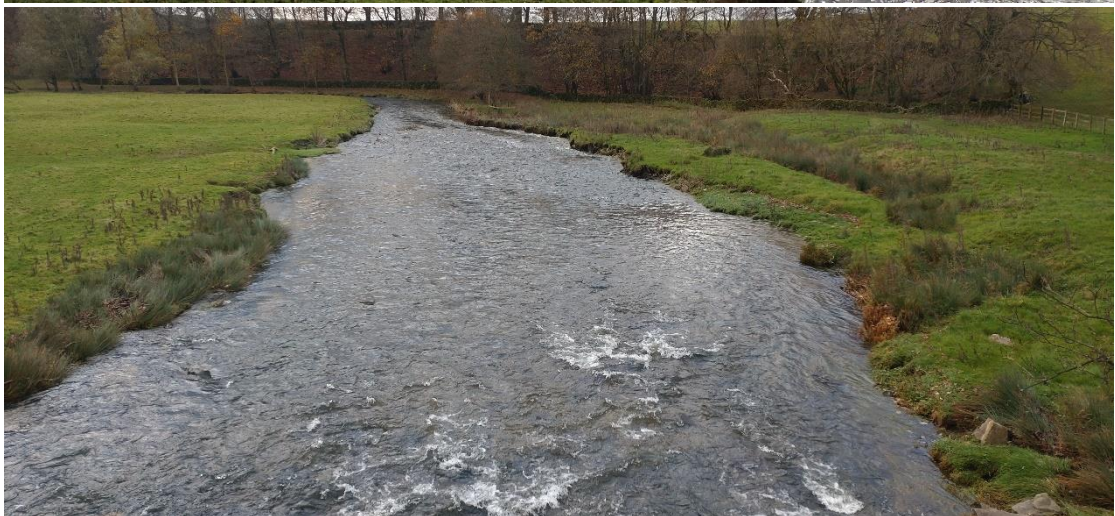
Fig 10. Looking d/s from Newfield Bridge: upper - degraded condition of the banks and lack of cover due to livestock, and the paleochannels evident within the field; and lower – the overwidened channel caused partially by 'release' from the pinchpoint of the bridge and subsequent deposition d/s, exacerbated by livestock using this point as a ford. Rushes on the RB hint at another paleochannel.

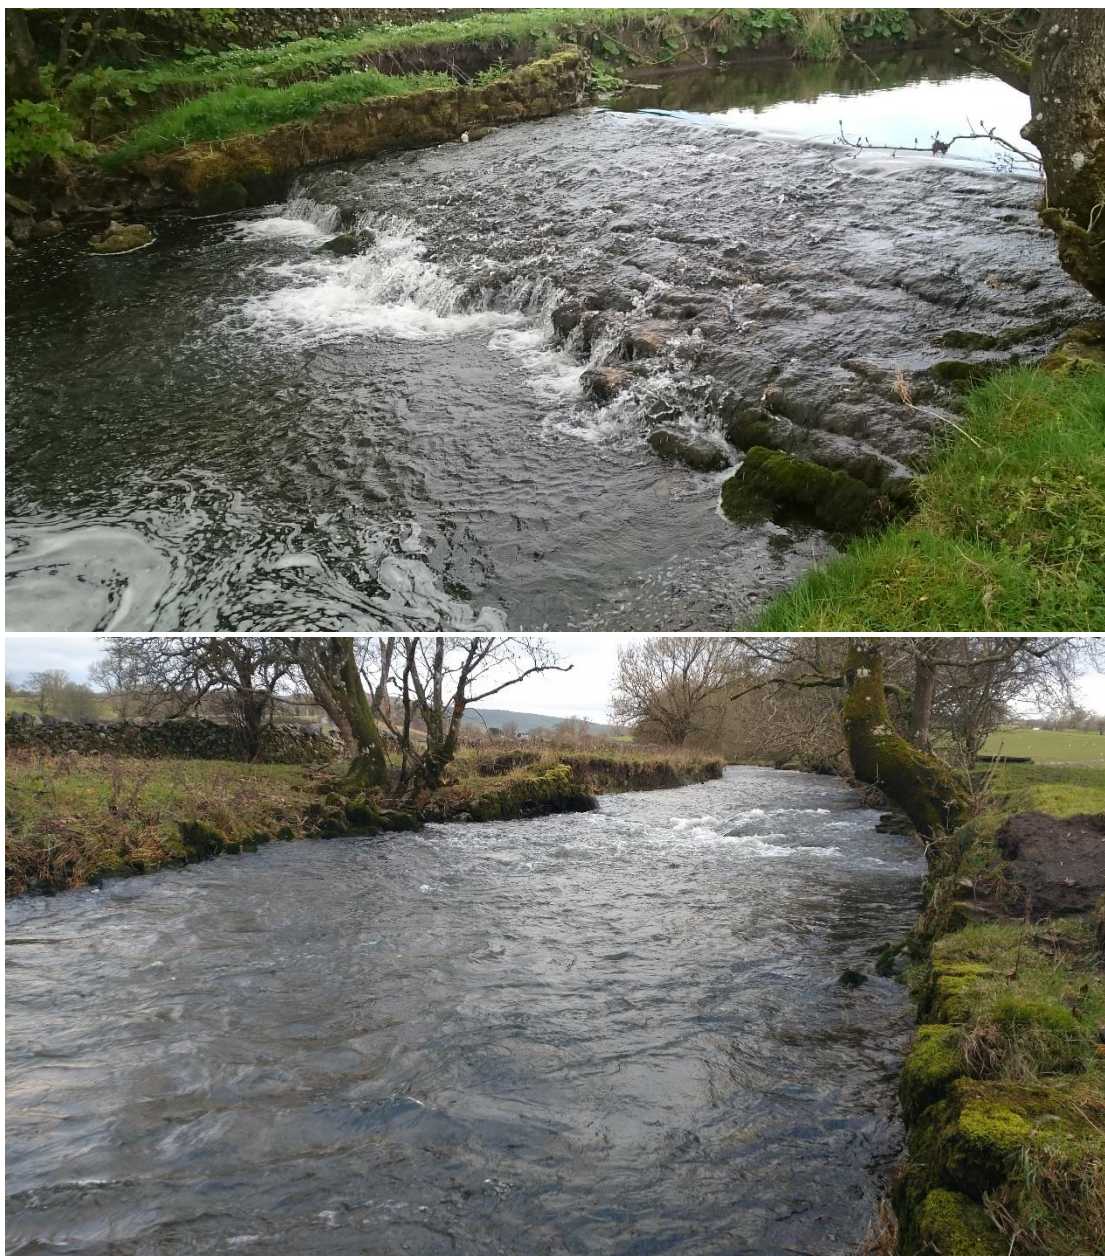
Immediately u/s of the bridge was the weir that used to create the offtake for the pumphouse and water supply to the Hall (Fig 11). Removed in 2021, free fish passage and sediment transport have been restored, with the channel evolving to a more natural profile. Unfortunately, the channel is still constrained with walling to the LB to prevent it migrating back into the field where it would naturally be, and instead keeping it arrow straight and aimed at the bridge aperture.

Fig 11. Newfield weir prior to removal in 2021, and the retained wall stubs still visible in 2023 – no longer a barrier to fish or sediment.

While there was a row of mature trees along the wall providing some shade and low cover in places, quite a few were ash, and with no opportunity for succession because of browsing pressure, the

numbers will dwindle (Fig 11). With a drystone wall boundary already in place between 3-5m from the channel on the RB, fencing and a watergate to protect both banks for ~100m u/s of the weir has been set aside within the Upper Aire Project but to date, the land agent and the tenant have not formally agreed. Unfortunately, the condition of the RB in particular continues to degrade, as does the drystone wall, because of cattle access.

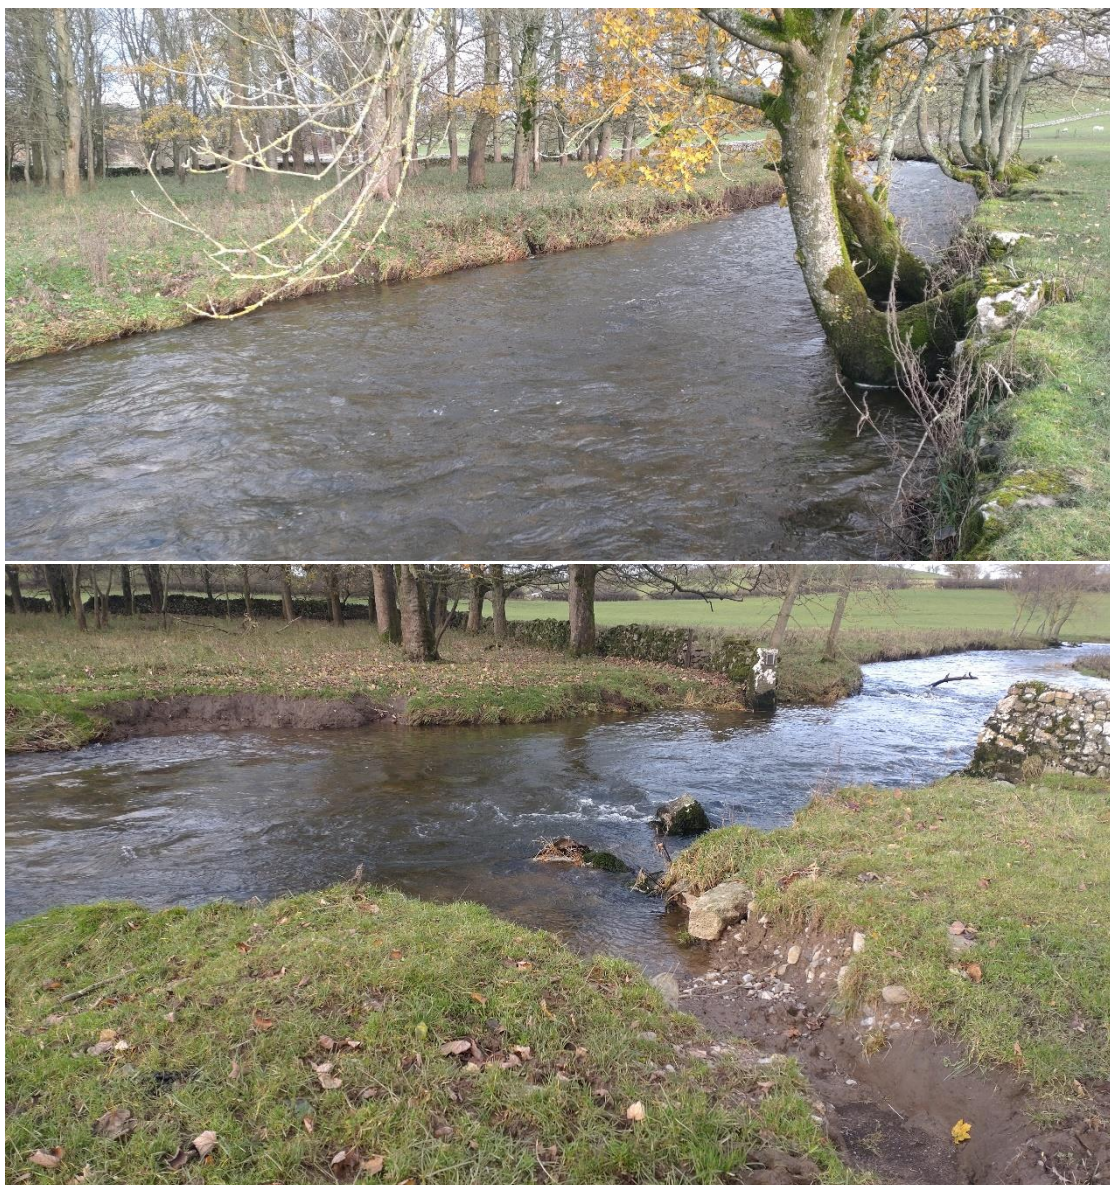
A reasonably sized copse of native deciduous trees provides some shade over the water around the Barn Pool, but the channel is still relatively homogenous because of the walling or revetment to the LB. The copse is also maturing and there is no sign of future proofing for the loss of trees.

Fig 12. Upper – looking u/s towards the Barn Pool with a small, mature copse on the RB providing some shade but little low or marginal cover. Lower – the Barn Pool itself is somewhat artificially created by a pinch of the channel by walling and large boulder revetment and walling to the LB which has begun to fail recently and there was evidence of erosion to both banks caused by cattle crossing.

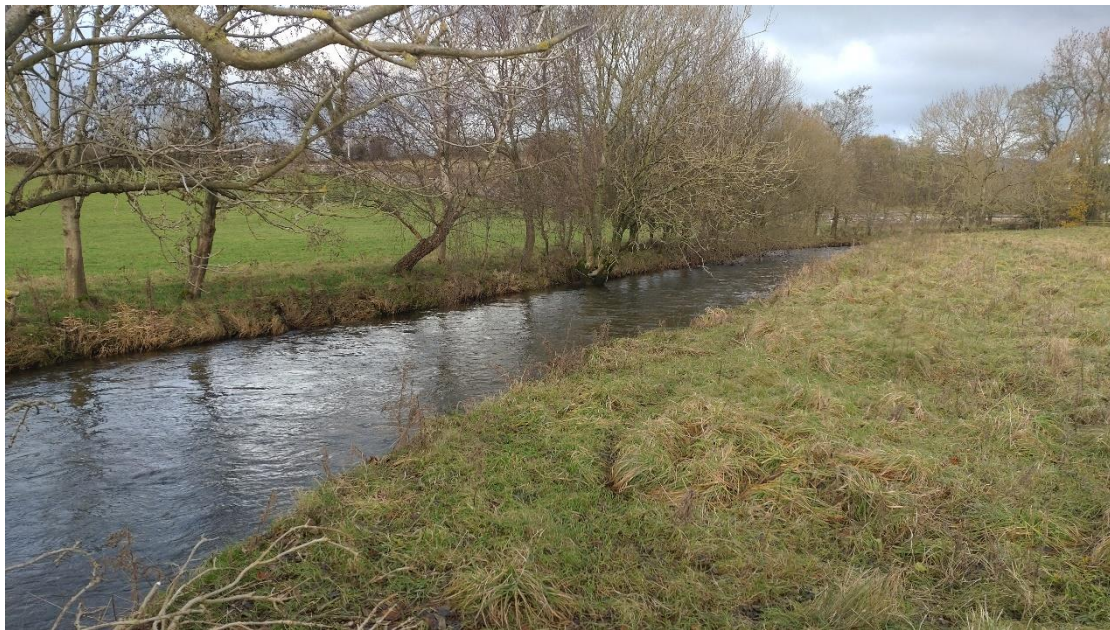
The next short field u/s had some tree cover instigated by the club on the RB and, as before, a few willow stems should be selected for hinging into the channel. Mature ash trunks could also be proactively felled and lodged or tethered *in situ*.

Fig 13. Another single line of trees planted by BGFA to bolster the cover which could now be managed to better effect.

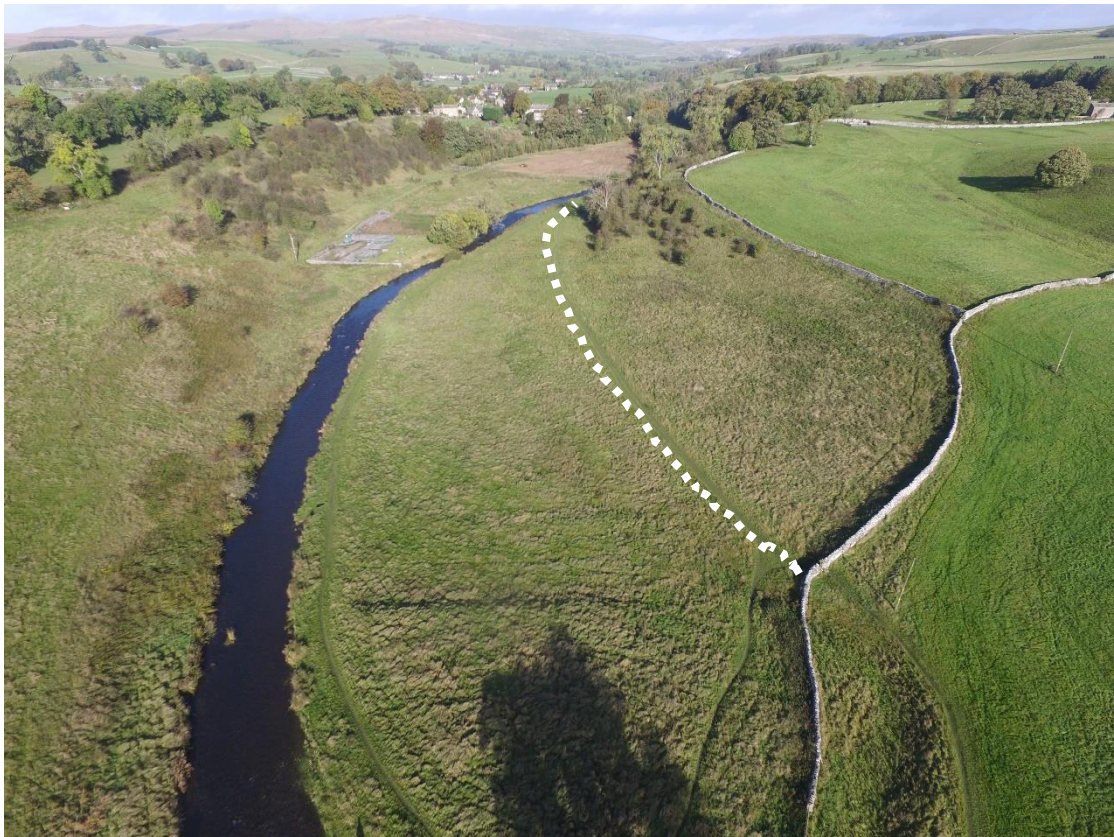
The top reach, almost 20% of the beat in one long field to the u/s limit at Caton Bridge, Airton, has undergone significant improvement over the last 18mo. The landowner has made strides to 'rewild' the 7ha plot which surrounds a small Yorkshire Water wastewater treatment plant (which currently does not have discharge monitoring, although there has been scant evidence of issues whilst work was carried out on site). The project has involved removing sheep grazing pressure, allowing scrub encroachment and planting of some standard trees in the wider plot, and scattered alder whips along the LB. Fencing now prevents the public and dogs from walking along the bank top, a former desire line straying from the Pennine Way (Fig 14). There is a plan to use low density, conservation style grazing by native breed cattle to manage the wet meadow. Two dead ash trees were felled from the YW asset site and winched and tethered into position in the channel as tree-kickers (Fig 15), and the artificial embankments on the LB have been lowered in three places to allow better lateral connection with the floodplain (Fig 16). At the most d/s site, stone from the embankment which had been used to block a paleochannel was returned to the Aire as a low berm to kick the flow across to the RB. All of these actions will have improved the fishery.

Fig 14. Pre works drone flight over the upper reach highlighting the long sweeping engineered bend and the desire line of footfall running parallel to the bank top. White dotted line indicates the fencing to keep people on the Pennine Way, and the area given over for renaturalisation. 18mo prior to this image, all the grass along the river looked like the closely grazed sward in adjacent fields.

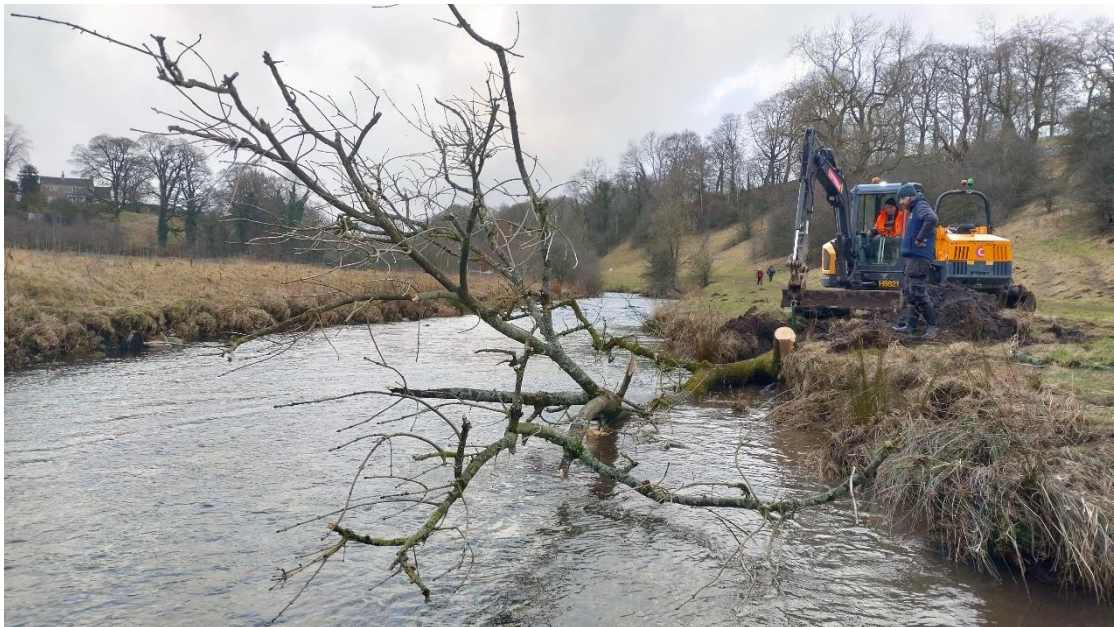
Fig 15. Felled ash being relocated and buried into the LB with available plant on an otherwise straightened and uniform reach.

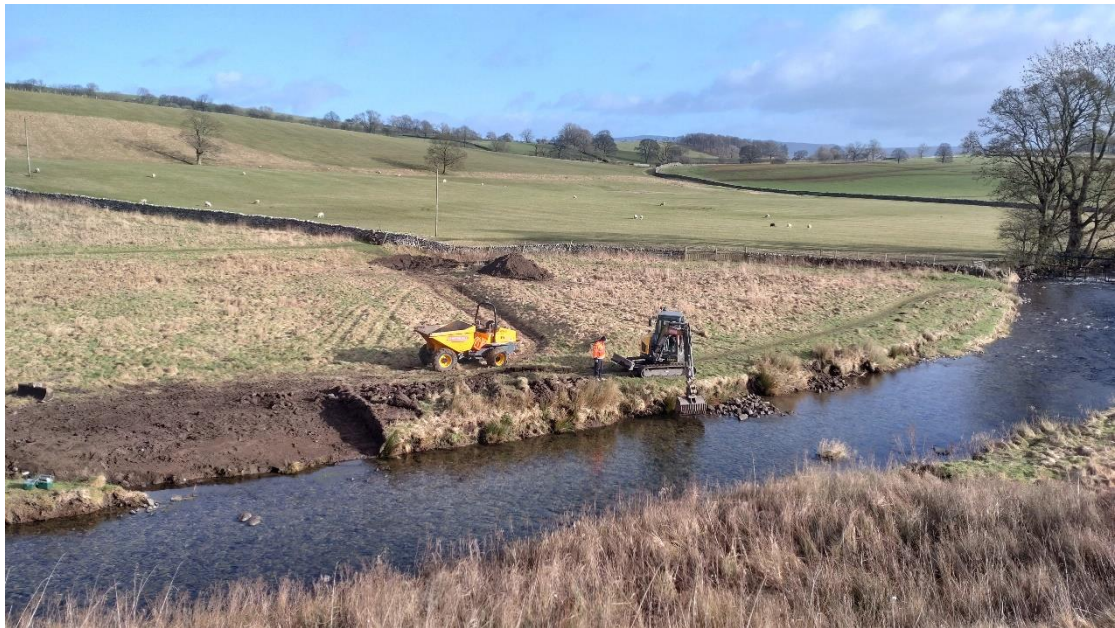
Fig 16. Lowering the LB artificial embankment to improve connectivity with a paleochannel in the floodplain, and returning any stone arising to the channel as a low bar to the LB.
