WILD TROUT TRUST

Boyken Burn
(Border Esk tributary)

Dumfries and Galloway

January 26th 2023

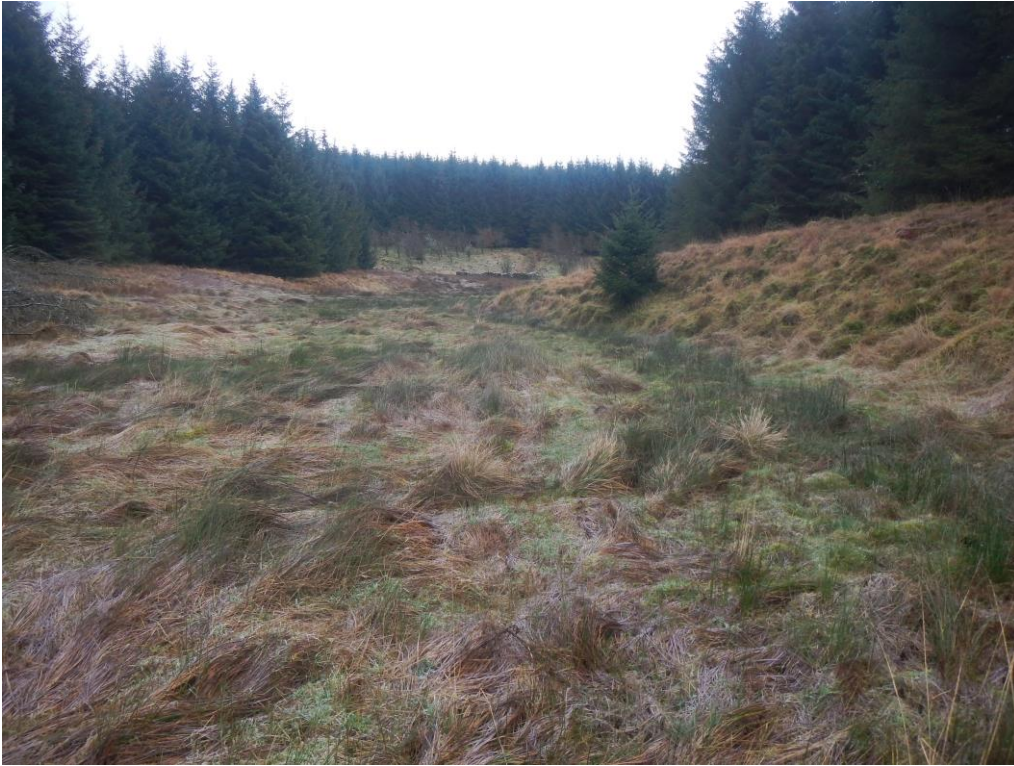
Figure 1. The initial section of watercourse walked was very overgrown, with limited accessibility for fish, but will support various invertebrate species.

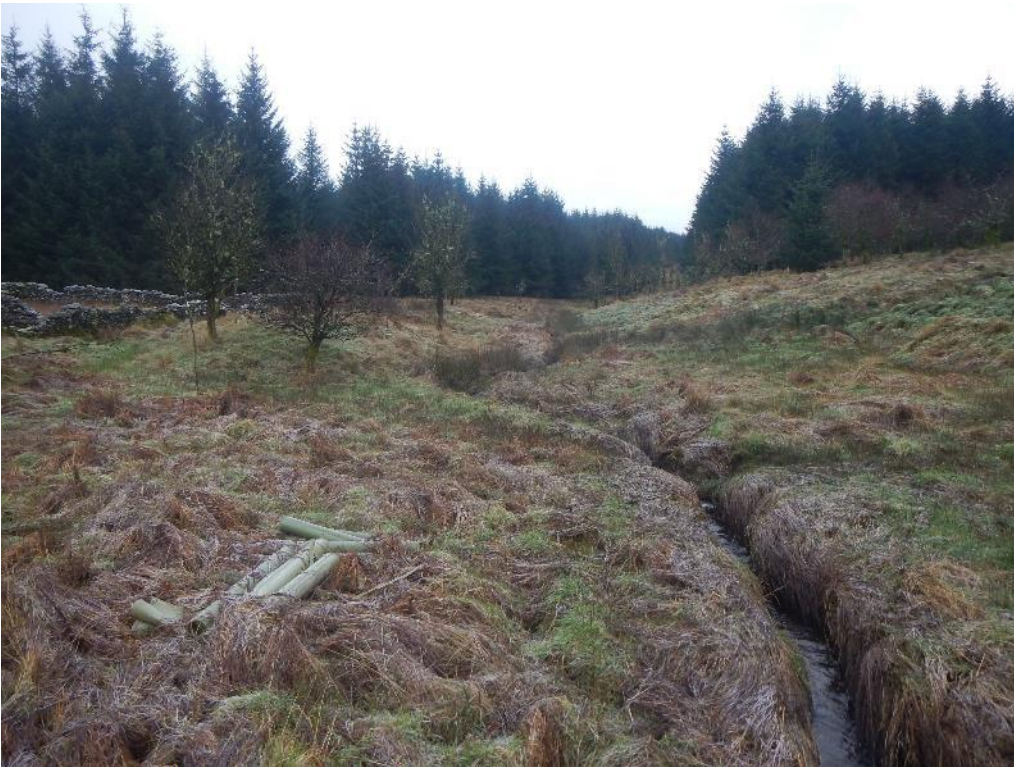
Figure 2. Eild Burn (55.190088, -3.134803), which appeared to also be fed from an alternative outflow from the reservoir was much larger and could certainly support trout, if they are present. However, most areas lacked bankside trees and the shade and organic inputs they would provide. Numerous signs of deer were noted around the valley, highlighting at least one reason that tree regeneration may be suppressed here.

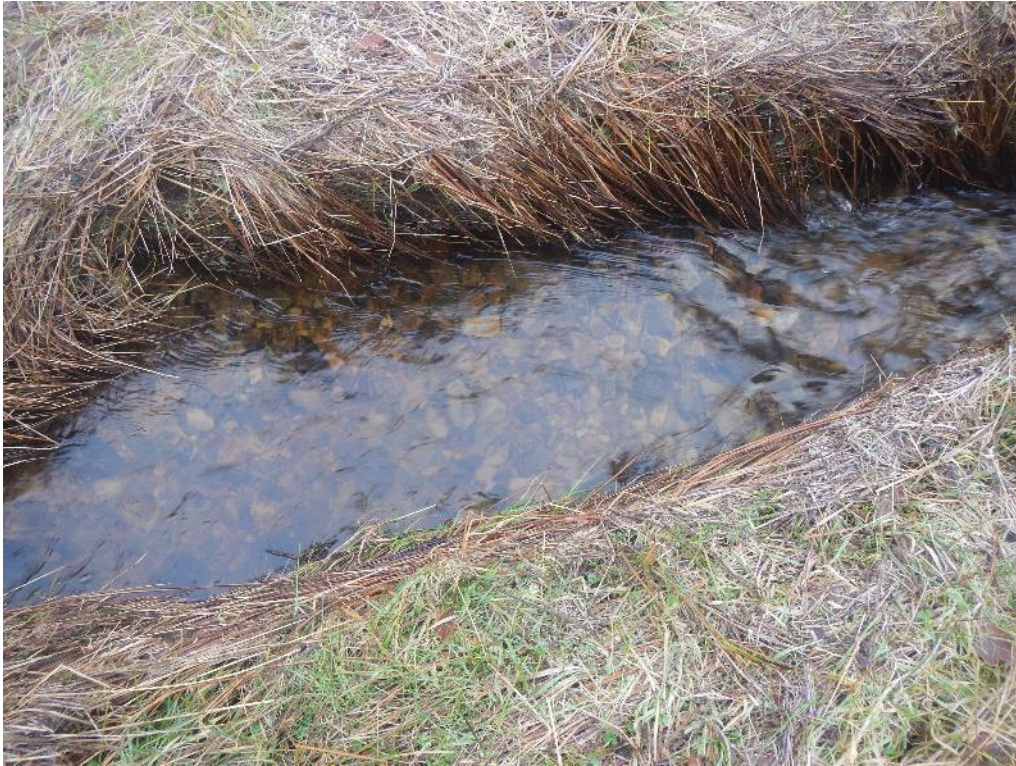
Figure 3. The substrate was relatively free from fine sediment and of a suitable size for trout spawning.

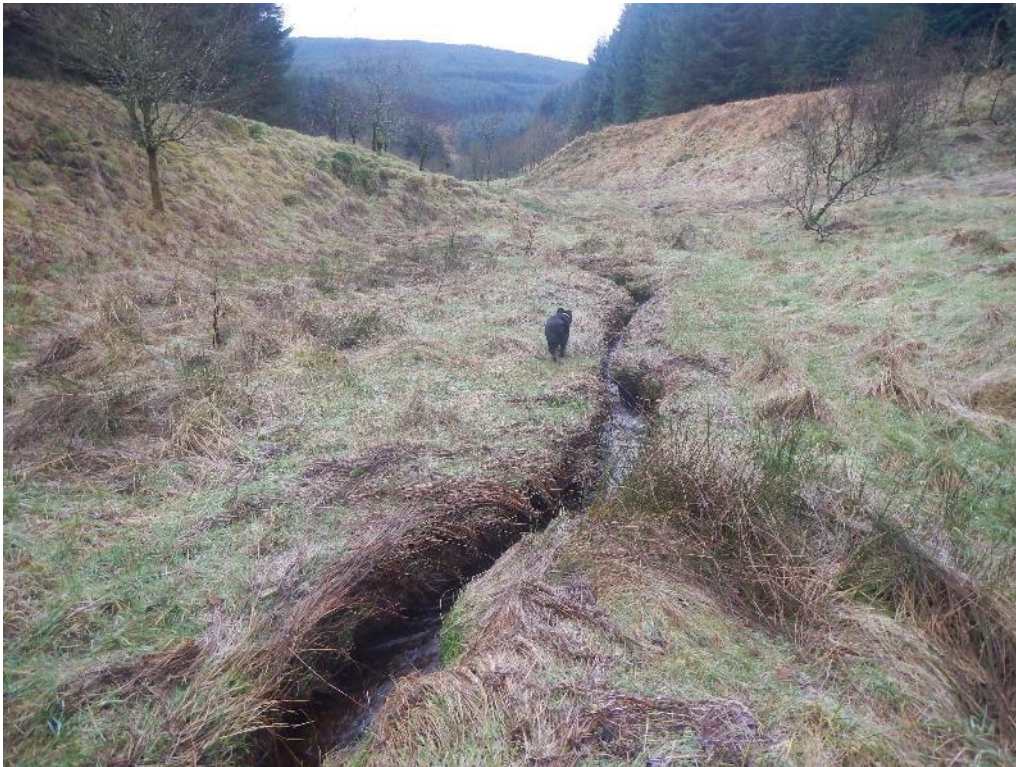
*Figure 4. The straightness and steepness of the burn, almost certainly influenced by past land drainage, limited water depth and there was a lack of pools. This in turn reduced the availability of ideal spawning habitat, but opportunities were available. Most of this area and the areas d/s would benefit from more bankside trees and at least *Willow whip planting* (55.189712, -3.134832).*

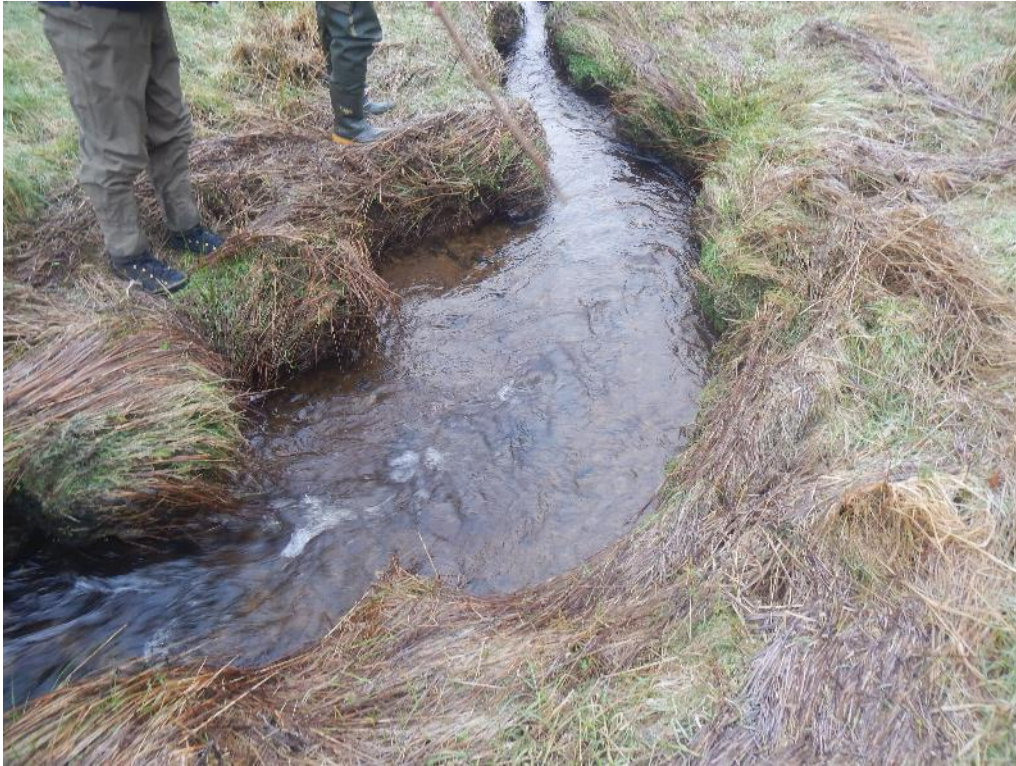
Figure 5. One of few, slight bends: if greater meandering and width variability were created/encouraged, more fish holding pools and gravel lifts, providing improved spawning opportunities and invertebrate habitat would naturally form.

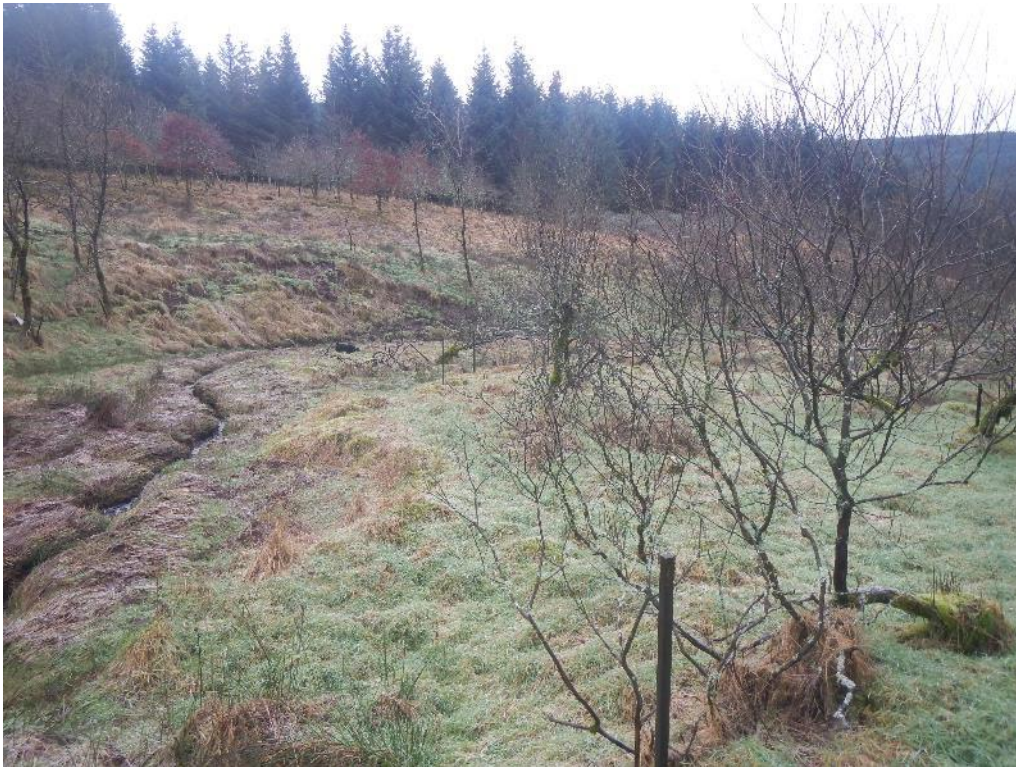
Figure 6. Light planting with native broadleaves had been undertaken through the valley, within a generous buffer from the coniferous plantations. While some of the trees did not appear to be in the greatest health, they provide valuable diversity; the issue could be related to a lack of trees there previously and slow reinstatement of the mycorrhizal network, which should develop with time.

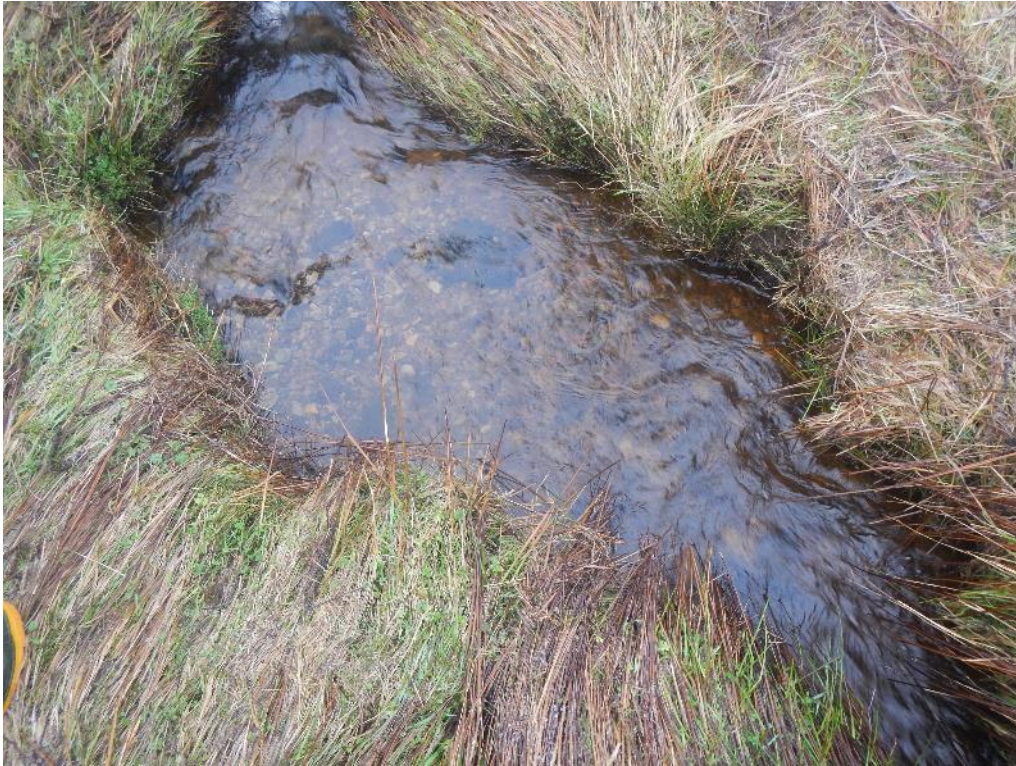
Figure 7. Potential salmonid (primarily trout) spawning gravel deposition, facilitated by a slightly wider area of channel. It would be worthwhile ascertaining whether fish are this far up the watercourse, u/s of the large waterfall.

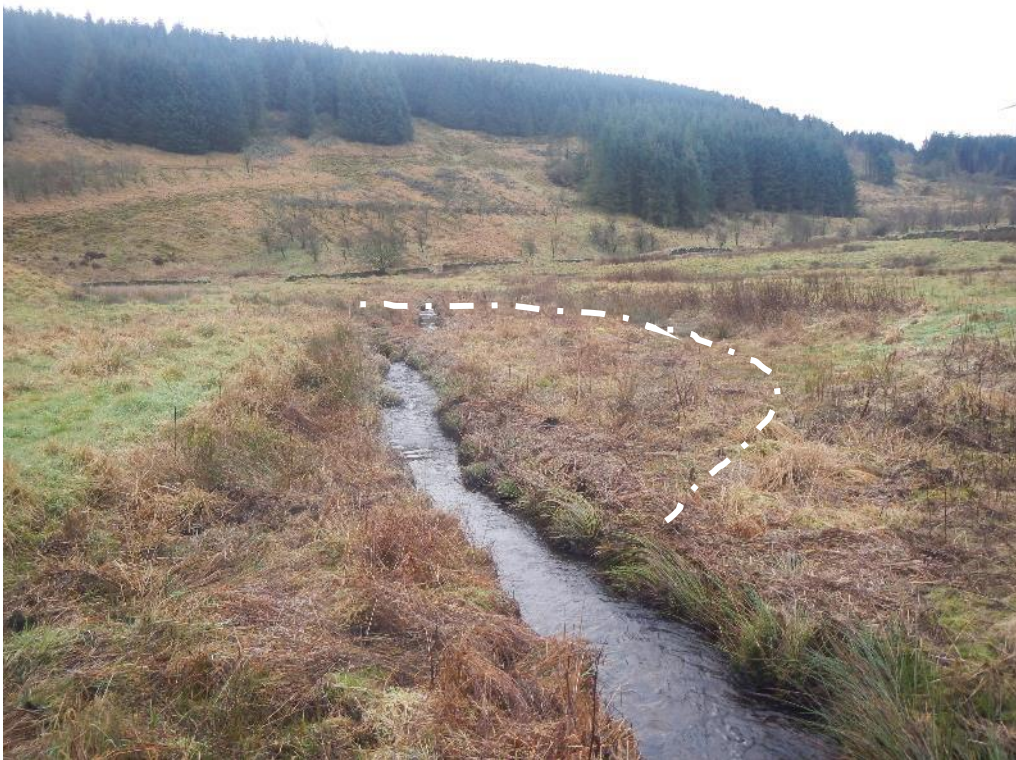
Figure 8. A straightened section of watercourse (55.18508, -3.13377), with paleochannels (including LH meander) still visible (white dashed line). Such straightening reduces the watercourse's ability to create pools and depth variation, and to naturally sort and store a natural array of substrate. This could be very easily reinstated.

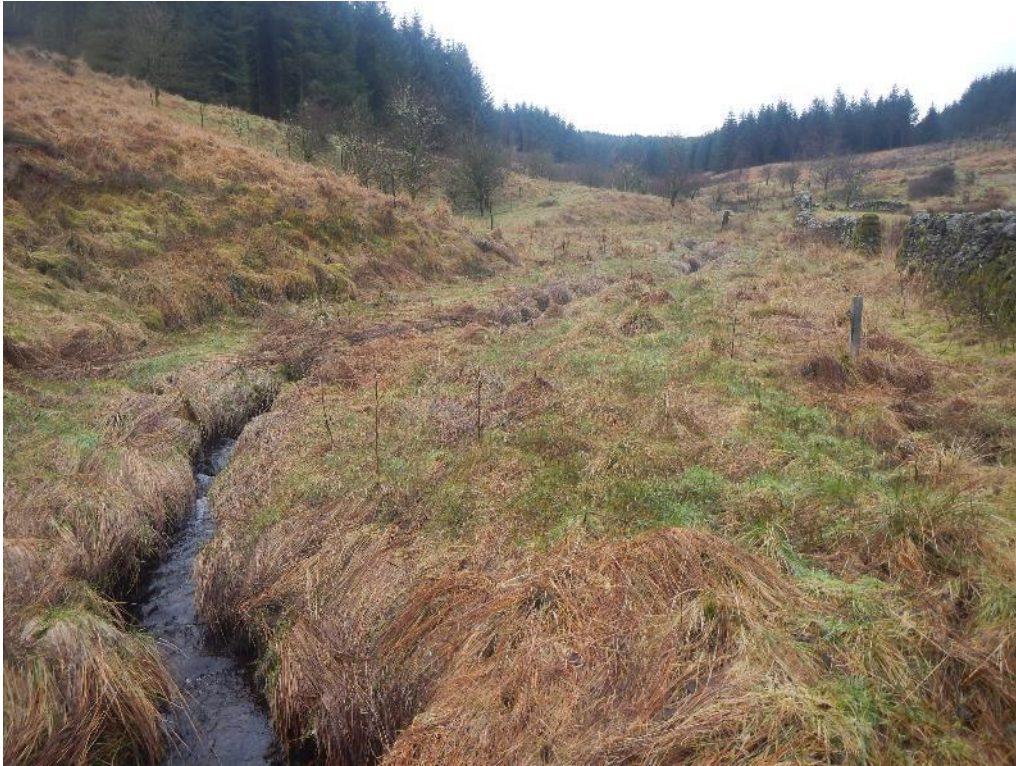
*Figure 9. Trough Burn (55.183915, -3.133568), which drains the westerly valley in the upper catchment of Boyken Burn is a similar size and character to Eild Burn and would similarly benefit from bankside tree planting (at least *Willow whip planting*).*

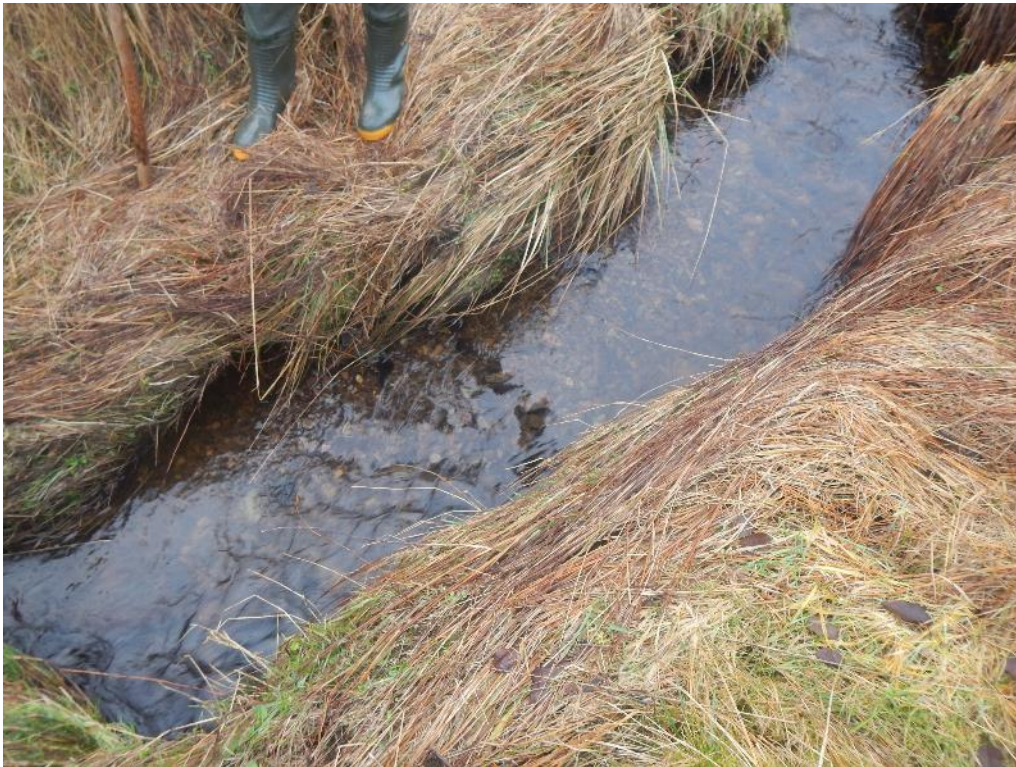
Figure 10. Although lacking cover and in-channel structure, some potential salmonid spawning habitat was retained.

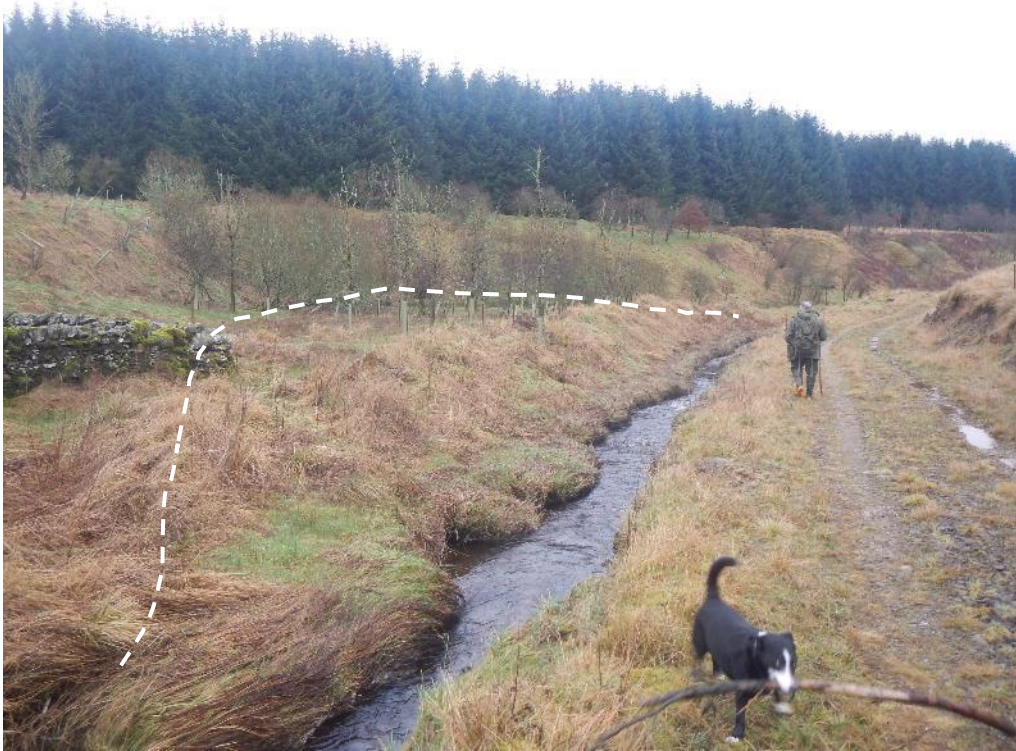
Figure 11. D/s of Trough Burn the now much larger watercourse was also clearly straightened (approximate past course - dashed white line), reducing gravel retention and increasing incision. This channel could be restored (55.18405,-3.132652).

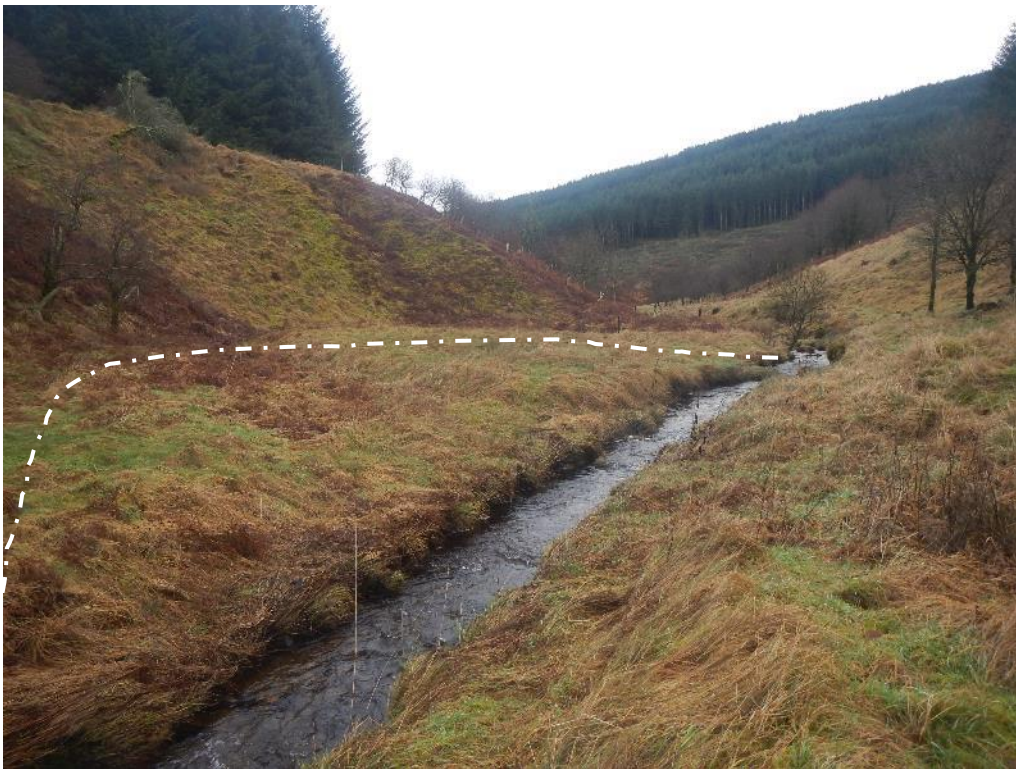
Figure 12. The next straightened section also had potential for reinstatement (55.18431,-3.130378). The main issue in doing so would be the level of incision that has occurred, requiring raising the channel to the original level, however, it is certainly still achievable.

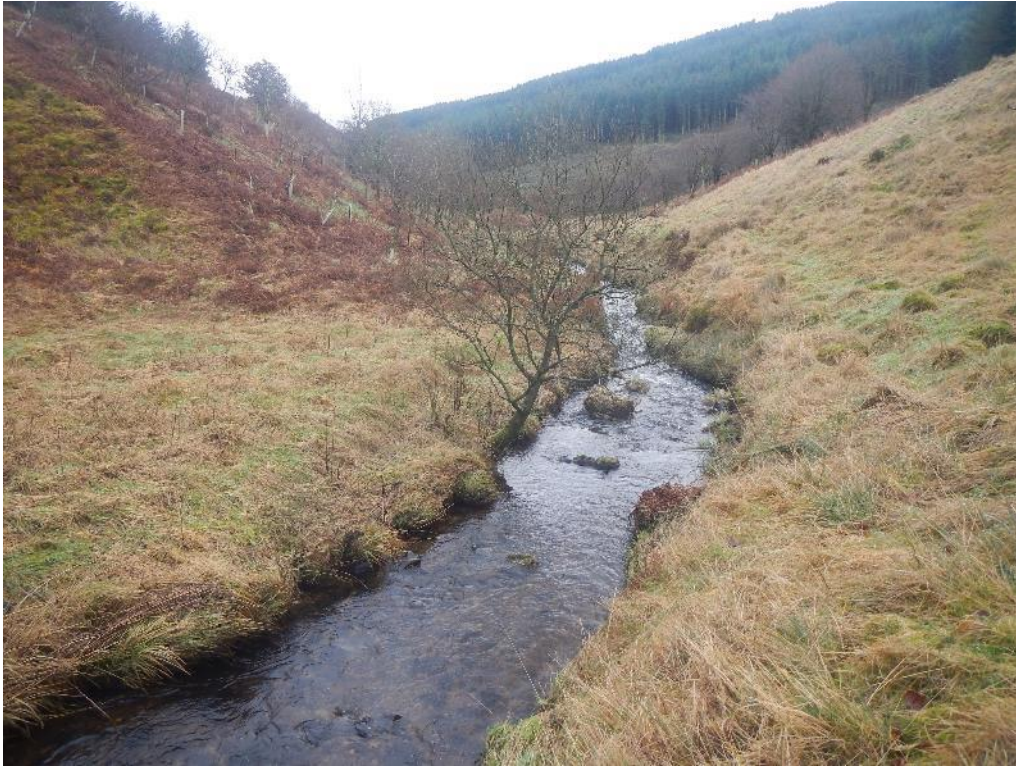
*Figure 13. One of the few bankside willows observed in the upper section (55.184098, -3.129988). It would be beneficial to transplant cuttings to replicate this throughout the reach (*Willow whip planting*). If that were done, it would be beneficial to hinge this tree into the channel (*Tree hinging*); if not, it is best left as a standing bankside tree.*

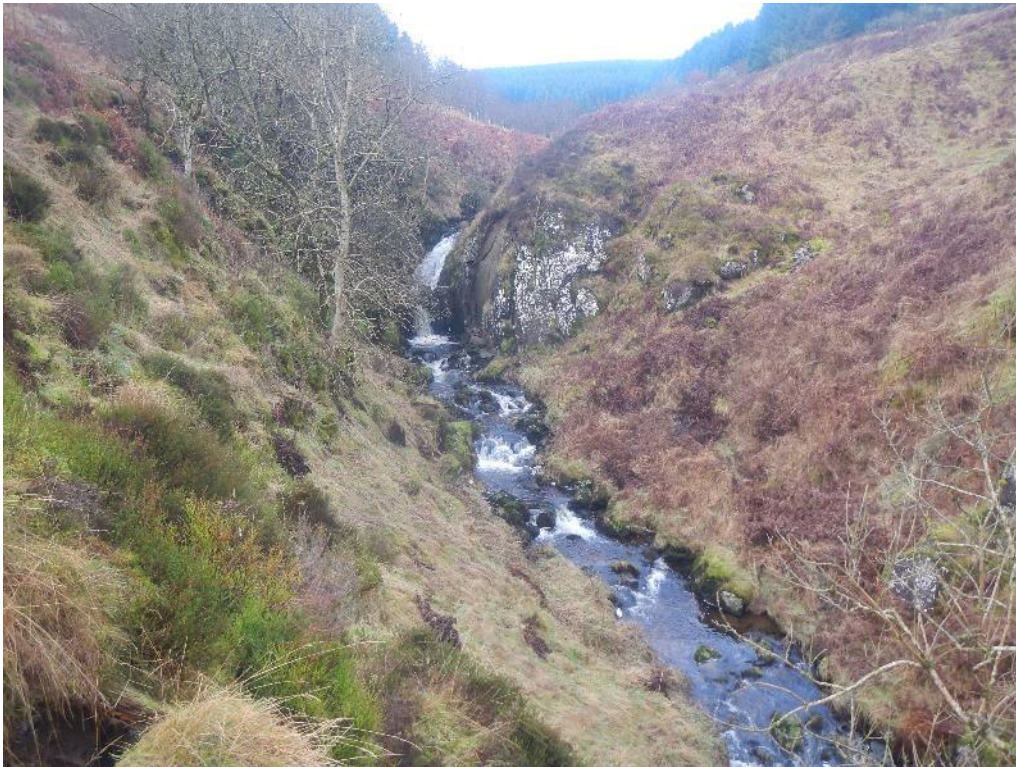
Figure 14. A major waterfall bisects the upper and lower habitat of Boyken Burn (55.183592, -3.126713). It would be useful to ascertain what, if any, fish populations are sustained u/s.

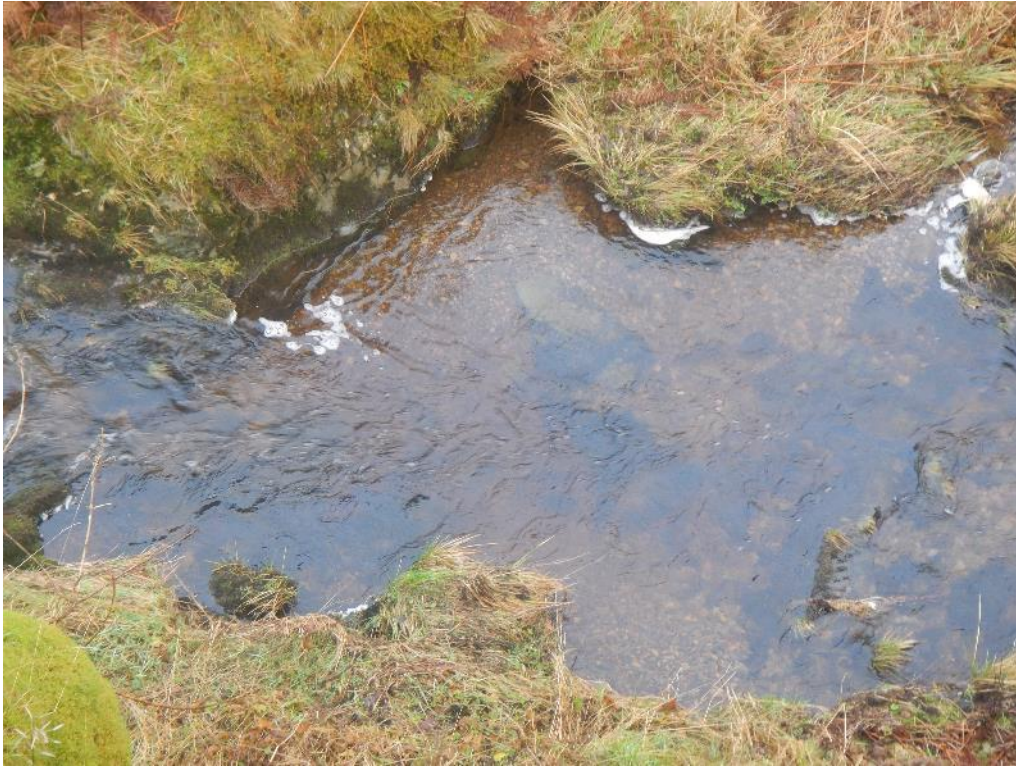
Figure 15, D/s of the waterfall, more wider areas of channel were observed, with a corresponding increase of gravel deposits – although they are still not in ideal areas for salmonid spawning, predominantly occurring in the sheltered margins.

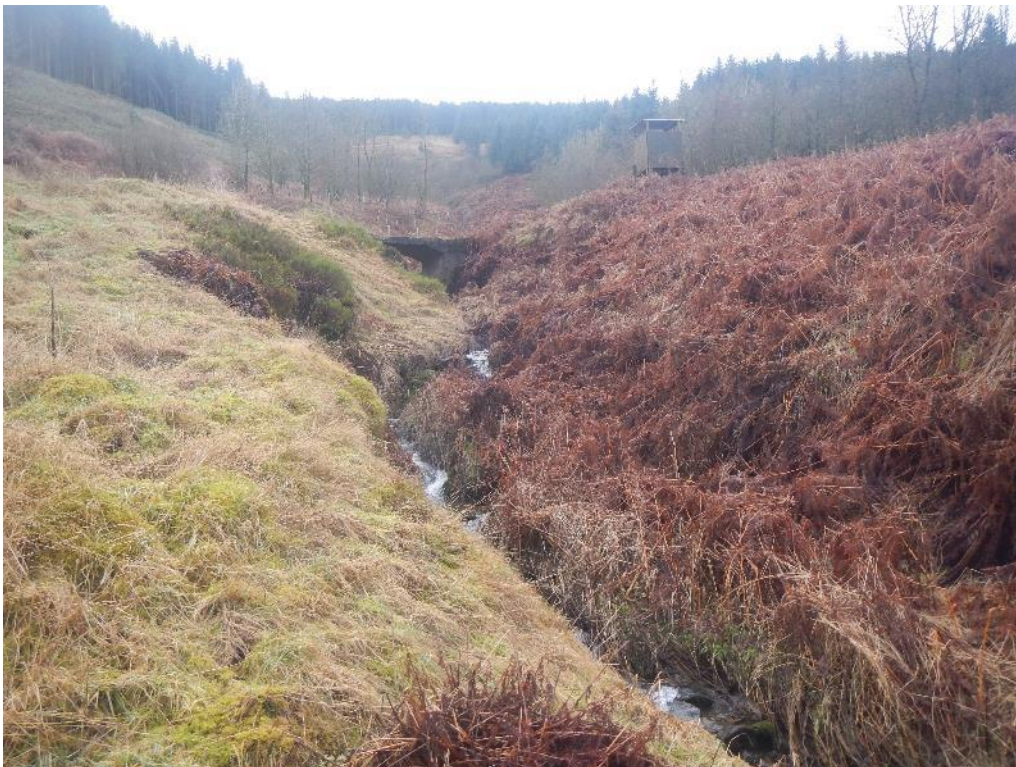
Figure 16. Clackanna Sike is a steep and poorly accessible tributary, with the track crossing creating an additional obstruction (55.1833578, -3.1258847).

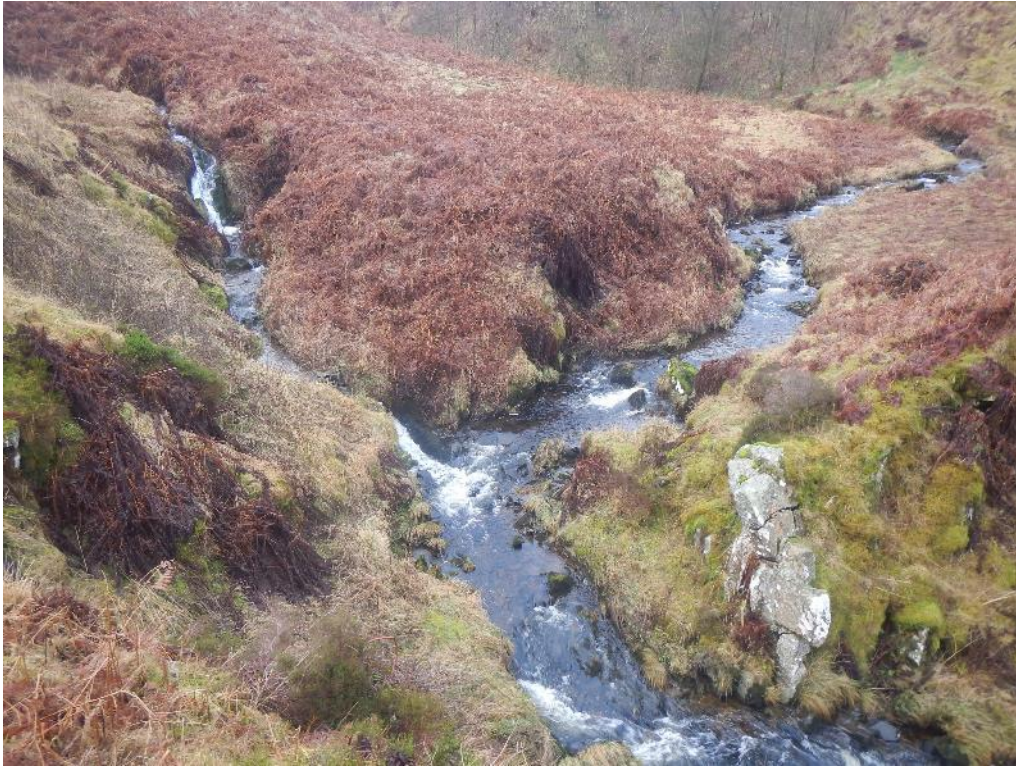
Figure 17. Looking u/s at the confluence with Boyken Burn: even the first 20m create an obstacle to fish (55.1837557, -3.1257363), owing to exposed bedrock (left of shot).

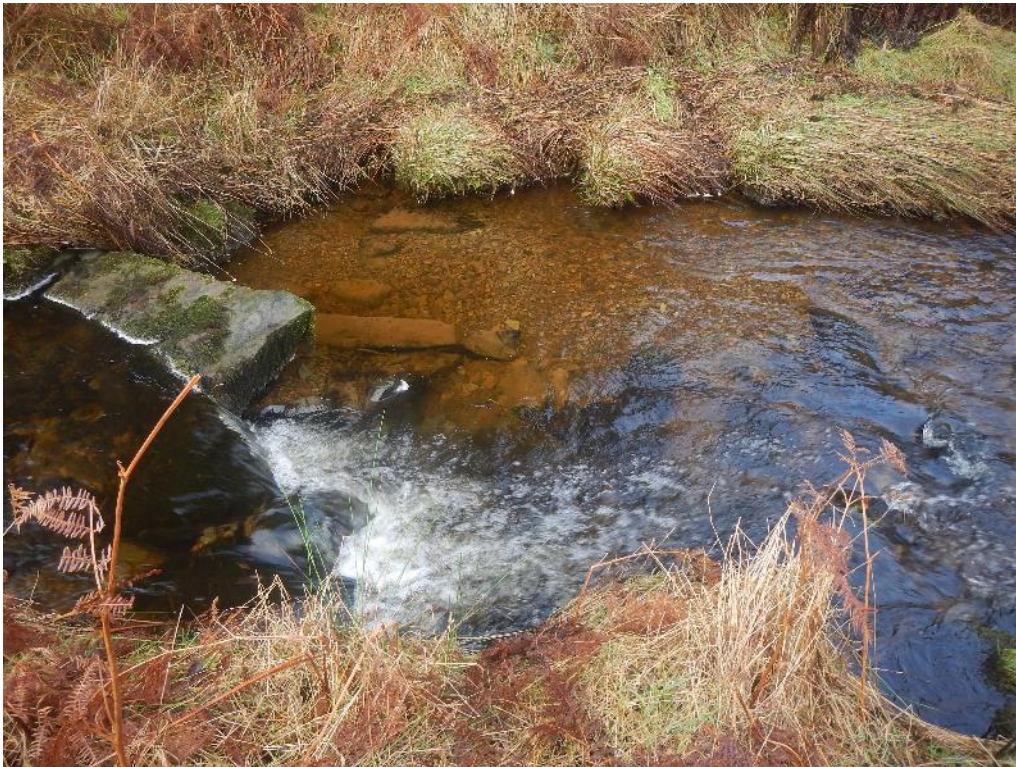
Figure 18. Further valuable gravel deposits in the lee of a boulder. This could offer some potential for salmonid spawning but also provides important habitat diversity for invertebrates.

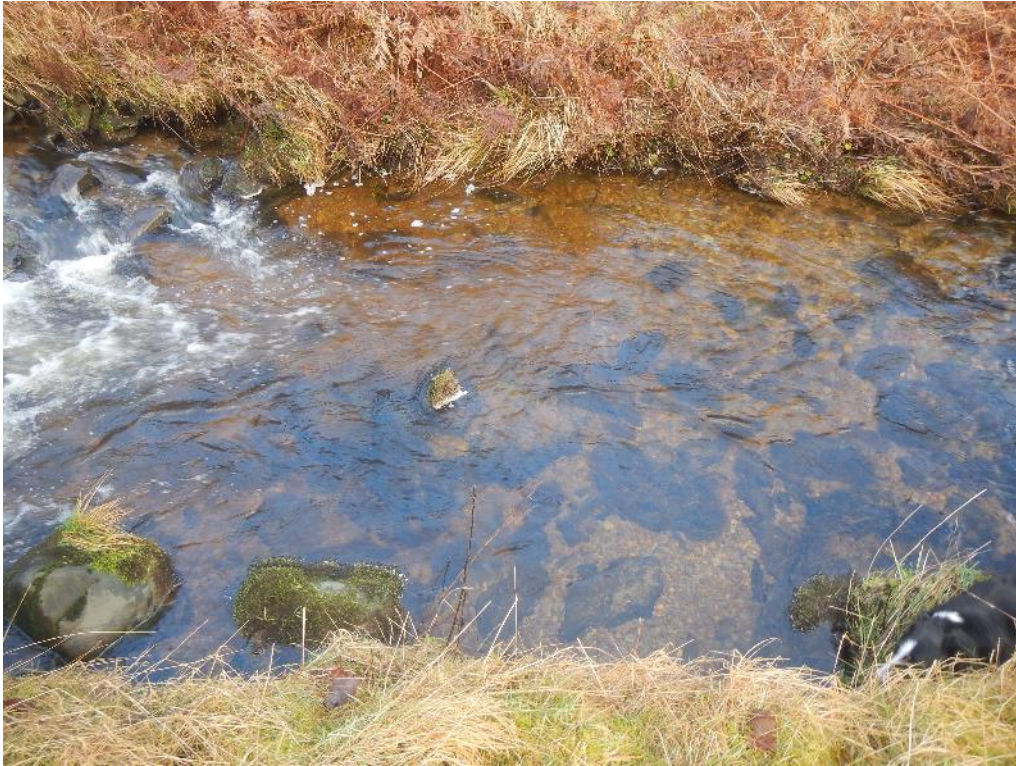
Figure 19. The roughness of the generally cobble bed does retain some gravel, but not typical spawning riffles. More bankside/trailing and in-channel structure could help baffle peak flows and increase gravel retention.

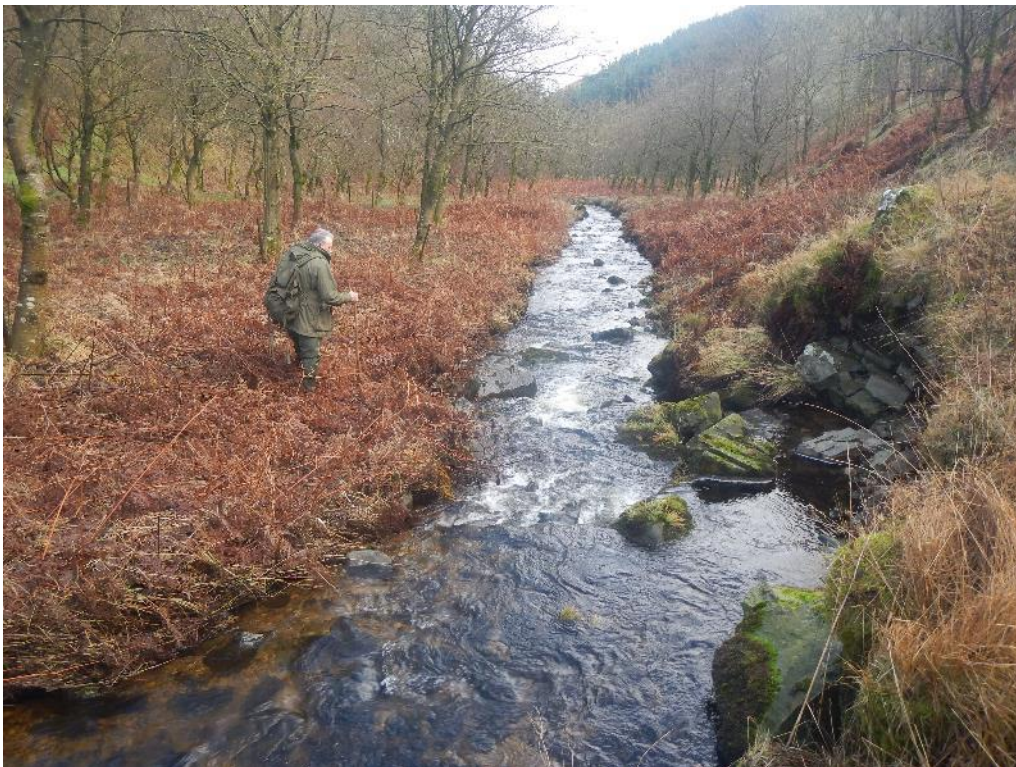
Figure 20. Another straightened section: note the boulder/cobble nature of the straightened, steepened channel (55.185008, -3.119887). The watercourse should be flowing off to the left of shot, as per the previous straightening. Potential for bed raising/restoration to reinstate the paleochannel.

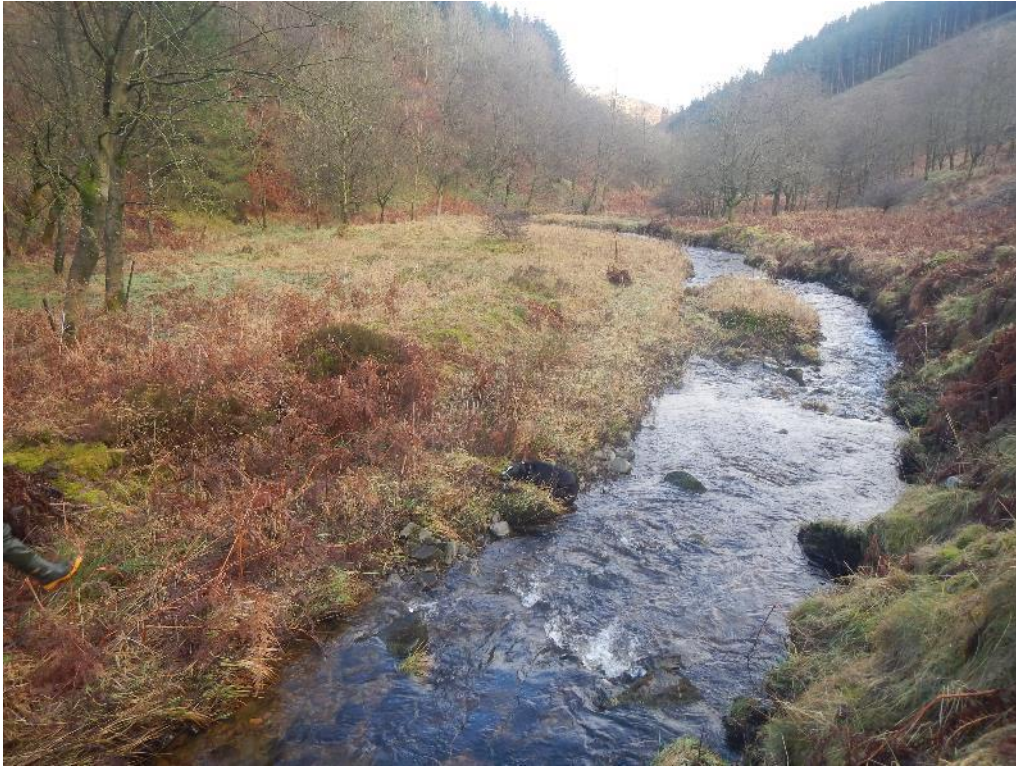
Figure 21. Even in more sinuous sections, this steep watercourse lacks the finer sizes of coarse substrate (55.185035, -3.117865) – the scarcity of bankside trees and in-channel woody material exacerbate the issue. Planting here would be beneficial and the installation of very large woody material could facilitate significant channel recovery.

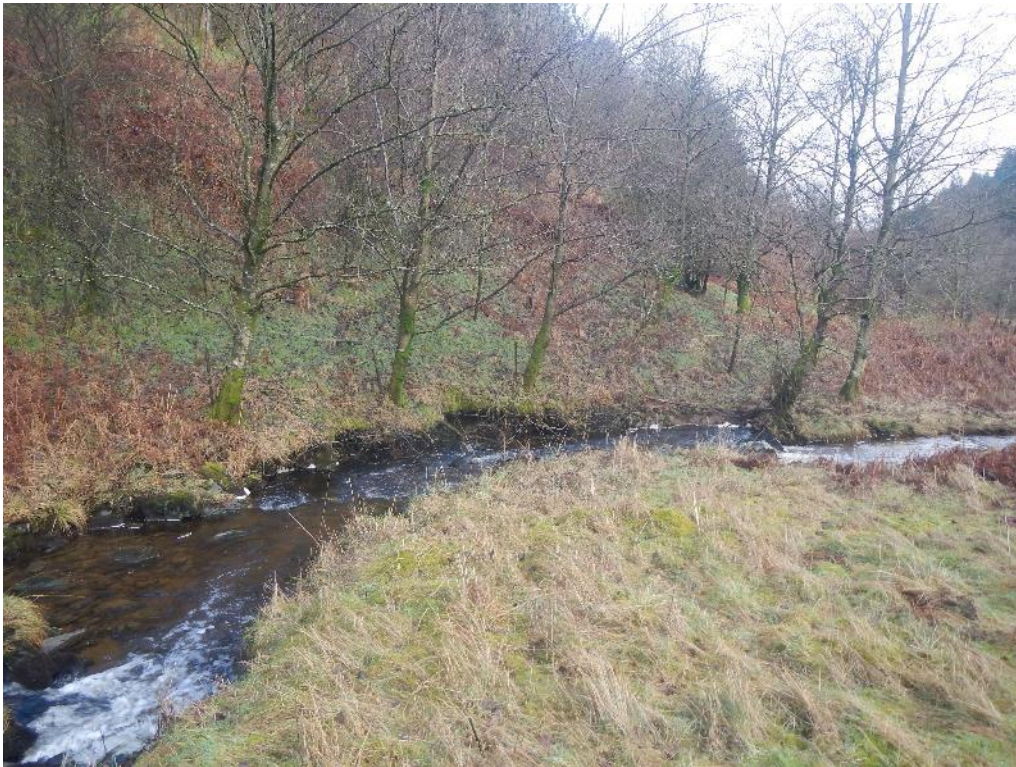
*Figure 22. where a few bankside trees (sycamore) were observed, the undercut bank and shade provide a valuable addition. The trees could form an anchor point for **Lodged Woody Material**.*

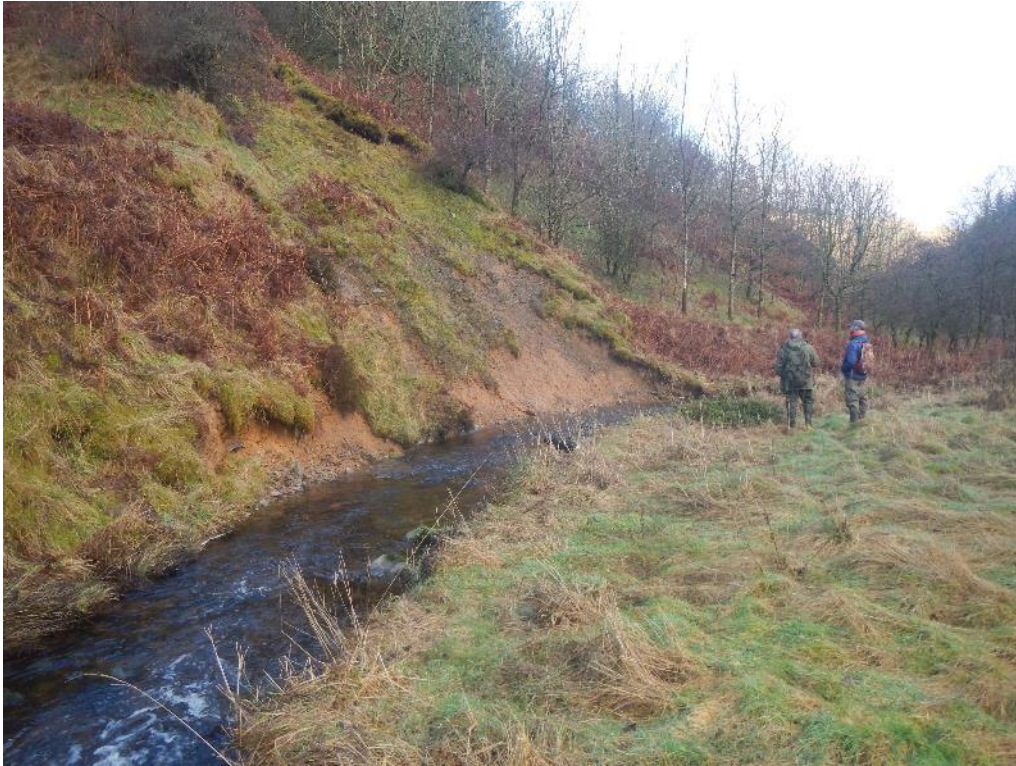
*Figure 23. Without the protection of bankside tree roots, several of the sharper bends were subject to erosion and land-slipping (55.185703, -3.115677). It may be possible to install some **Pinned Woody Material** here on either bank, but it would require adequate anchoring to the bed and bank.*

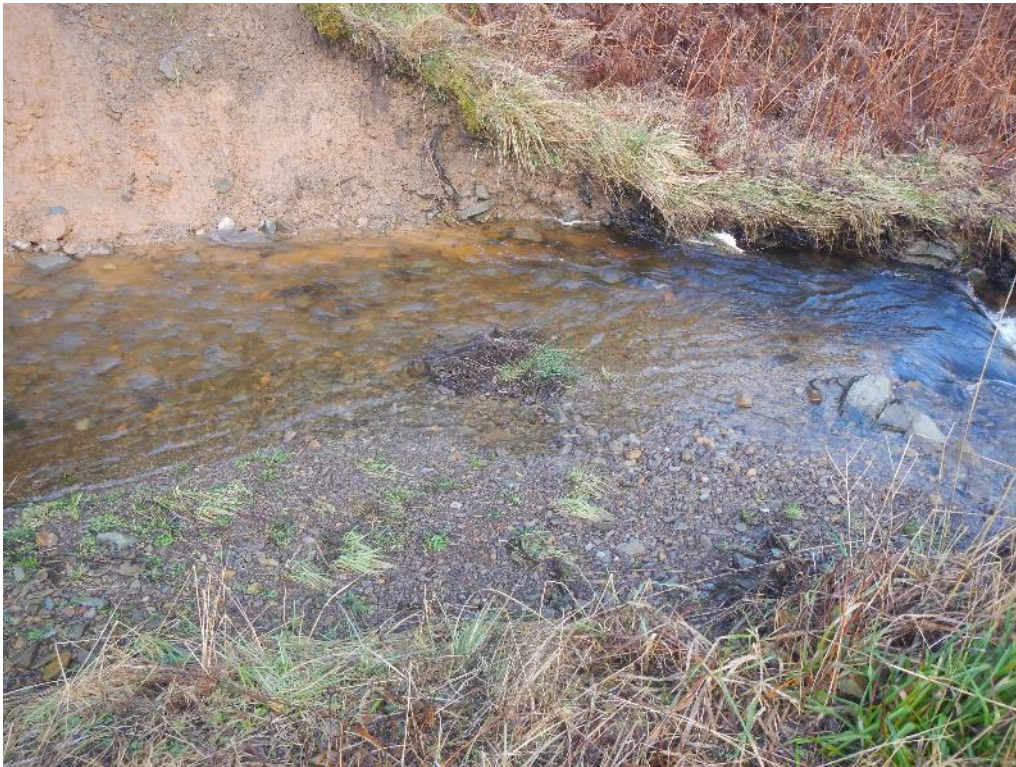
Figure 24. The bends and slightly wider channel areas did provide some improved gravel retention.

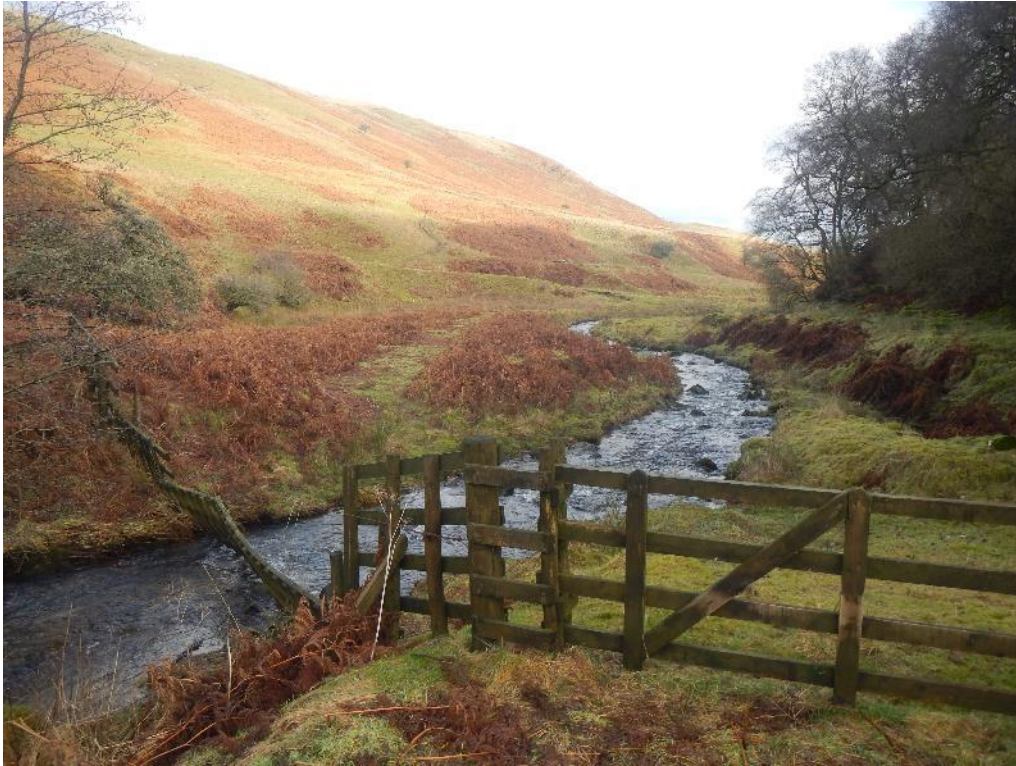
Figure 25. At approximately 1/3 of the way through the walkover, the valley opened slightly facilitating a slightly more meandering course (55.188298, - 3.11035). The area also became more heavily grazed. Buffer fencing would be beneficial, coupled with bankside planting.

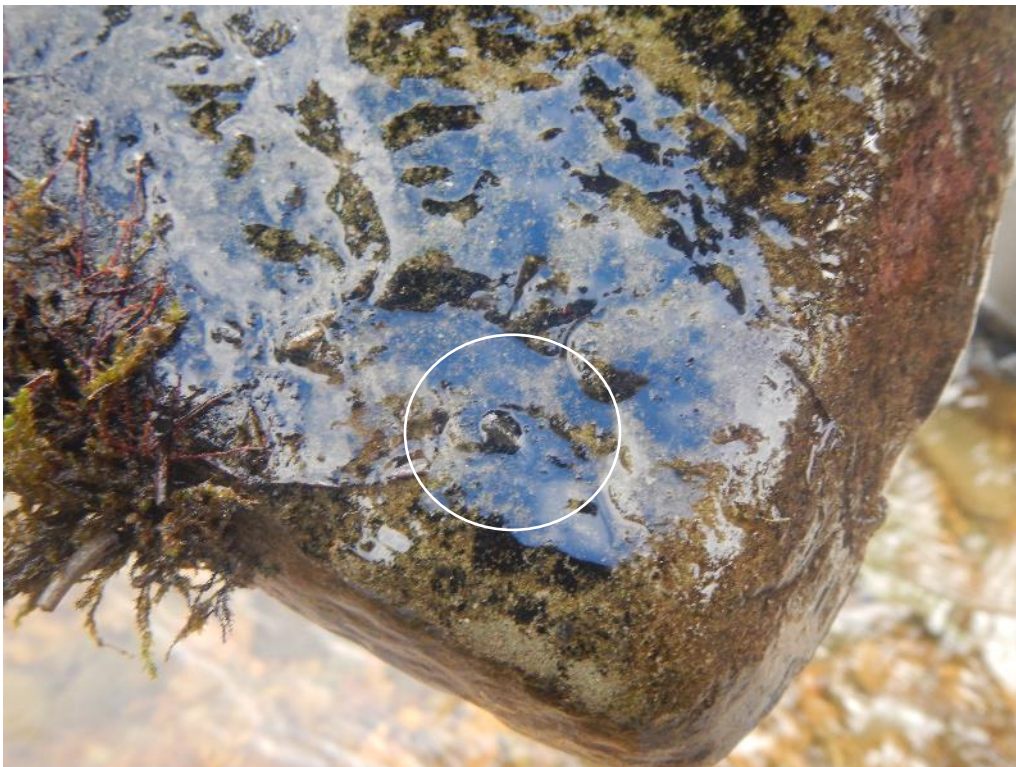
Figure 26. Stone turning revealed the expected invertebrates: predominantly heptageniid mayflies (white circle) and stoneflies, with occasional caddis in the slower areas. The lack of slack water and organic material in-channel is clearly limiting the numbers of detritivorous species.

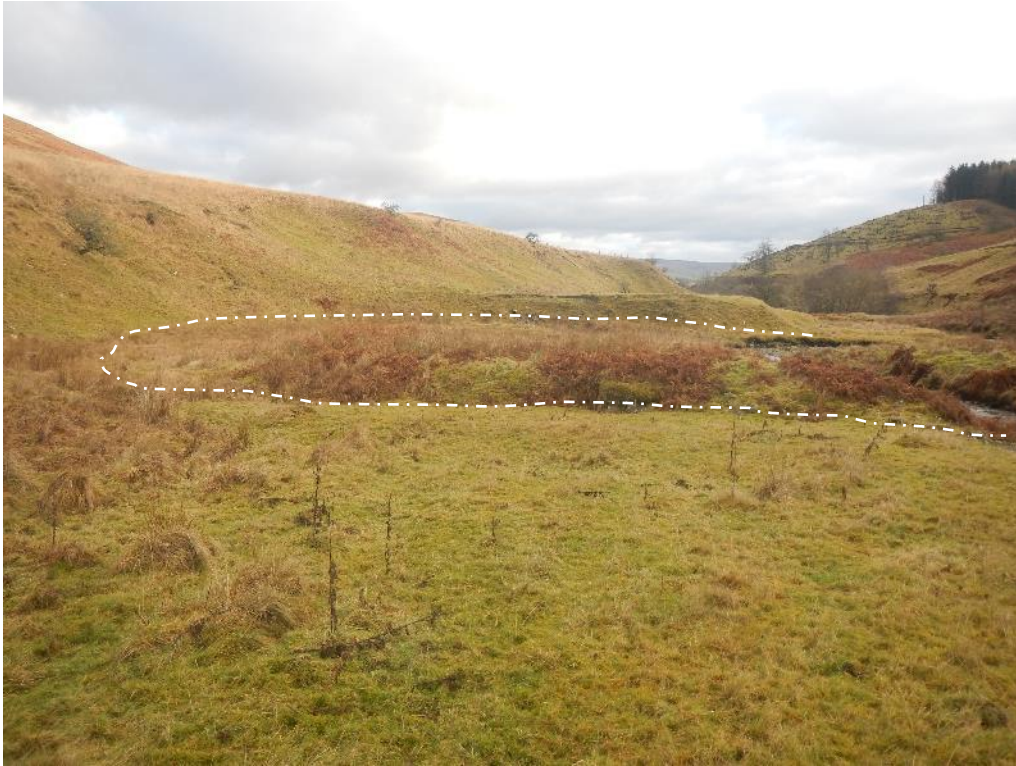
Figure 27. Numerous paleochannels were evident in the floodplain, some potentially naturally abandoned, but others (as here) almost certainly resulting from artificial straightening (55.187552, -3.104055). The meanders could be reconnected through restoration.
