WILD TROUT TRUST

Boyken Burn
(Border Esk tributary)

Dumfries and Galloway

January 26th 2023

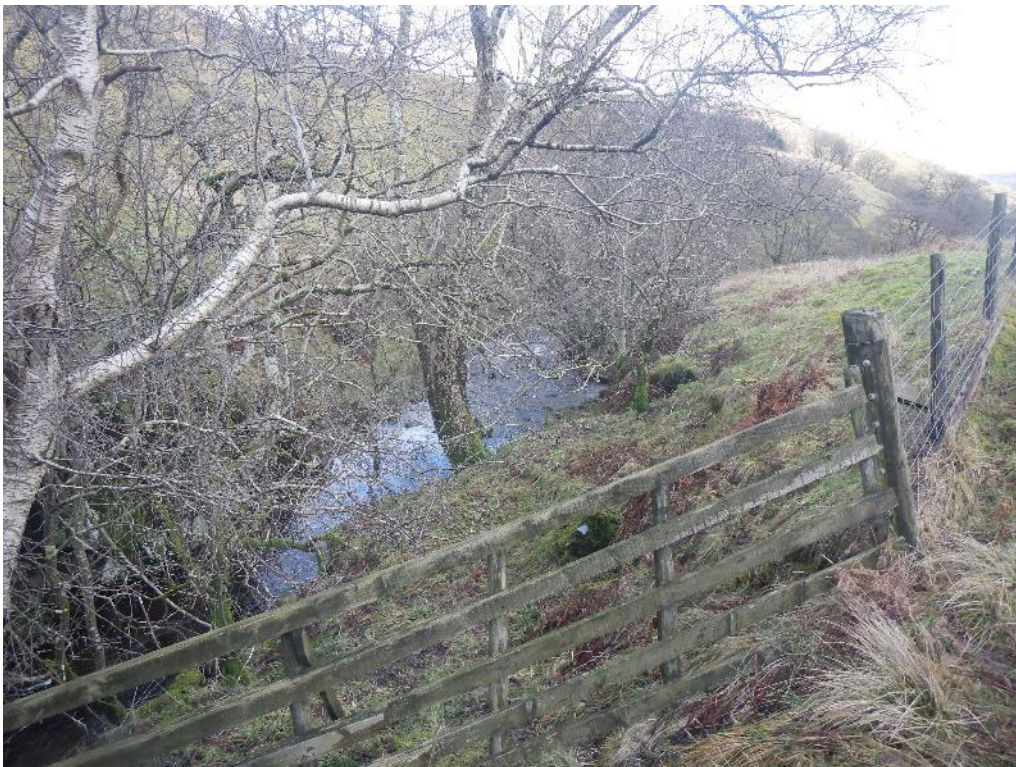
*Figure 28. Progressing d/s, bankside trees become a more regular occurrence, although their veteran status highlights the issue of livestock grazing preventing regeneration (55.187177, -3.10067). Existing trees could be used as anchors for **Lodged Woody Material** to increase flow diversity and sediment deposition, and to provide more cover for fish and invertebrates.*

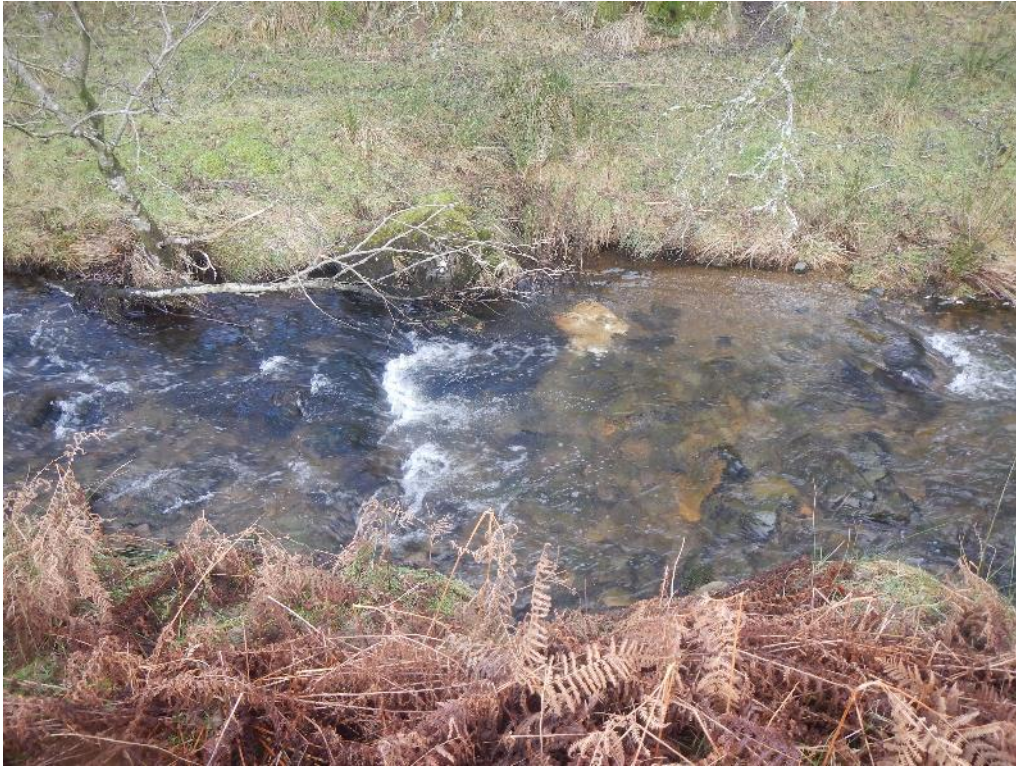
Figure 29. As u/s, wider areas retained some smaller gravel, but spawning habitat was limited.

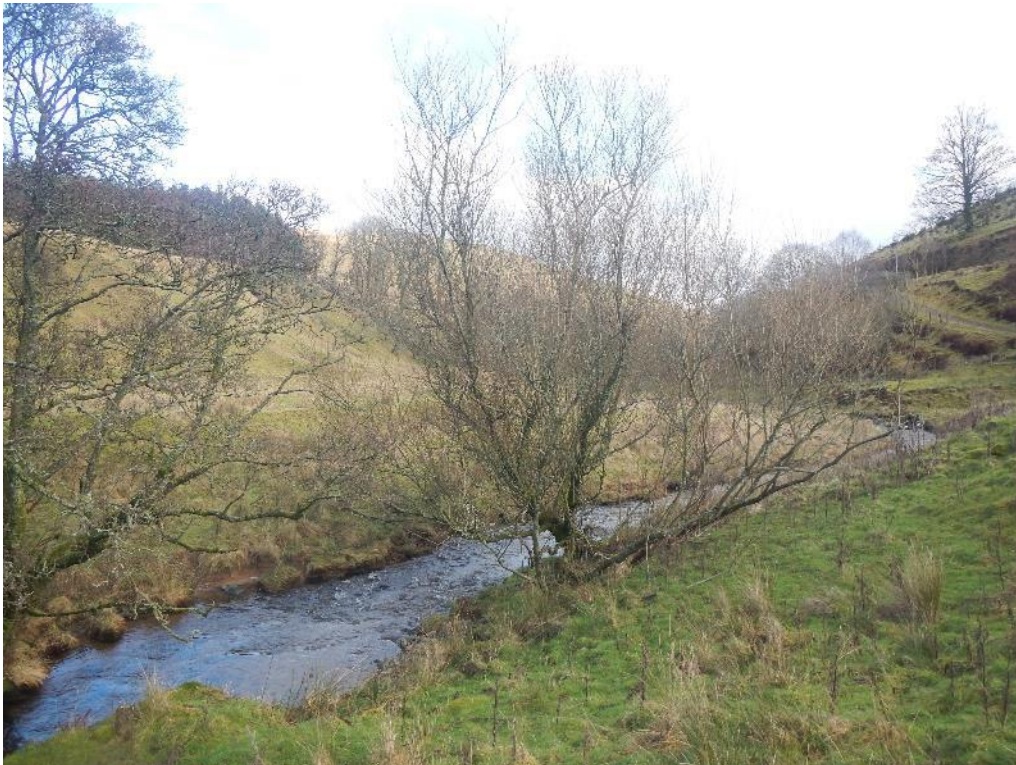
Figure 30. A bankside willow (55.187195, -3.097787) offers an opportunity for hinging to reinstate some of the lacking in-channel woody material. Care should be taken to ensure it is not left within the danger-zone of livestock browsing.

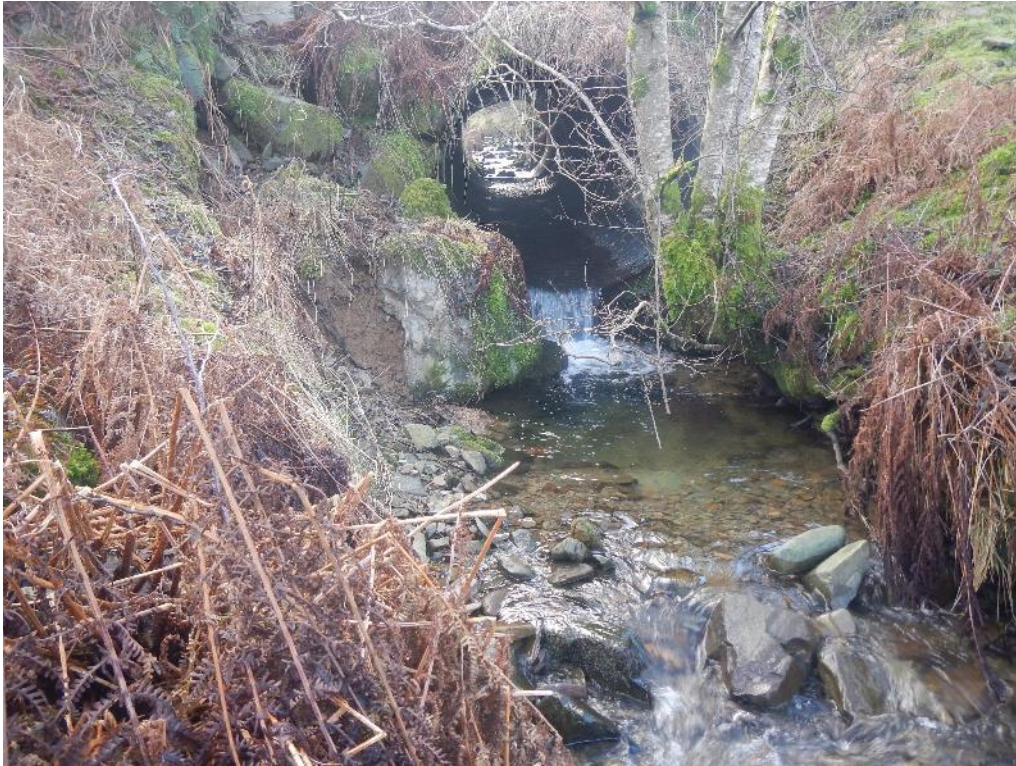
Figure 31. The potential of a viable spawning tributary is greatly reduced by the obstruction of a poorly installed, perched culvert (55.186822, -3.097292). While passable, this greatly reduces the opportunities for adult and juvenile salmonids to ascend.

Name	Recommendations	Latitude	Longitude
Figure 5	Planting (willow whip and saplings)	55.18925	-3.134995
Figure 8	Channel restoration	55.18508	-3.13377
Figure 11	Channel restoration	55.18405	-3.132652
Figure 12	Channel restoration	55.18431	-3.130378
Figure 13	Tree hinging and planting (willow whip and saplings)	55.184098	-3.129988
Figure 20	Tree and whip planting. Possible channel restoration with large trees	55.185008	-3.119887
Figure 21	Tree and whip planting. Possible channel restoration with large trees	55.185035	-3.117865
Figure 22	Lodged woody material	55.185295	-3.117158
Figure 23	Pinned woody material	55.185703	-3.115677
Figure 24	Buffer fencing d/s	55.188298	-3.11035
Figure 27	Possible channel restoration	55.187552	-3.104055
Figure 28	Lodged woody material (here and with nearby trees)	55.187177	-3.10067
Figure 30	Willow hinging	55.187195	-3.097787
Figure 31	Fish easement - difficult towing to track above	55.186822	-3.097292

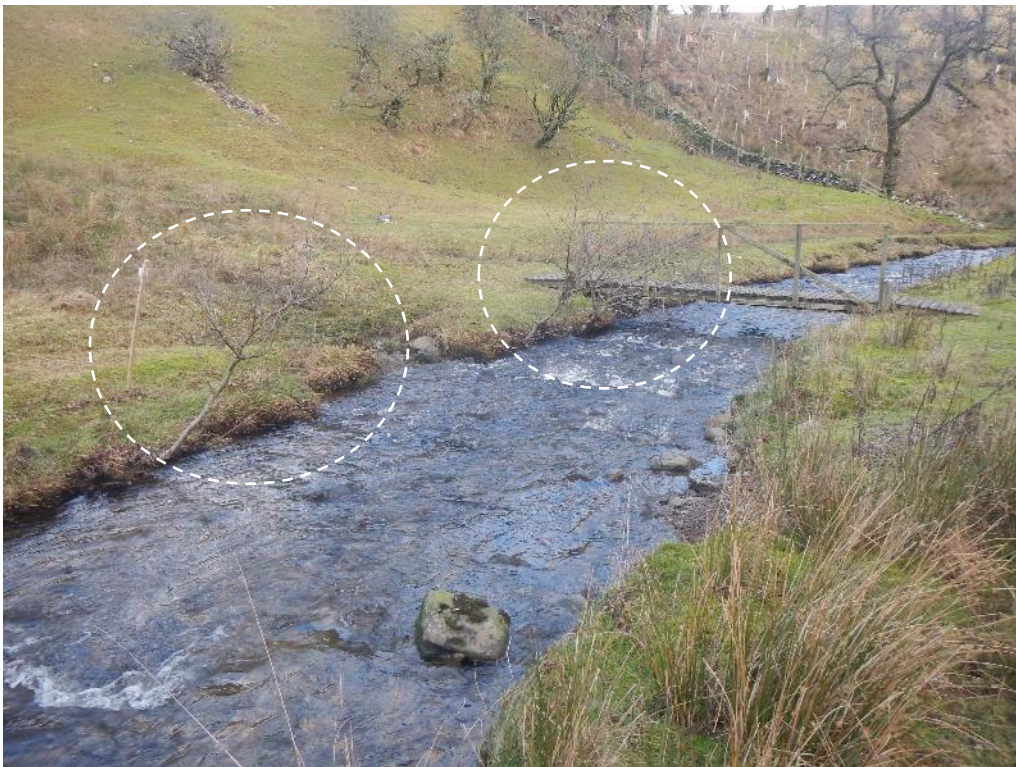
Figure 32. The heavily grazed banks around Calkin leave limited opportunity for bankside trees (55.18758, -3.095863); however, two small alders had managed to become established by growing out over the channel (out of reach). Replicating this with willow whips could afford them a chance, but it would be far better to exclude livestock from the riparian zone.

Figure 32	Buffer fencing and tree planting (at least willow whips out of livestock reach)	55.18758	-3.095863
Figure 35	Buffer fencing, tree planting and woody material	55.186573	-3.089977
Figure 36	Lodged woody material (here and with nearby trees)	55.18616	-3.08885
Figure 37	Measures to reduce surface runoff from track	55.185787	-3.084923
Figure 41	Fish easement - difficult towing to causeway track above	55.185678	-3.077052

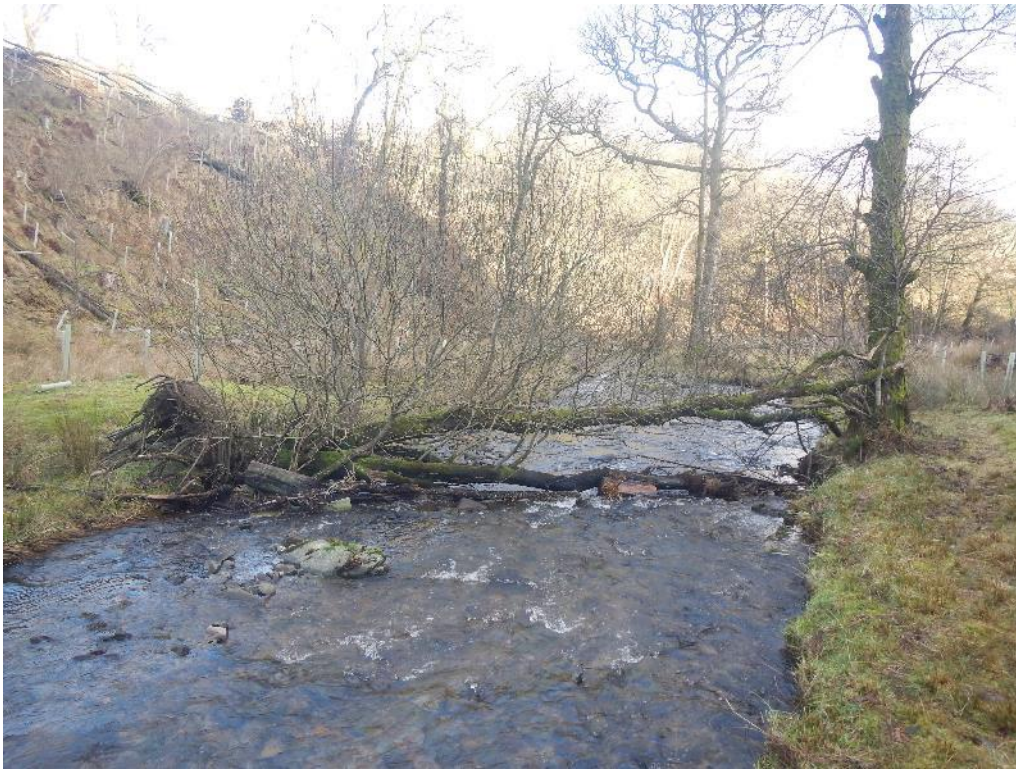
Figure 33. Naturally lodged woody material. There would and should be more of this valuable habitat in the upper ~2/3 of the burn, if there were more trees.

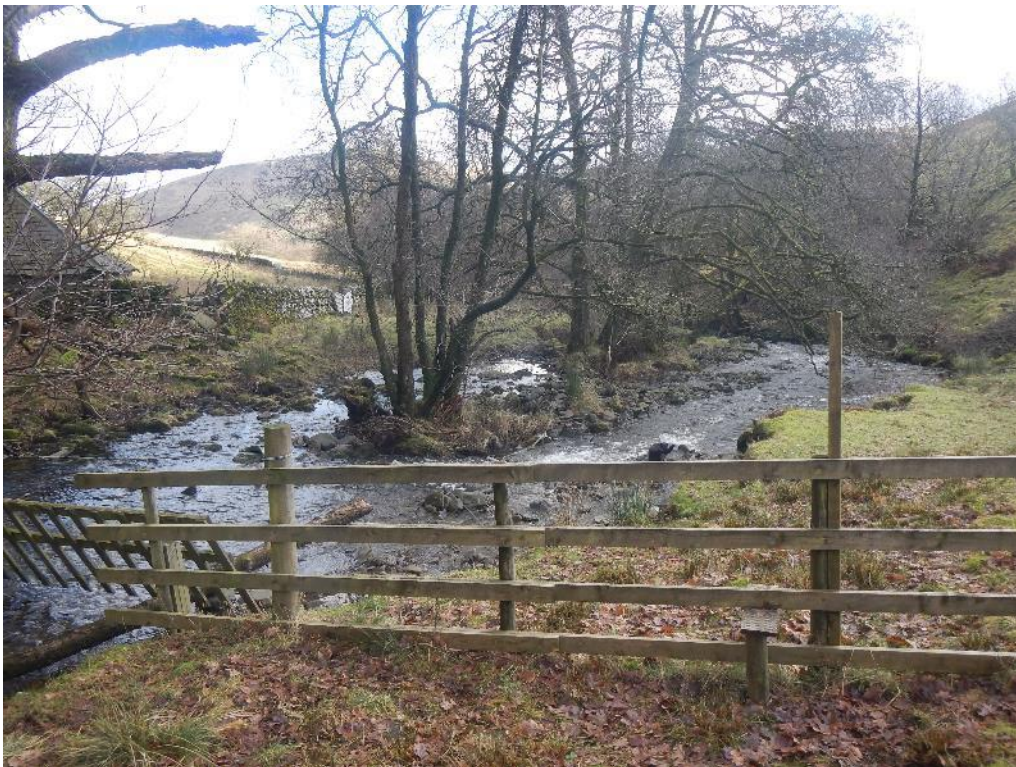
Figure 34. The next field d/s was similarly grazed, with an island of trees strongly suggesting they have been outflanked by excessive bankside erosion – a symptom of heavy sheep grazing.

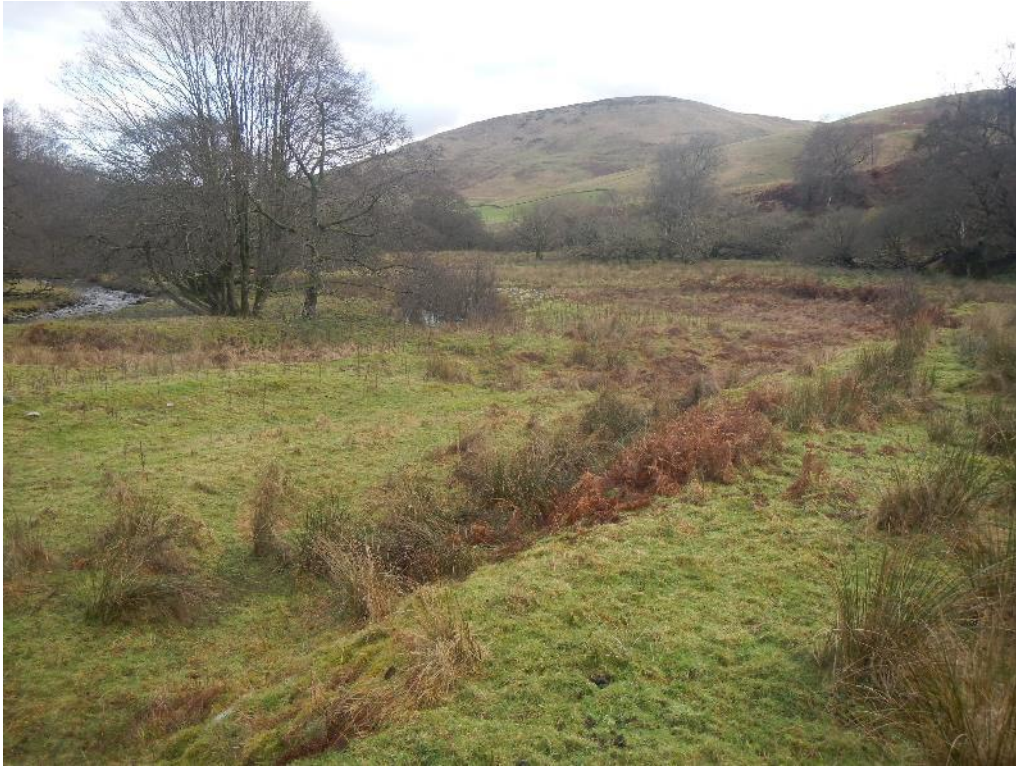
Figure 35. Another series of lost meanders. The abrupt nature of the cut-off suggest they may have been artificially straightened (55.186573, -3.089977). Increased trees and woody material in these areas could help the channel re-naturalise. Buffer fencing would also be beneficial.

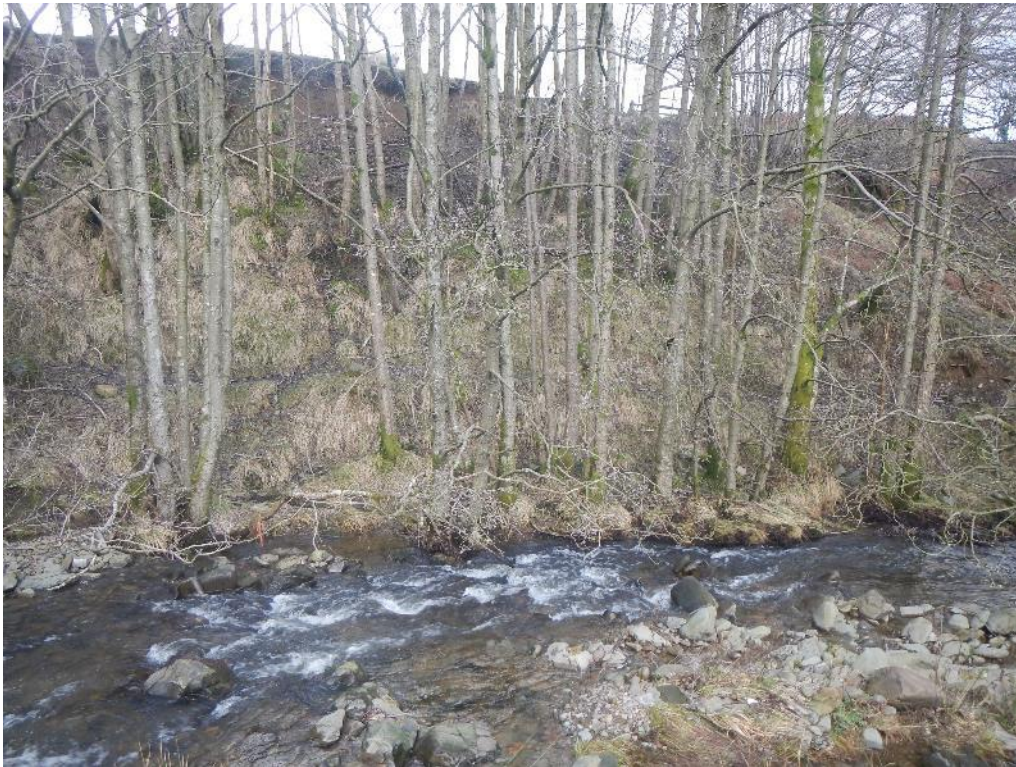
*Figure 36. Where a greater number of bankside trees are present, there is greater opportunity for increasing woody material to the channel (55.18616, -3.08885). Unfortunately, the suitability of this otherwise ideal location for **Lodged Woody Material** is reduced by the steep gradient, but some use of the technique here would still be worthwhile.*

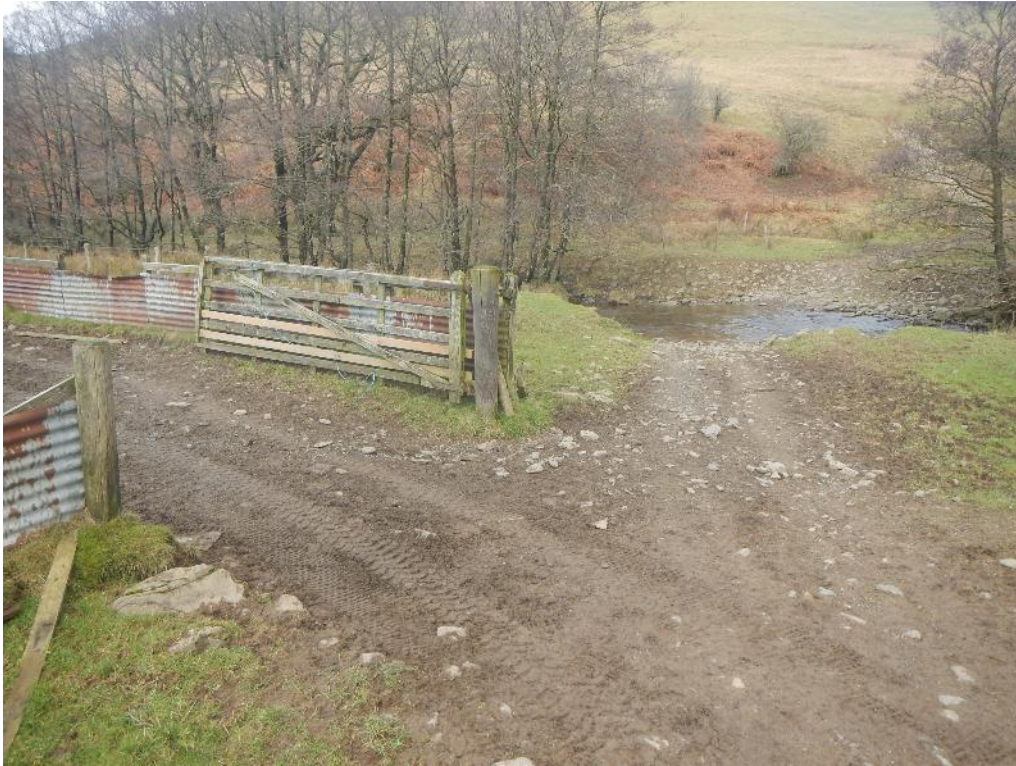
Figure 37. Track erosion and a likely source of surface runoff and fine sediment to the burn (55.185787, -3.084923).

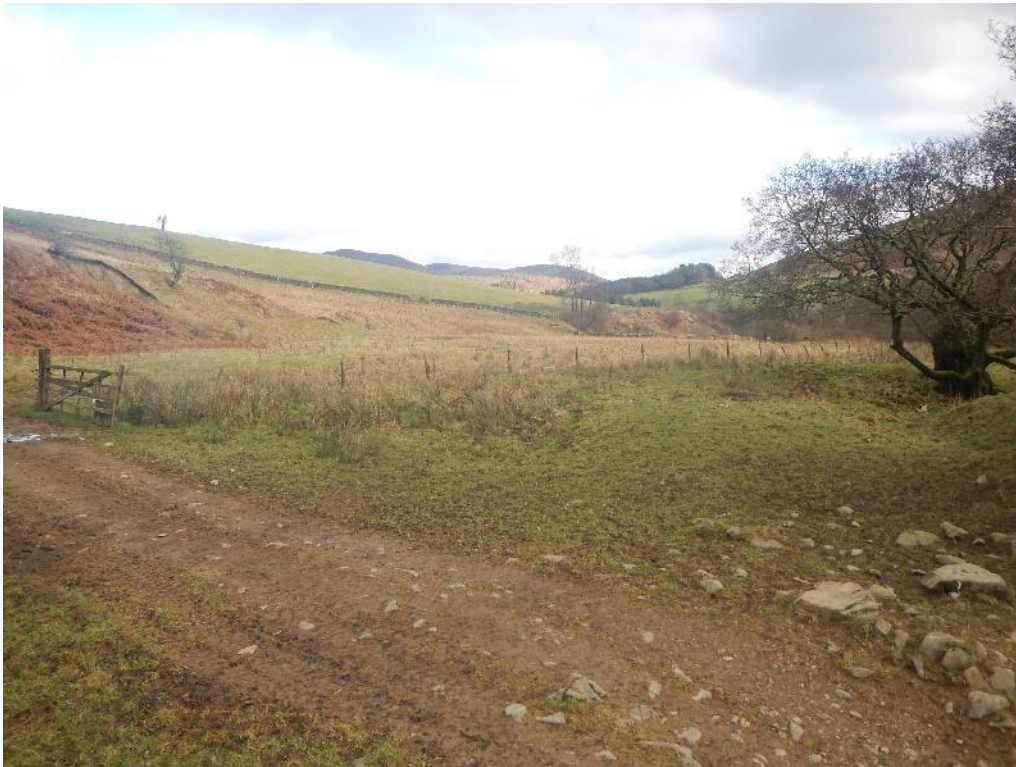
Figure 38. Further signs of lost paleochannels, some of which will be natural, but the incredibly straight, incised and embanked channel alongside suggest modification.

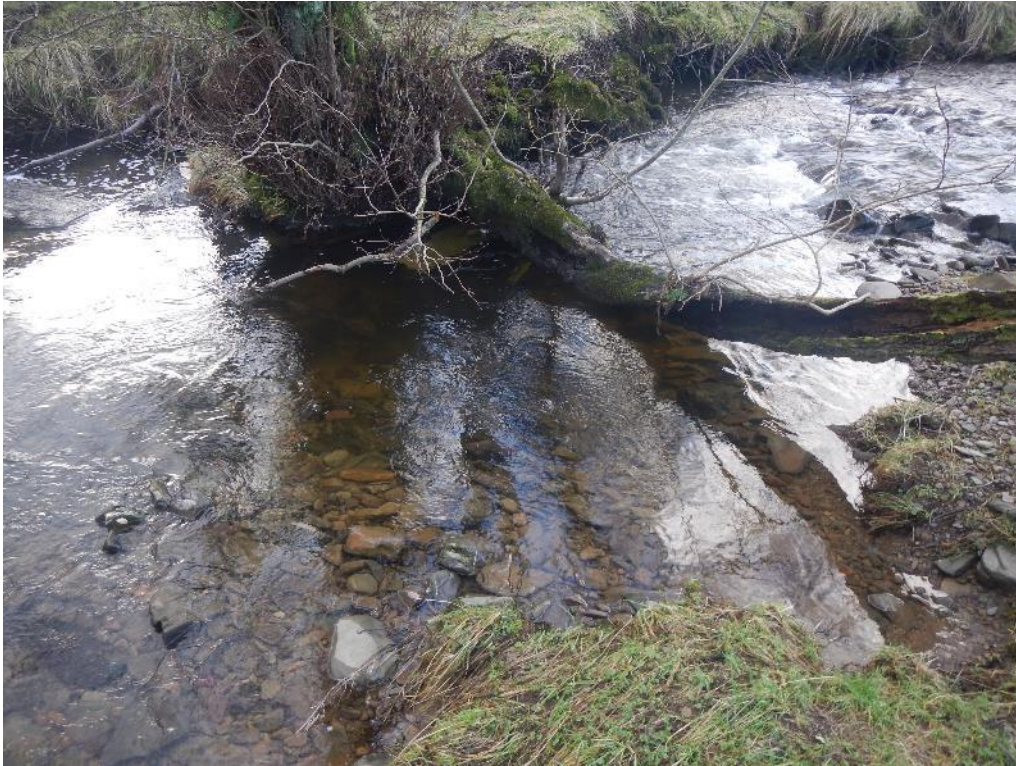
Figure 39. Where trees were present at even slight bends and/or lower gradient areas, valuable pool features were observed. The reinforcement of the bank by the tree and the undershot/overtopping scour from the branch maintains additional depth.

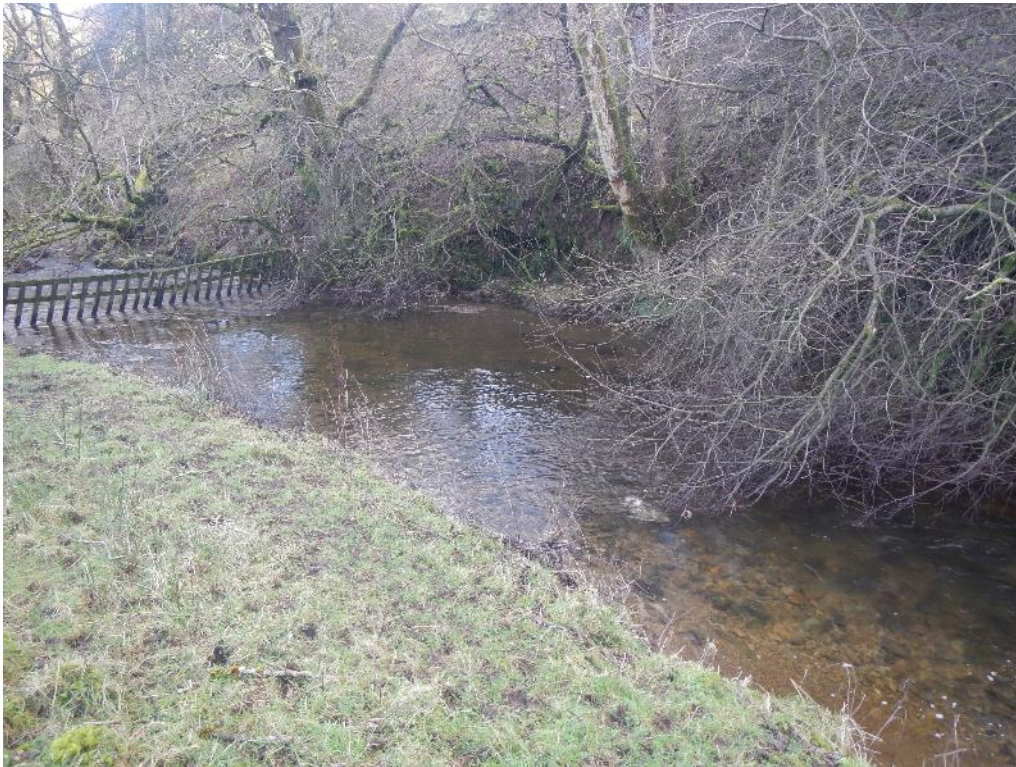
Figure 40. Potential spawning at the tail of a more sedate, larger-capacity pool, significantly enhanced by the availability of deeper water and overhanging/trailing cover nearby. The trailing cover will also help to dissipate peak flow energy to encourage the deposition of spawning substrate d/s.

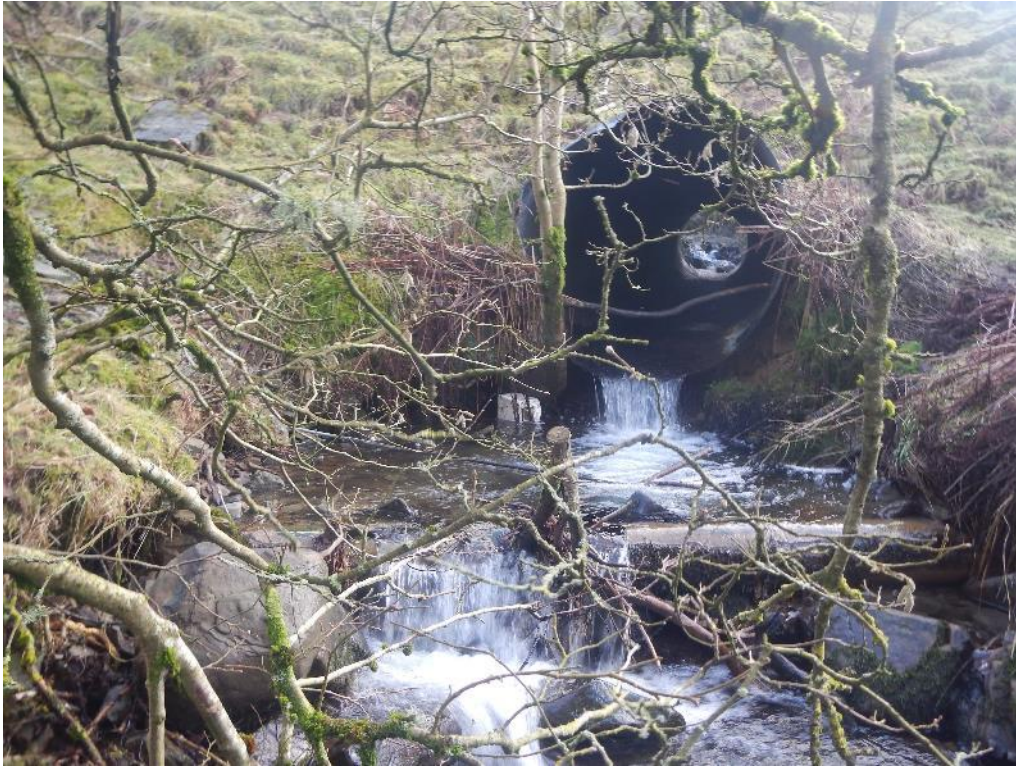
Figure 41. Glenbertle Burn suffers the same issue as many of the southern Boyken Burn tributaries, with fish passage greatly inhibited by a perched track culvert (55.185678, -3.077052).

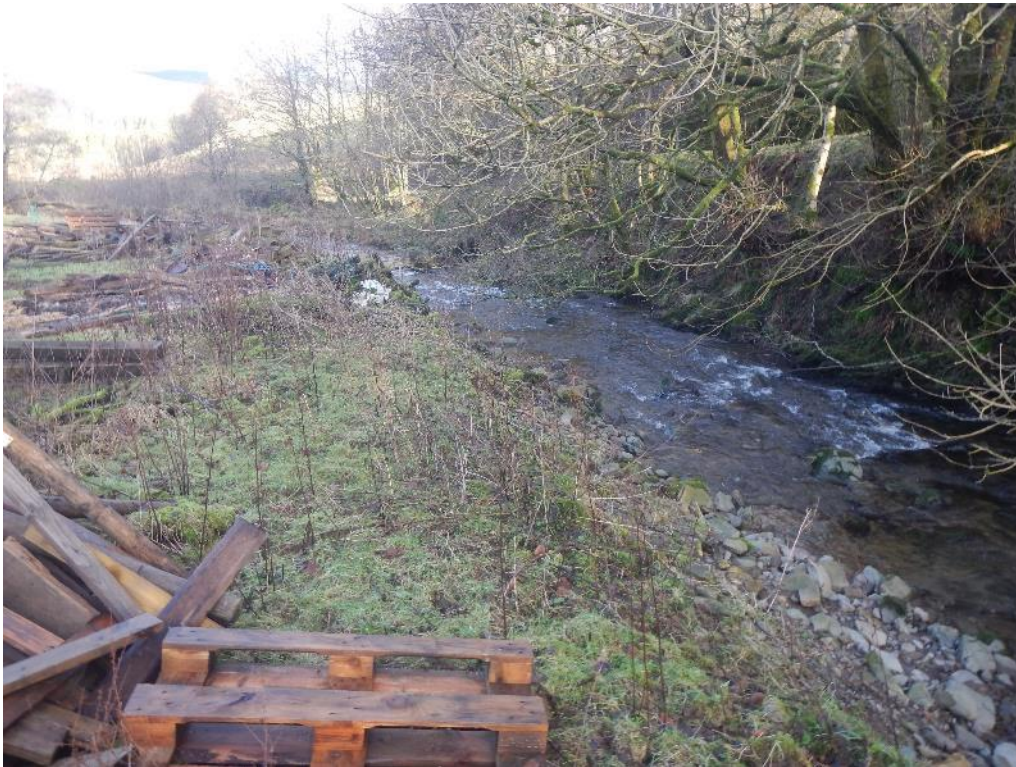
Figure 42. Just d/s of the Glenbertle Burn, the LB of Boyken Burn was being used to store wood and rubbish, with some of the rubbish items sufficiently close to be washed into the burn on a moderately high flow (55.1863, -3.076835).

Figure 42	Seek removal of rubbish from bankside	55.1863	-3.076835
Figure 45	Seek retention of bankside trees during harvesting operations	55.18935	-3.072395
Figure 46	Install Woody material	55.190138	-3.072103

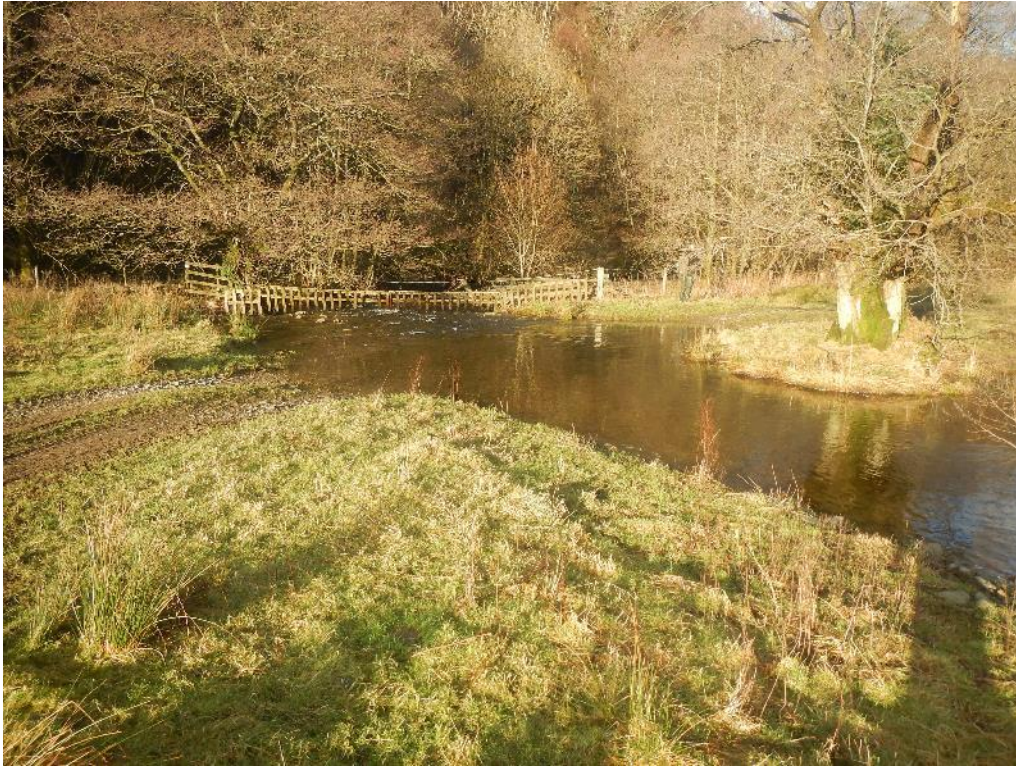
Figure 43. The large bend and lower gradient d/s of Old Hopsprigg creates good conditions for gravel retention and [potential salmonid spawning. Unfortunately, an access track crosses one of the prime potential locations at the tail of a pool (55.186673, -3.076423).

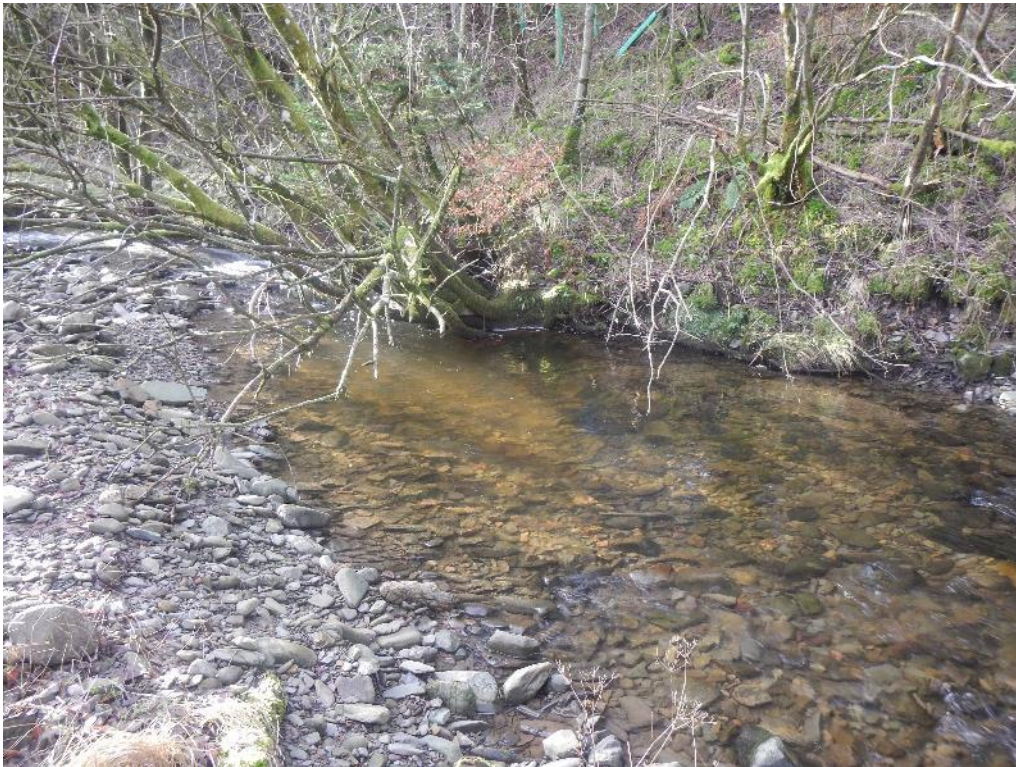
Figure 44. Habitat in the wood d/s of the ford was high quality, with low cover and structure.

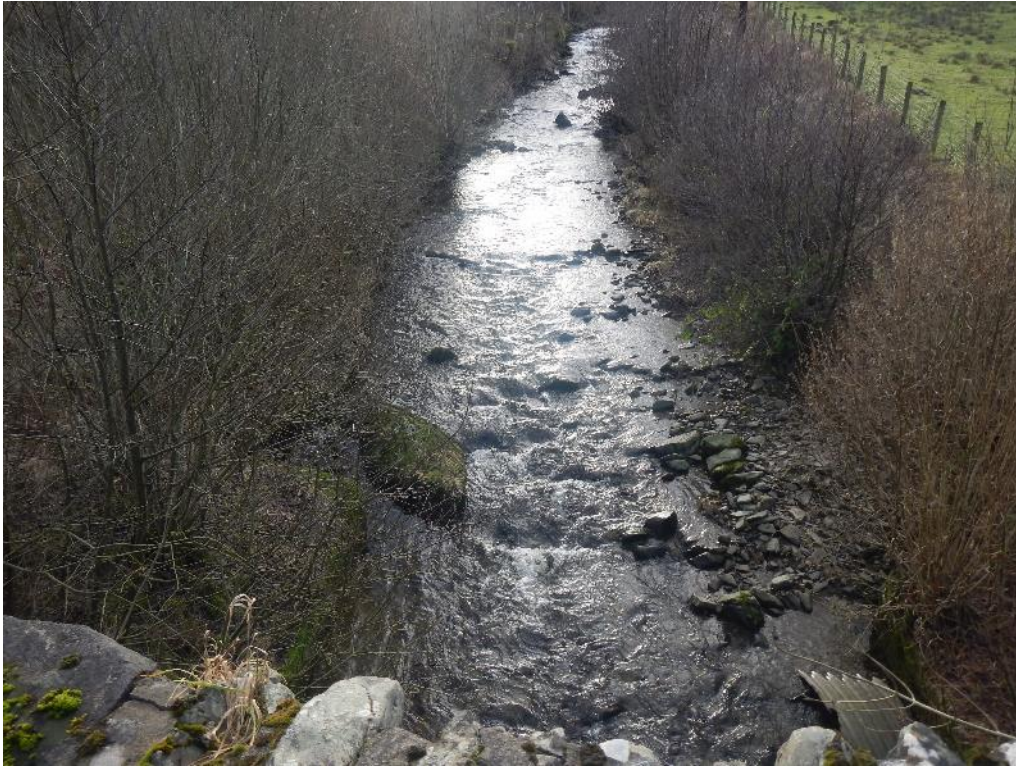
Figure 45. U/s of the B709, the bankside trees appear to have all been coppiced at the same time, presumably during the conifer harvest, which greatly denuded habitat. Subsequent uniform regrowth will result in uniform shading. The requirement to even fell the bankside trees in such situations should be questioned, with a presumption to retain valuable bankside trees. This would be relevant to protect other areas owned by the estate.

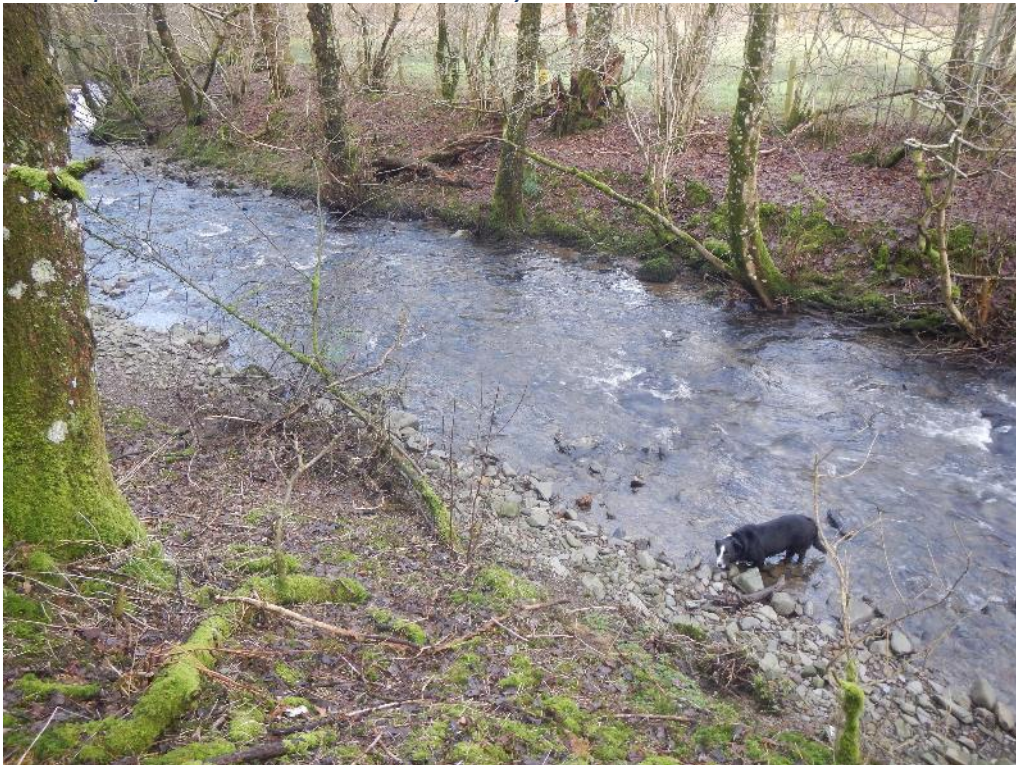
Figure 46. D/s of the road, habitat improved again, but would benefit from more in-channel woody material (55.190138, -3.072103).
