WILD TROUT TRUST  
wildtrout.org

## Advisory Visit River Doe Lea

11/09/2023

<b>River</b>	River Doe Lea
<b>Waterbody Name</b>	Doe Lea from Source to Hawke Brook
<b>Waterbody ID</b>	<a href="#"><u>GB104027057290</u></a>
<b>Management Catchment</b>	Don and Rother
<b>River Basin District</b>	Humber
<b>Current Ecological Status</b>	Poor
<b>U/S Grid Ref inspected</b>	SK45862 66592 (53.194444,-1.315000)
<b>D/S Grid Ref inspected</b>	SK45987 71013 (53.234167,-1.312500)
<b>Length of river inspected</b>	2.3km (in sections of 1.7 km and 600m)

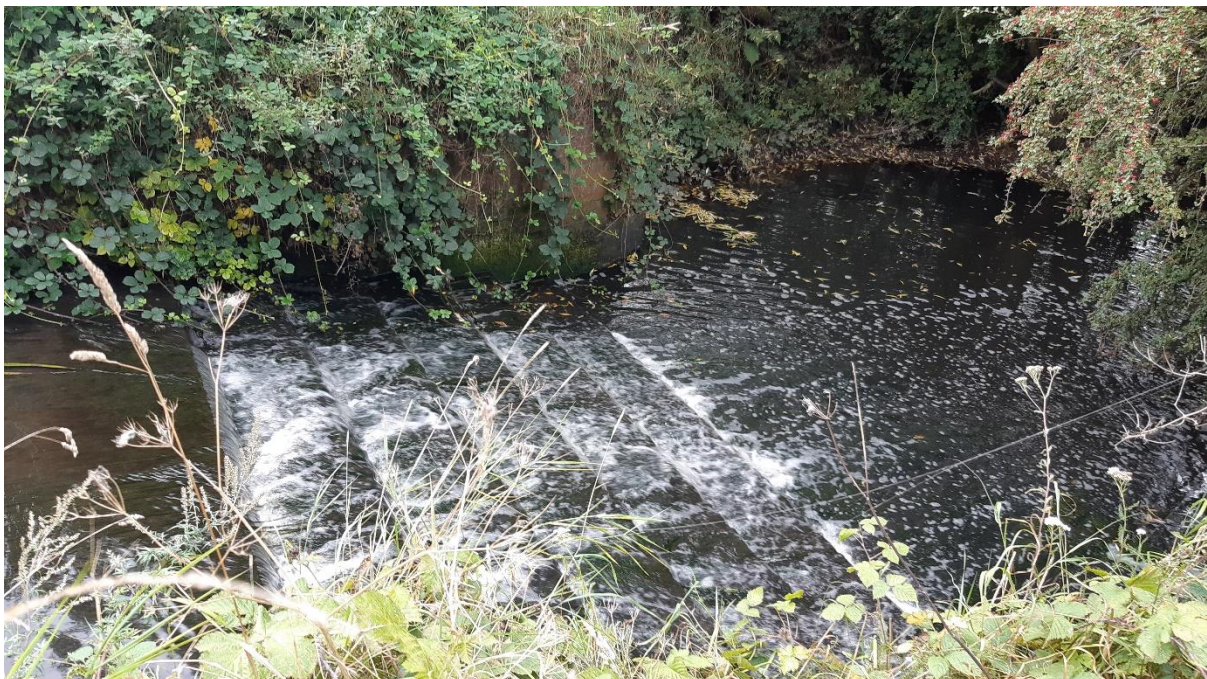
A stepped weir and extensively impounded flow upstream (and also low longitudinal gradient downstream) of the structure marked the downstream limit of this visit (Fig.1).

Figure 1: Stepped weir causing both a barrier to migration and inhibition of bed material transport at 53.234167, -1.3125000.

- Assess feasibility of weir removal in **Sections 1 and 2**
- Seek to establish paleochannel location for **Section 2** – along with feasibility study for returning the Doe Lea to a portion of that channel

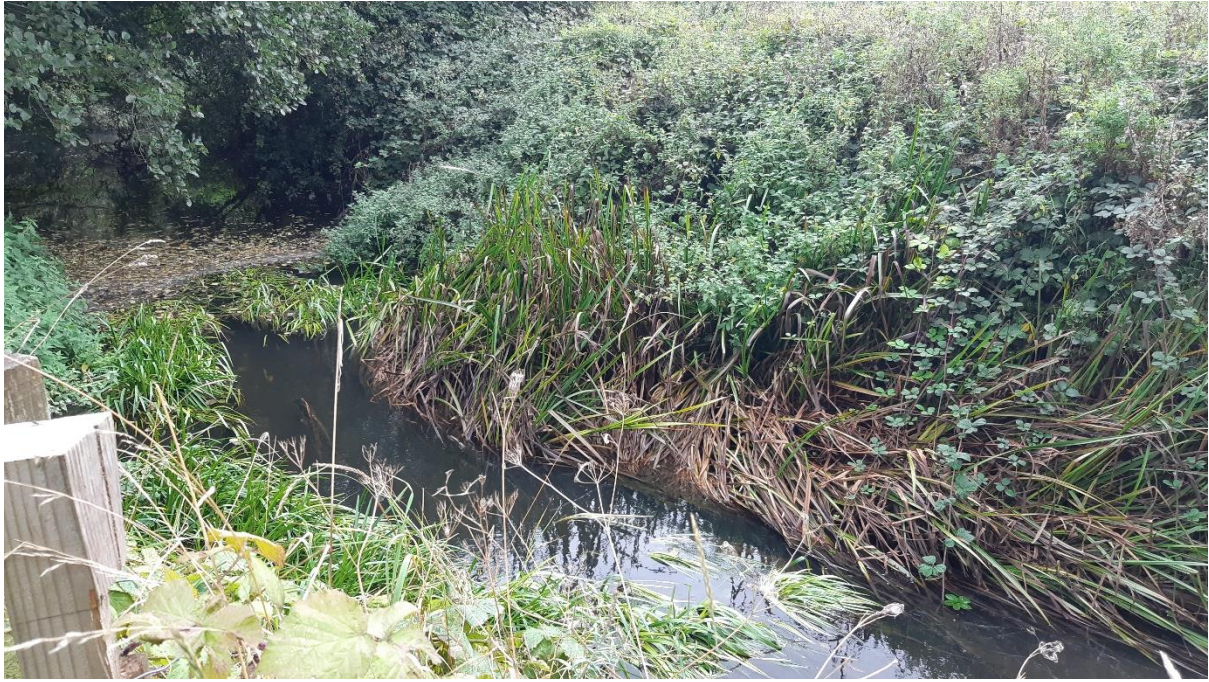
The high proportion of sand-sized particles making up the riverbed was notable and, in the impounded reach, encroachment of emergent macrophytes (aquatic higher plants) were noted (e.g. Fig. 2).

Figure 2: Fine sediment and ponded flows favour extensive ingress of emergent plants in this section of the Doe Lea.

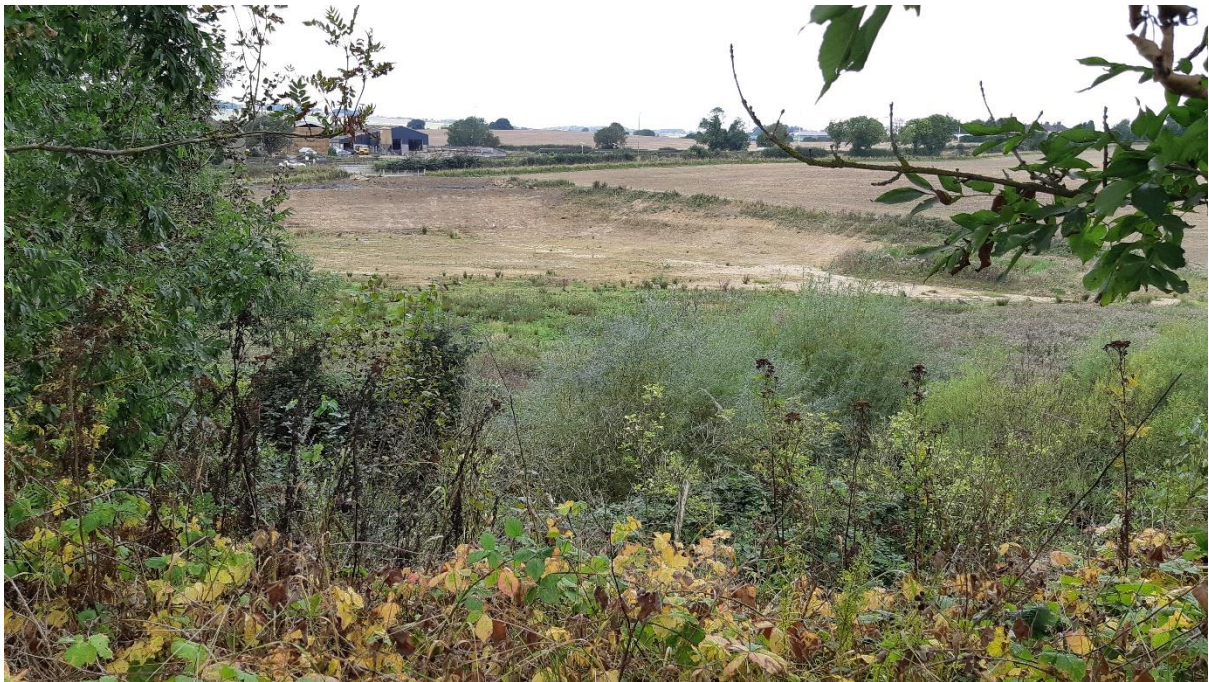
As well as surface runoff from the carriageway of the A632, there are likely to be significant sediment inputs from the surrounding agricultural land (e.g Fig.3).

Figure 3: Looking down on the valley bottom from a vantage point above the RB shows the potential for sediment runoff to enter the Doe Lea – particularly from the LB around the downstream limit of this visit.

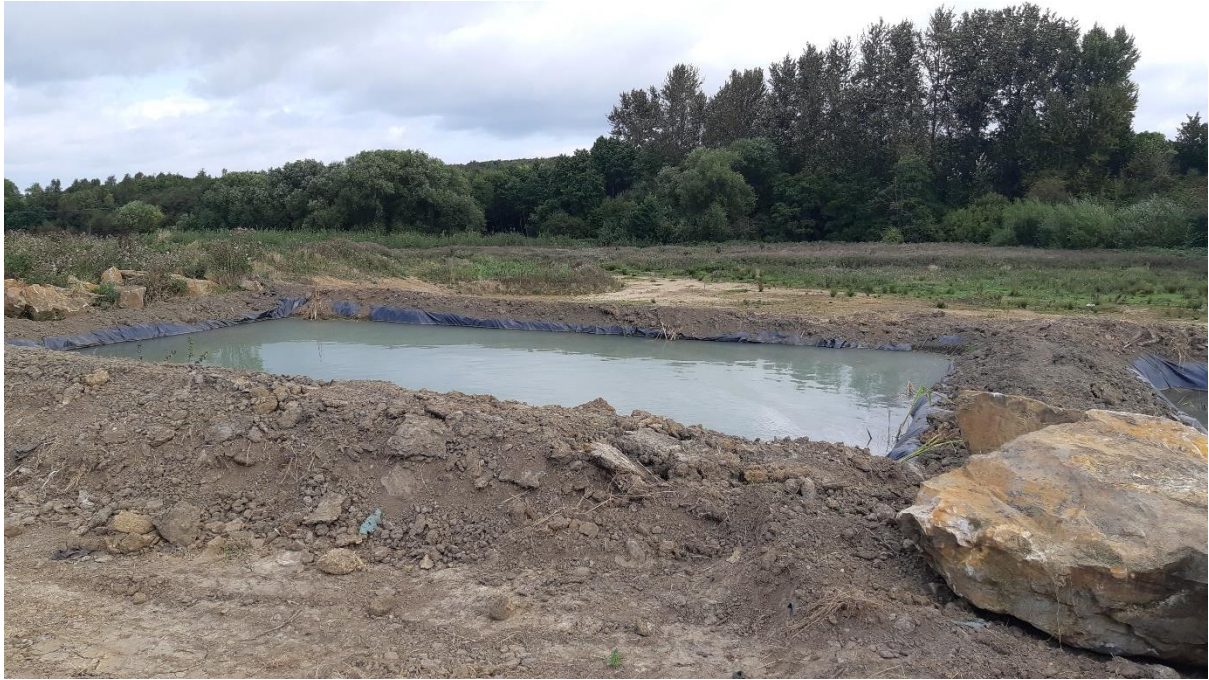
Moves towards creating wetted and vegetated areas within the floodplain on the LB were observed along with recent construction of possible “runoff interception” or (somewhat steep-sided) “newt” ponds (Fig. 4).

Figure 4: With the river at the foot of the distant treeline, these plastic-lined ponds and (beyond) floodplain vegetation re-establishment may offer a degree of sediment interception. Note the uniformly steep, smooth sides of the ponds are likely to limit their habitat value.

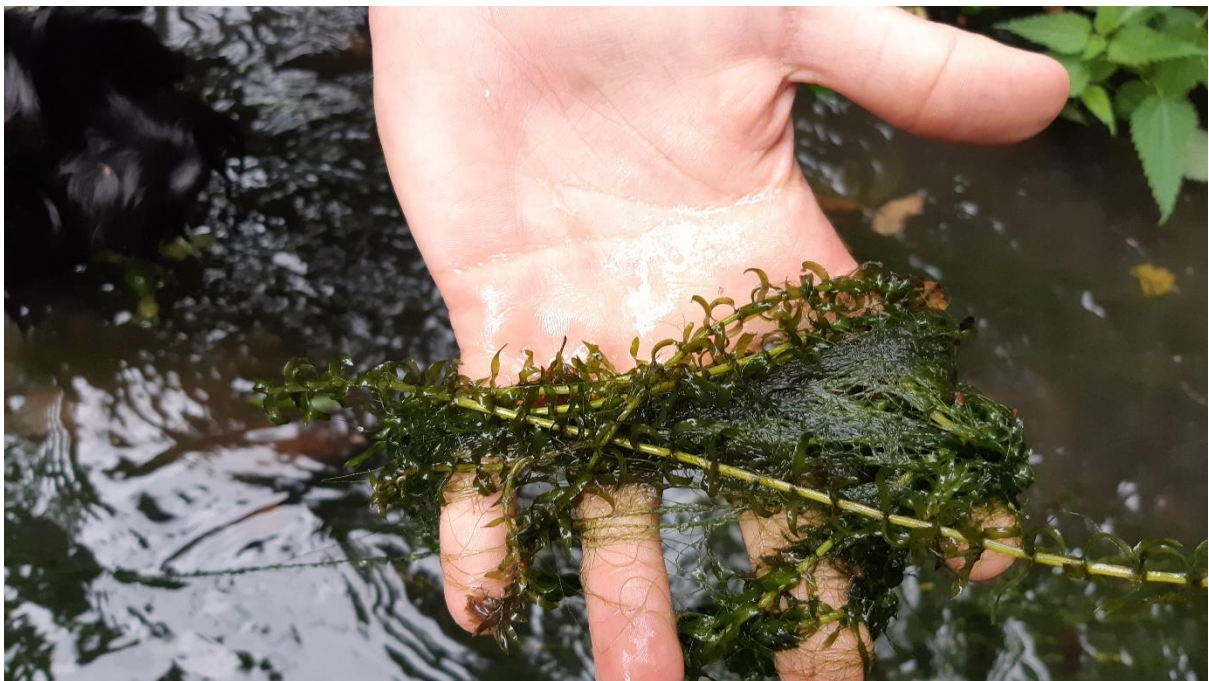
The reach shown in Figs.1-4 has also, reportedly, been subject to petrochemical pollution from a nearby industrial source and is likely to suffer from nutrient enrichment from surrounding land-use (as well as sewage outfall inputs). Entering the channel in the area where the A632 crosses the Doe Lea revealed ecological consequences of both soluble and particulate pollution inputs (e.g. Figs.5-7).

Figure 5: Extensive growth of filamentous algae and pond weed within the channel indicate significant nutrient enrichment (indicating a probable increase in biochemical oxygen demand and associated depression of dissolved oxygen levels).

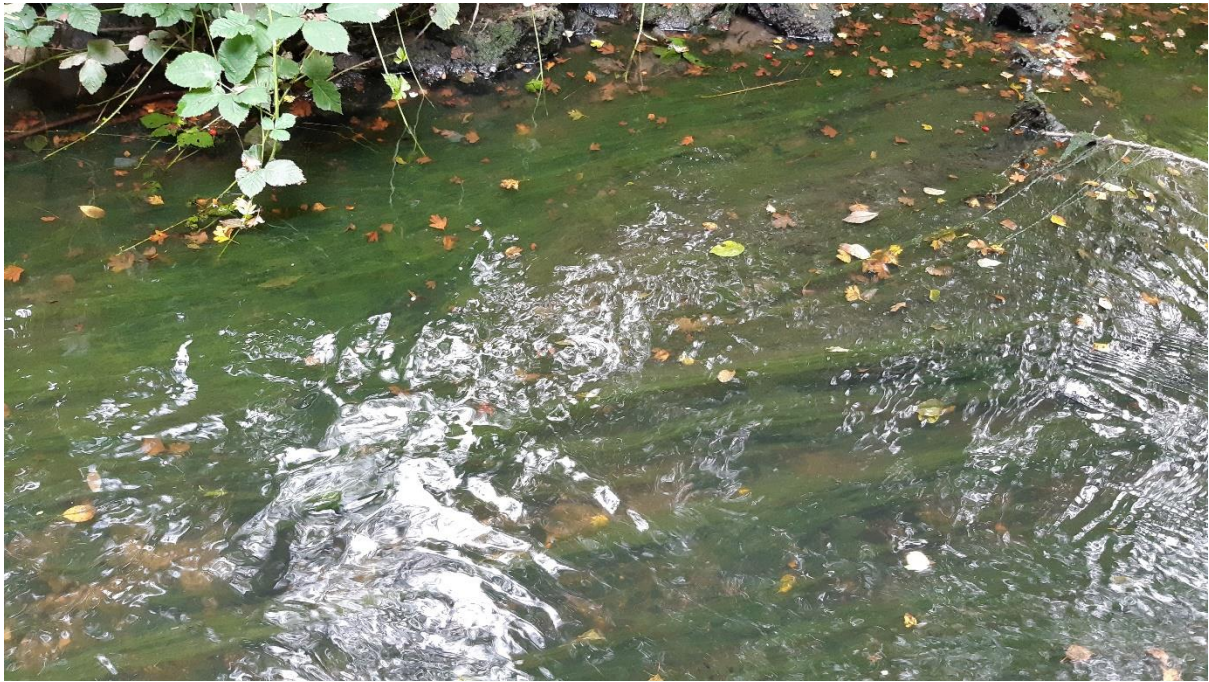
Figure 6: Sand and silk weed choked riverbed – indicating degraded habitat and poor water quality.

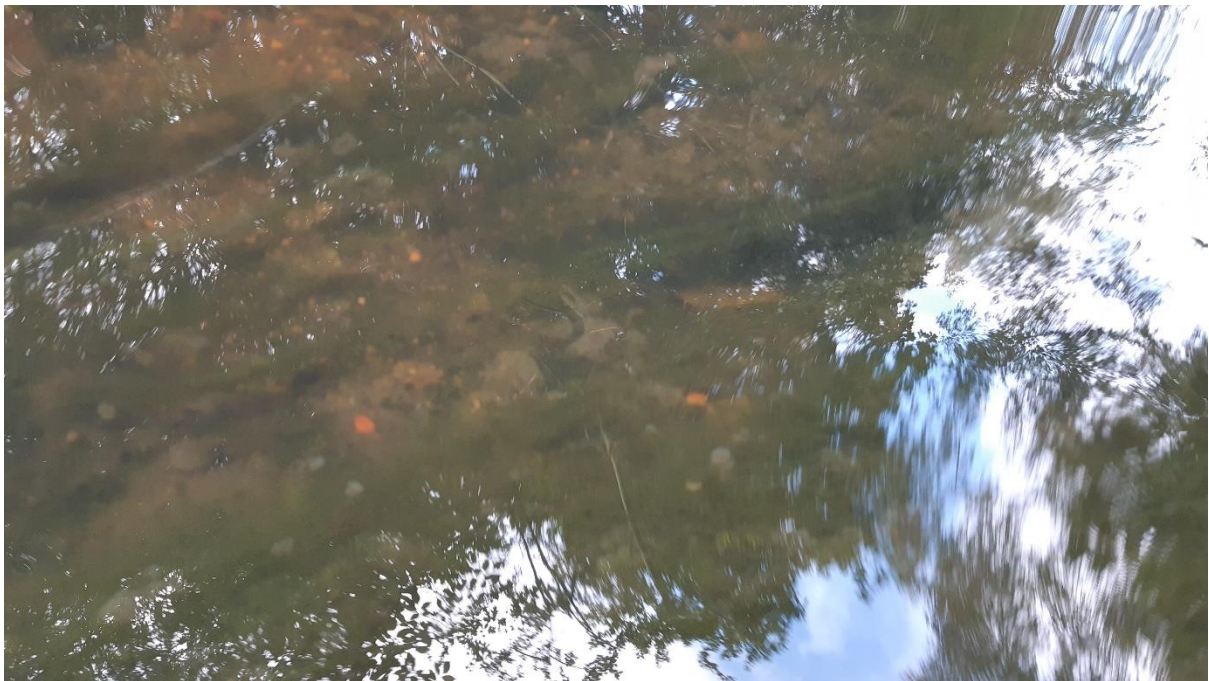
Figure 7: Sewage fungus is a colloquial name for the pale, gelatinous bacterial colonies visible (with difficulty) above the weed and sandy substrate here. These colonies thrive in response to excessive elevations in nutrient levels and strip the water of dissolved oxygen.

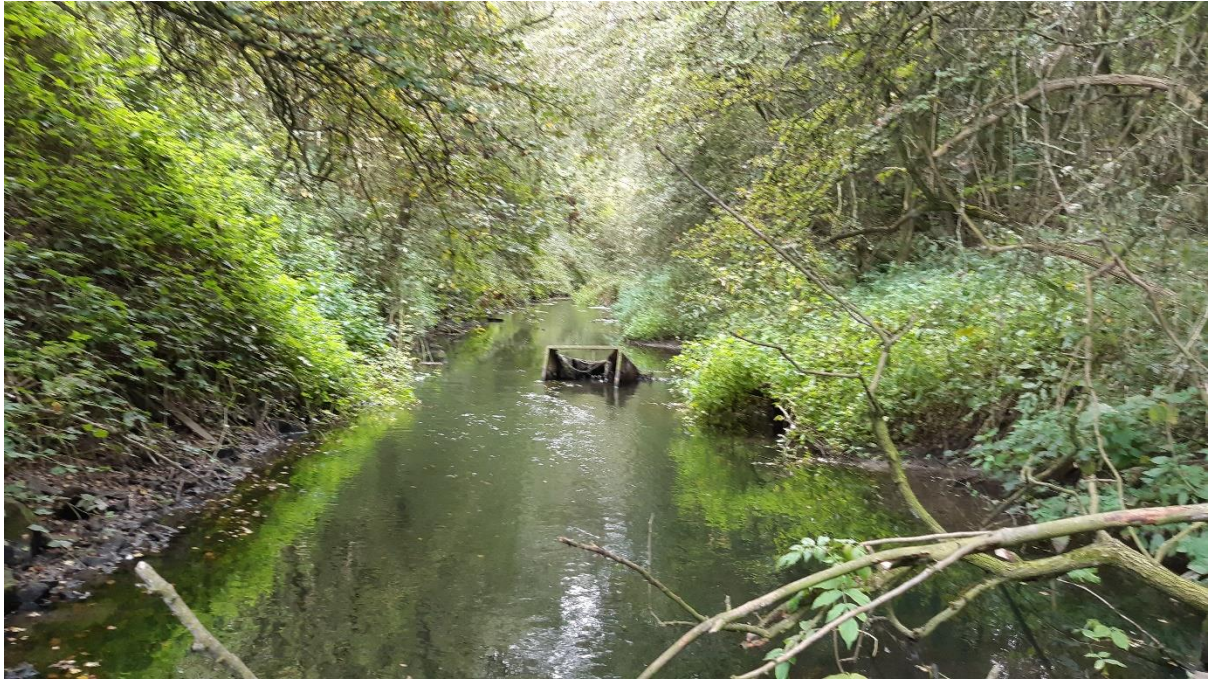
The channel is both straightened and rock-armoured in this reach – further limiting the potential for diverse habitat structures to arise (Fig.8). In rivers with a higher proportion of natural processes governing their formation, a much wider range of substrate particle sizes are found – along with a greater variation in cross-sectional depth and flow-velocity. That physical complexity provides far more opportunities for a diverse range of species to co-exist (whereas the Doe Lea lacks adequate structural variety).

Figure 8: Although flanked by vegetation in this particular reach - the straight "box-shaped" armoured channel generally provides poor habitat.

A combination of armouring the banks and changing the course of the river will limit the variety of substrate entering the stream. By cutting the straightened channel more deeply into the landscape, the river has been separated from its floodplain over a much greater proportion of its length. As a result, some of the natural capacity of a river to lower its nutrient load (by depositing nutrient-enriched silt on the floodplain during spate events) is also constrained.

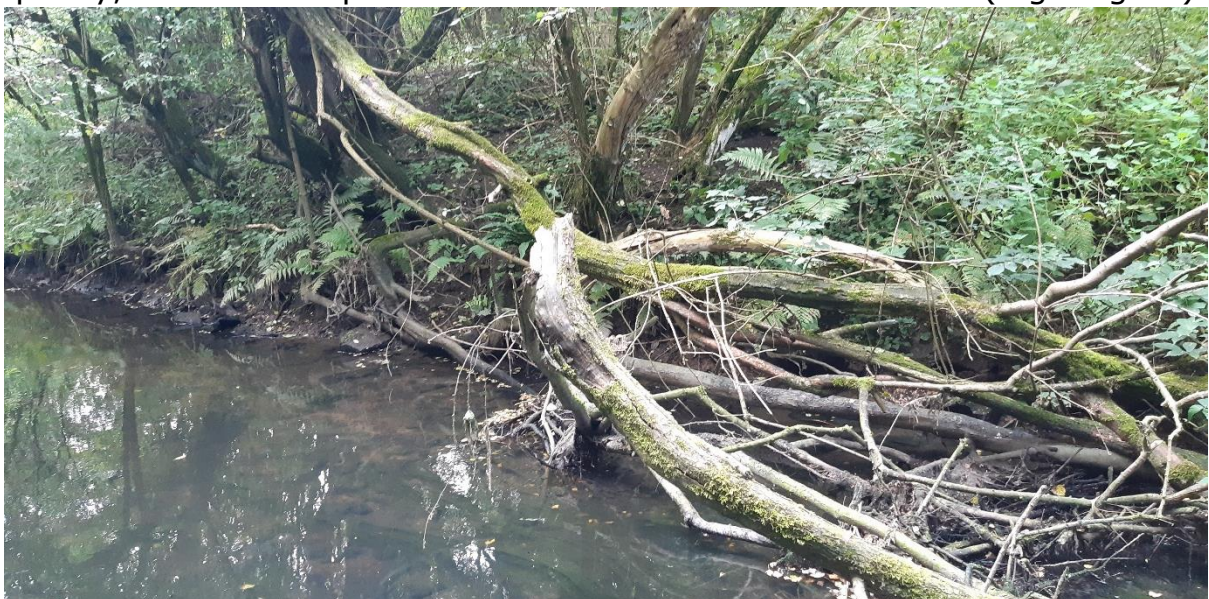
Despite the multiple, compounding impacts on both habitat and water quality, some examples of valuable habitat were noted (e.g. Fig. 9).

Figure 9: Natural dead-fall of riparian trees creates much-needed structural complexity in river channels.

However, it will not be possible to offset all of the previously mentioned negative impacts by simply allowing (or even deliberately increasing) this type of stable woody material within the channel.

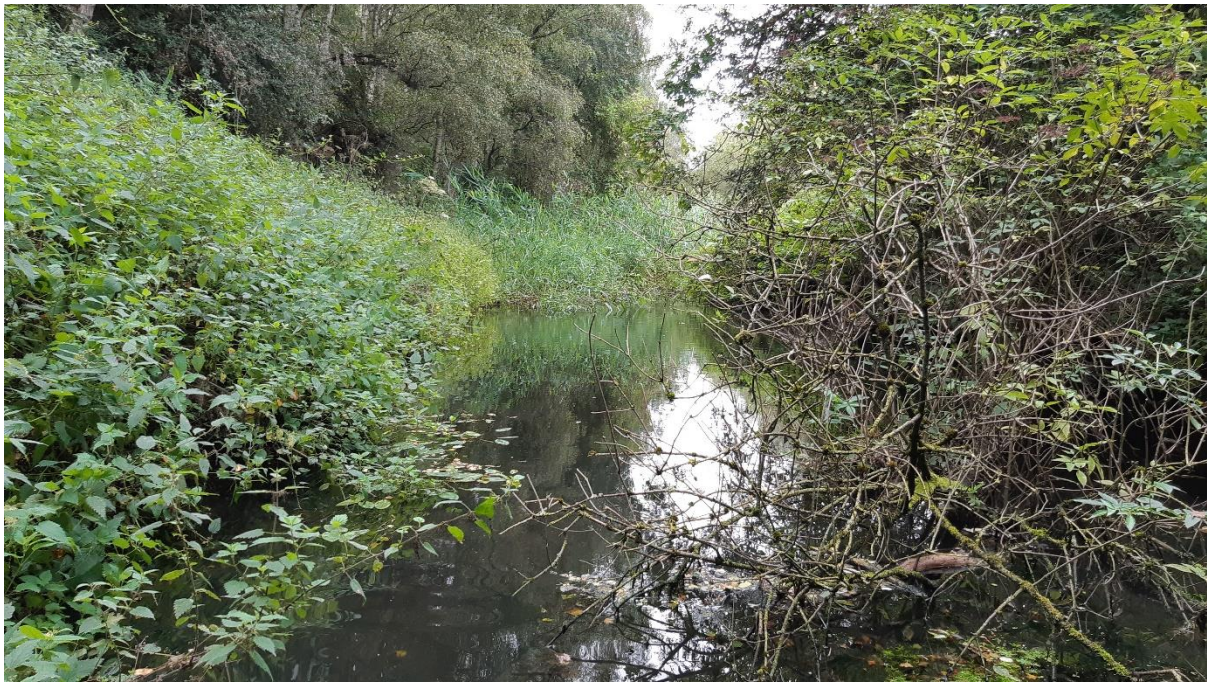
Restoration of diverse habitat is constrained by the extent of previous channel modifications. Through an apparent combination of increased cross-sectional area of the channel and realignment, to create reduced longitudinal gradient, flow velocities are much reduced. The habitat within the channel commonly resembles a linear pond (e.g. Figs.10-12).

Figure 10: Under normal discharge levels, water is almost static in many reaches observed in Section 1 of the Doe Lea considered in this report.

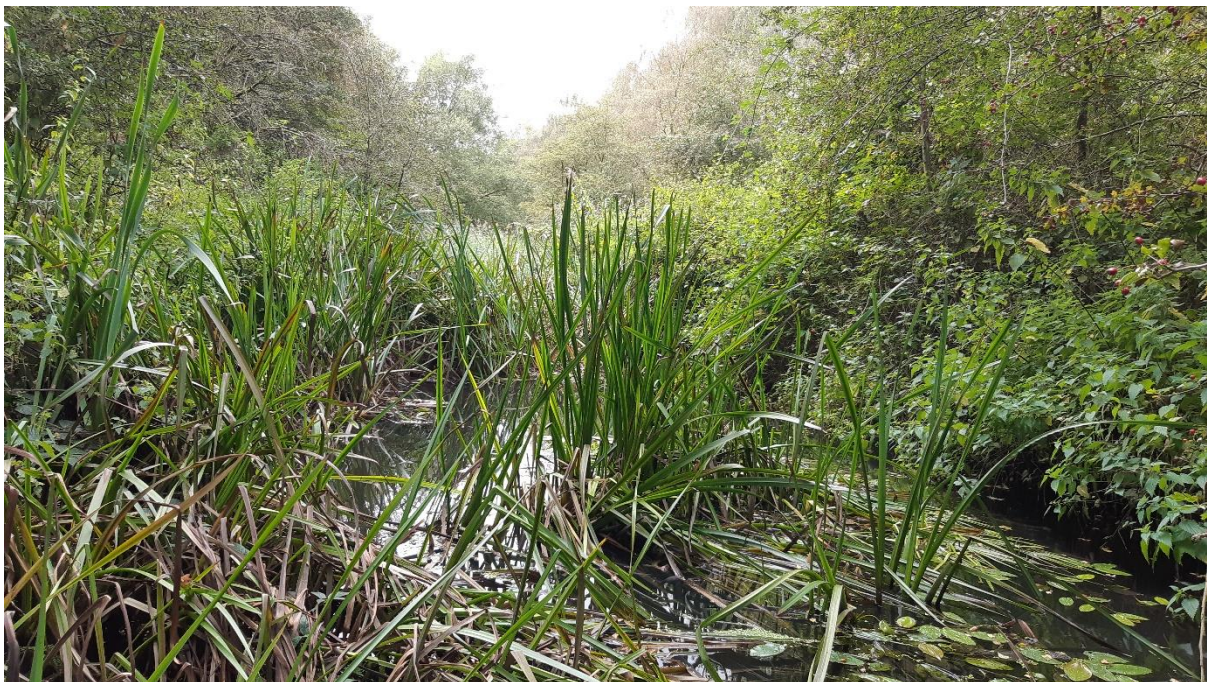
Figure 11: Emergent vegetation dominates the channel in the slowest flowing areas.

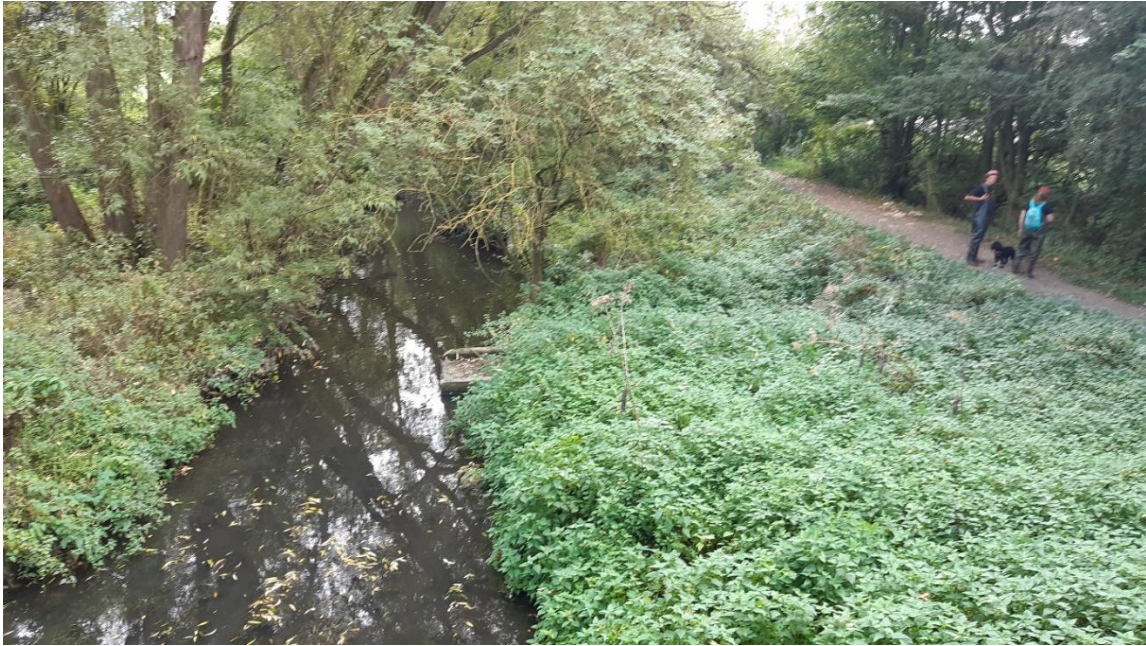
Figure 12: Further example of an extensively straightened, incised channel with ponded flow.

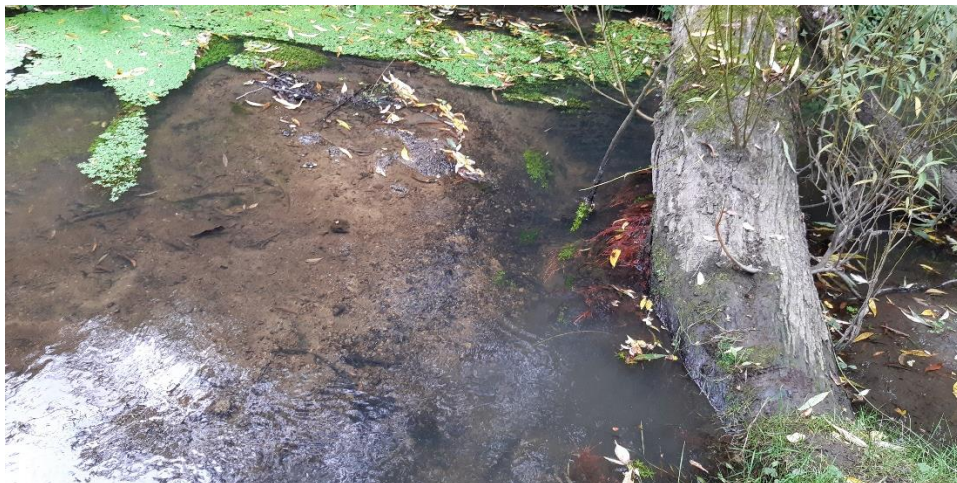
Figure 13: Though dominated by sandy substrate, the pinched flow caused by the tree has created some diversity in flow depth and velocity.

It may be possible to achieve a degree of habitat diversification in some locations by raising bed levels with imported cobble and gravel substrate. This would require topographical surveys to determine whether sufficient longitudinal gradient is available at specific locations. Without the gradient (coupled with reducing cross-sectional channel area) to support silt-dispersing flows at normal discharge levels, imported substrate would quickly become blanketed with fine sediment. However, indications that this may be possible were noted adjacent to Carr Vale Nature Reserve (e.g. Figs. 13-15).

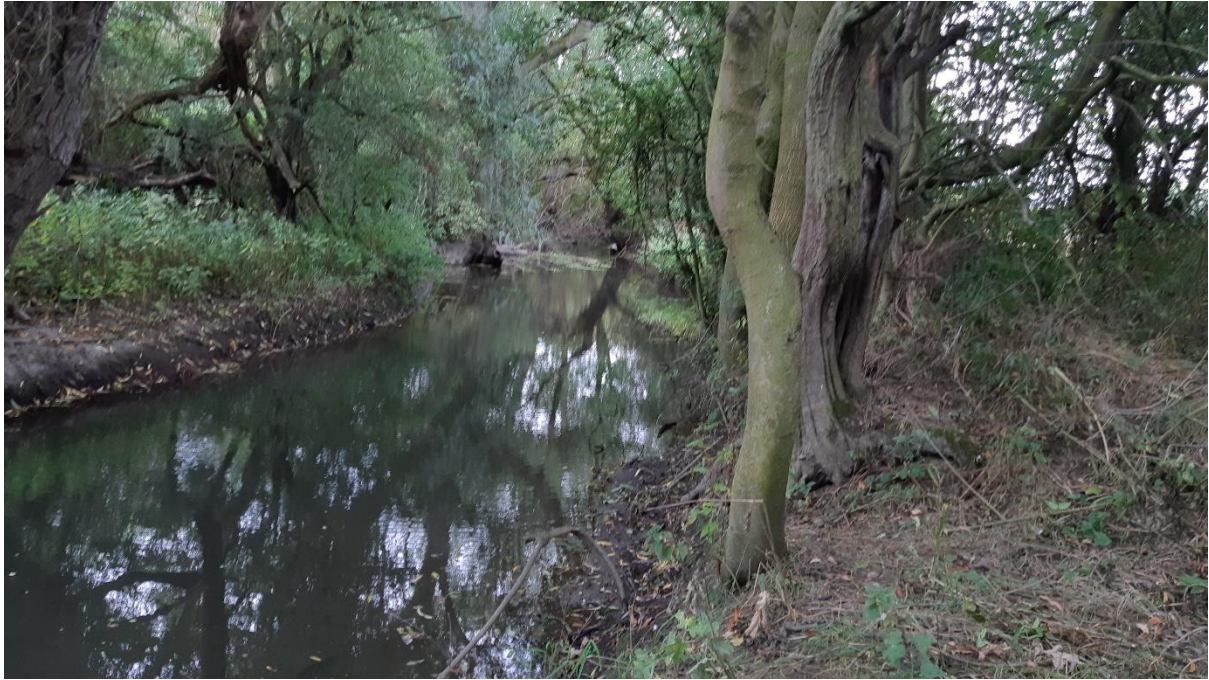
Figure 14: A section where, if sufficient gradient is available, bed-raising may create a more diverse riffle/pool sequence. It is worth investigating potential for removing any downstream structures that may be impounding water in this reach.

- Topographical surveys, removal of impounding structures and associated hydraulic designs for raising the riverbed in **Section 1** in the region of **Carr Vale Nature Reserve** to create riffle/pool sequences, augmented by stable, large woody material installations (subject to specific design proposals and flood risk modelling)

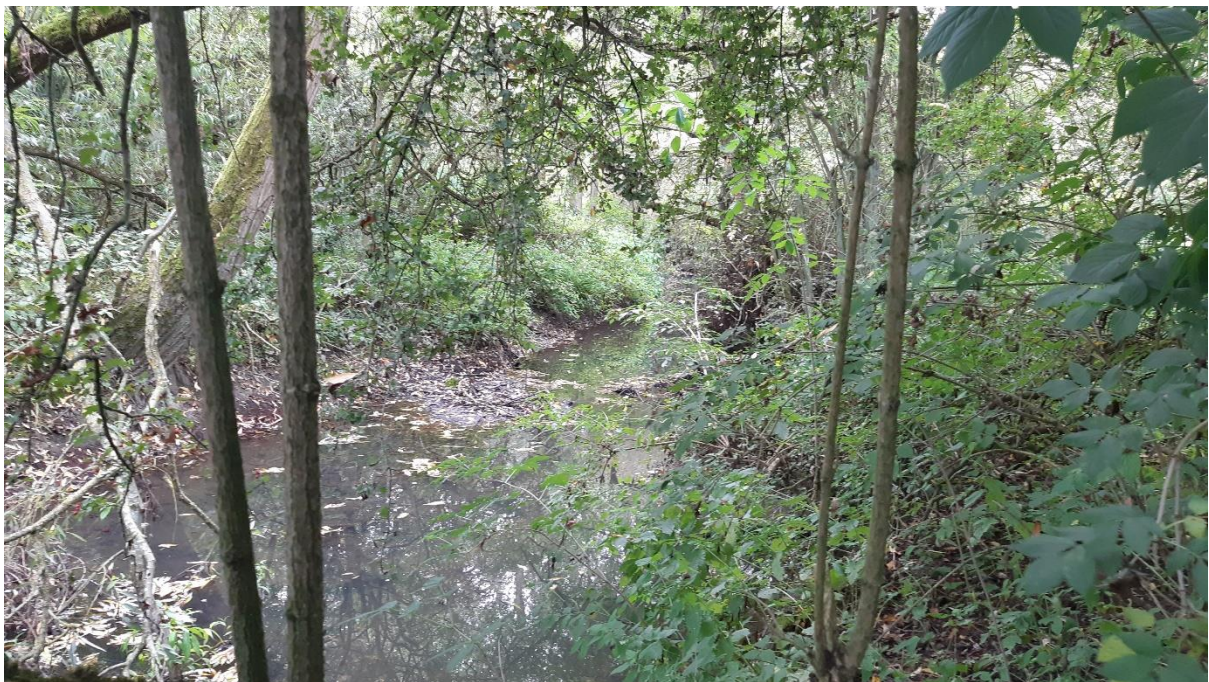
Figure 15: A plentiful supply of large woody material would help stabilise imported substrate in structurally diverse habitat features.

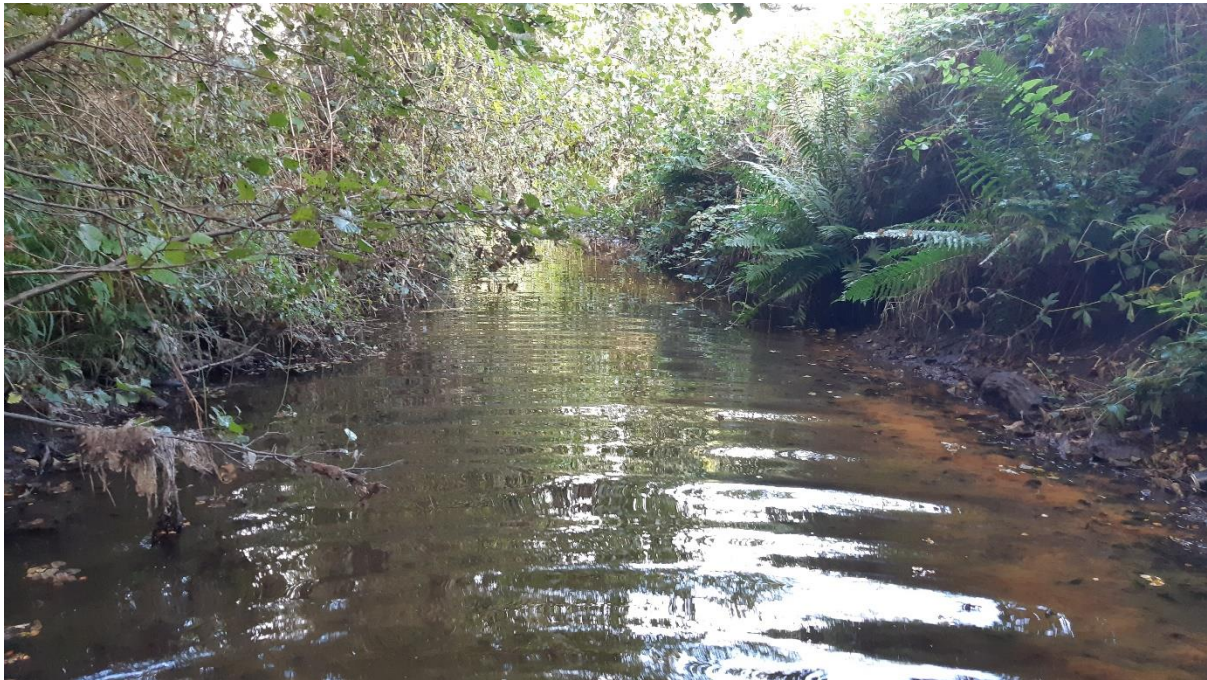
Moving upstream to consider the lower limit of section 2 at 53.20005 - 1.312421 revealed a narrower channel that was markedly more incised below the bank-top level of the surrounding floodplain (e.g. Fig. 16). Densely vegetated on both sides, the watercourse appears to be of a smaller volumetric discharge – while at the same time supporting higher average velocities at normal flow levels. While the watercourse is, again, apparently highly modified; evidence of a somewhat more

Figure 16: Steeply incised but well vegetated banks. Note also the ochre (iron oxide) precipitation commonly associated with coal measures

The greatest potential for ecological improvement in Section 2 appears to lie in the creation of a nature-like meandering channel. Reprofiling the banks to promote better connectivity with the surrounding floodplain would be important to maximise the benefits of any scheme. In an ideal scenario, the watercourse could be put back into its paleochannel and have a woodland buffer created around it. However, this would depend on the potential to locate and re-establish that previous channel – which may well be unfeasible.

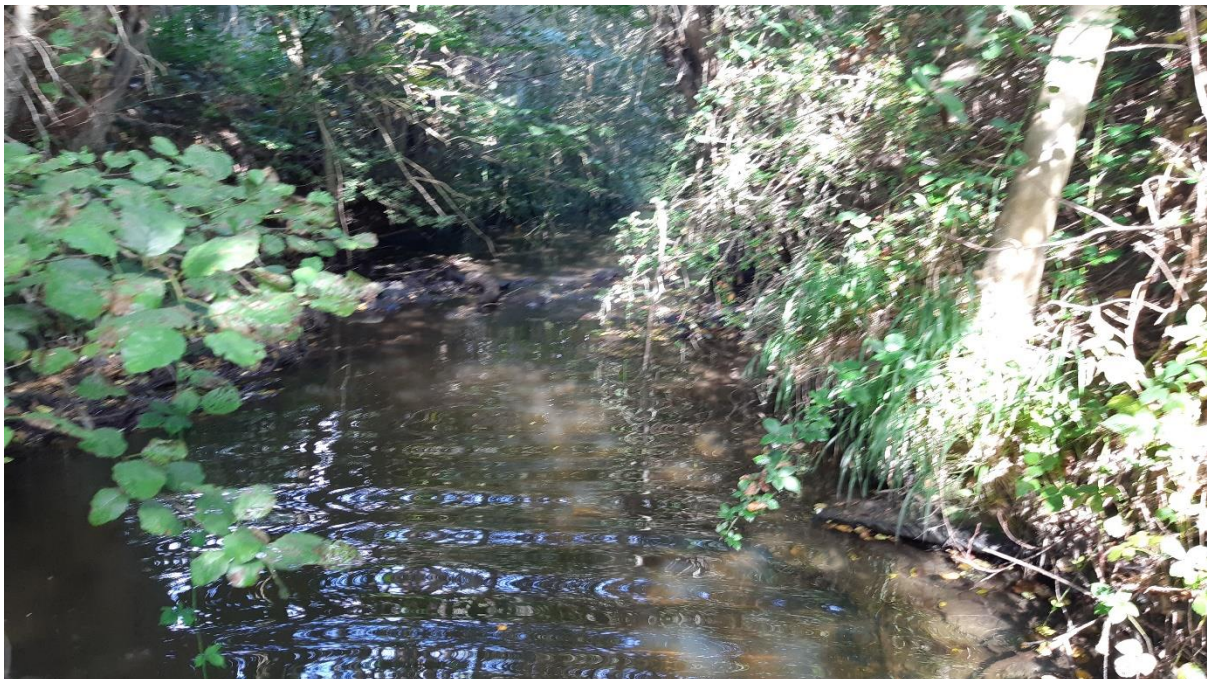
geomorphologically active channel was noted. For instance, the scour pool and cobble bar (Fig.17) observed a short distance up from the lower limit.

Figure 17: A scour pool approximately a meter deep under normal flow conditions was associated with a cobble and boulder feature formed from deposited material arising from scoured substrate.

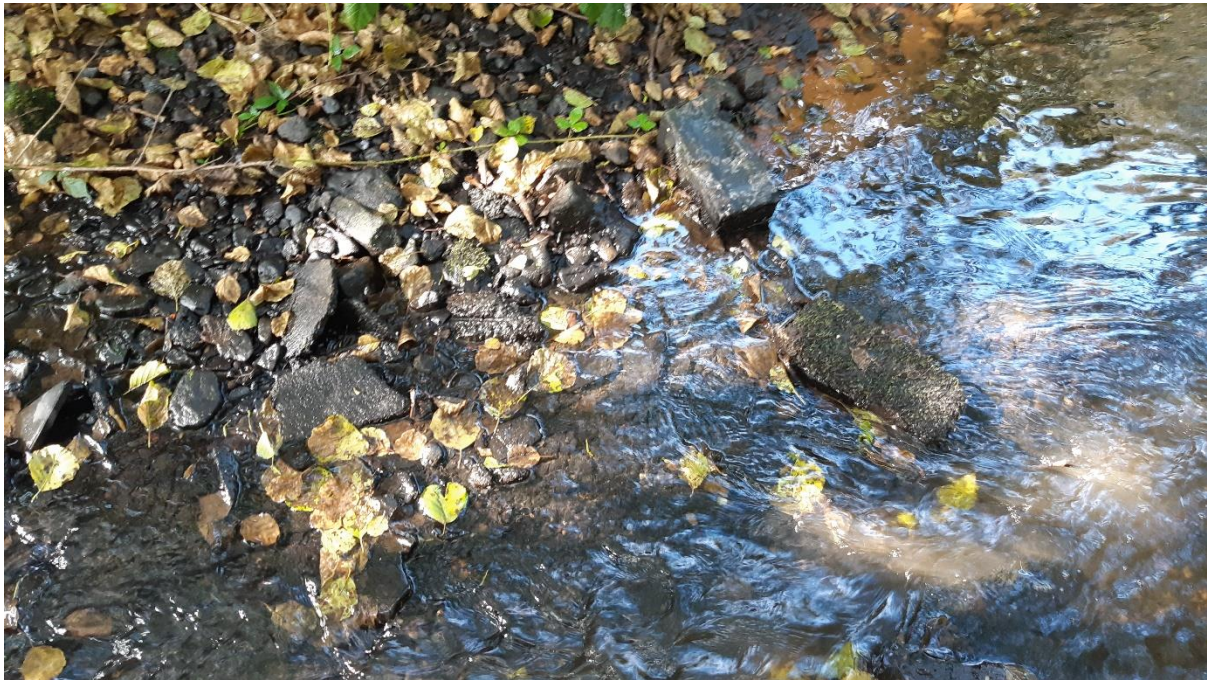
Although relatively sparse, some deposits of gravel-sized particles were noted within Section 2 (Fig.18). These consisted of shale/coal measure strata material and provide a contrast to the substrate observed in Section 1 - which was dominated by sand and fine silt laying over a largely artificial

bed. However, it is important to recognise that this section of channel is also likely to have been significantly straightened and revetted in the past.

Figure 18: Gravel sized shale deposits - along with ochreous discharge and eroded brickwork.

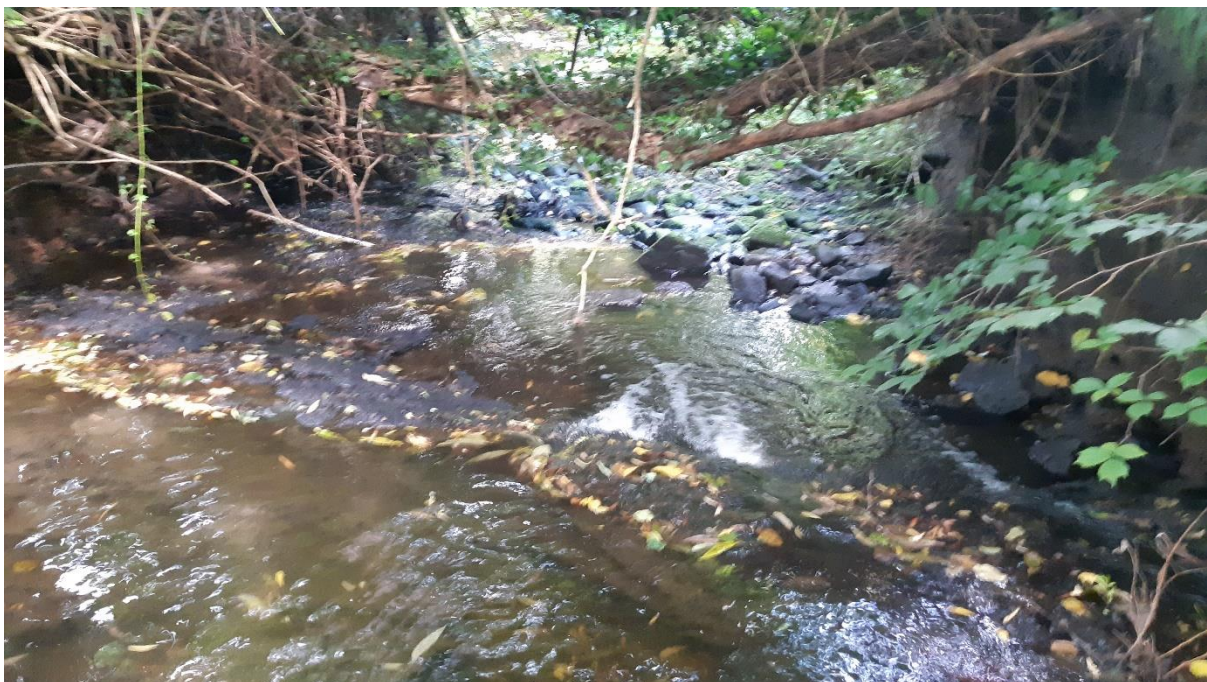
Further upstream, towards the A617, a low weir was noted which seemed to have been consolidated with slag or similar industrial by-product material. It was not simple to distinguish its construction from a natural shelf in the bedrock. Consequently, it is possible that some artificial construction had been added to an existing bedrock feature (Fig.19).

Figure 19: Low weir (foreground) and small boulder-sized substrate (background) which may have originated from engineered channel structures.

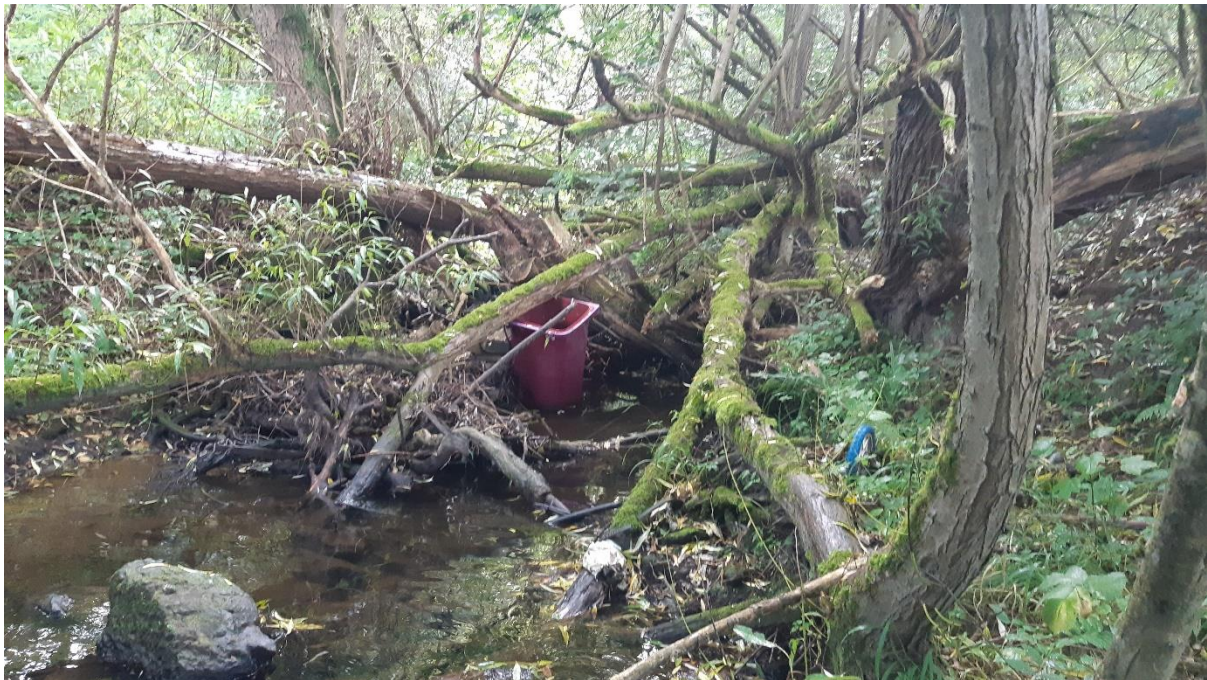
Just upstream of this weir a significant accumulation of woody debris had formed (Fig. 20). However, the conveyance capacity of the channel doesn't seem to be restricted below the hydraulic limit already set by the A617 culverting at 53.194444, -1.315000 (Fig.21).

Figure 20: Woody debris – mixed with bins, bike and plastic debris. In spite of the size of this structure, multiple flow paths through and beneath the lodged material are present and it is not expected to pose a flood risk to surrounding land.

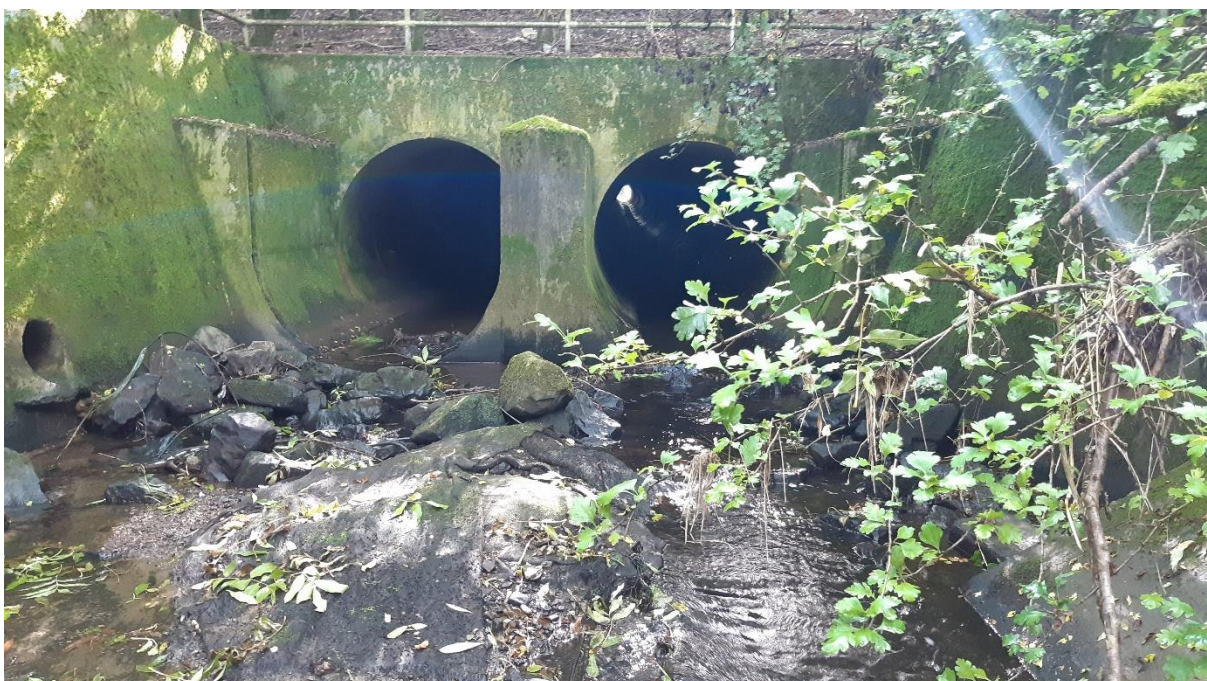
Figure 21: Twin pipe culvert running beneath the A617 at the top of Section 2 and setting the hydraulic limit for the downstream reach.
