Advisory Visit

River Manifold, Staffordshire

25th March, 2019

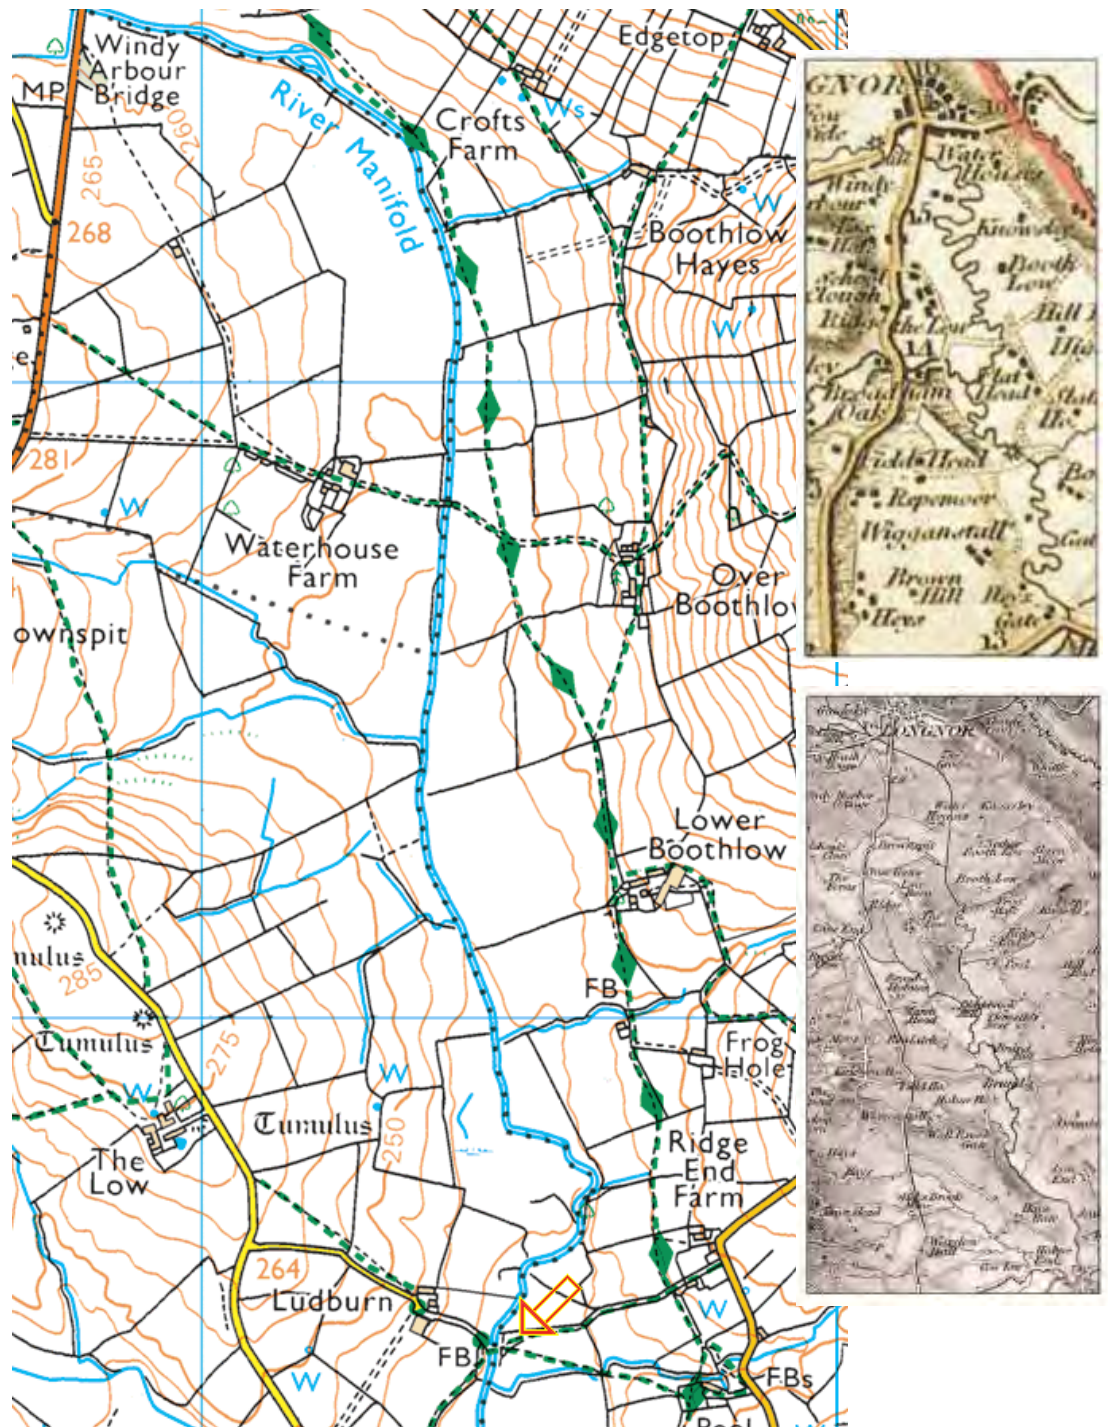
Ludburn Farm is more sinuous and meandering whereas the northerly section up to Windy Harbour Bridge is artificially straightened. Historic maps show the straightening of the latter section took place between 1801 and 1838 (Figure 1).

Figure 1 River Manifold between Windy Arbour Bridge, Longnor and Ludburn (flow north to south). Inset (top), extract from map of Smith (1801) showing sinuosity of the river. Inset (bottom) extract from Ordnance Survey First Edition 1838, showing straightened river (Rice & Toone, 2011).

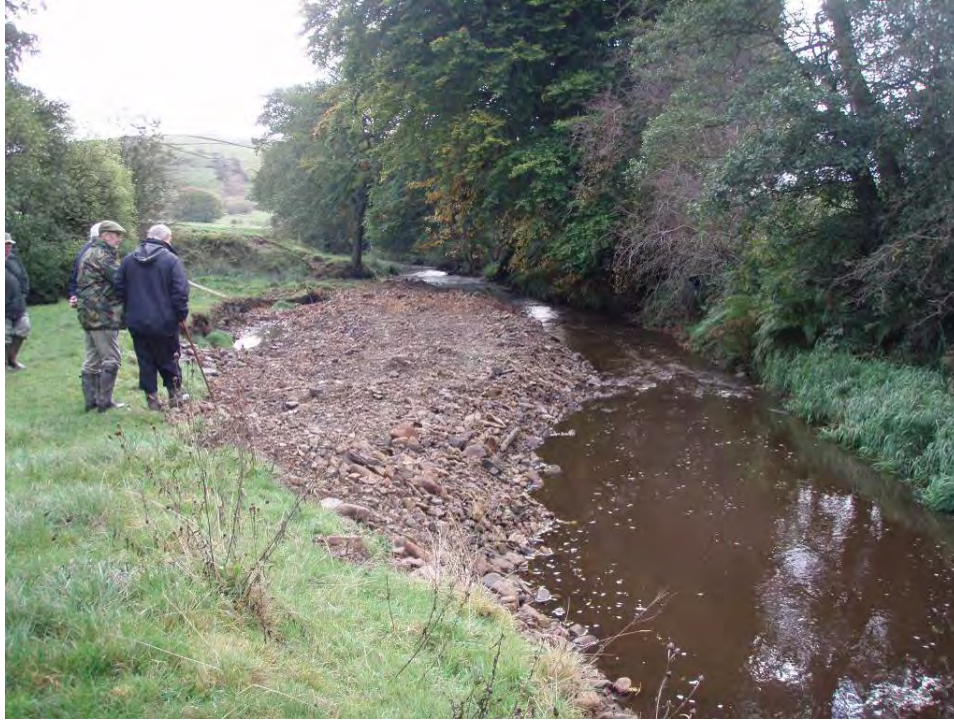
Photo 1 October 2007. Example of unconsented channel straightening and gravel dredging downstream of Windy Arbour Bridge. This prevents the straightened channel from re-gaining sinuosity and better habitat.

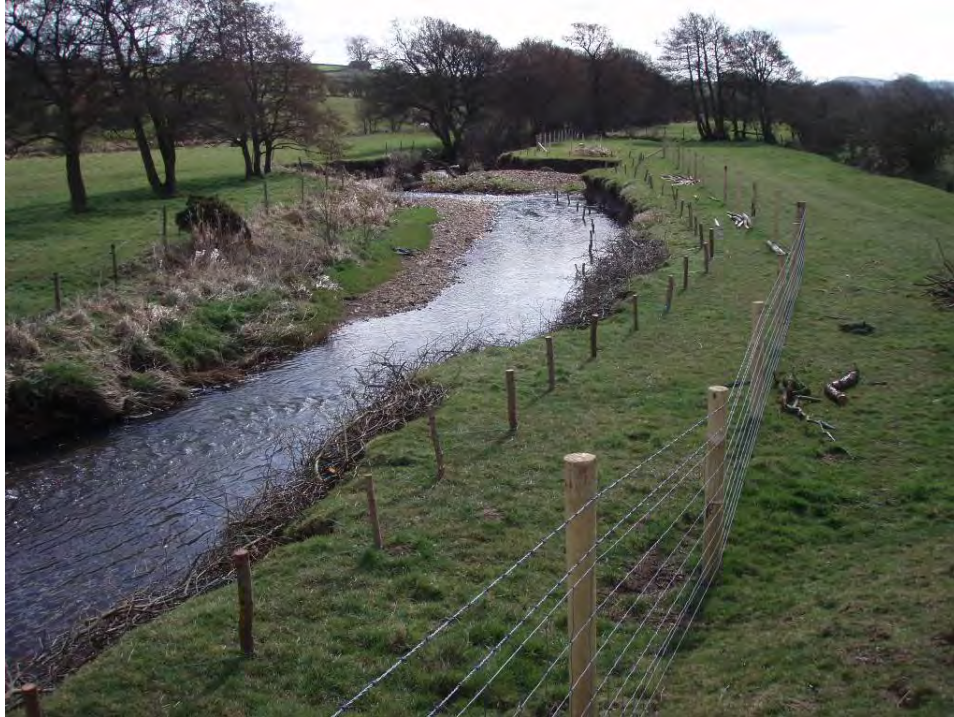
Photo 2 March 2009. View downstream towards the d/s end of the Ludburn beat, shortly after completion of brushwood installation and fencing.

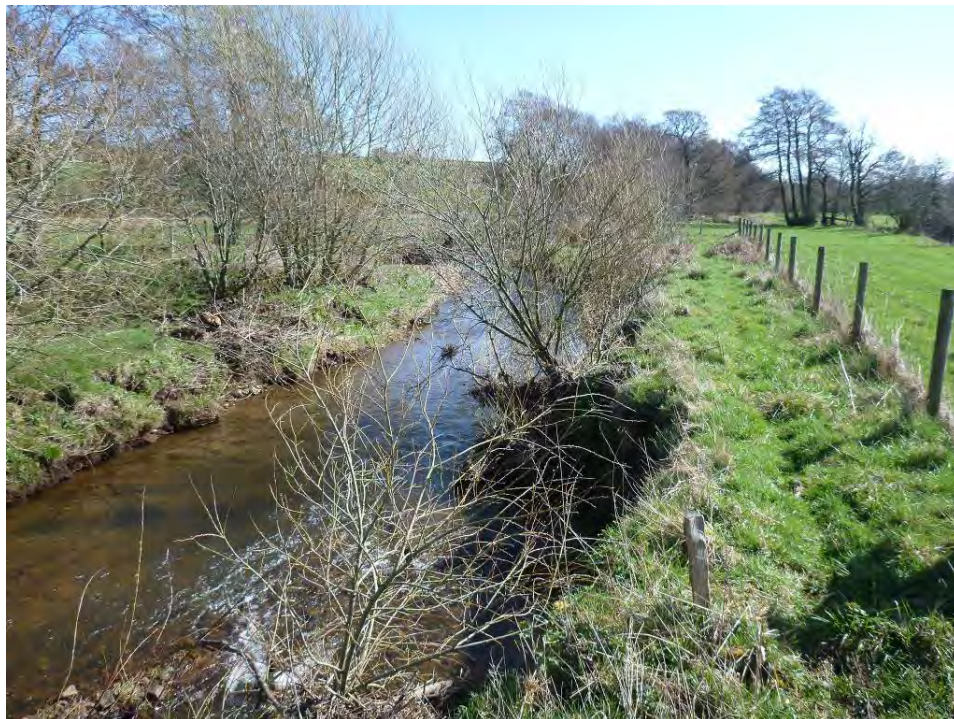
Photo 3 March 2019, same view as above (NGR SK0953162178). More willow whip/stake planting here would be beneficial.

- Plant willow whips or stakes within the fenced sections of river (e.g. Photos 3 & 5) and elsewhere where they are likely to be inaccessible to grazing livestock. The quickest and easiest way of establishing willow trees is by driving short sections of freshly cut willow into the ground. This can be undertaken at any time of the year, but will have the greatest success during the dormant season, shortly before spring growth begins (ideally late Jan-March). Whips should ideally be planted into soft, wet ground so that there is a greater length within the ground than out of it, to minimise the distance that water has to be transported up the stem; 30-40cm of whip protruding from the ground is sufficient. Whips of 5mm-25mm diameter tend to take best, but even larger branches/stems can be used. If taking cuttings during the growing season, care should be taken not to leave excessive amounts of foliage on the whips as these greatly increase the surface area of the plant and can lead to their dehydration. Bushier willow species like sallows (*Salix caprea* and *S. cinerea*) are recommended over taller, faster growing species.

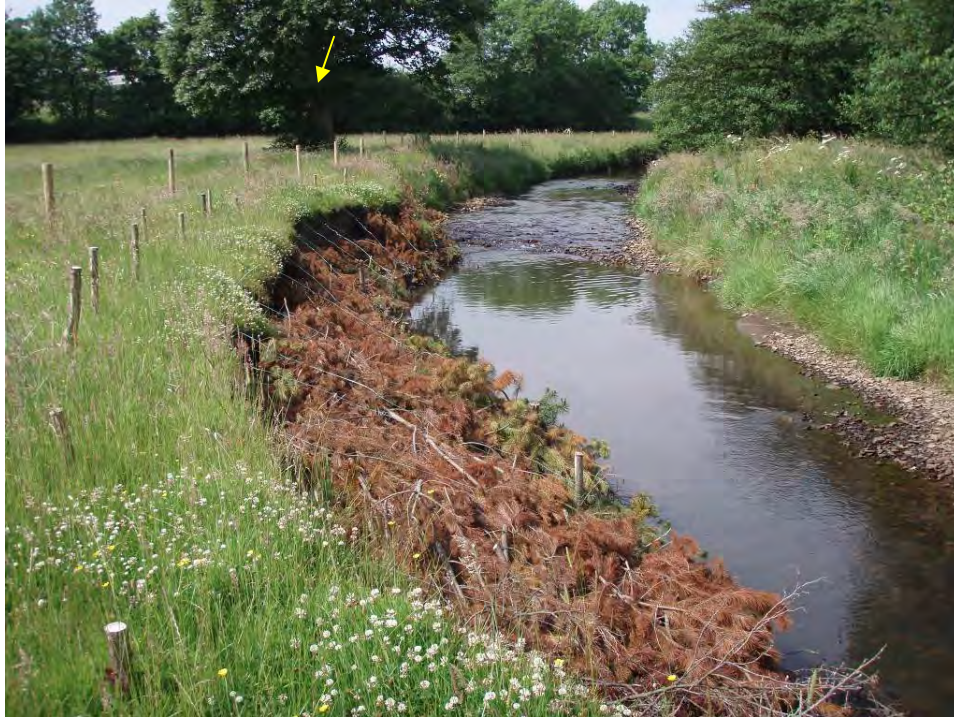
Photo 4 June 2009. First summer after brushwood installation and fencing. Site in first field downstream of Ludburn footbridge (Grid ref of tree indicated by arrow: SK0942962357)

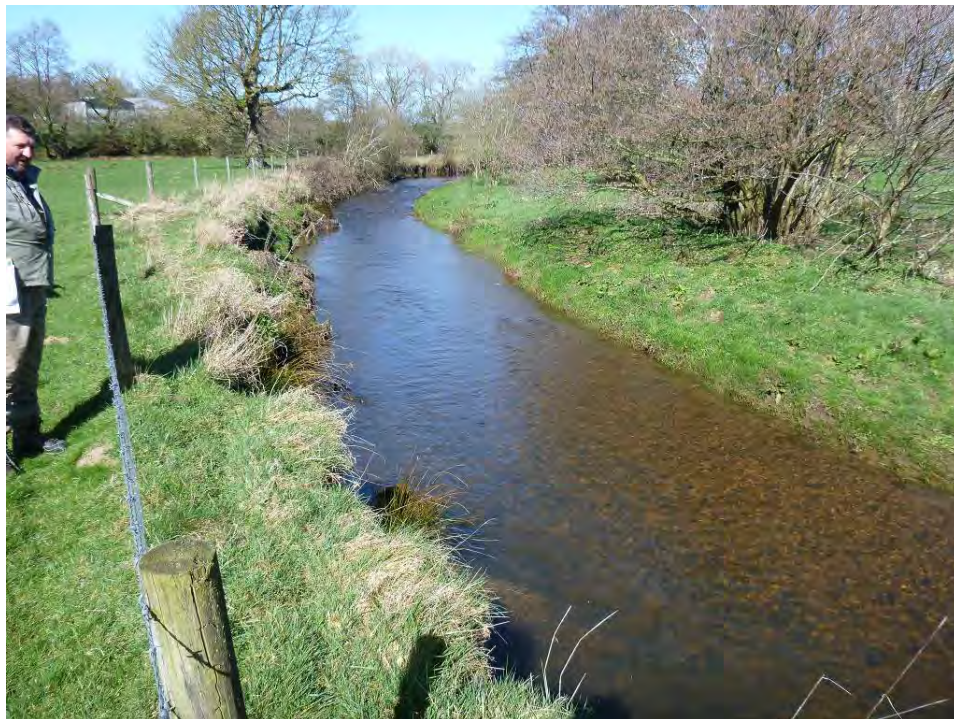
Photo 5 March 2019, view as above. Fewer trees have established here compared with the site in Photos 2 & 3. Planting willow whips/stakes here is recommended to increase fish cover and bank protection.

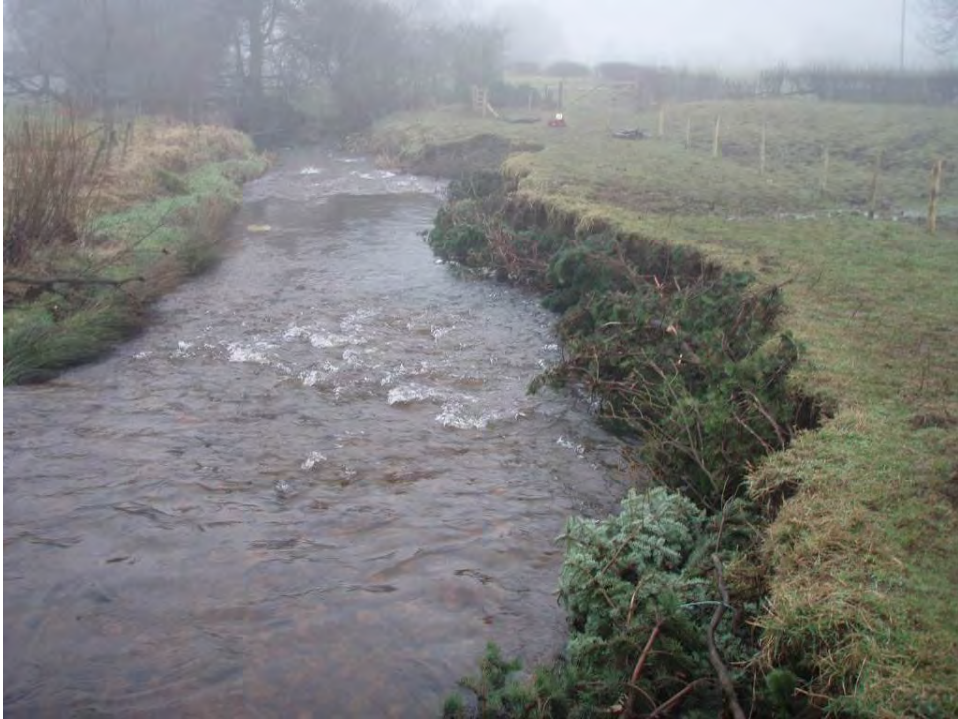
Photo 6 January 2009. View downstream towards footbridge and DCAC signing-in box at Ludburn Farm, immediately after installation of conifer brush at the toe of the bank and fencing well back from the river. (NGR SK0947562521).

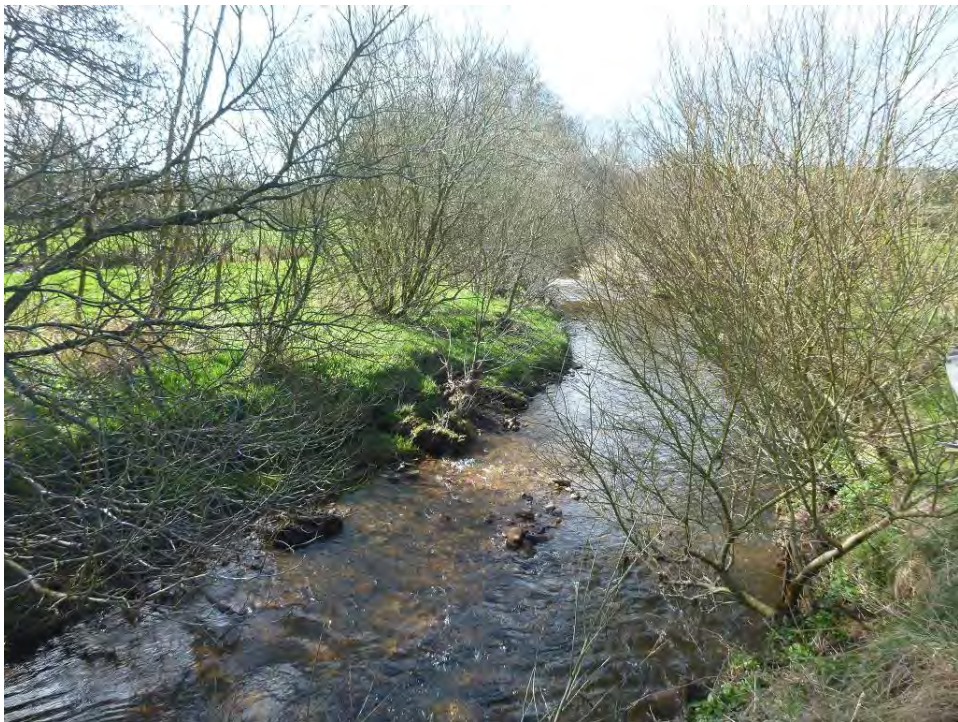
Photo 7 March 2019. The same view as above. The combination of brushwood bank protection and exclusion of livestock (fencing) has been successful, allowing planted willow cuttings to establish, stabilising the bank. The willows on the right bank should be laid over into the water (like hedge-laying). A living willow stake could be driven into the bank to hold the top ends down.

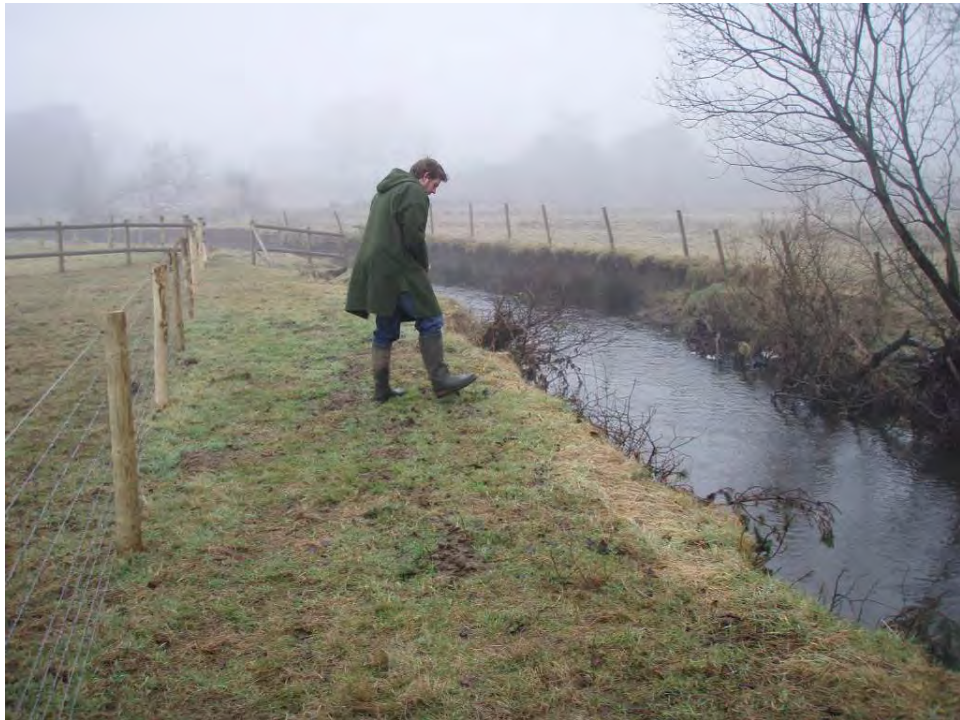
Photo 8 January 2009, upstream view from same position as Photo 7.

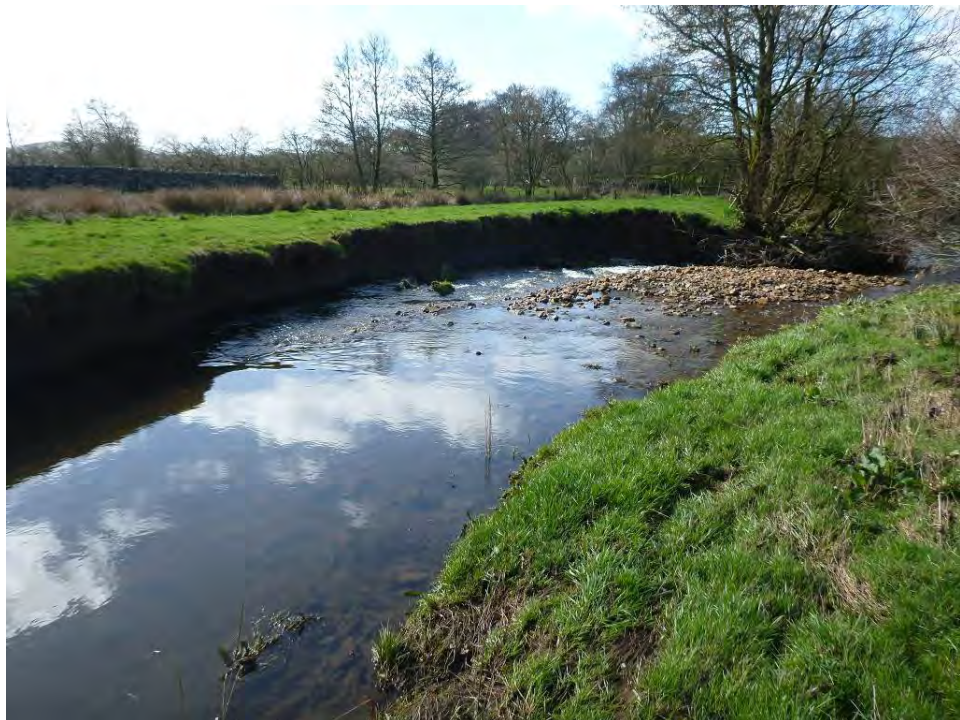
Photo 9 March 2019. Same location as Photo 8 (SK0949662539), downstream view. The Manifold is very dynamic, with sediment supply and transport (gravel bar formation) and bank erosion demonstrated by the above two pictures of the same location a decade apart. Rice & Toone 2011 discuss the cause and effect of these process (Appendix 1).

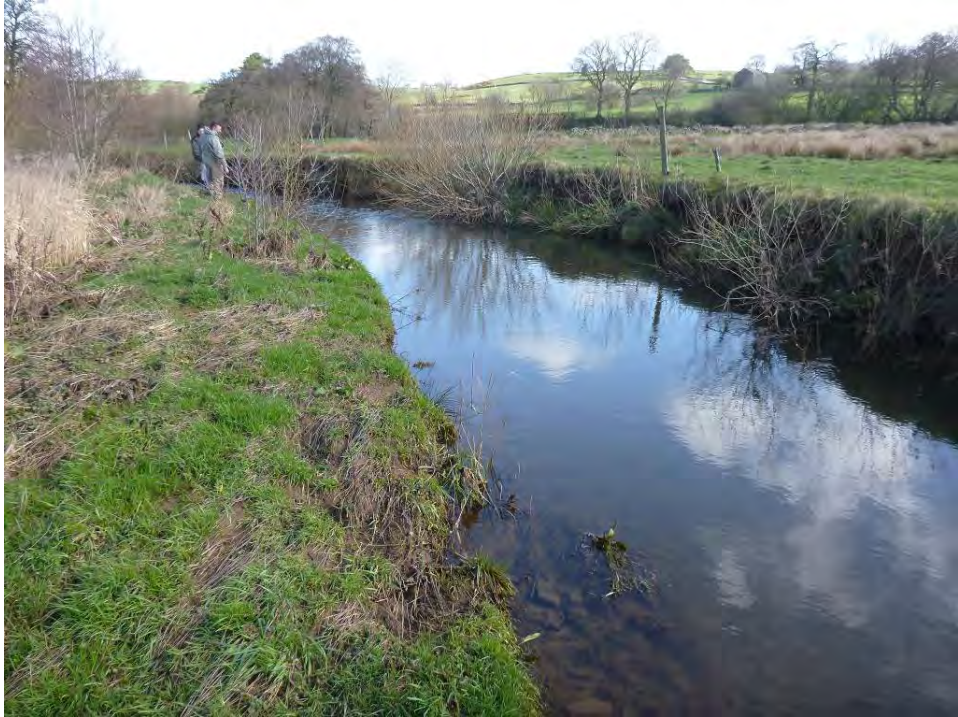
Photo 10 Some saplings have established on the LHB here. These are providing good cover and should be left until larger before considering laying them over for cover (SK0951562574)

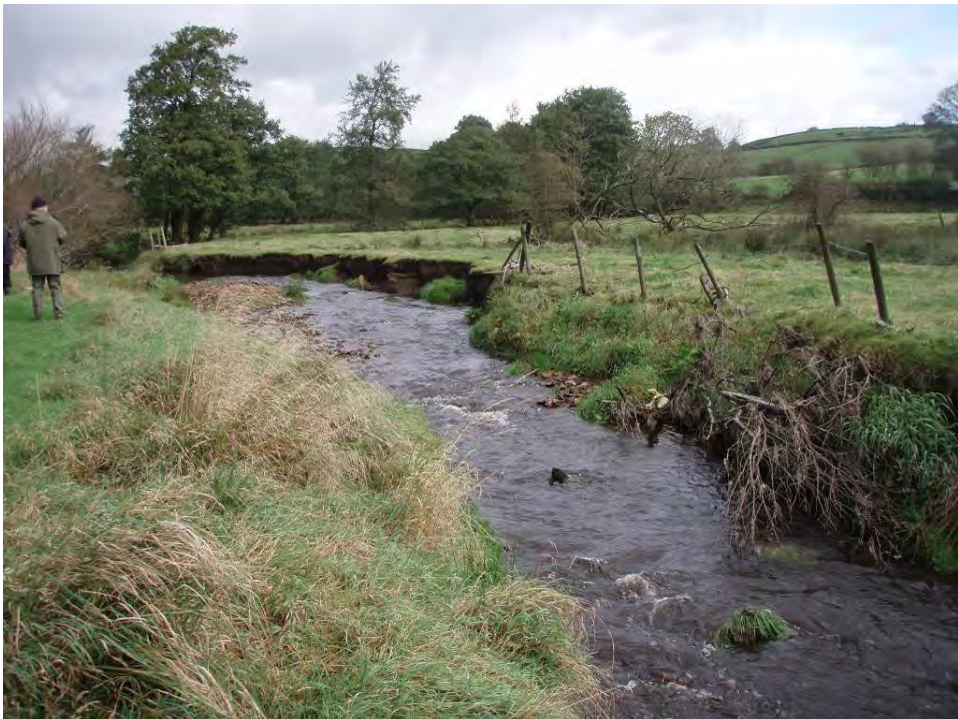
Photo 11 October 2007. Same area as Photo 10, illustrating the dynamic nature of the river. A complete change from a riffle to pool habitat has occurred (now impounded by the gravel bar in Photo 9).

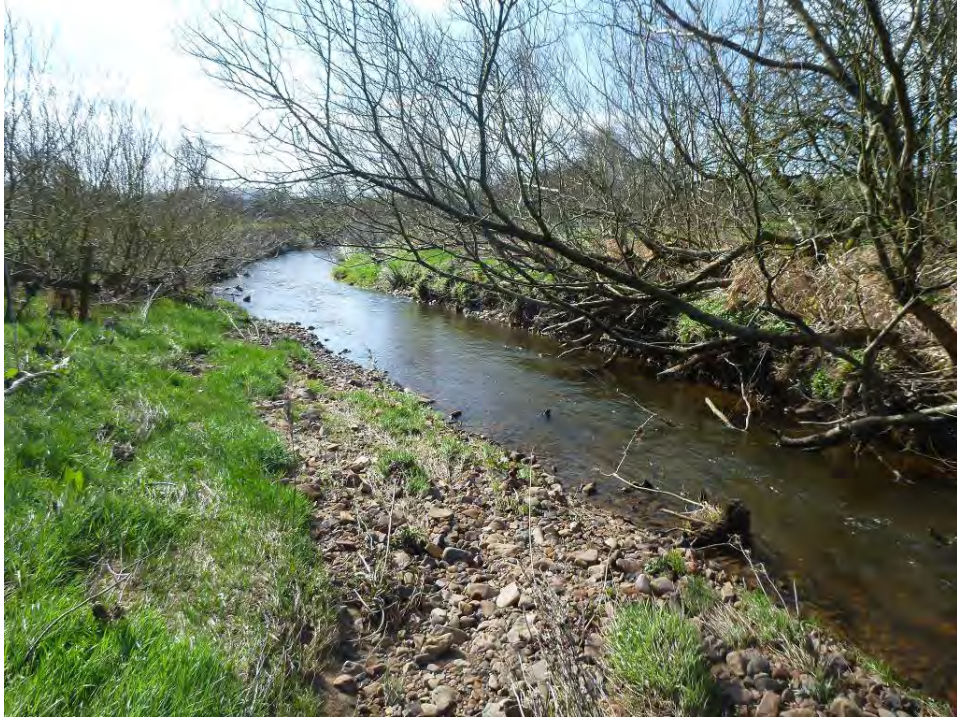
Photo 12 Some of the overhanging willow branches on the RHB can be partially cut and laid along the bank here to provide cover and bank stability (SK0951562605); retaining some high cover will also be important to provide shade and reduce river warming.

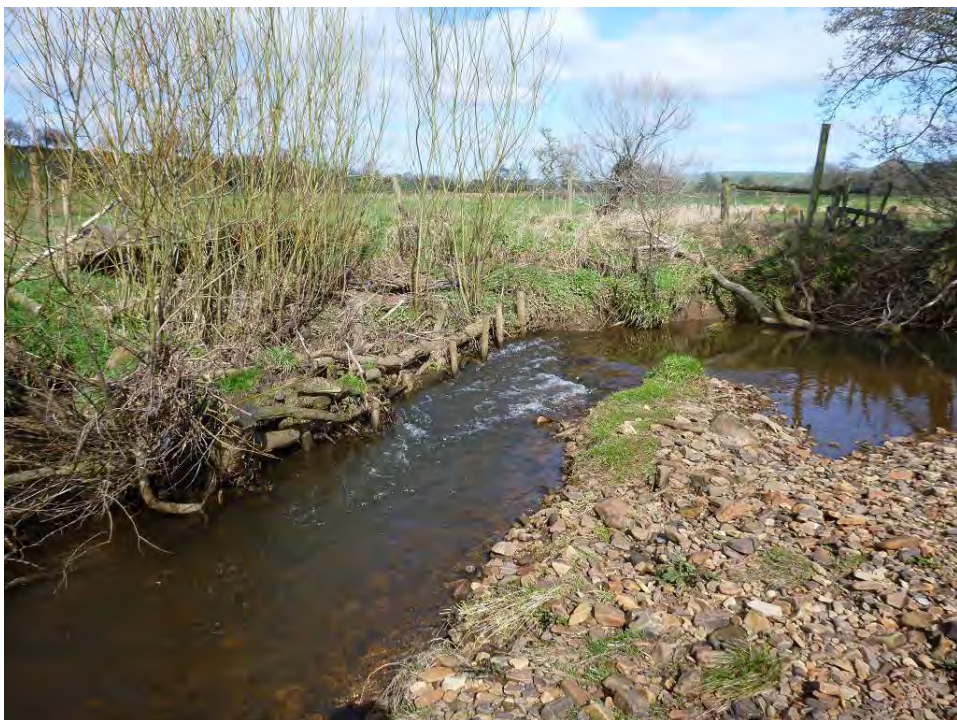
Photo 13 Immediately u/s of Photo 12. Bank protection with woody material and living willow in-fill has successfully protected the bank. The sprouted willow could be coppiced and used to reinforce this area and elsewhere.

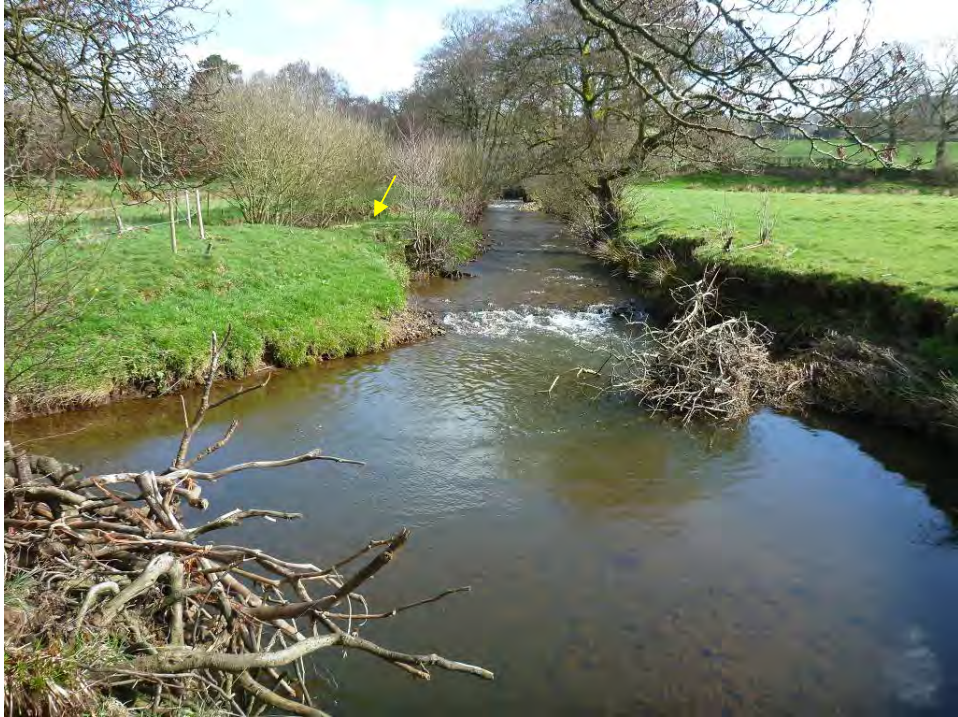
Photo 14 View u/s from SK0952062614. Apart from the pool in the foreground, this section is straight and shallow, with no deeper water to hold adult trout. The arrow indicates the area shown in Photos 15 and 16 below. This area may have been artificially straightened in response to bank erosion that was occurring (Photo 16).

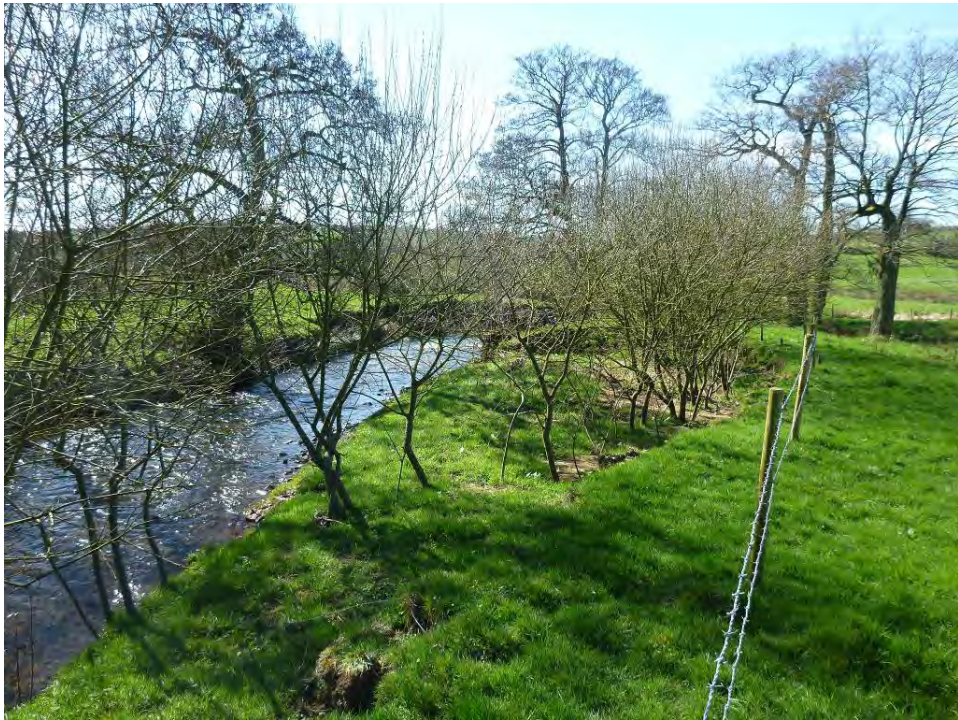
Photo 15 Area indicated by arrow in Photo 14 (downstream view from RHB). Brushwood revetment and willow planting had been carried out here (shown by the line of willows). The area in front of the willows appears to have been filled with river sediments.

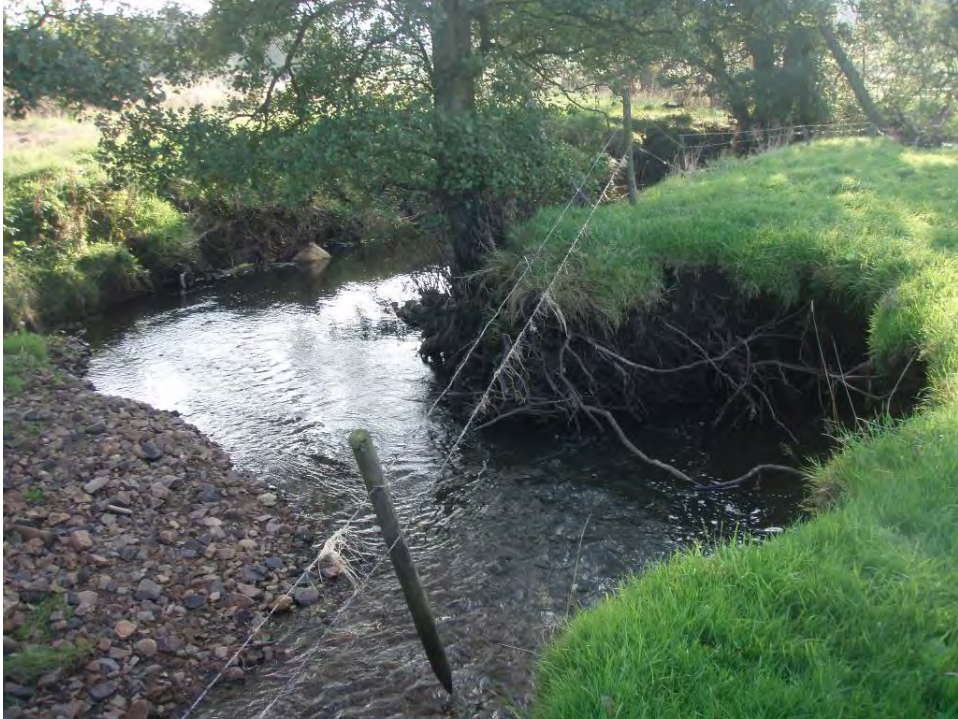
Photo 16 September 2008. The same area as Photo 15. If the river here was actively realigned and the above eroding area back-filled with river sediments, this illustrates the problem that this type of intervention poses to the fishery. The bends in the river where the erosion occurs is where deeper pools form, and these deeper pools hold adult trout. The straightening of the river and in-filling of bends with sediment leaves a shallow riffle/glide (Photo 14) with no areas for adult trout and little angling interest, devaluing the fishery.

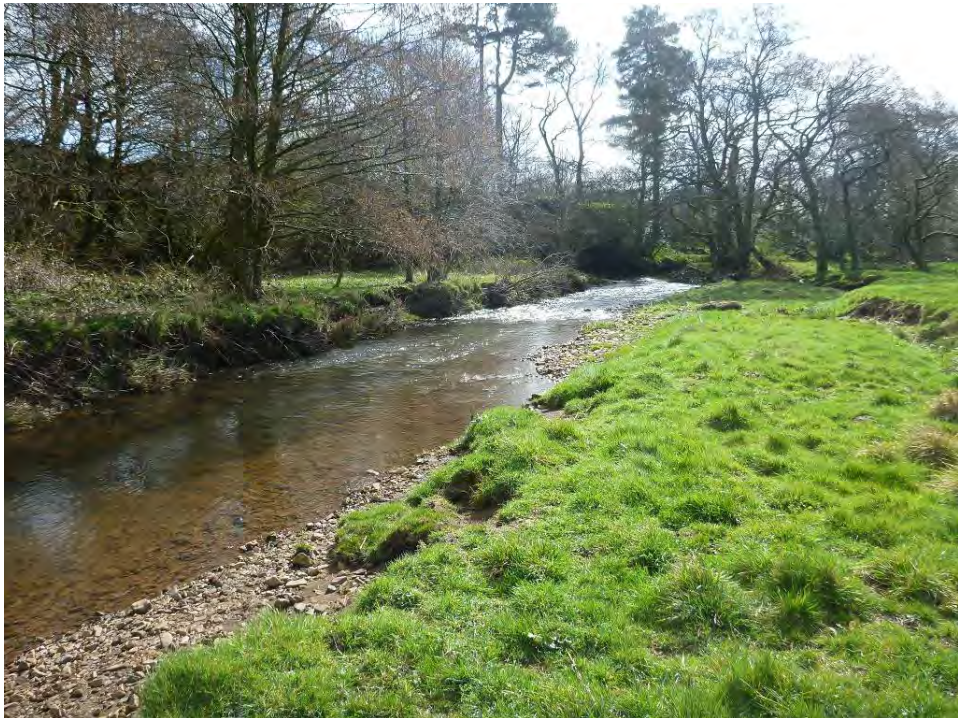
Photo 17 Another site where channel straightening has probably been carried out, (NGR SK 09598 62656).

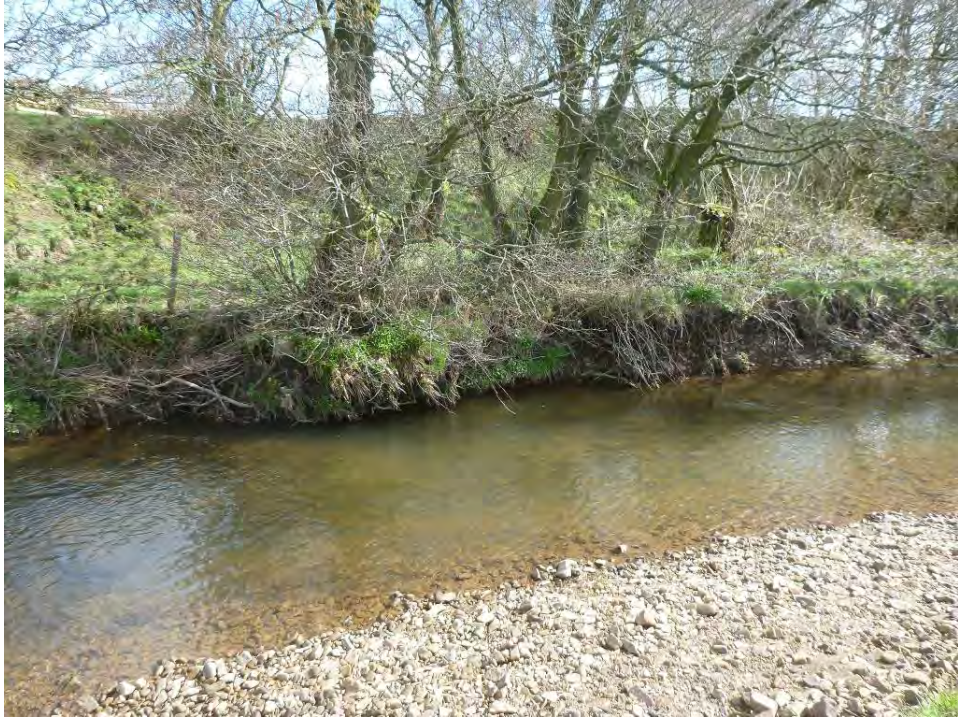
Photo 18 A deeper area at the head of the straight section in Photo 17. Hinging branches over to provide extra cover from the LHB is recommended.

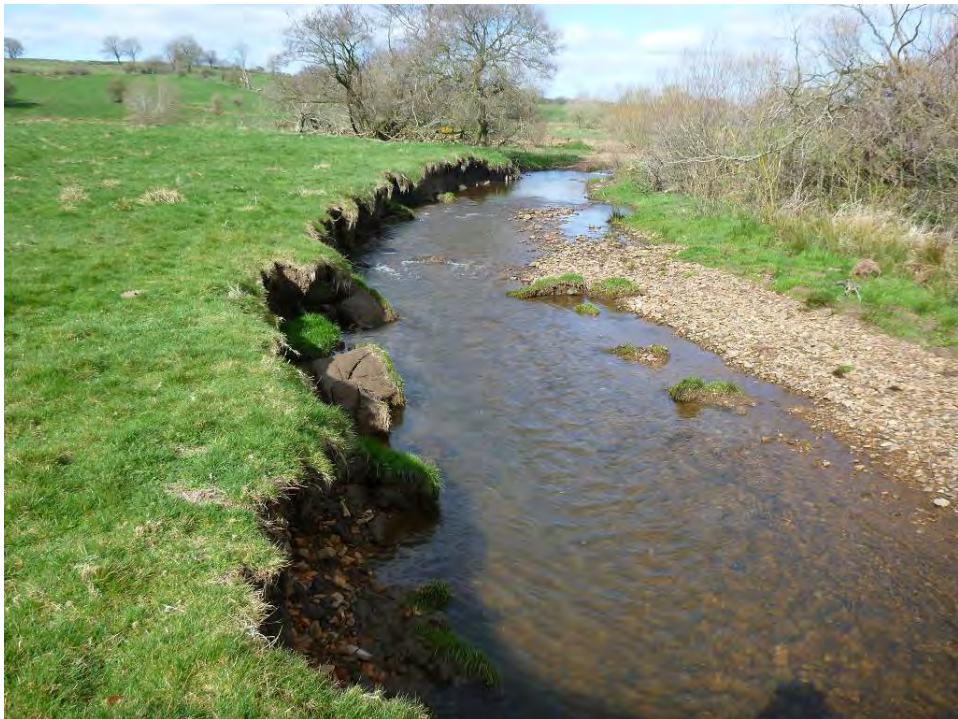
Photo 19 Block failure erosion. Revetment with willow bundles may slow down erosion on sections like this and provide some fish cover, but livestock exclusion would also be required on low banks like this.

- Consider installing bank protection / fish cover (e.g. Photo 6) in areas such as Photos 19 and 20. Use thorn brash to deter grazing and incorporate living willow bundles (or stakes/whips).
- Continue with the invertebrate monitoring being carried out under the Riverfly Partnership's Anglers' Riverfly Monitoring Initiative (ARMI).

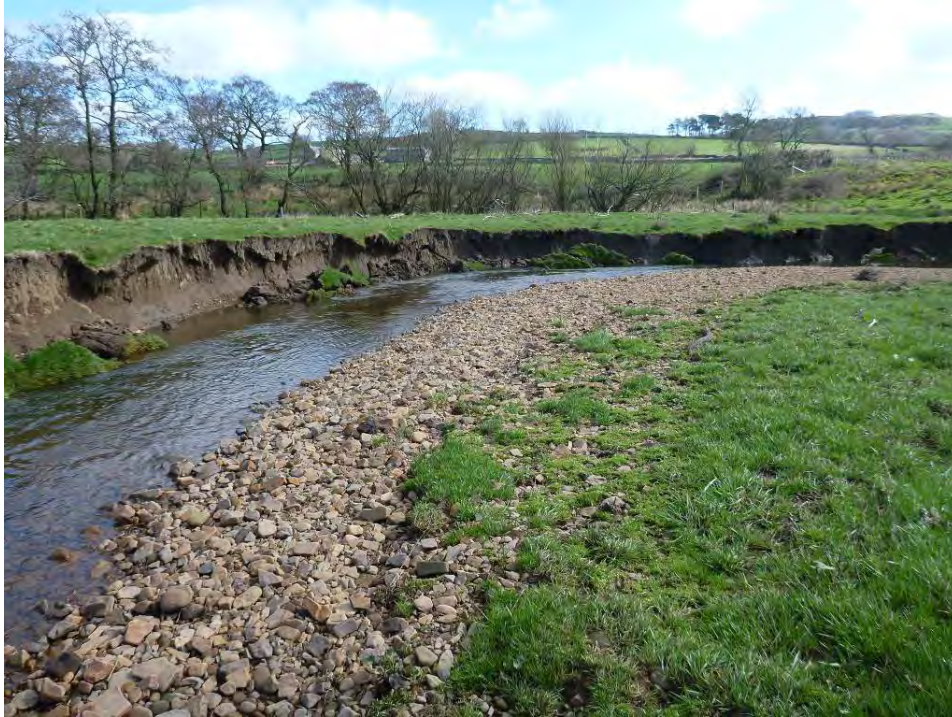
Photo 20 Rapidly eroding bank. Erosion may be slowed by stabilising the bank with brushwood and willow (see Photo 22), which would tend to focus the river energy into scouring the river bed and creating more depth; along with the woody cover, this would improve the fish holding capacity. Livestock exclusion would be ideal, but the use of thorn brushwood and willow may provide some grazing protection. Stopping bank erosion is not a possibility, nor desirable, but slowing it to improve habitat is.

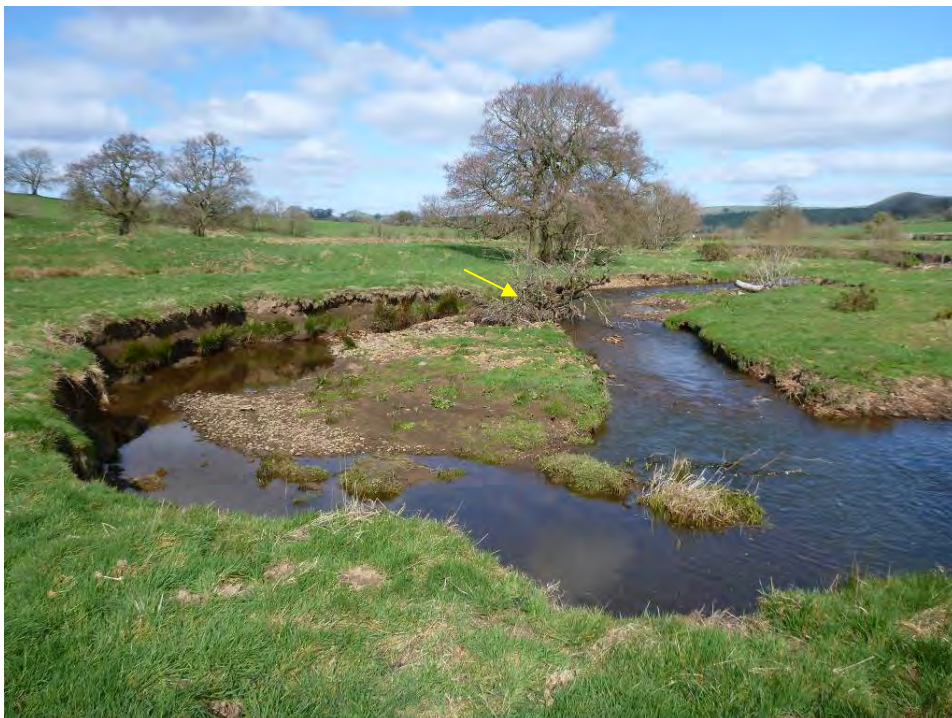
Photo 21 Another cut-off meander, possibly as a result of the fallen tree (arrow) altering the river course.

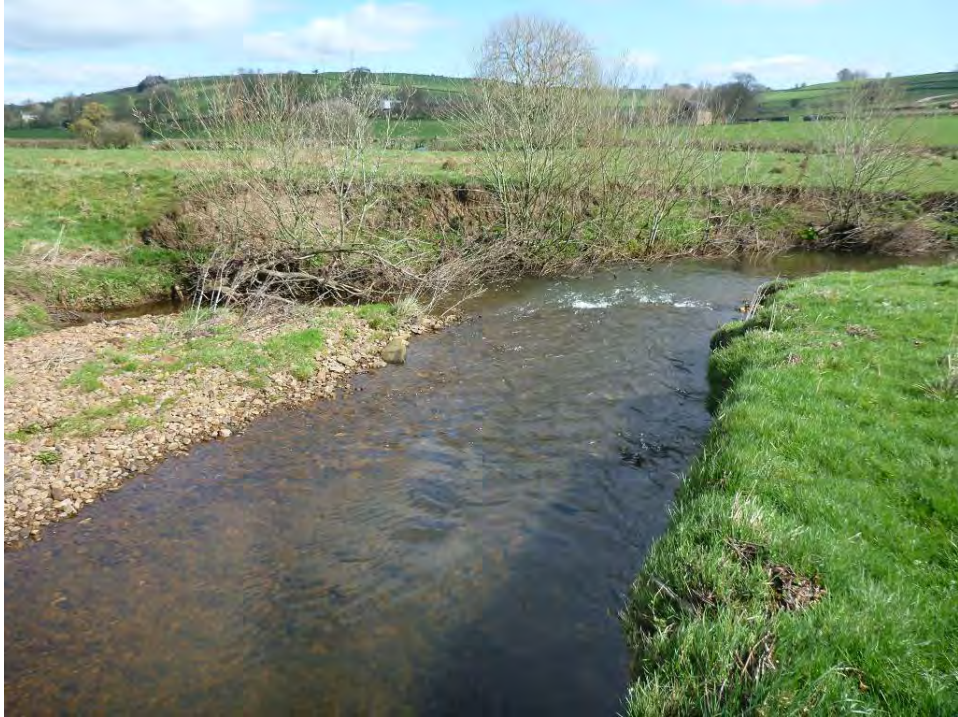
Photo 22 Willow bank revetment approximately 10 years old has provided some bank stability and channel depth in front of it, creating a nice holding pool. These willows could be laid over to provide ongoing bank protection and cover.

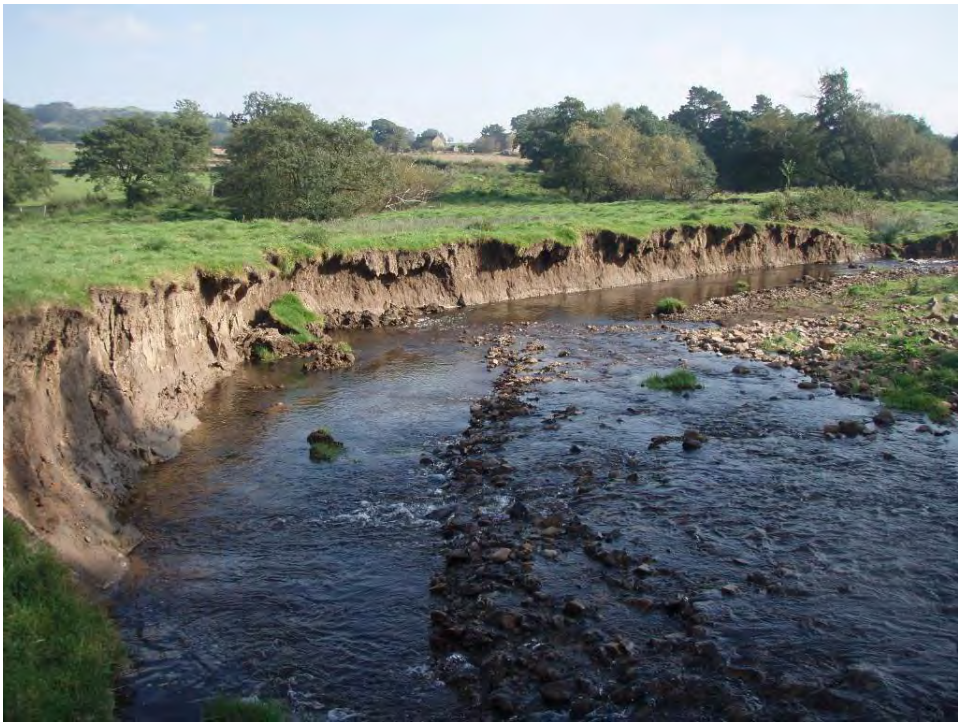
Photo 23 September 2008. The same area as Photo 22 before the work was carried out – insufficient depth and cover to hold trout.

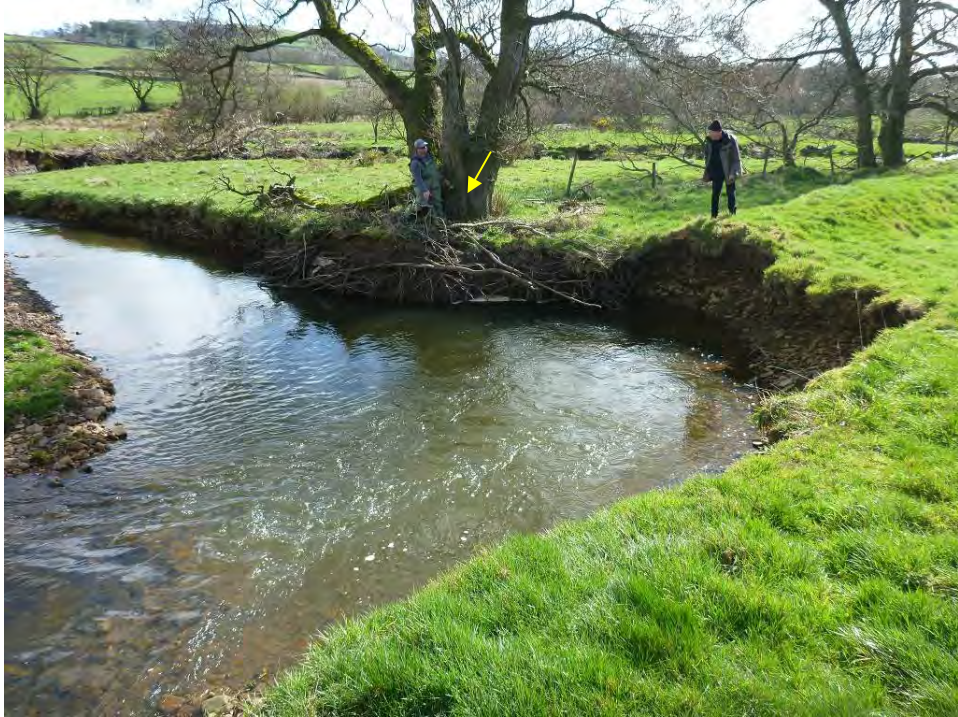
Photo 24 Meander bend at SK0946262886.

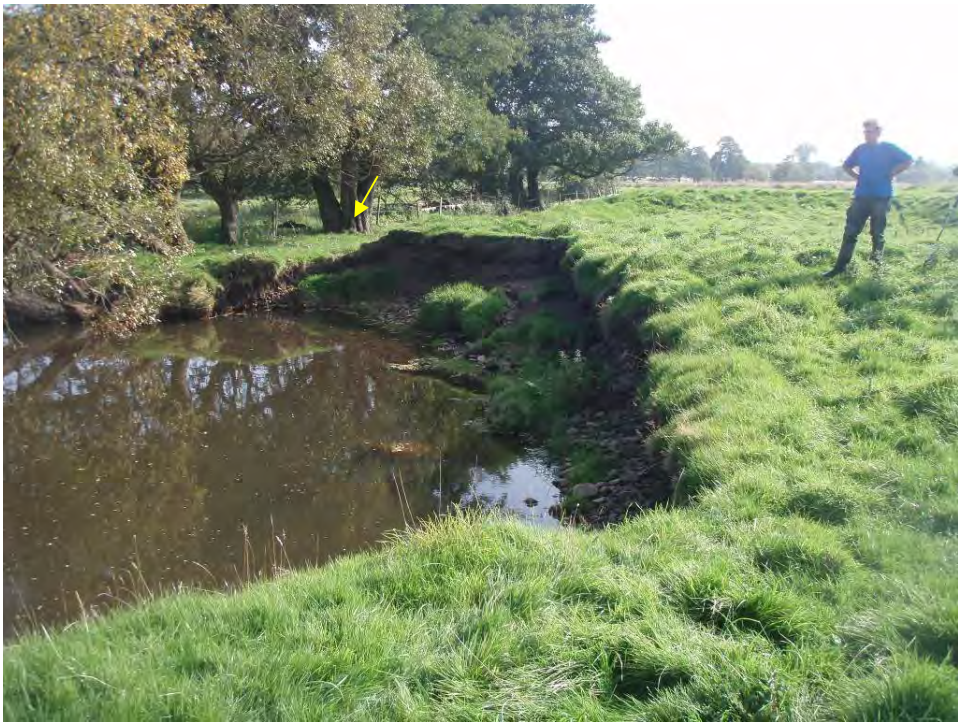
Photo 25 September 2008. The same bend as Photo 24. The arrows in each picture indicate the same tree, showing how far the river channel has moved in a decade.

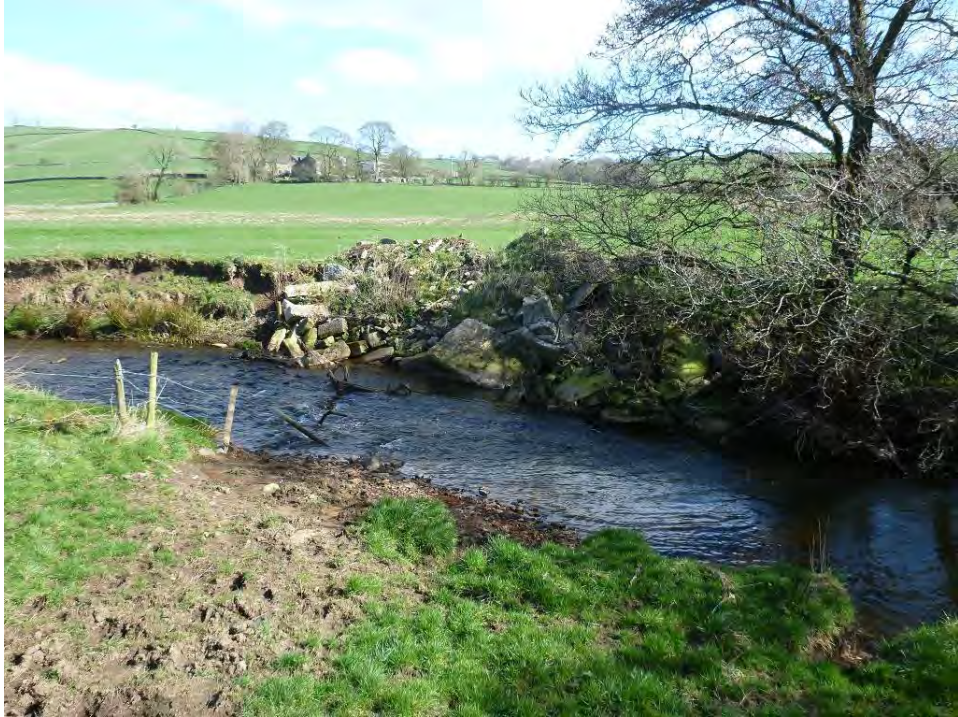
Photo 26 Hard bank protection such as this does not reduce the shear stress caused by fast water, hence erosion tends to occur where the stone begins and ends, undermining it. Use of brushwood and willow is preferable as it absorbs the energy of the water, binds the bank with roots and provides good cover and habitat.

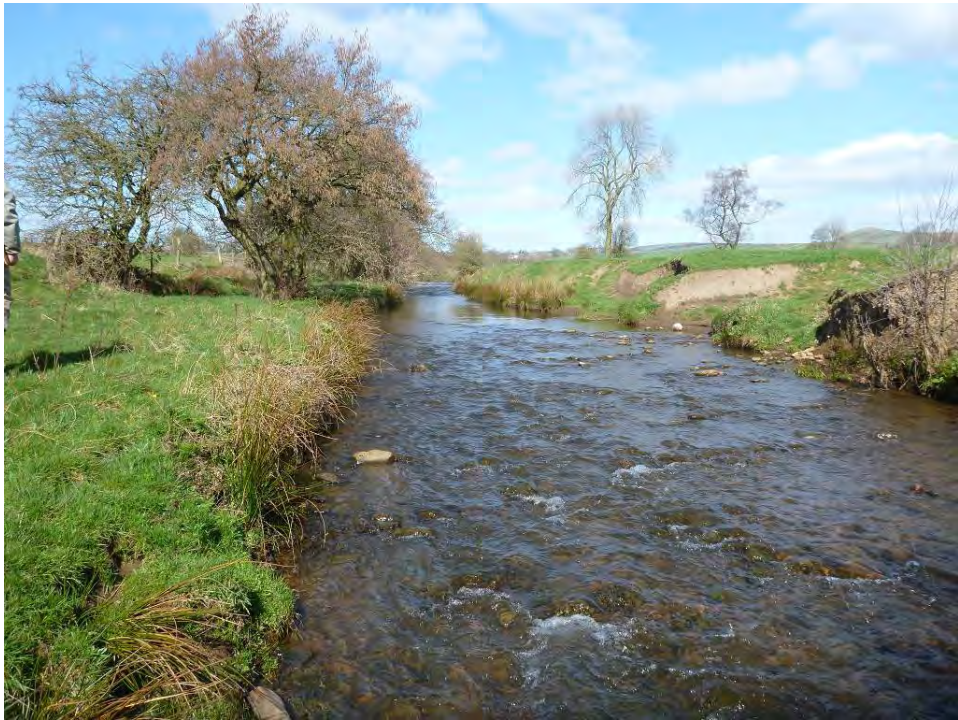
Photo 27 The very straight river channel which begins above the Ludburn section (at approximately SK0947162955) and continues to Longnor (c.2km). The straightening of the channel here dates to the early C19th (Rice & Toone, 2011), and is a fundamental reason for the generally poor habitat for adult trout (and hence fishery quality) throughout. Riffle and glide habitat predominate and there are very few deeper holding areas for adult fish.
