Advisory Visit

River Manifold, Staffordshire

25th March, 2019

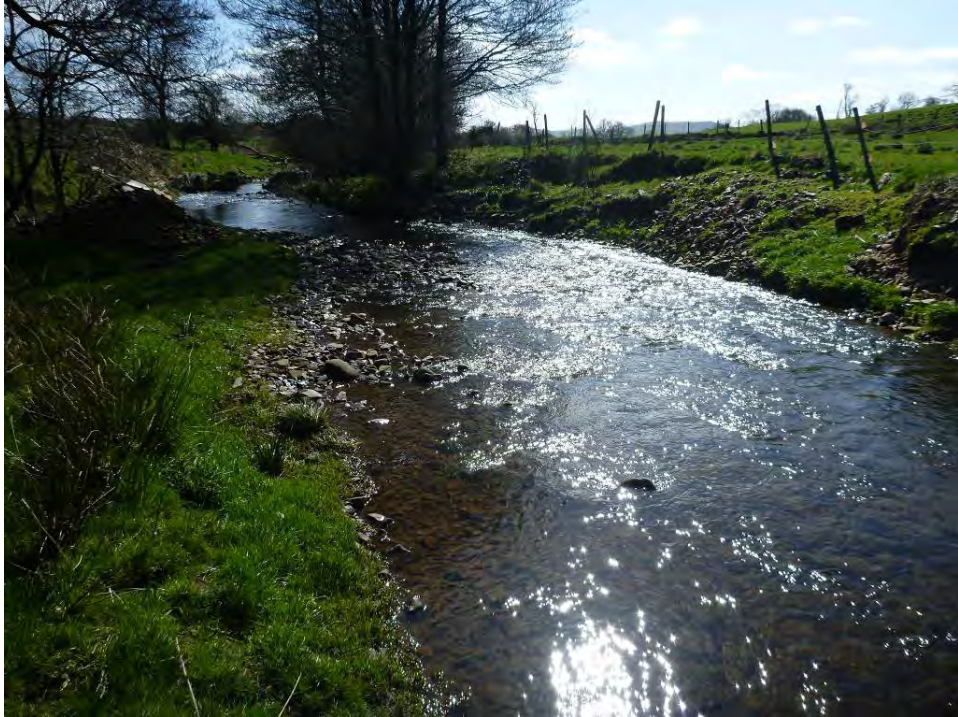
Photo 28 Example of the use of river bed material to shore-up an eroding bank and prevent lateral movement of the river channel. Such activities are damaging to in-stream habitat and prevent the straightened river from re-developing meanders and better trout habitat; if the gravel disturbance is carried out during the fish spawning season (Oct – May), direct damage to fish eggs could be caused. For these reasons, such activities are governed by the Environment Agency’s Environmental Permitting Regulations.

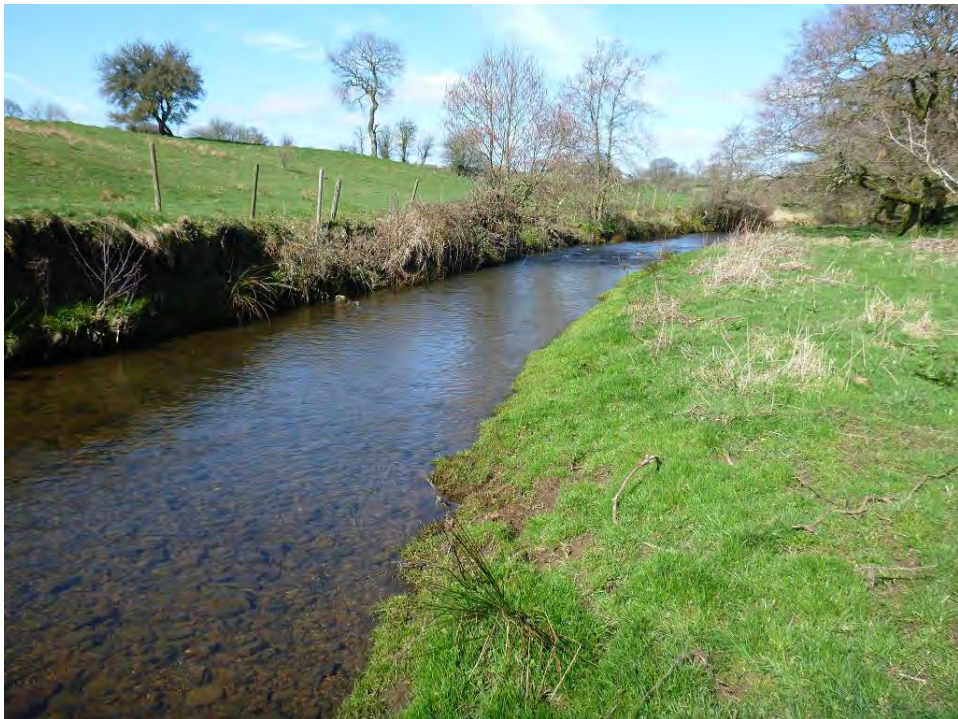
Photo 29 Typical section of the straightened channel, illustrating the lack of adult trout habitat.

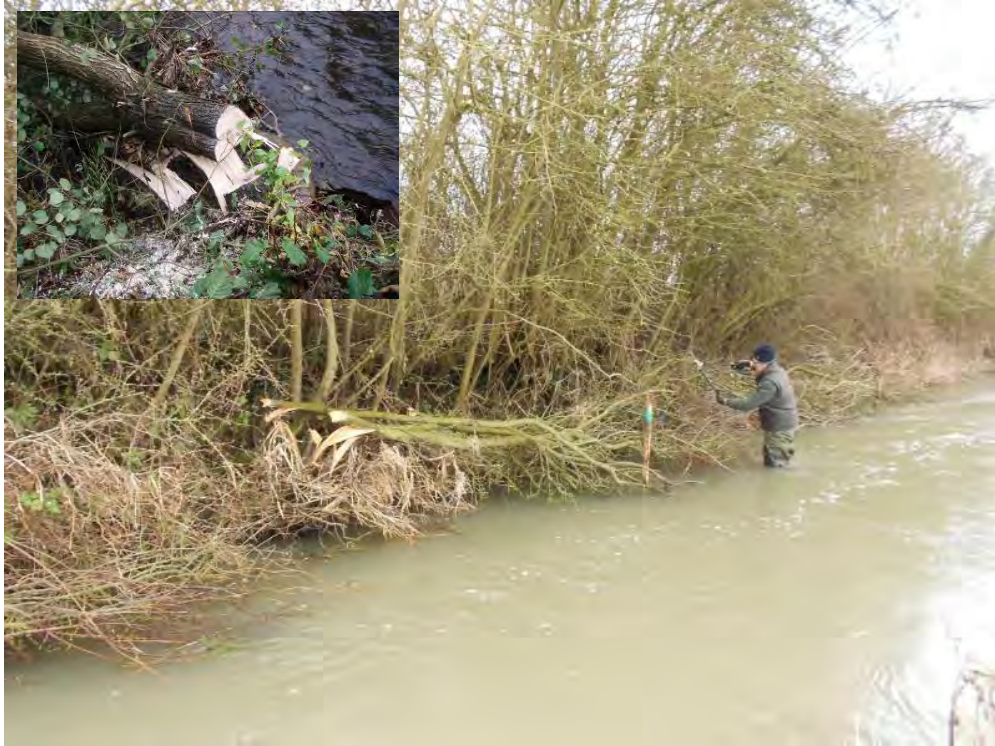
Photo 30 Laying trees into the water to provide excellent cover for trout. Inset: detail of partial cut to retain the tree and keep it alive.

- On the section of river upstream of the footbridge at Ludburn, lay the willow along the RHB into the river margins (Photo 30). This technique can also be used elsewhere, where there are suitable trees present.

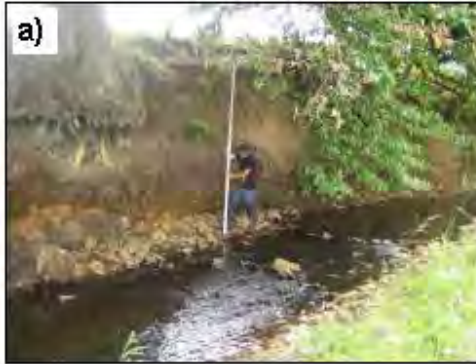
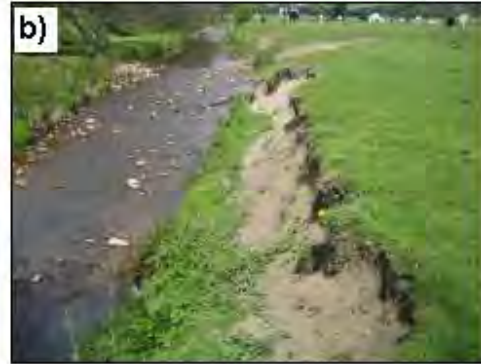
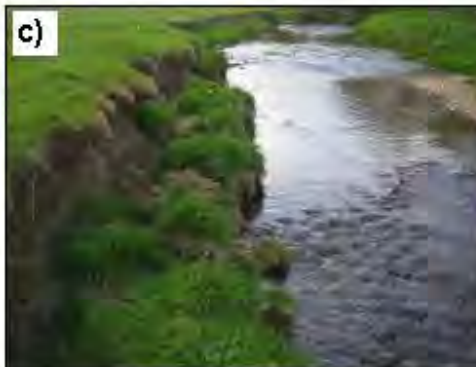
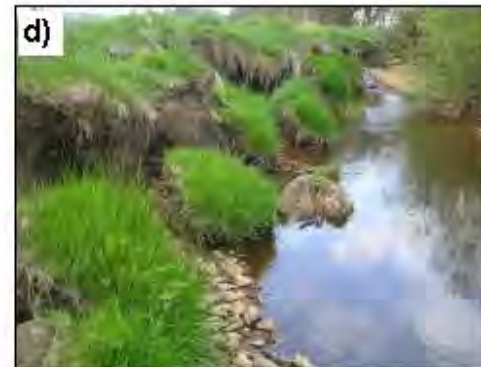
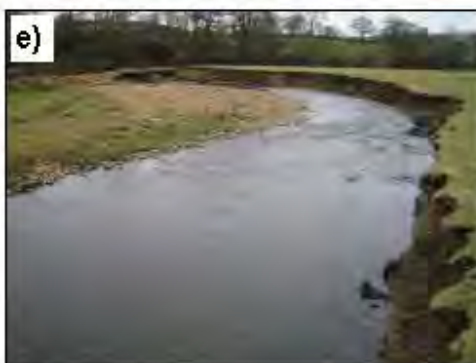
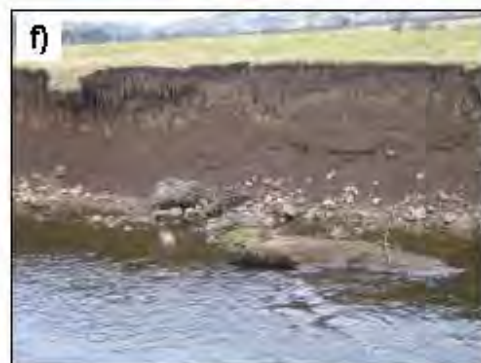
Figure 6.9 Bank erosion features in hotspot two on the River Manifold

a) Incision, associated with historical straightening of reach 12 downstream of Windy Arbour bridge, has resulted in over-steepening of the right channel bank which is unstable. Stability is improved by the root networks of mature riparian trees, but these trees are now undercut so their role is increasingly tenuous. The bank is approximately 4 m high. b) Bank erosion is aggravated in reach 12 by livestock poaching of bank surfaces. c) Mass failure typical of severe bank erosion in reaches 13 and 14. Note that the failed blocks extend along the toe of the bank as far as the eye can see. d) Removal of coarser but unconsolidated gravels at the base of some of the banks in reaches 13 and 14 (foreground) is probably a precursor to these cantilever failures. e) Long runs of erosion characterise the banks in reach 16 where (f) subaerial weathering of thick overbank sands is an important source of fine sediment.
