Axe Vale Rivers Association, Seaborough, River Axe

**An Advisory Visit by the Wild Trout Trust
July 2020**

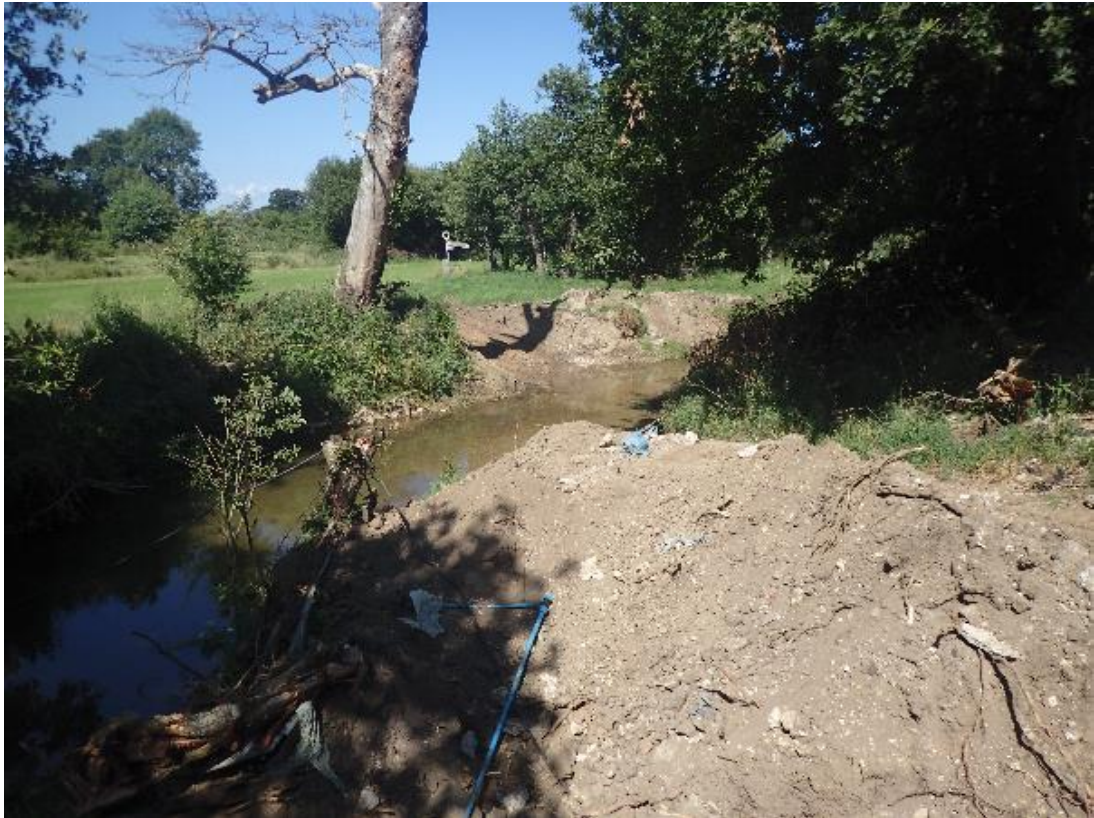
At the bottom of the reach, the river passes through a farm yard at Seaborough Court (photo 1), the site of an old bridge that is being replaced, but the damage evident during the visit to river banks and from vehicles fording it is of some concern. This type of work needs to consider potential environment impact and should follow the correct consenting procedures to ensure work is carried out sensitively. In the meantime, this bank will take some time to recover and it is now exposed to erosive processes that were not there previously.

Photo 1: Farmyard at Seaborough Court: notable plastic pollution and disturbance of riverbanks.

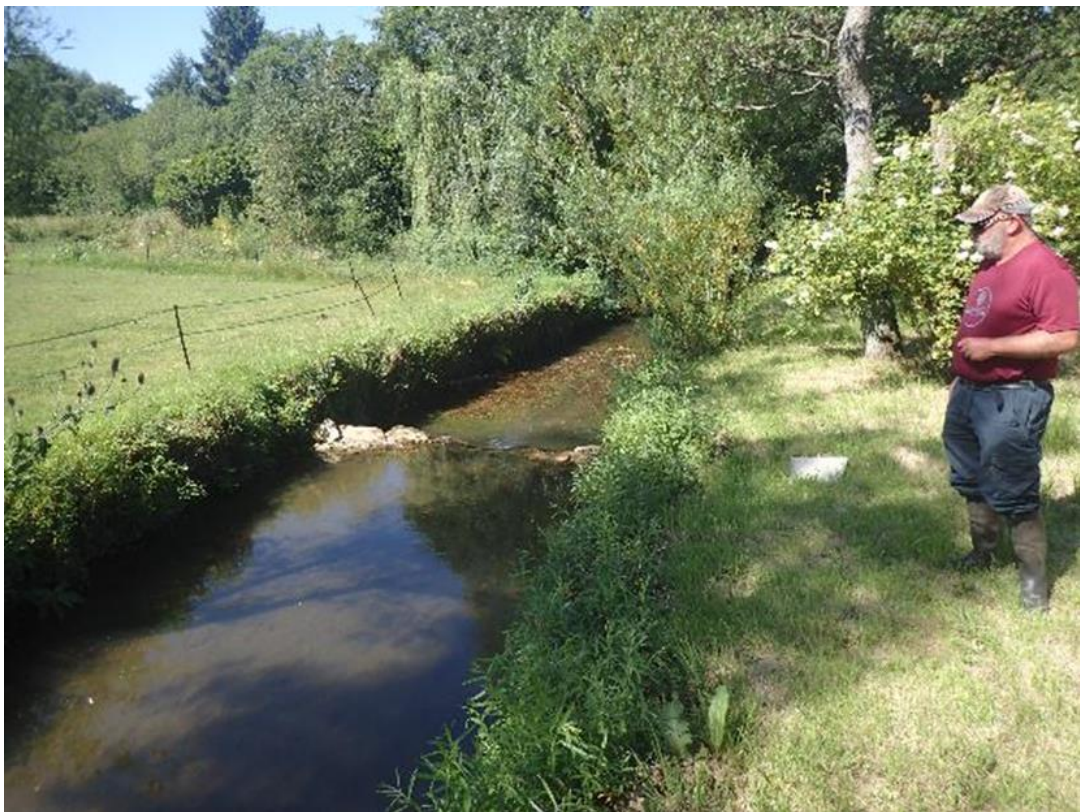
Photo 2: Summer weir, interrupting natural pool and riffle formations.

Upstream from the farmyard, the river takes on a more formal setting through a garden and beyond into woodland. The river here has good habitat and a nice meanders, though a number of summer weirs (photos 2 & 3) have been created to form small pools, to the detriment of the river upstream of them, impacting the natural river processes, hindering gravel and sediment movement. Note the darker gravels upstream of the weir in photo 2 and brighter gravels downstream. Drawing 1 demonstrates exactly what is happening around these weirs.

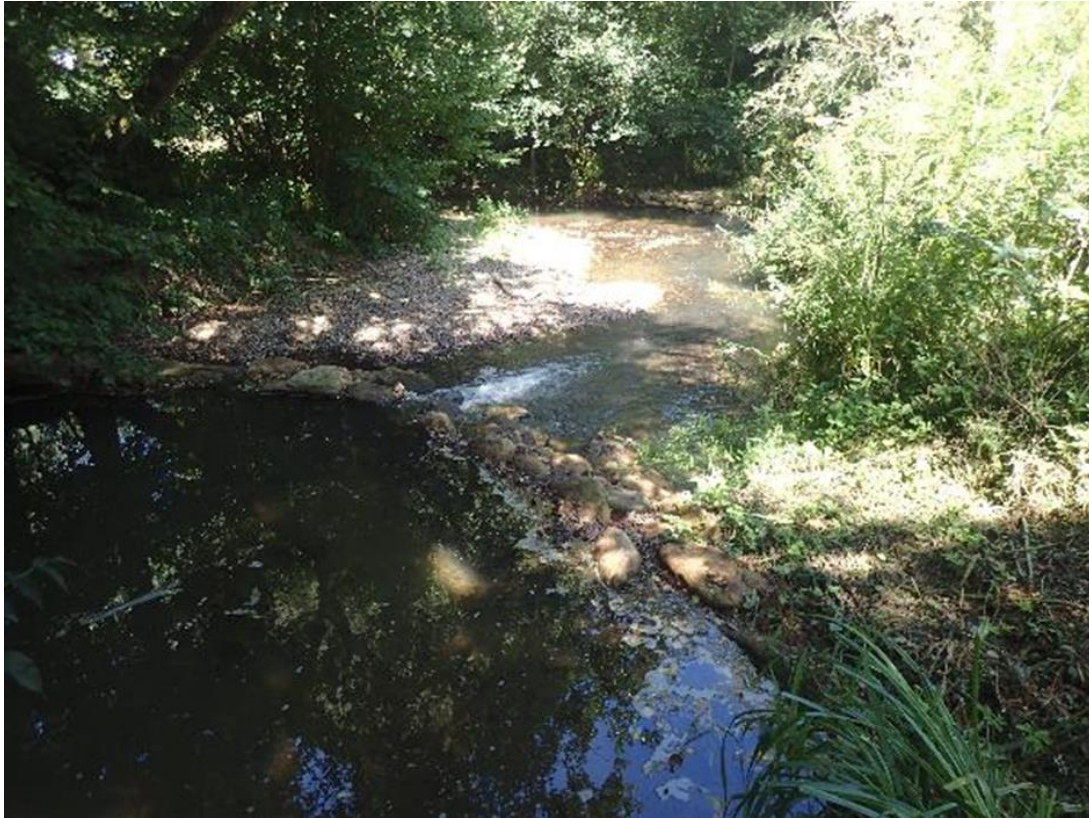
Photo 3: Another summer weir: note laminar water upstream and dynamic river processes downstream.

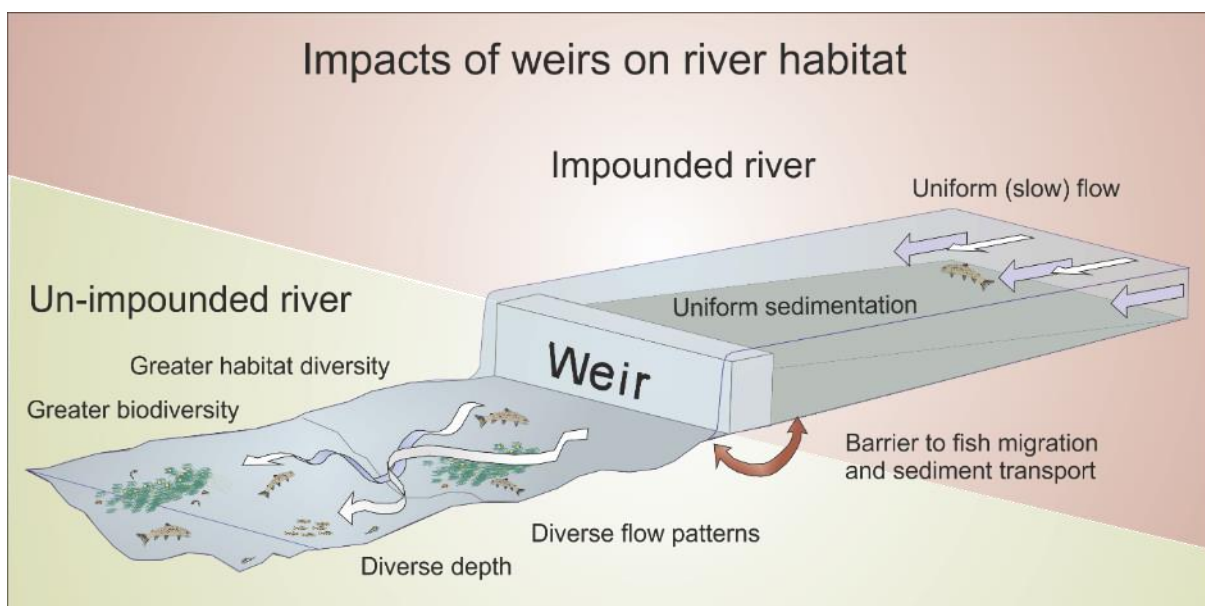
Drawing 1: The effects a weir can have upon a riverine environment.

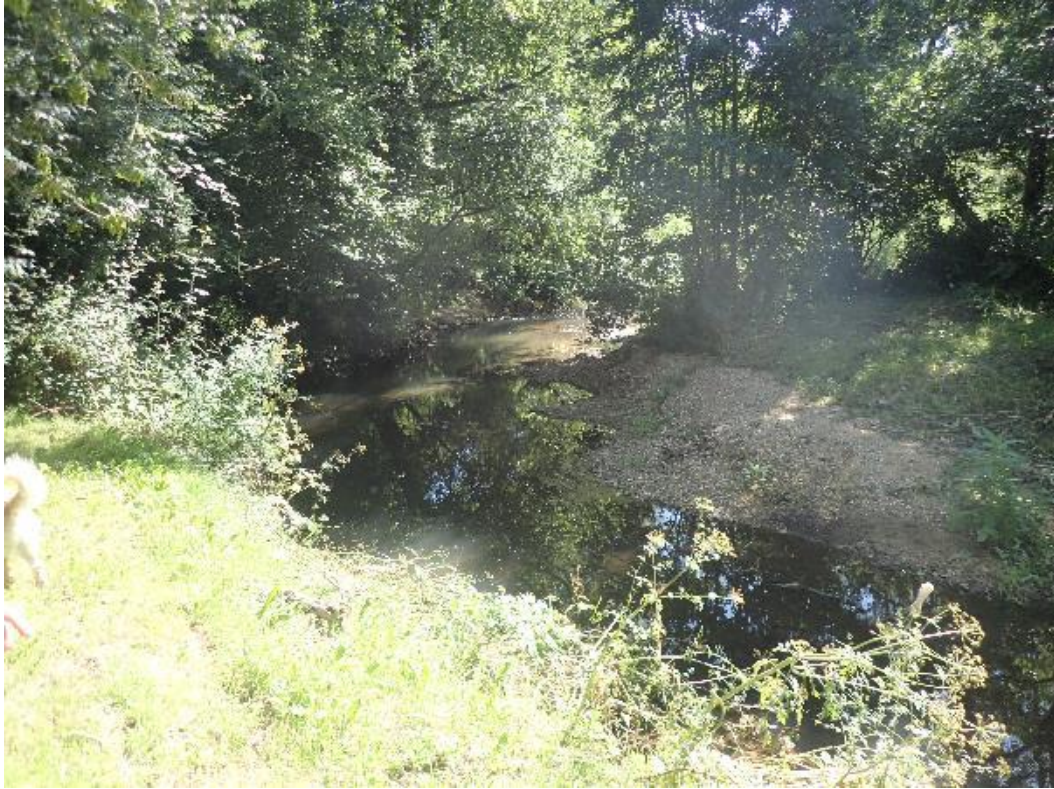
Photo 4: Downstream of the weirs, the habitat was good with lush overhanging trees and abundant gravel seams.

The habitats downstream of the weirs, in the wooded section, were rich in dynamic processes, with a good shade/light ratio in equal measure. The low overhanging cover on the RB on the bend in photo 4 (left of shot) will provide a good bolt hole for trout. The river throughout has rich seams of gravel that is readily available through bank erosion, which no doubt, if in good condition scoured and cleaned by sediment-free water, would be a good spawning medium for trout and sea trout.

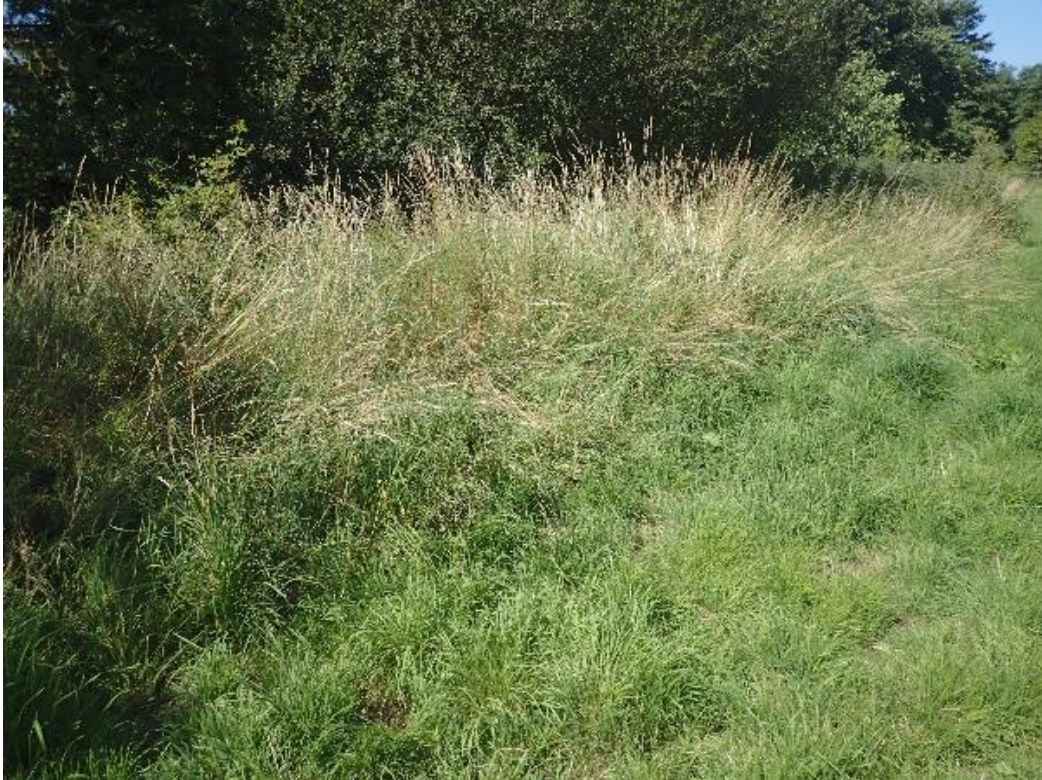
There was evidence of historic dredging downstream of the road at Manor Farm where a large bund of gravel was piled up on the banks, now vegetated over; the bund may well have been from historic straightening and agricultural land management. This bund (photo 5) should be broken to reconnect the floodplain with the river which will help with flood water storage and allow sediments and nutrients to be absorbed by the land. The river in times of flood is kept within its banks, further incising the channel; the high flow energy created will be detrimental to any trout redds and prevents the river's natural interaction with its floodplain.

Photo 5: A bund possibly from historic dredging and straightening: it is likely to be formed from river gravels. It disconnects the river from its floodplain and retains high flows in channel.

- Engage with Iorwerth Watkins yog@wrt.org.uk who is involved in some pilot environmental land management (ELMS) schemes in the catchment.
- Explore the possibilities of reinstating the floodplain, lowering banks or dredged bunds to reconnect the floodplain for its intended purpose of storing floodwater and allowing sediment to drop out of the river onto the floodplain. This could be part of an ambitious river restoration project, reinstating the river to a previous course; the EA may be interested. WTT would be happy to act as a broker to help such a meeting happen.

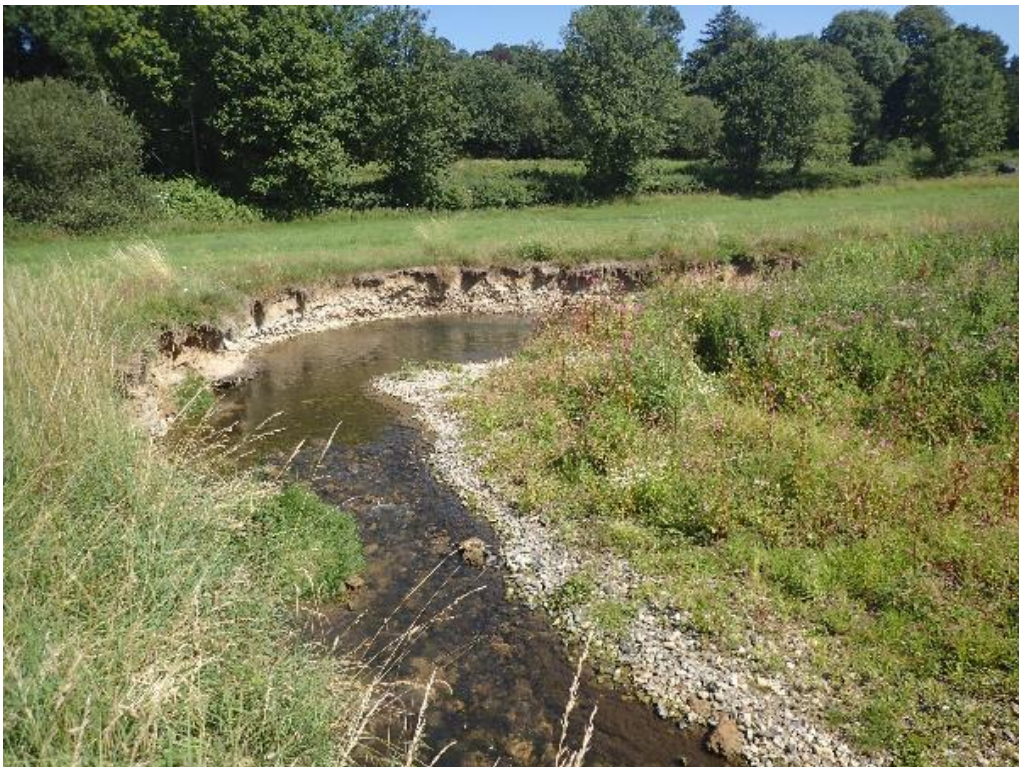
Photo 6: Geomorphology in action! From a previously straightened reach the river decided to cut a new meander and start to heal itself.

There is evidence of the river attempting to right the wrongs of the past (photo 6), where a previously straightened reach has now cut a new, meandering path through the floodplain, evidence that rivers need room to move around the floodplain. It also shows how new gravels are available to the river, with an eroding RB. A livestock fence would be useful here to diversify marginal habitat and encourage tree regeneration; if a fence is installed, this may well need some strategic management to ensure invasive monocultures do not proliferate i.e. full shading of willow. This classic pool and riffle meandering sequence is scarce in the reach of water visited. The upper section is mainly straightened; further evidence of the previous meandering channel is seen in photo 7, where the old river channels (paleochannels) can be seen meandering through what is now a field, with the straightened channel moved to the edge of the floodplain. This historic straightening can be blamed for the lack of natural river features throughout the reach.

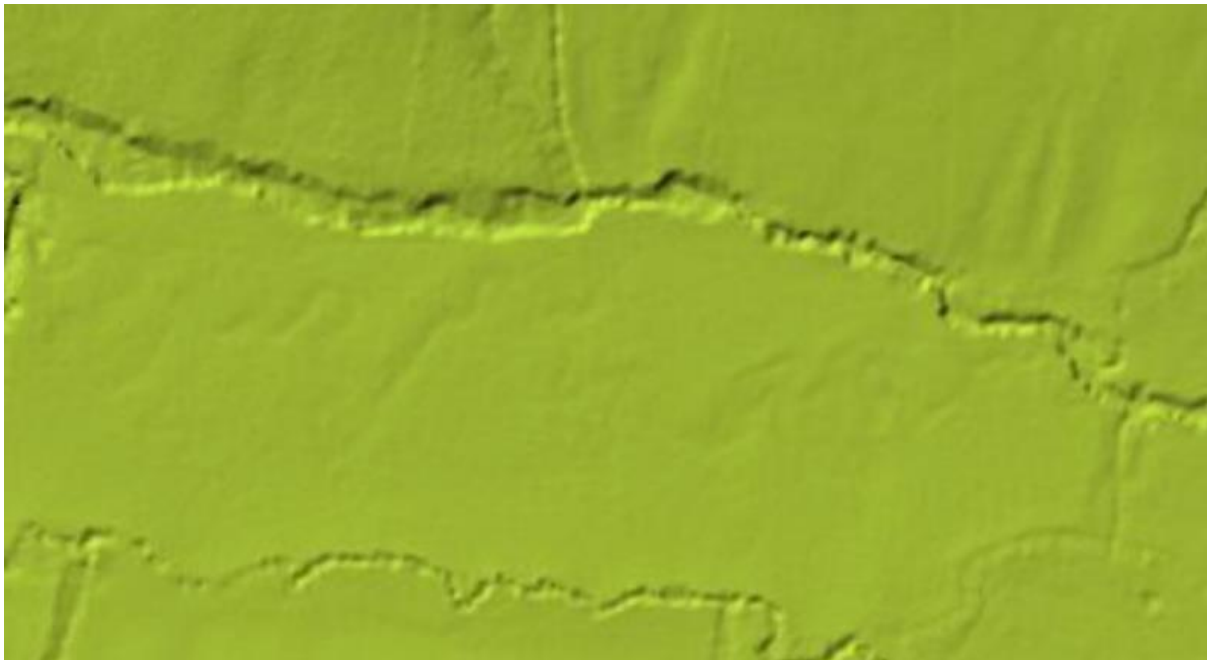
Photo 7: LIDAR map (National Library of Scotland): note straightened channel top and old paleochannels meandering through what is now a grass field.

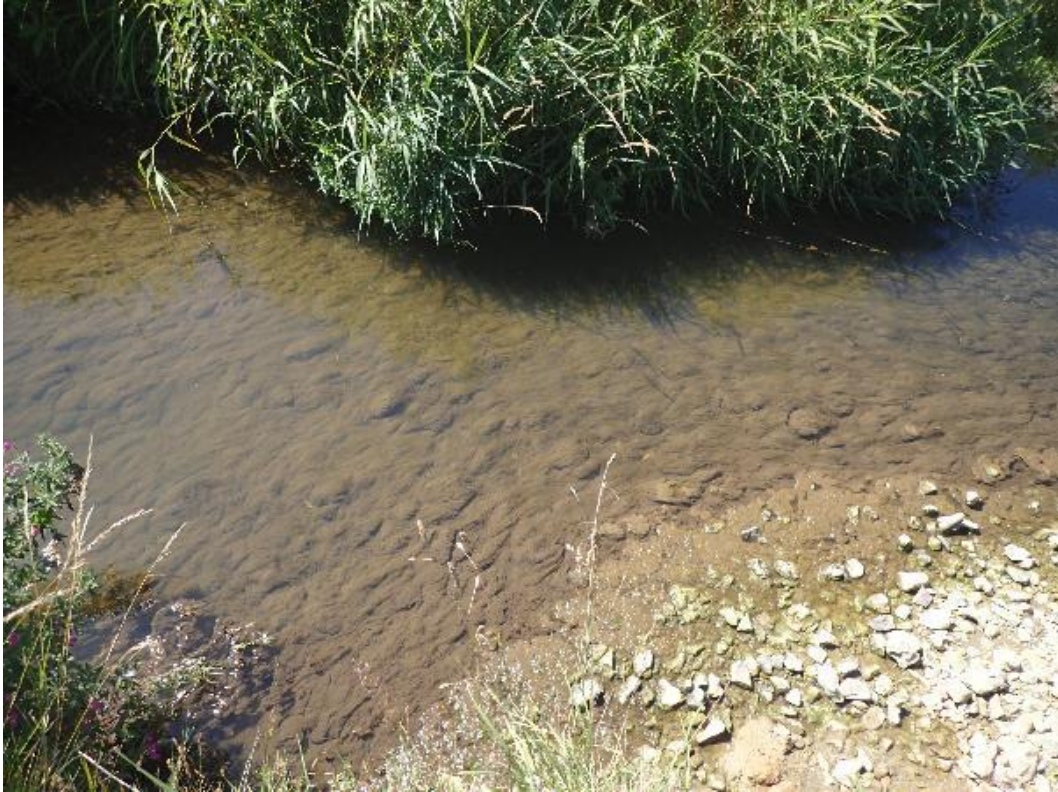
In areas with reasonable trout habitat, there were many fewer fish spotted than expected for the apparent quality of the habitat. A systemic problem was evident throughout the reach, with a thick sludge and algae (photo 8) smothering what could be quality spawning gravels. With many gravels showing this kind of stress and historic experiments with sedimentation of gravels done by members of AVRA, this is a catastrophic problem for trout, other native fish species and invertebrate communities of the river. An EA report published in 2019 noted widespread agricultural pollution on the Axe; this visit suggests that the issue remains on the upper river which could, and should, be a pristine environment, packed with hundreds of juvenile trout and rich with invertebrates.

Photo 8: Extreme suffocation of gravels, overlain by algae and sediment.

- Encourage work aimed at improving water quality; for example, Westcountry Rivers Trust (WRT) may be willing to undertake some wet weather walkovers to map sediment ingress from land use. Issues considered to breach the farming rules for water (https://assets.publishing.service.gov.uk/government/uploads/system/uploads/attachment_data/file/695598/farming-rules-for-water-policy-paper-v2.pdf) can be reported to the EA pollution hotline 0800 80 70 60.

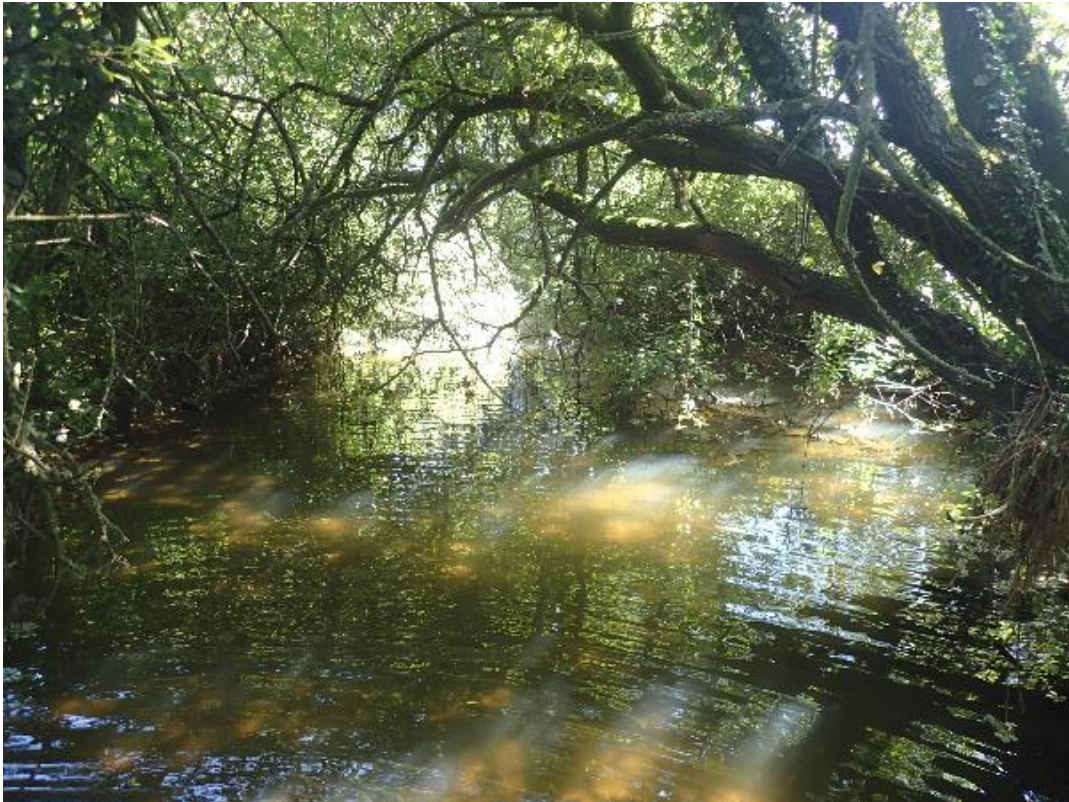
Photo 9: Quality shade over a pool, perfect for adult trout.

Downstream of the road bridge at Manor Farm, the river is diverse in habitat, with trees and scrub dominating providing good quality shade over pooled areas (photo 9); areas such as this are prime habitat for adult trout and should be conserved and replicated where possible elsewhere.

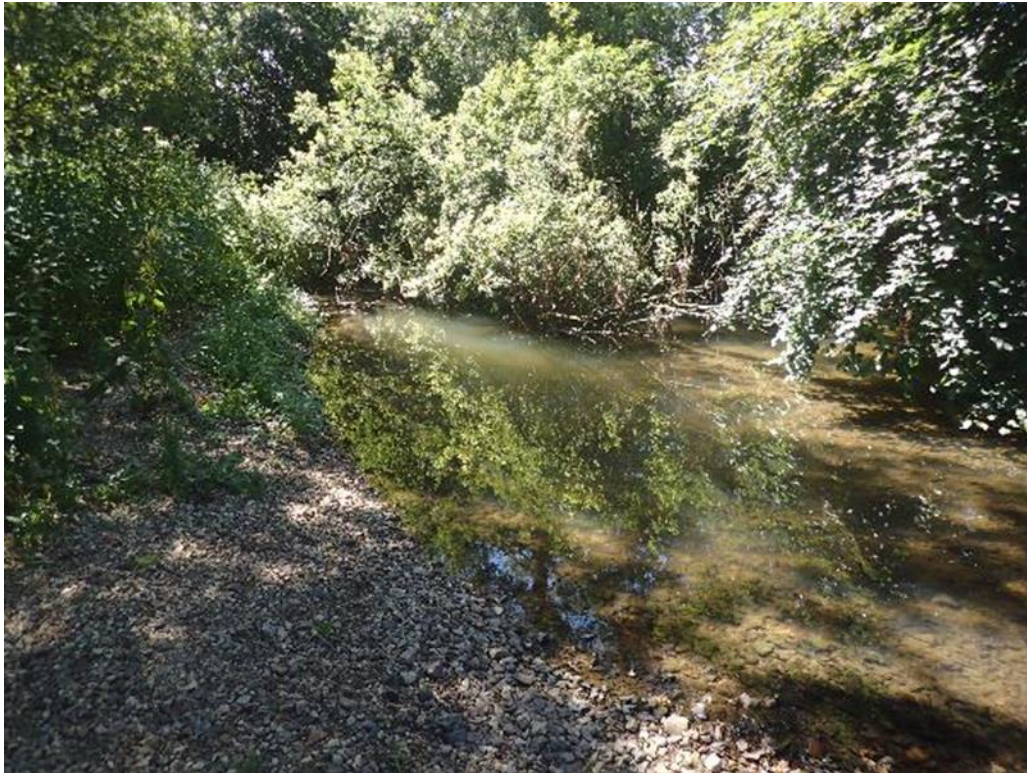
This area had many “gifts from nature” as in photo 10, where a goat willow has self-hinged into the river to provide good low cover, perfect for fish to avoid predators; such areas (photo 9 & 10) were some of the best habitat within the whole reach visited and the benign neglect that is employed as a management technique here should be continued and applauded.

Photo 10: Fantastic low willow cover from natural treefall.

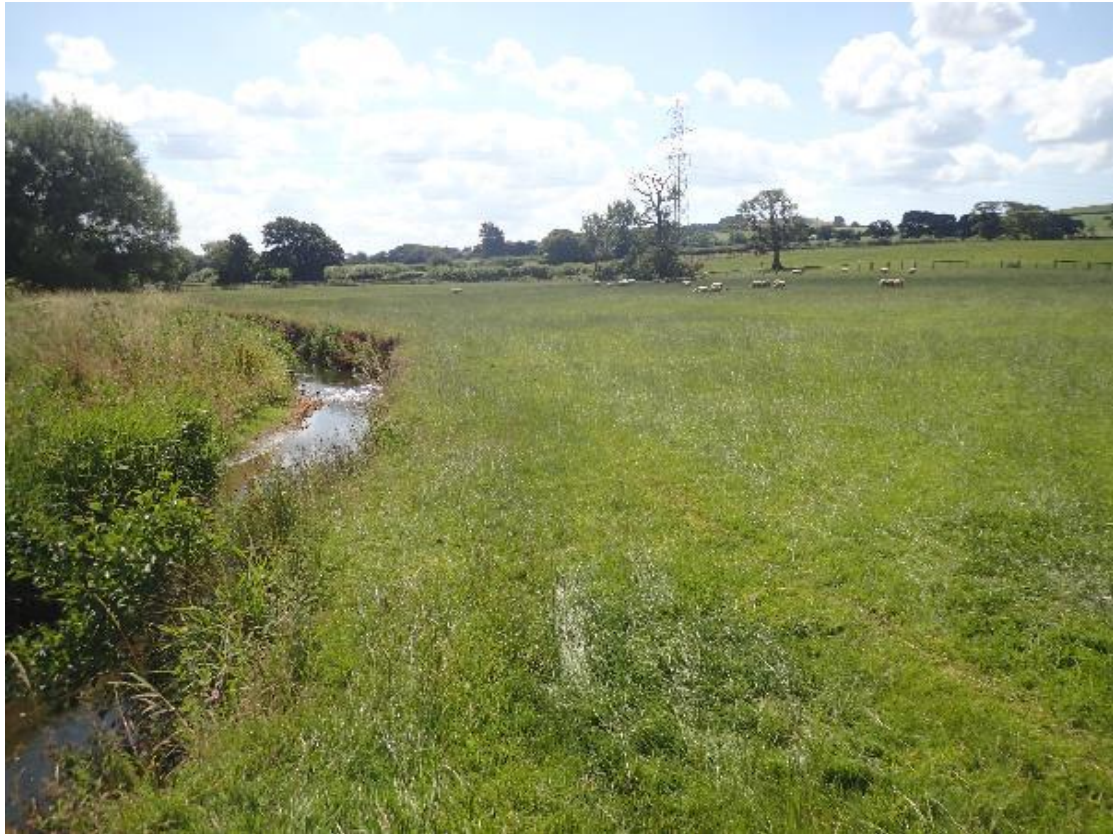
The land use is open grazing and hay cultivation, often with inadequate or no fencing, which leads to a biodiversity loss in the riparian habitats of the river, due to sheep and cattle grazing. A typical scenario is depicted in photo 11: livestock grazing to the edge of the river, leaving no room for plant and tree diversity. If a large buffer strip were established here, it would allow plants to flourish and in turn improve the resilience of the river.

Photo 11: A typical scenario on the upper reach, sheep grazed to the edge of the river with a lack of riparian trees and marginal plants.

- Engage with farmers in a proactive way, to attempt to co-exist without conflict, this could be applying for some fisheries improvement funding (FIP) to fence or reference sufficient buffer strips, including cattle drinking areas, which could benefit both parties. WTT can help here.

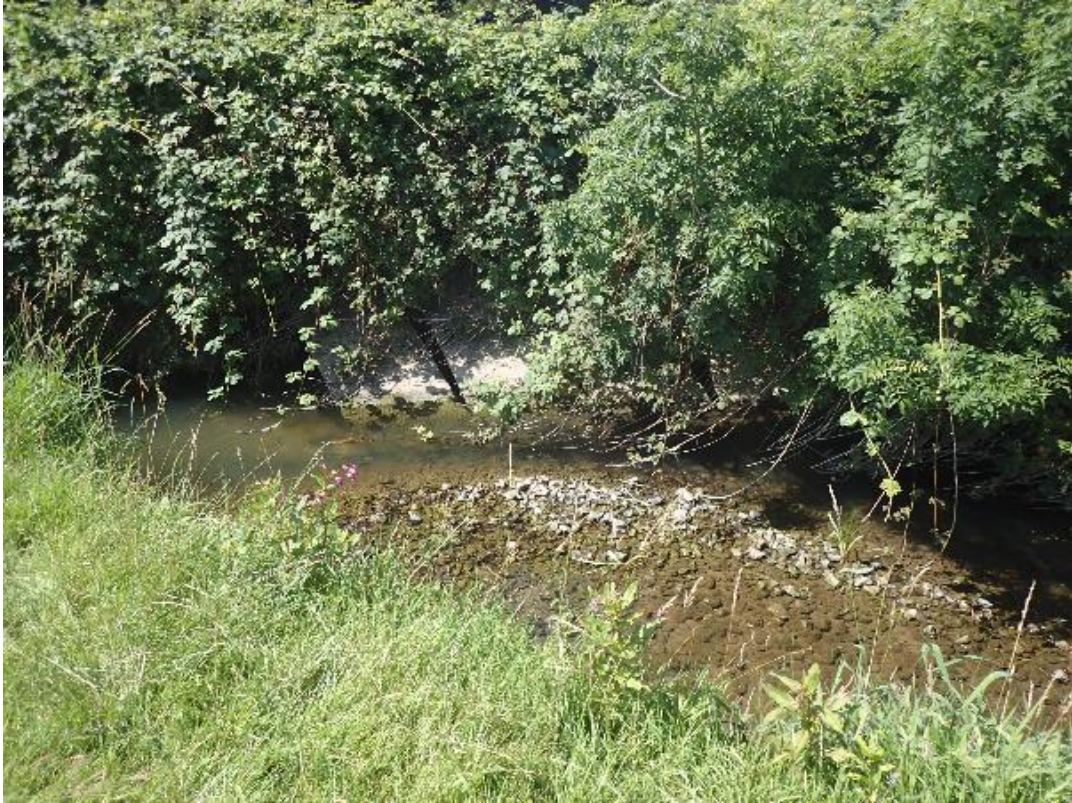
There was some evidence of unsustainable efforts by land managers to address what they see as problematical erosion (photo 12). The river here needs space within the floodplain to move around and attempts to constrain it within a small channel with little to no buffer strips are futile. With the start of farm cluster groups and new Environmental Land Management Schemes (ELMS), some improved practice may be attempted. Iorwerth Watkins yog@wrt.org.uk at Westcountry Rivers Trust may be able to help, through his involvement ELMS trials in the catchment.

Photo 12: Concrete dumped in the river in the vain attempt to reduce erosion! It simply deflects the river's energy downstream and will eventually fail leaving concrete in the river.

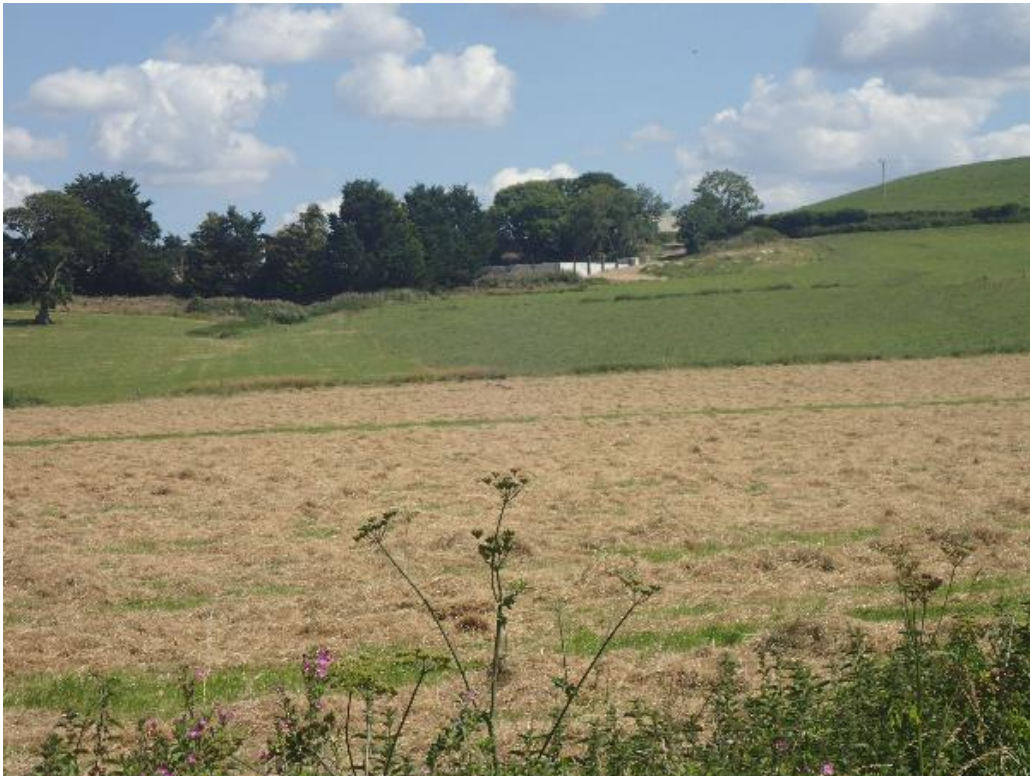
As noted earlier, the Axe suffers from catastrophic water quality issues, chronic and acute, with diffuse and point source pollution; the 2019 EA report highlighted some of these problems and the hope locally is that some of these issues are being addressed. However, AVRA members lack hope: slurry lagoons perched on the edge of the valley (photo 13) point to an accident waiting to happen!

Photo 13: A slurry lagoon on the edge of the valley, centre of shot; its failure would lead to environmental disaster.

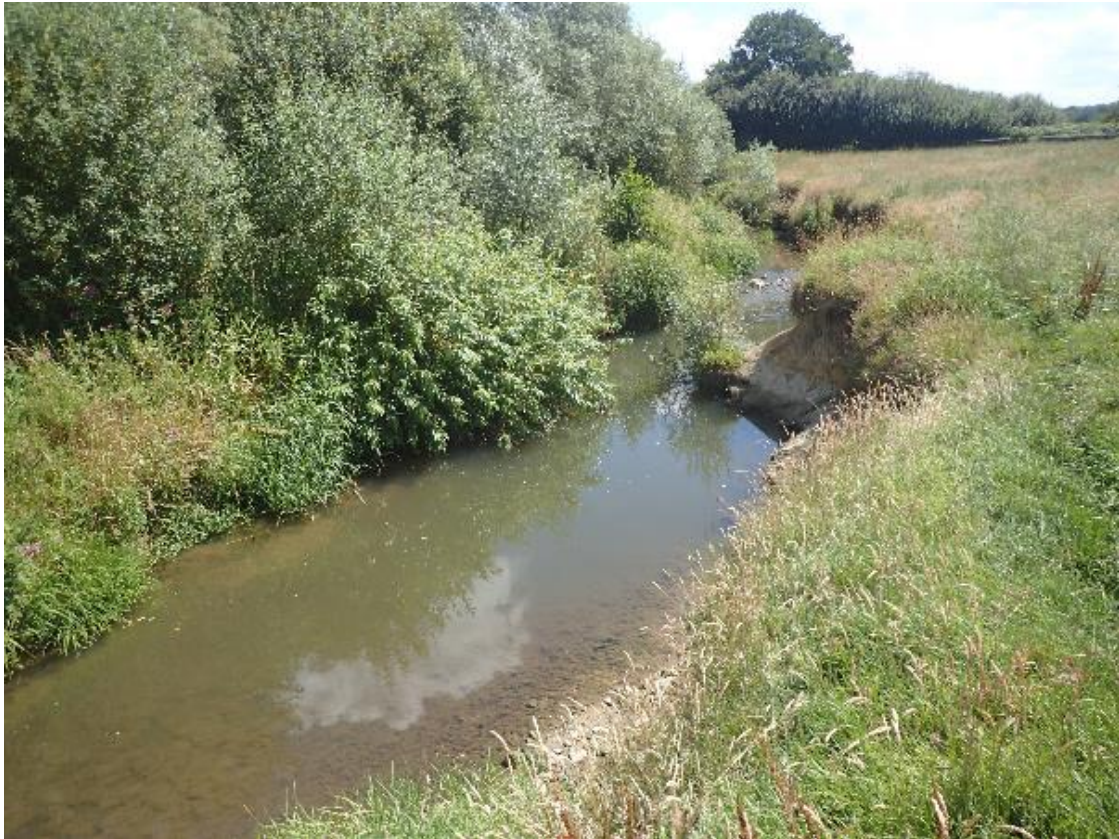
Photo 14 is a good example of a naturalised bank, diverse in plants providing lush overhanging vegetation for fish cover, especially over the pool. The area of concern yet again is the condition of the gravels, overlain with sediment and algae, likely to be a limiting factor for fish.

Photo 14: Where the LB has been left to naturalise, there is good plant diversity and pool formations, with quality low cover. Note again, however, the gravels covered in sediment and algae.

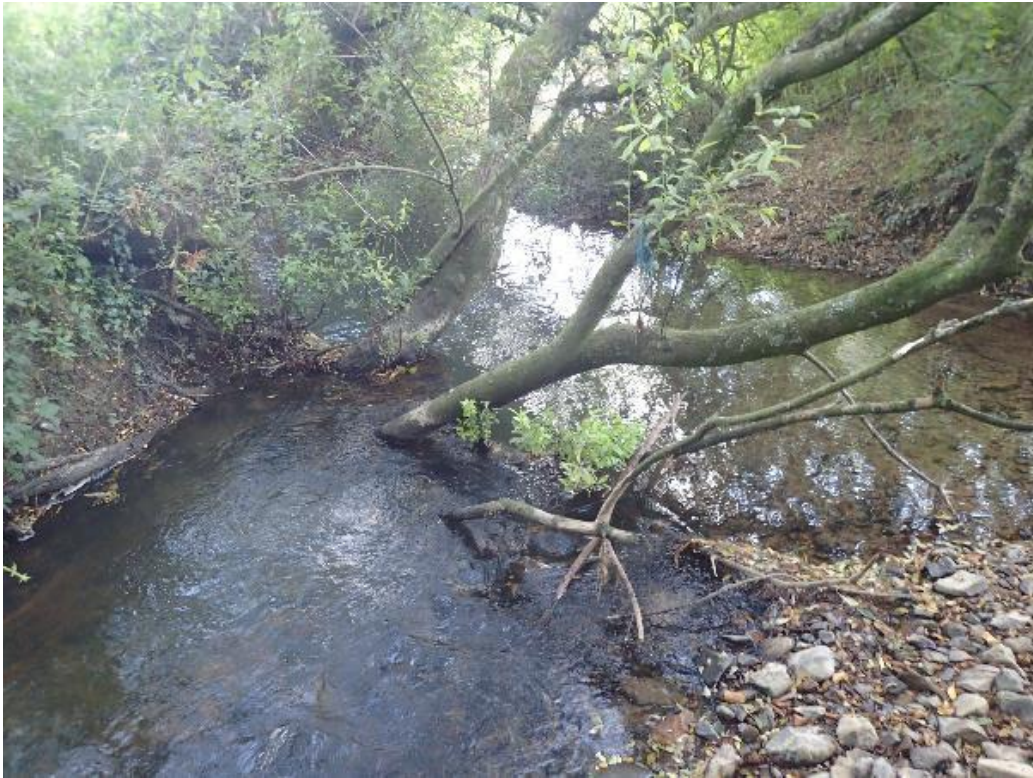
Natural wood features help kick start natural processes on rivers and without wood falling into them these processes can take a lot longer to happen. This is another reason to give the river space and provide buffer areas for natural tree regeneration. There were many examples of natural treefall (photo 15) which are providing additional habitat benefits; again, these areas should be encouraged through benign neglect.

Photo 15: Natural tree fall helping in diversifying habitat, no action required here.

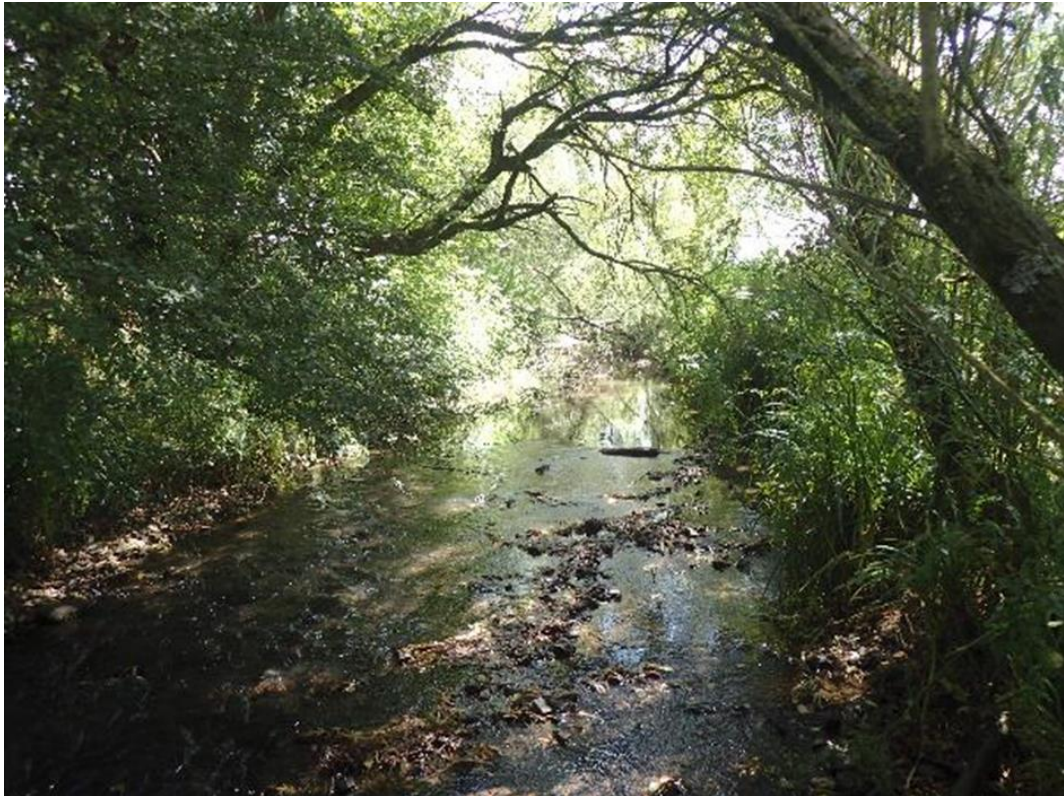
This upper section has some of the best tree cover on the whole reach, which is testament to buffer strips working, excluding agricultural practices to allow succession of woodland. This particular area could have some small-scale enhancement works where the right tree opportunities present themselves (photo 16 & 17). Depending on the scenario, this could be a hinged tree, tree kicker or a lodged woody material feature, bespoke to the situation. The willows right of shot on photo 16 could be hinged into the channel to kick start some natural processes, for example, as in photo 20 in the appendix.

Photo 16: A typical reach where there is tree cover on both banks which presents many opportunities for habitat enhancement using woody material.

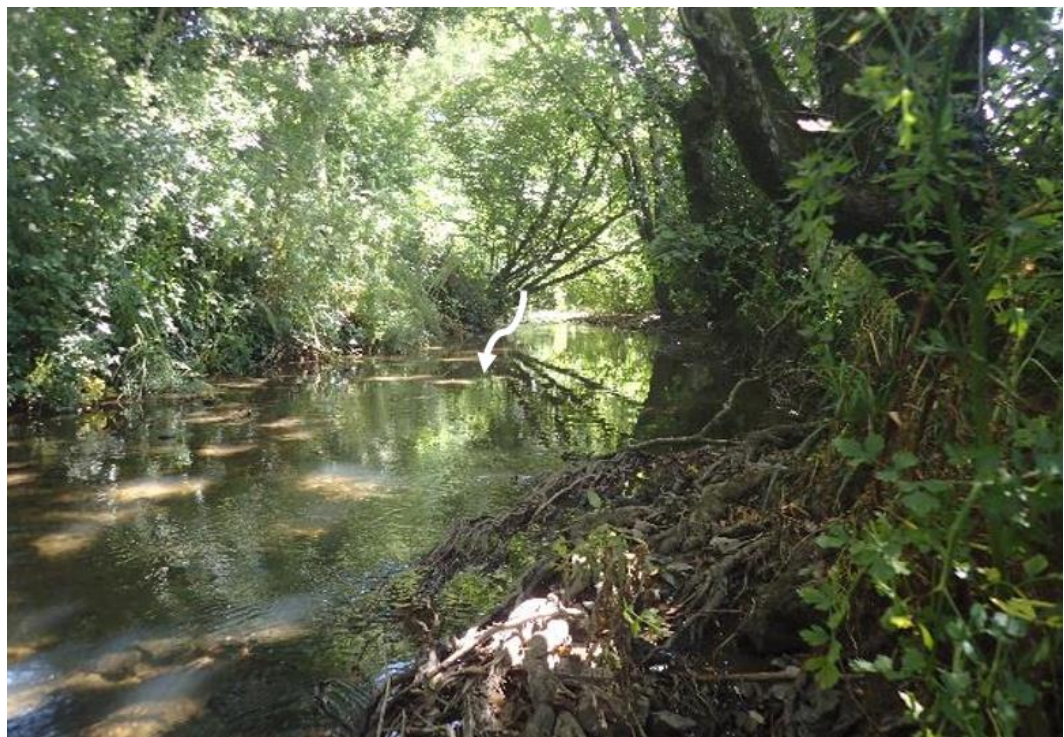
Photo 17: A lovely pool sequence with dappled shade; the trees top left of shot could be introduced to the channel to provide extra cover, denoted by white arrow

The area in photo 17 could be enhanced through the use of woody material, in the form of the trees dropped into the channel demonstrated with the white arrow, this will provide additional cover for fish and diversify the riverbed to scour and clean gravels.

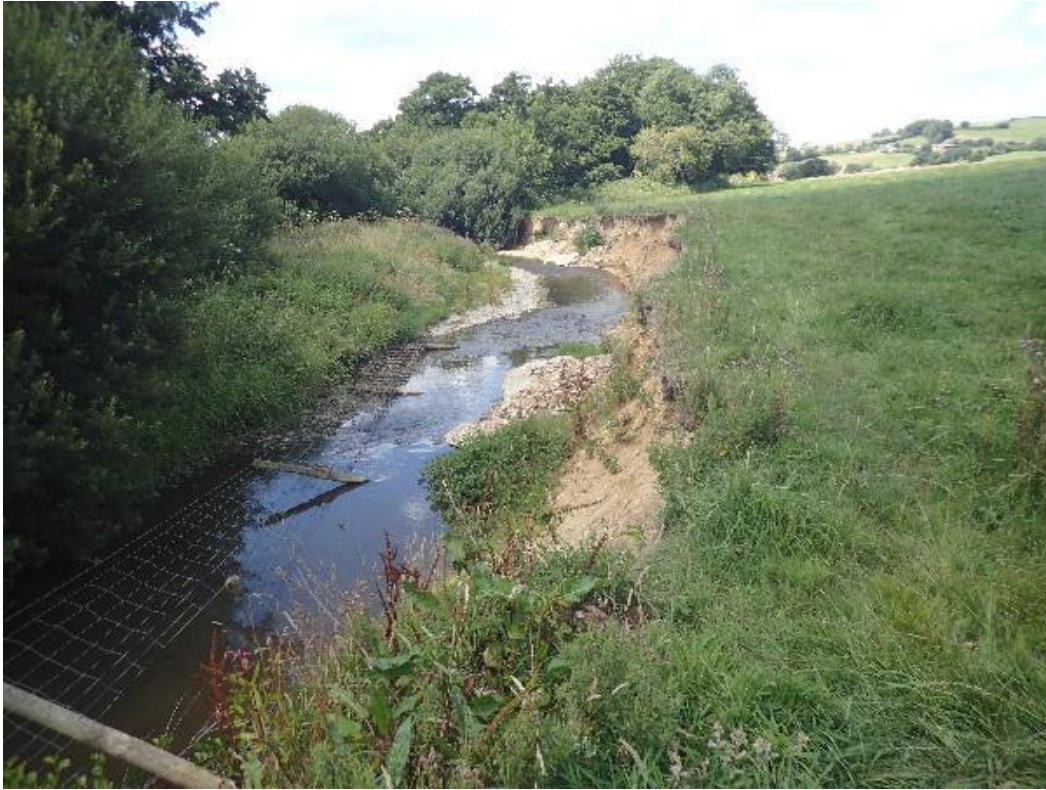
Where buffer strips are inadequate, and fences are placed too close to the river, conflict normally arises as the river is seen as the problem. In photo 18, the fence was placed too close to the river, allowing inadequate space for the river to move around and tree succession within a buffer strip to help slow the erosion process and tie the bank together with roots.

Photo 18: Insufficient buffer, erosion has taken place before the bank has stabilised or been strengthened through tree roots. Fences should be set well back from the river, 5 metres at a minimum.
