WILD TROUT TRUST

Advisory Walkover, Nov 2023

Snaizeholme Beck: [GB104027069350](https://www.gov.uk/landranger/view/GB104027069350)

Prof J Grey (jgrey@wildtrout.org)

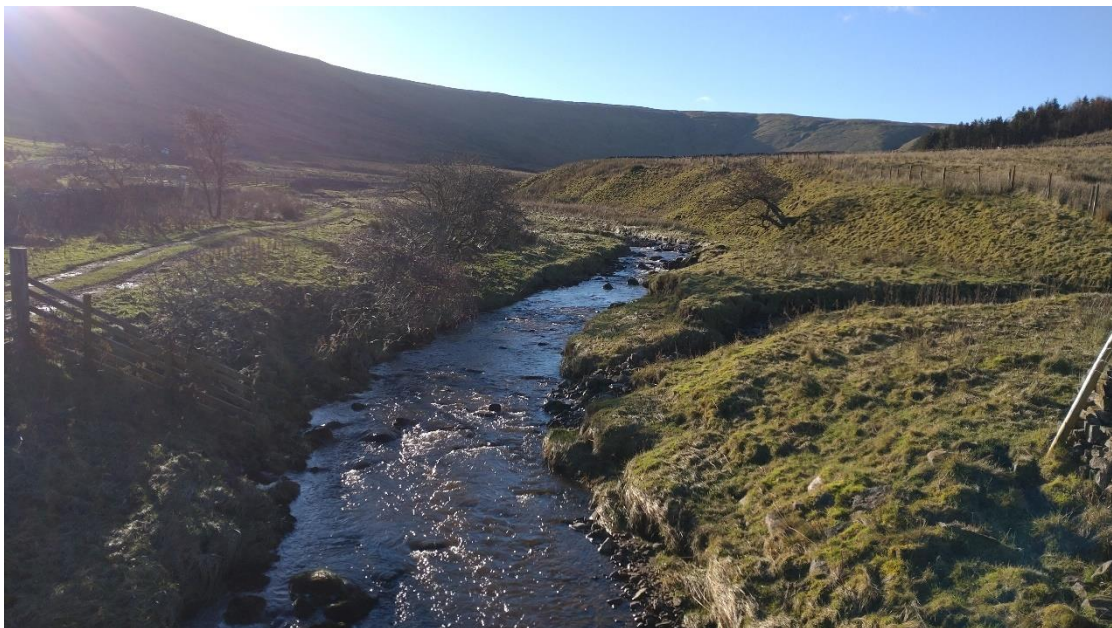
The walkover started towards the d/s limit of the Woodland Trust site on the packhorse bridge at a pinchpoint where the channel was naturally constrained within the valley (Fig 1). Immediately u/s on the eastern side (RB), a track ran parallel to the channel, and appeared to have been formalised historically using dredged material; the channel was probably also straightened at the time given the position of the wall to the east (See Fig 2). For the first 50m or so from the packhorse bridge, this was probably sufficiently far removed from the channel (in terms of height) but it was clear from Fig 2 satellite imagery that the channel had begun to meander to the east over time, and the track had probably been adjusted to accommodate it (note gap in the wall running N-S opposite the deposition bar; Fig 2). A return to a more sinuous and dynamic course should be aspired to as it will increase the channel length, reduce the gradient, create a more diverse habitat mosaic instream and revert to a more natural riparian flora.

Fig 1. Looking u/s from the starting point of the walkover at SD 82887 85842. A natural pinchpoint in the valley was an obvious site for an old packhorse bridge.

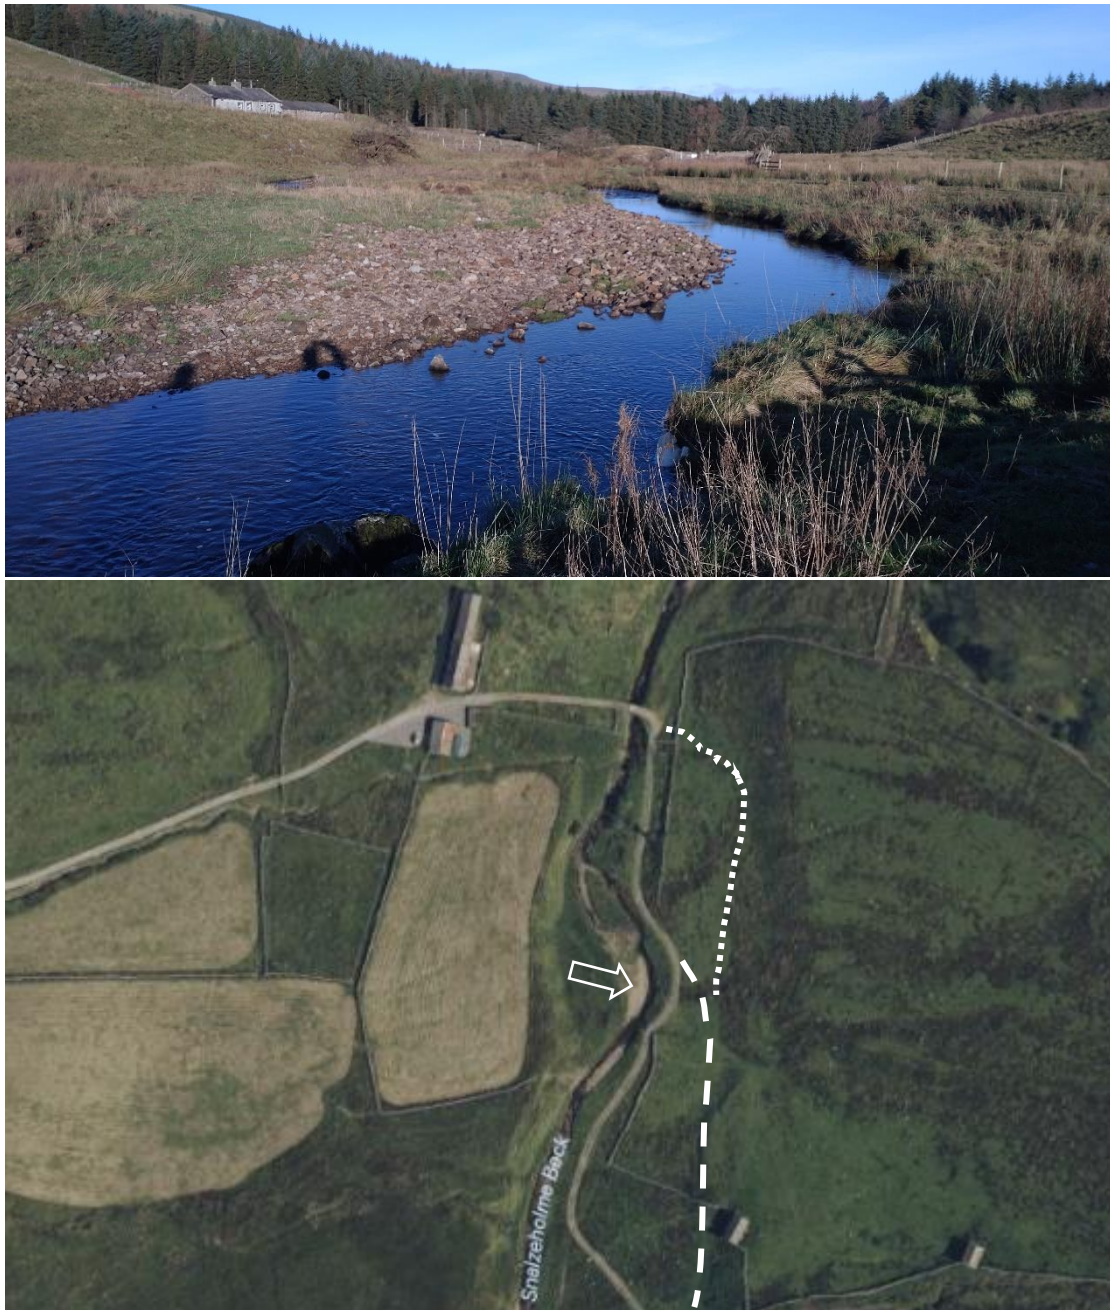
One section of the track had recently been directed by WT away from the channel to service a refurbished barn (dashed line; Fig 2) providing an opportunity to curtail any further use of the 'old' track near to the channel. A further opportunity to consider is the viability of removing even more of the constraint of the track along the channel by rerouting it along a postulated dotted route from closer to the packhorse bridge (Fig2).

Fig 2. An unconsolidated deposition bar of boulder, cobble and gravel points to the dynamic nature of the channel here, highlighted by the white arrow in the satellite image. Historically, a track was formalised using material from the riverbed, running close and parallel to the channel on the RB and the channel straightened. A new track to the barn has been laid further away (indicated by the dashed line), but it is worth considering whether it could be moved even further (eg on the dotted trajectory from the bridge), allowing for renaturalisation of the riparian zone. NB flow direction: south to north.

The unconsolidated deposition bars of rock, cobble & gravel hint at the dynamic nature of the channel at this location – loosening any obvious boulder revetment put in place to protect the old track will rekindle the true spatial and temporal dynamism of the channel once more. Similarly, the LB of another straightened reach just u/s (labelled 2 in Fig 3) should be examined for any obvious boulder armouring and returned, dispersed within the channel, if found.

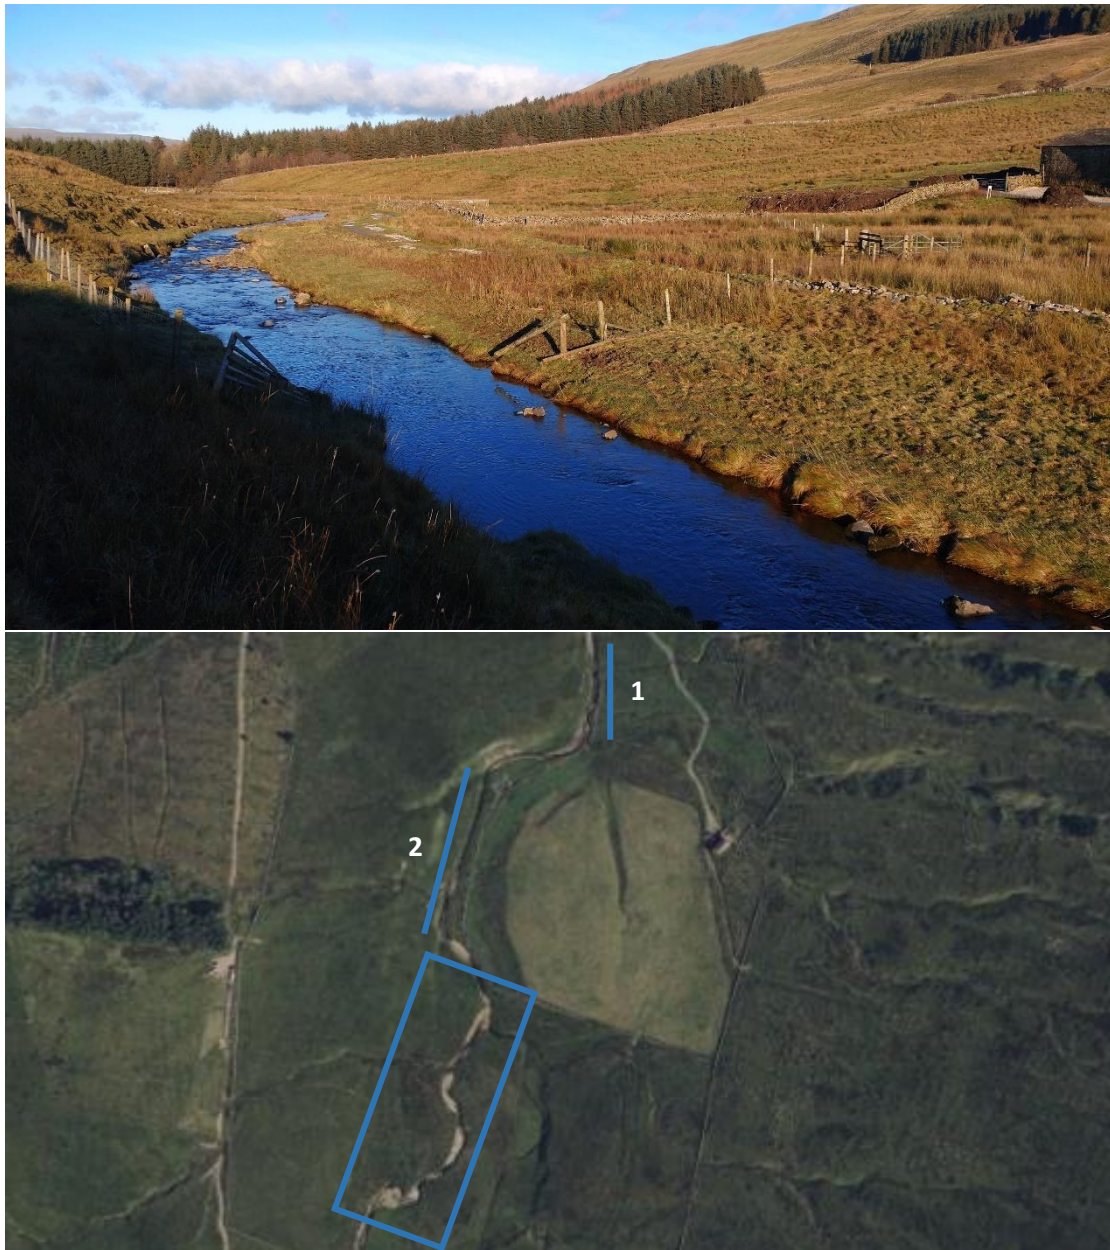
Fig 3. Looking d/s at the tail end of a straightened reach (labelled 2 in the satellite image). That labelled 1 is the u/s extent of the straightened reach in Fig 2. The channel is trapezoidal in cross-section within each reach and relatively featureless because of the historical modification. The channel highlighted within the blue rectangle appeared more natural with sinuous meanders and is discussed in Figs 4-5. NB flow direction: south to north.

It should be noted that straightening of the channel both d/s (Fig 3) and u/s (eg Fig 8) of the boggy area would exacerbate the incision of the extant channel by increasing conveyance. Indeed, historic land management practices across the whole of the upper catchment coupled with increased frequency and duration of rainfall events in recent decades would all contribute. The wider aspirations of slowing the flow across the entire site need realising to aid recovery.

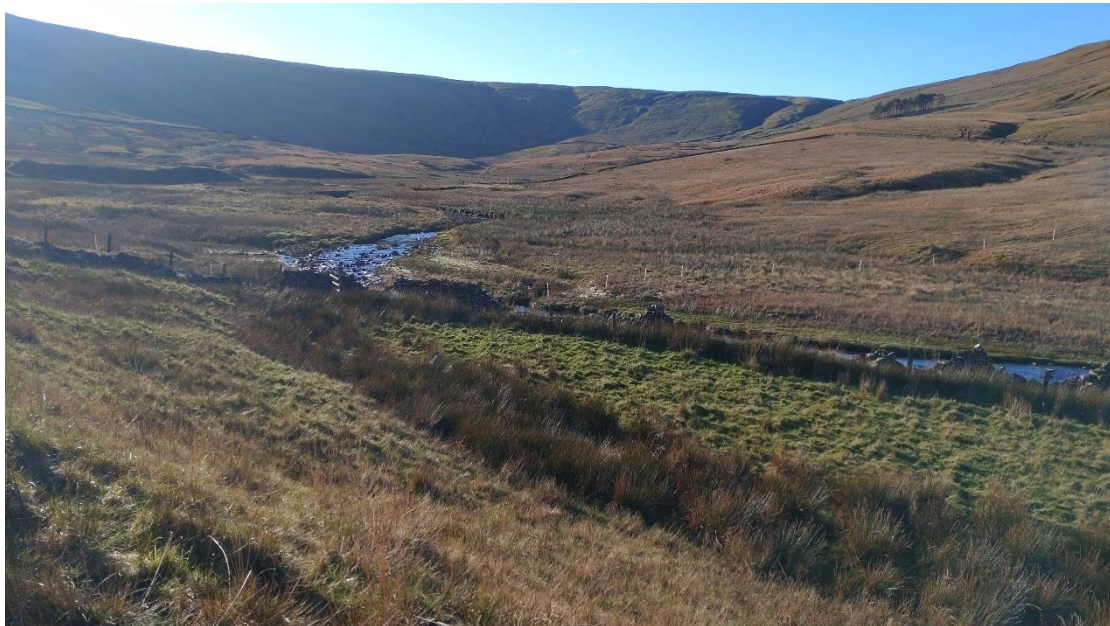
The area with greatest potential for restoration appeared to be that highlighted by the rectangle in Fig 3 and exemplified in Figs 4-5. The gradient was low (Fig 4) and the depth of the fine peaty soil above any coarser alluvial substrate evident in the incised reach (Fig 5) suggest it was a depositional zone (either bog or shallow lake) for a considerable period in the past. [LIDAR data](#) point to an even more sinuous and hence longer course with several paleochannels to the east of the extant channel (Fig 6). Hence, one might speculate that the extant channel may have originally been a drain run straight through the centre of the boggy area relatively recently to increase

Fig 4. Looking u/s from afar at the low gradient and relatively broad floodplain of the meandering section highlighted in Fig 3.

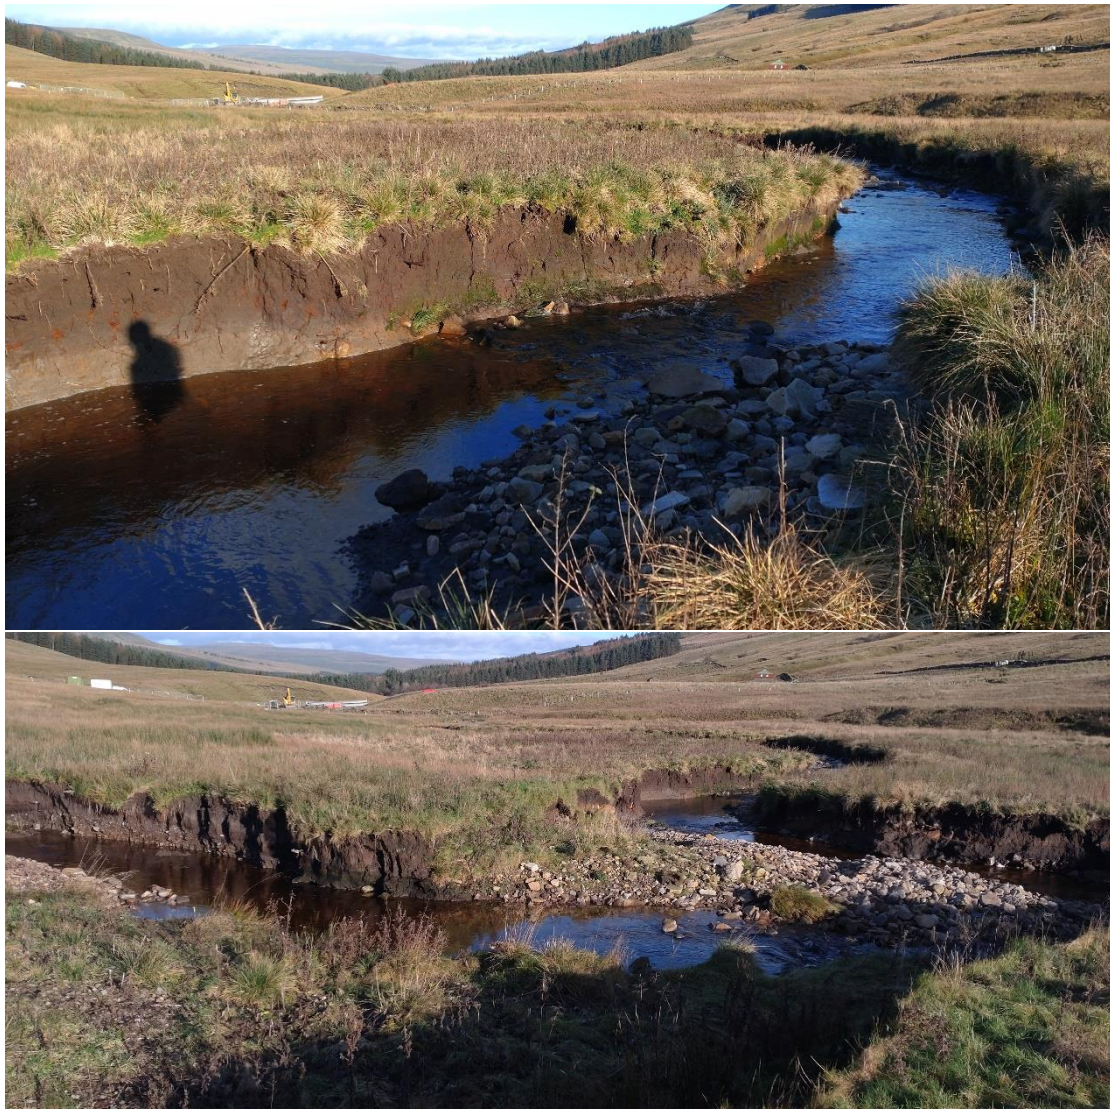
viability for pasture. Current Ordnance Survey mapping of the area indicates the main flow path as being that of the paleochannel, not the extant channel also suggesting the change has been recent. The incised nature would tend to support the supposition of a drain, and the meanders and narrow point bars observed could be indicative of the channel beginning to recover. Given the overgrazing of the banks that occurred prior to WT ownership and lack of root matrices in the highly erodible soil, those nascent meanders would have developed at an accelerated rate.

Fig 5. Meanders within the section highlighted from Fig 3. The channel was highly incised, probably resulting in part from the straightening of the channel reaches downstream accelerating flow velocity and increasing erosive power within an area which was clearly more depositional in the past (based upon the fine soils above the coarser alluvium). More frequent and intense rainfall events in recent decades, and historic land management practices of drainage and grazing resulting in a lack of tree cover, will have undoubtedly contributed.

In terms of rehabilitation, returning the flow to the paleochannel to the east would be a major coup, almost doubling the channel length from 180 to 350m. This could be achieved by identifying the exact location where the extant and paleochannel diverge to determine as suspected if the paleochannel was deliberately blocked. Windblown trees including root plates could be packed into the u/s end of the extant channel as well as any rock and cobble from the (re)opening of the paleochannel to divert and encourage flow to return – see Recommendations. Windblown trees could also be used to introduce sinuosity within the straightened reach of the paleochannel.

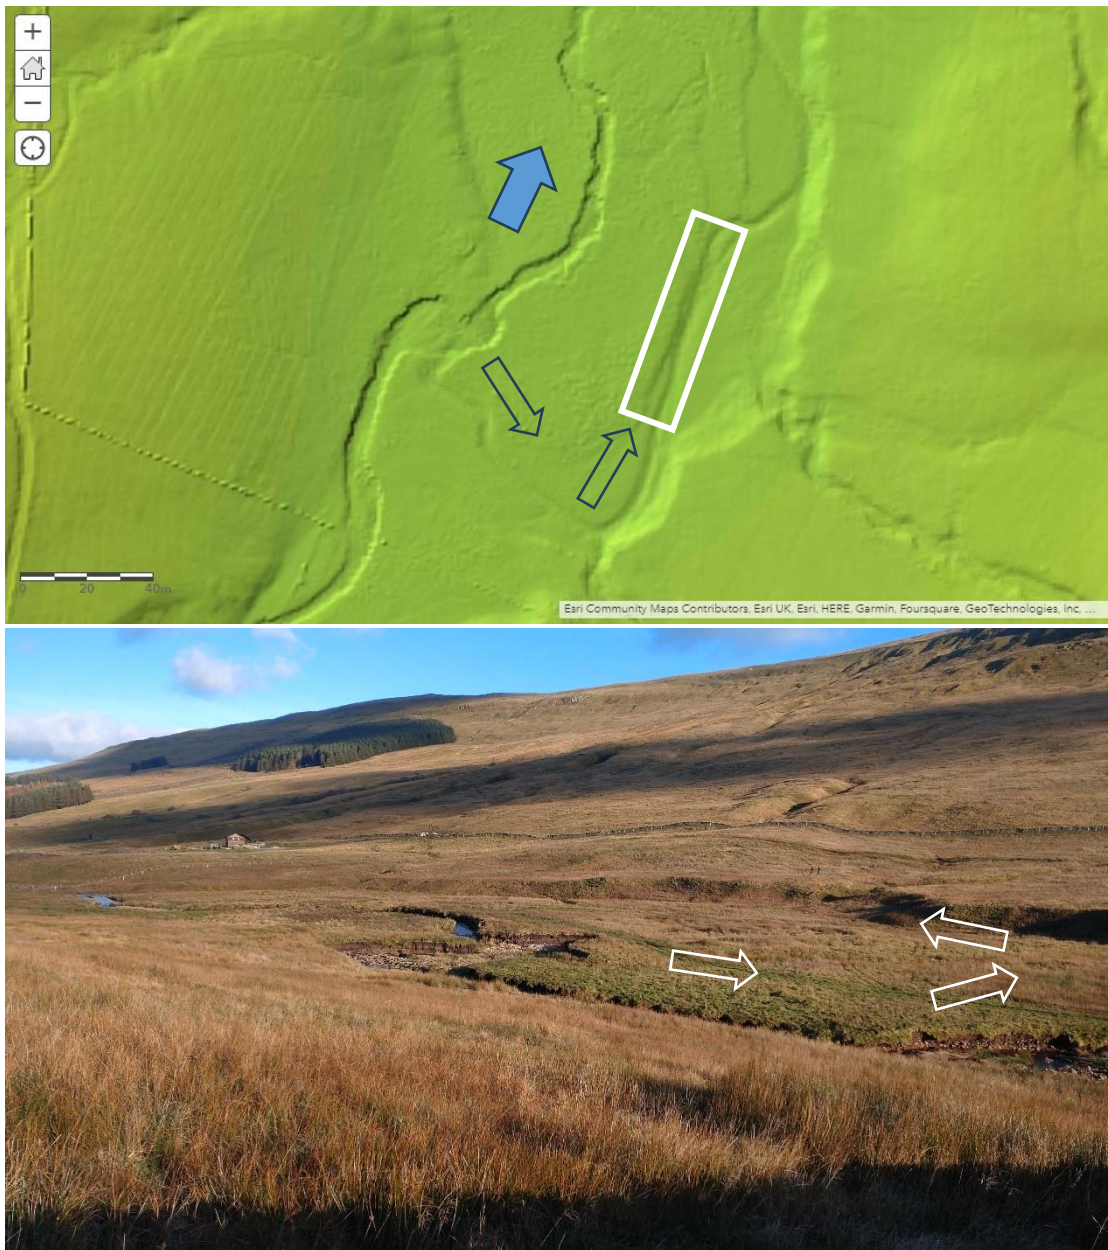
Fig 6. Upper - examination of the area using the 2022 1m LIDAR derived Last Return Digital Surface Model Composite produced by the Environment Agency, suggests that the extant channel is much straighter, shorter and incised (blue arrow) than one of the more recent paleochannels which almost doubled-back on itself and flowed more to the eastern edge of the valley. However, even the paleochannel appears to have been straightened at some point (white rectangle). Lower - photo taken from SW side of the extant channel with white arrows to indicate the former, longer path across this depositional area.

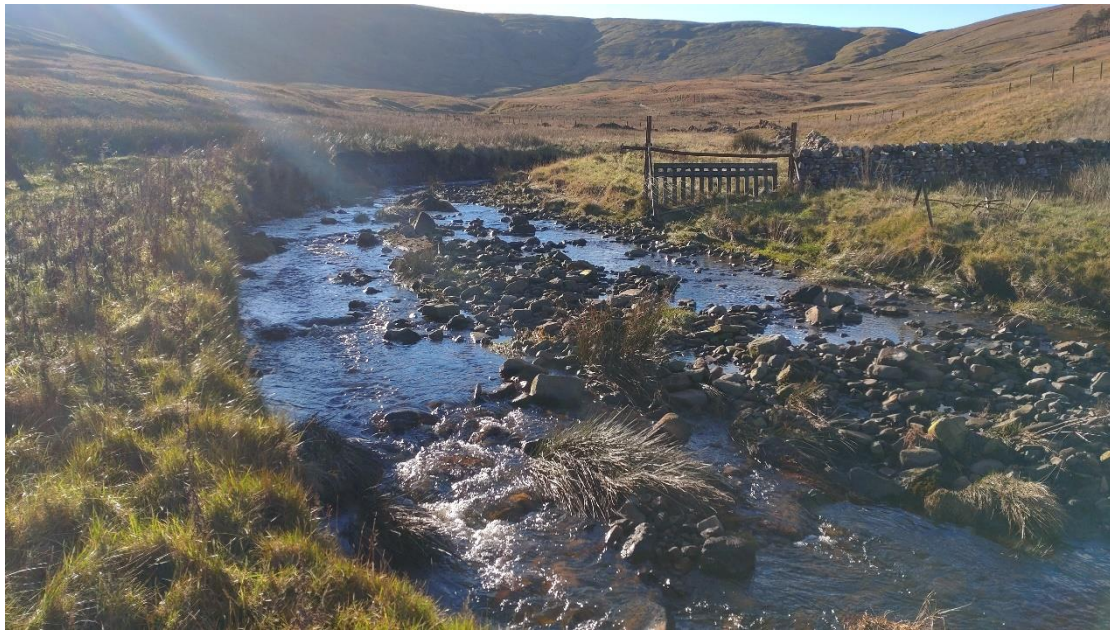
Further south and up the valley, at SD 82665 85109, there was more evidence of channel modification to cater for an old field boundary and watergate (although that was no longer evident; Fig 7). Spate flows had consumed and rearranged much of the stone material and the channel was diversifying nicely by braiding around several deposition bars. Whilst the physical recovery of the channel was good to see, such wide and shallow areas would be extremely susceptible to warming in summer, so it will be vital to consider riparian tree cover wherever possible to mitigate for climate change.

Fig 7. At SD 82665 85109, there were signs of modification to the channel to accommodate a cross-valley boundary; larger boulders and remains of watergates within the channel which were now diversifying flow by braiding around multiple small deposition bars.

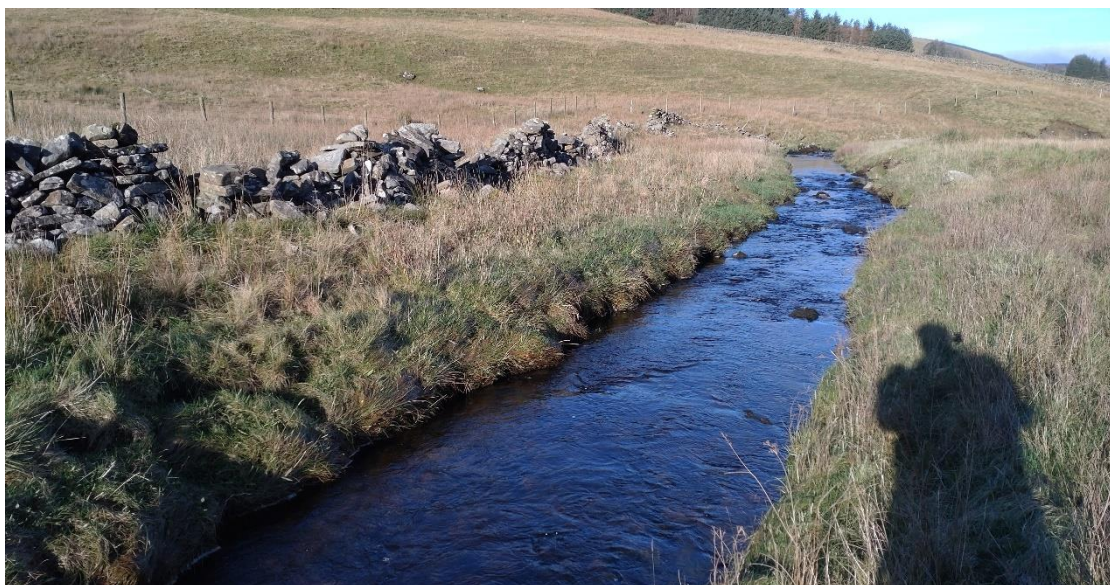
Fig 8. At SD 82621 85021, another suspiciously straight reach of beck running parallel to drystone walling on the LB and with some evidence of large boulders within the RB. Again, the straighter reaches lacked physical diversity in cross-section and bed form, reducing the variety of habitat niches.

Further straightened sections of channel were evident u/s (Figs 8-10) typically associated with old drystone wall boundaries. It is most likely that the channel was straightened and armoured with boulders to each bank first to prevent it from wandering, and then the drystone walls erected adjacent and parallel afterward. Unsurprisingly, because of increased conveyance, there was evidence of exacerbated erosion at the d/s extent of all the straightened reaches. Historic shackling of the channel into a straighter course should be unpicked.

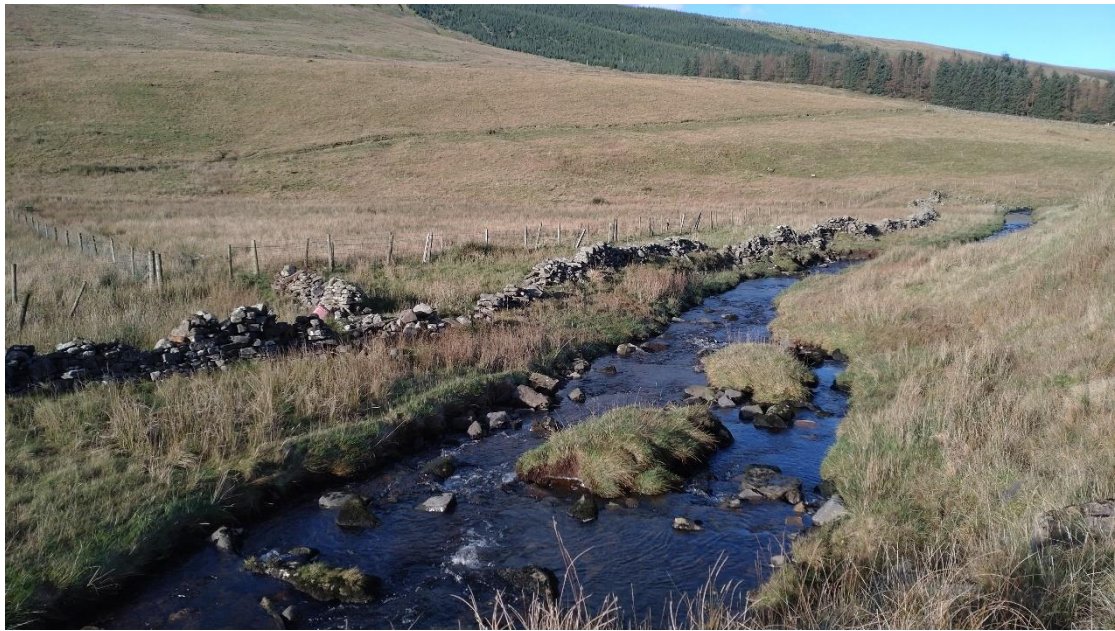
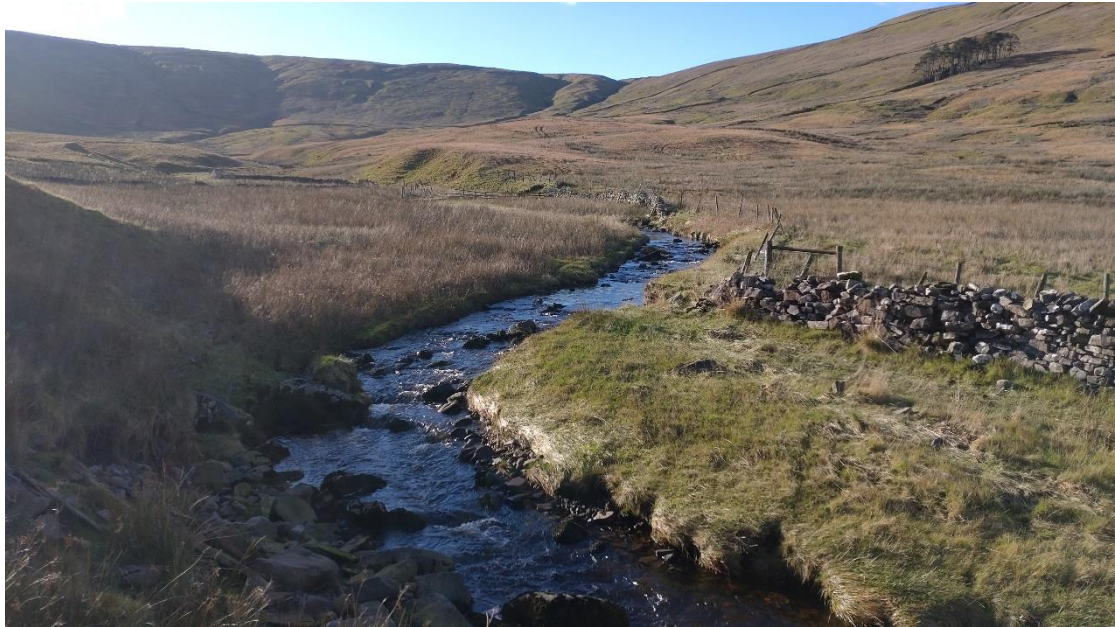
Fig 9. U/s of the reach in Fig 8, the amount of large boulder material to the RB was more notable on the outside of a bend and it appeared that historic boulder armouring may have been breached – the ‘islands’ in the upper image – as the channel has started to renaturalise.

In several locations, old walling boundaries had been replaced with fencing (Figs 9 & 10). These were generally where the channel had migrated and undermined the wall, and the cheaper fencing was substituted as close as possible to the channel. Such action generally proves to be a false economy as it restricts the space available for livestock to move between the channel and the fence, thereby focussing trampling and grazing pressures to weaken the bank and make it more susceptible to erosion and further land loss. If fencing or walling is still required under the new management regime, then

Any boulder material used for armouring could be redistributed within the channel; for example, placed in low piles alternately to either bank to encourage sinuosity. Addition of some windblown trees with root plates would also accentuate physical diversity as well as introduce submerged cover, given the lack of riparian cover at present.

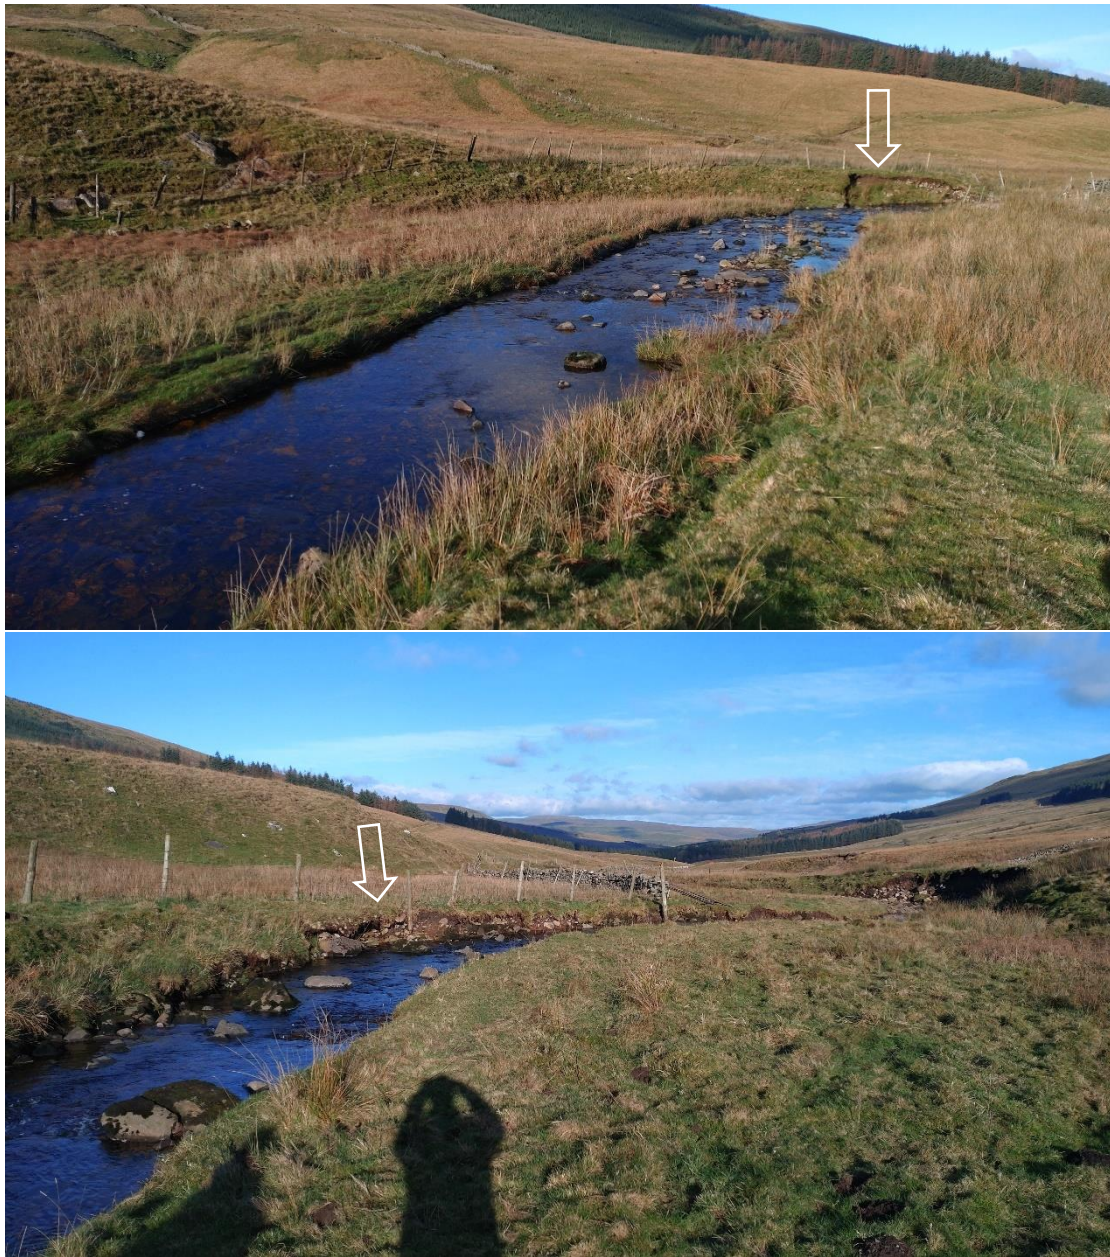
The erosion caused by the historic straightening should not be cause for concern. Indeed, erosion and subsequent deposition of material is a component of hydrogeomorphology sorely missing from many of the Dales’ rivers as it is the source and supply of vital gravel often locked-up behind armament or trapped u/s of weirs.

Fig 10. Two examples of nascent erosion to the LB, in part natural because each was the outside of the bend and hence where flow was fastest, but also likely exacerbated unnaturally by straightening u/s, and the proximity of fencing which has focussed stock trampling and grazing at the bank top and hence weakened the integrity of the soils. It would be ideal to simply remove or adequately set back the fencing (off the floodplain) and allow the erosion to proceed.

it is advisable to site it well back from the channel and any potential (re)meander zones. One aspiration discussed was to manage the valley 'floor' via conservation grazing using appropriate hardy breeds of cattle. Care will be needed to monitor the level of grazing and poaching disturbance, especially on the wetter slopes. For example, in the upper panel of Fig 11, erosion scars of bare earth were visible on the RB. These are typically caused by livestock traversing the slope and plucking off any new growth trying to establish. Without livestock disturbance, over time the slope would adjust to a stable angle of repose aided by the colonisation and rooting of plants.

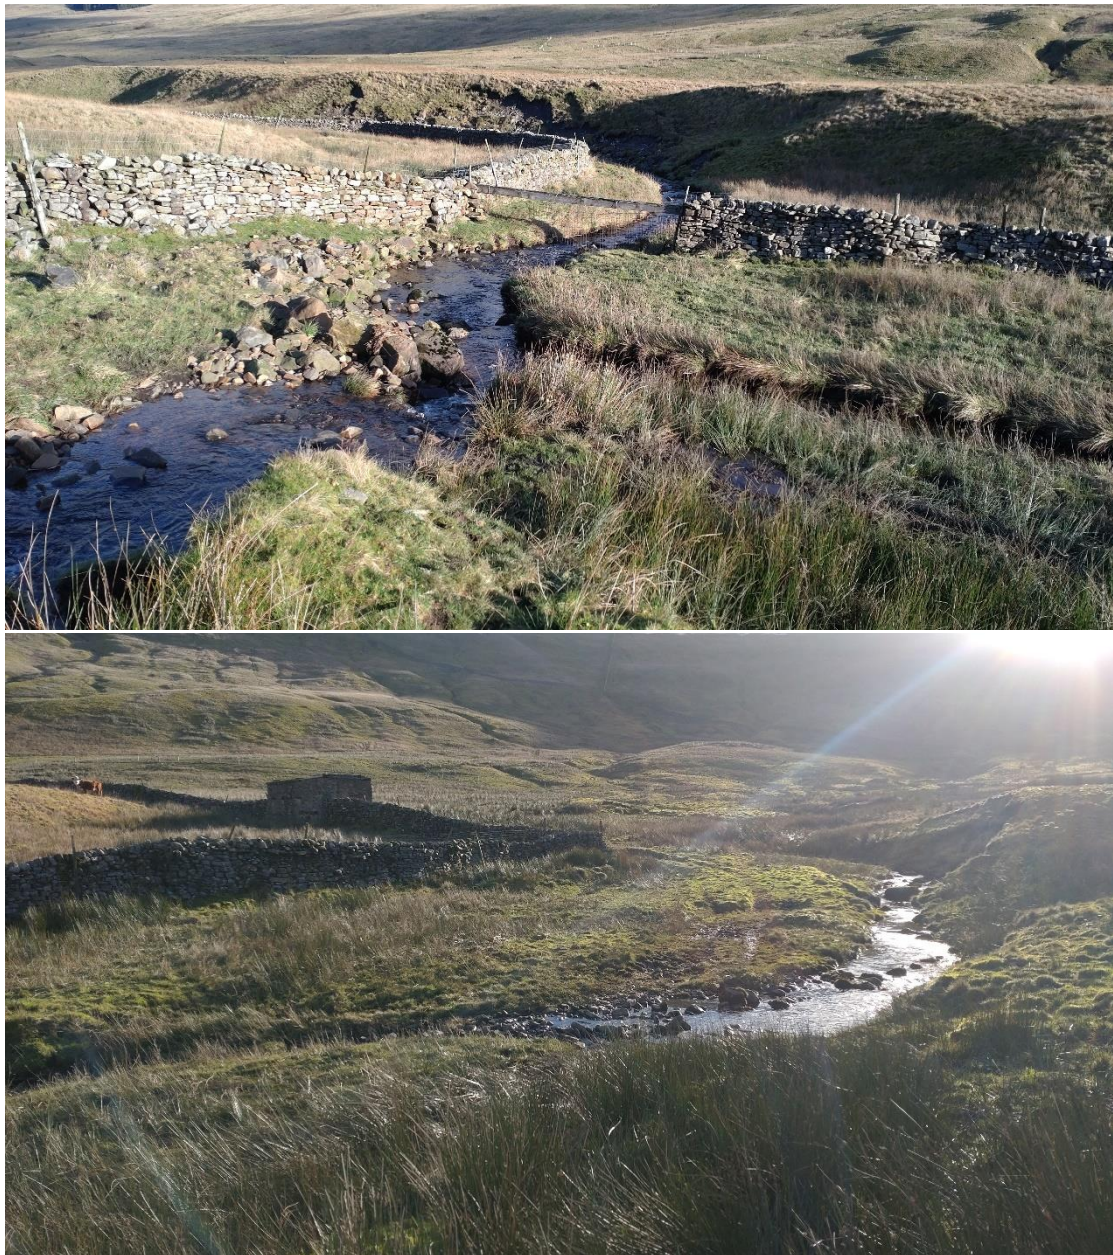
Fig 11. Upper - at SD 82380 84477, the confluence of the two main tributaries, and lower - looking u/s on Grove Sike which was the smaller. From here, the characteristics changed markedly reflecting the geology and gradient. Ideally, the proposed stock management for conservation type grazing should be arranged so that there is no need for watergates across channels which always require ongoing maintenance.

Upstream of SD 82380 84477, the confluence of the two main tributaries towards the head of the valley (Fig 11), the channels appeared less modified. Indeed, because of the changing gradient and more frequent interaction with seams and slabs of the underlying geology, the habitat became dominated by pool-cascade features (Fig 12), although it should be noted that Grove Sike (not walked; Fig 11) was of slightly shallower gradient for further.

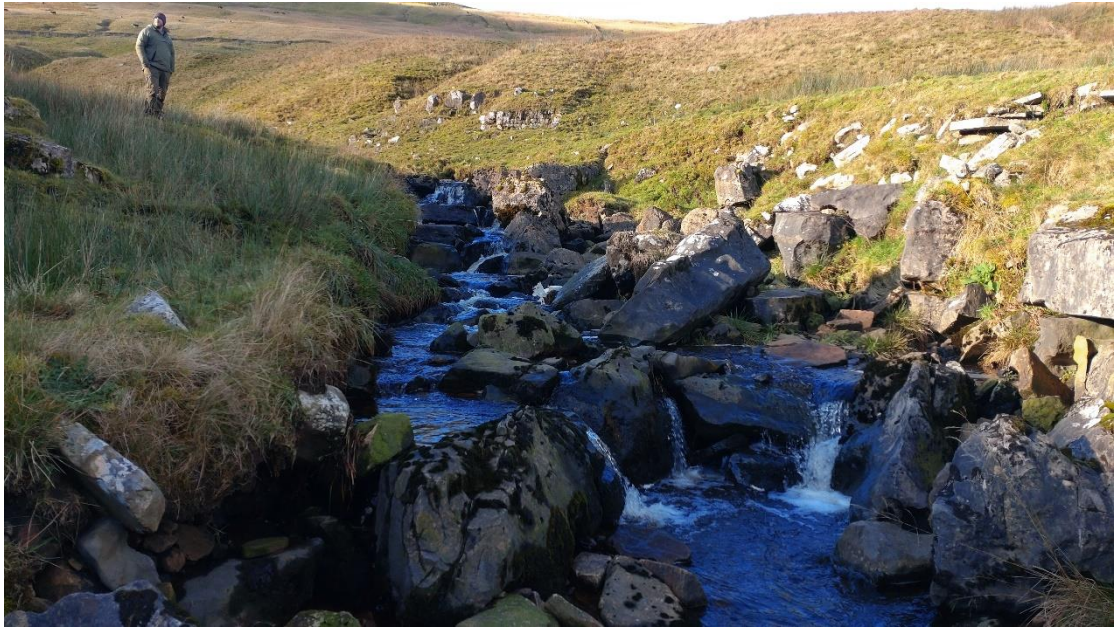
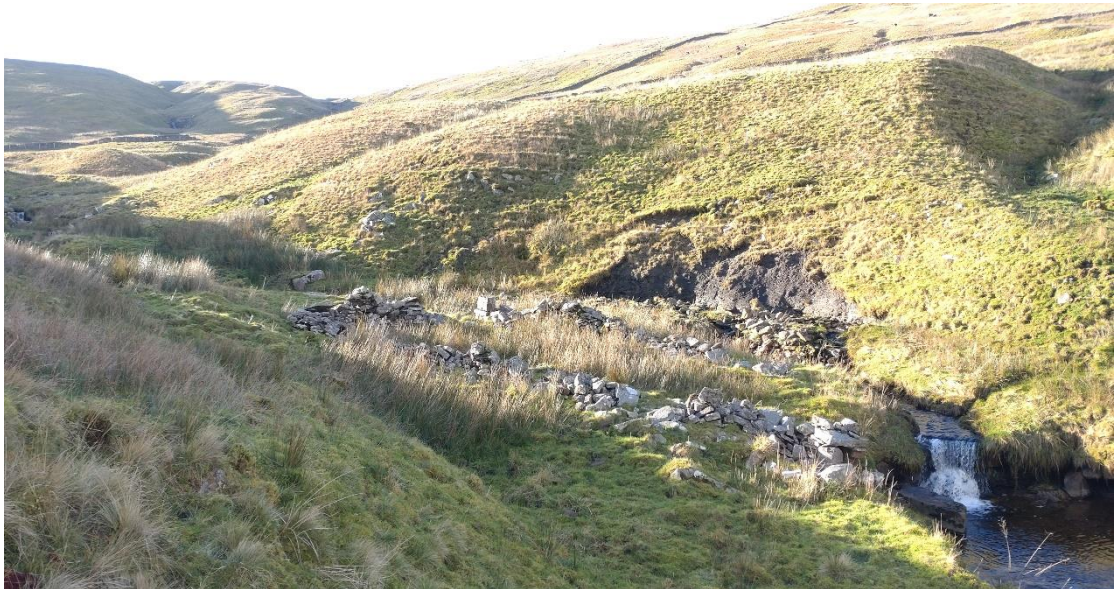
Some of the cascades, such as those falling directly onto further seams of bedrock, would prove challenging to fish passage because of the lack of depth of water from which to leap. Yet, often, the pools in between such cascades contain trout because they are relatively deep and secure lies. So whilst u/s movement may be greatly restricted for much of the year, there may still be components of the trout population(s) eking out an existence in seemingly inaccessible locations. Only an electric fishing survey will reveal the limits of distribution which would be useful to establish a baseline, certainly before any proposed NFM work is carried out that might be detrimental to ecology.

Fig 12. The uppermost reach of the walkover on North Scar Gill, within 200m of the confluence (Fig 11) and probably towards the upper limit for fish. The channel was much steeper and exhibited pool-cascade characteristics over large boulders or seams of underlying bedrock. Whilst naturally challenging for fish passage, the availability of focal flow paths between the rocks, and deeper pools in between, should allow some trout to access and reside at this point.

The sides of the gills and sikes were naturally steeper and would lend themselves to the establishment of shrub cover which would help to bind the soils and provide further shade and leaf litter subsidy for the channels. The grass in the riparian zone here appeared even shorter with fewer rushes than d/s and hence provided even less respite from the sun. All the exposed boulders within the channel would warm rapidly in summer, conducting heat to the water, and highlighting the importance of a functional riparian flora to help keep the water cool as well as slow the flow via hydraulic roughness. Every opportunity should be taken to augment cover with tree planting in the gills and on steeper slopes.

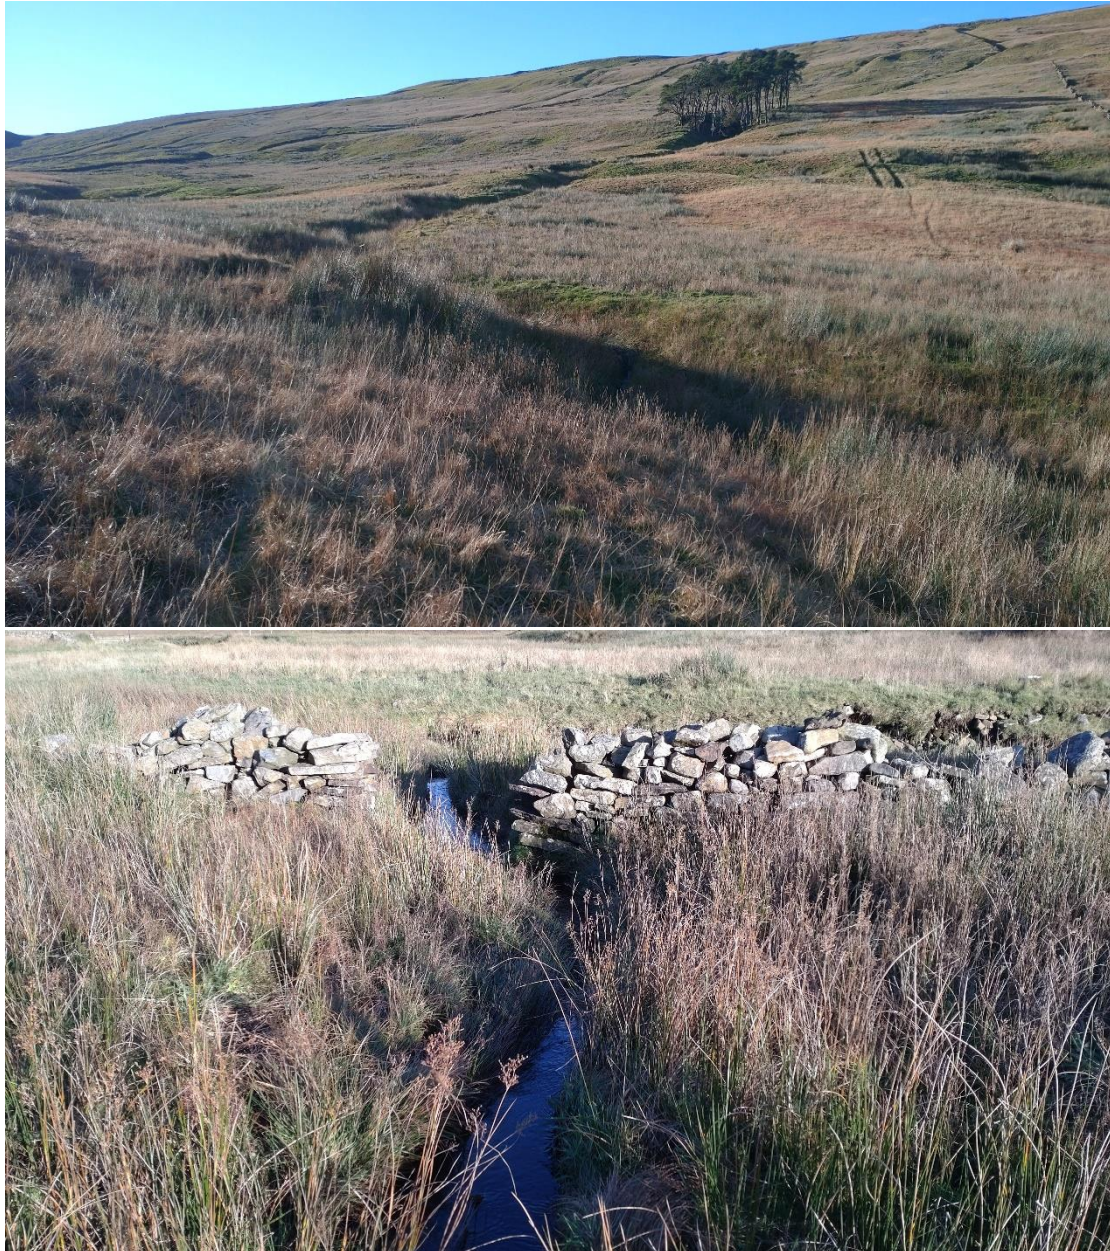
Many of the watercourses were small and some were undoubtedly ephemeral, but these take on a disproportionate ecological importance relative to their size; the capillaries of the arterial network. The few that were examined in brief were generally well vegetated relative to their width (refuge from / reduction of spate flow, full sun, and predation) and contained clean gravel of appropriate size for spawning trout (Fig 13). Hence, compared to the main channel, they may be much safer nurseries for eggs and swim-up fry. Even if they dry up in summer, the fry will have emerged and

However, some of the lower reaches of these small tributaries appeared to have been straightened near to the confluence with the main channel and/or realigned where tracks crossed. Each of these actions would have degraded their potential for spawning and fry habitat, so rehabilitation work should be considered wherever that had occurred.

Fig 13. Many of the watercourses such as Fell Sike at SD 82610 85029 were small and relatively well vegetated, with substrate notably clear of fine silts. The importance of these small and even ephemeral channels should not be underestimated if fish can access them. They may only be important spawning and nursery habitats for 4-5 months over winter.

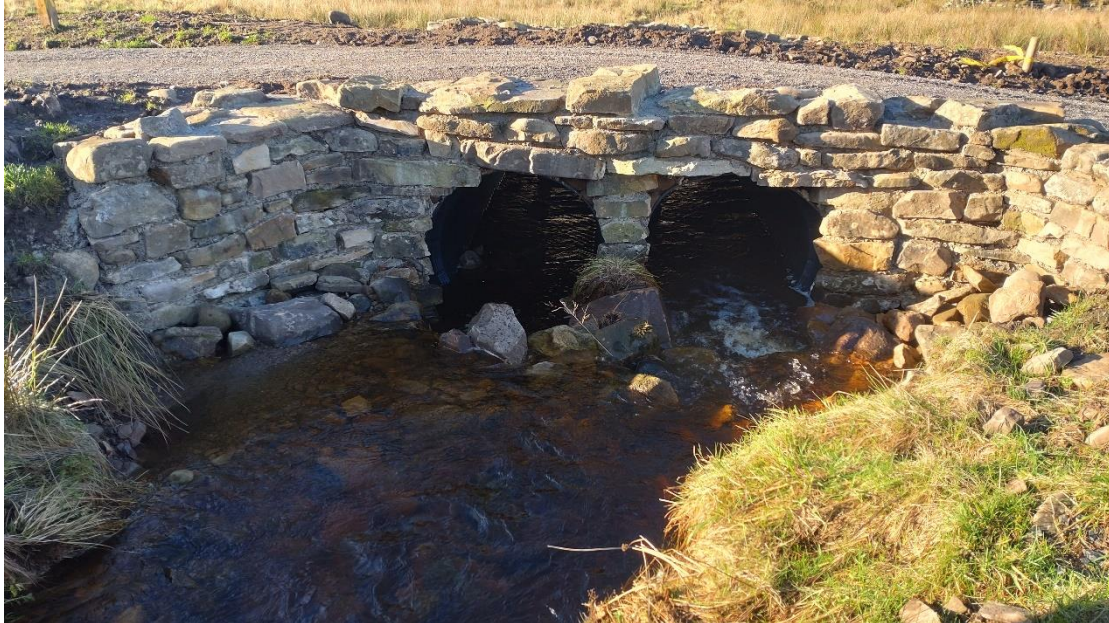
Track crossings were discussed on site, using a recently completed twin-culvert pipe as an example (Fig 14a&b). The ideal situation would be a clear-span structure, be that a bridge or an appropriately oversized and sunken culvert, to accommodate the entire wetted channel width and some bank on either side. Hence, there should be ample capacity for elevated spate flow and a natural substrate throughout.

Fig 14a. Twin culvert pipes discussed on site. On the u/s side, there was already evidence of deposition of larger boulders (esp. at left-hand pipe) under high spate flow when the capacity of the pipes would have been exceeded and water had backed-up. These created a perch at the u/s side, visible as the cascade of water into the right-hand pipe. Ongoing maintenance issue.

In a fragile landscape, it is essential to keep vehicles out of watercourses and any track crossings should conform to best practice, ie clear-span with sufficient bank space to accommodate spate flow in the channel, or over-capacity culverts buried sufficiently deep to accommodate a natural bed substrate.

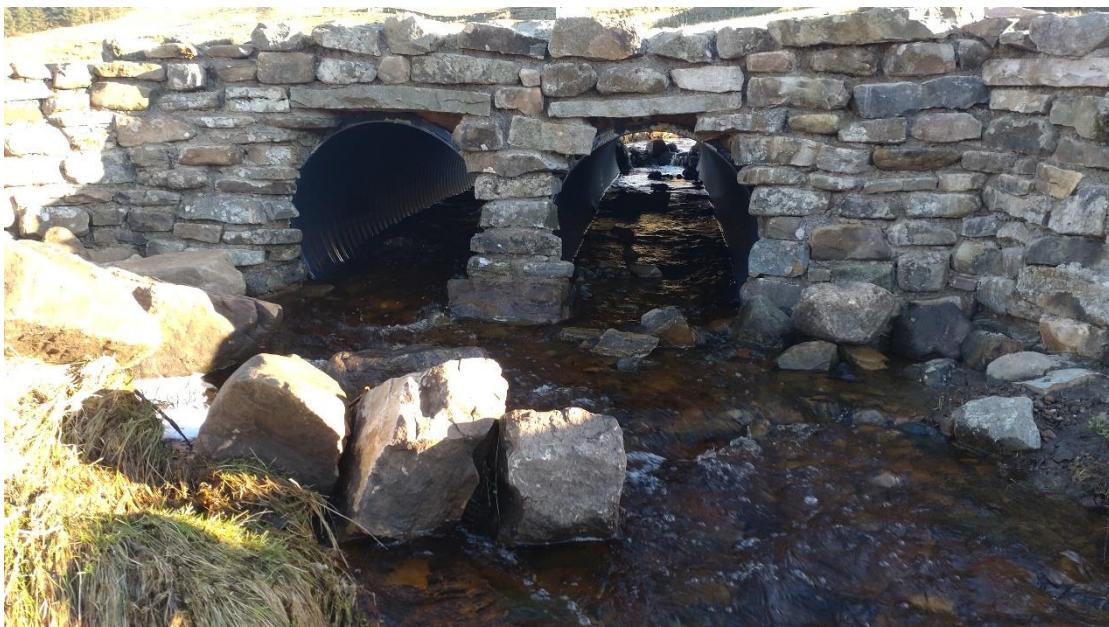
Fig 14b. Twin culvert pipes discussed on site. On the d/s side looking u/s, it was evident that the pipes had been buried to a certain degree and the angle of slope sufficiently low to retain bed substrate. A watching brief is required for potential development of scour below the pipes which could lead to bed lowering and perching of those pipes.

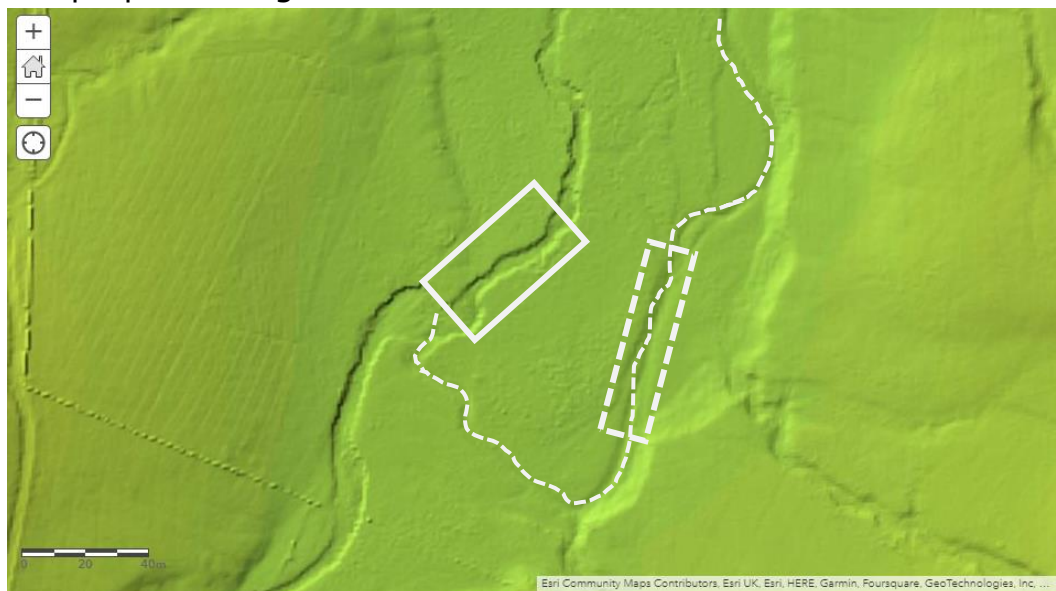
1. Paleochannel reconnection

The LIDAR image from Fig 6 has been repasted here to help outline the proposal for gold standard channel restoration.

The dashed white line indicates the paleochannel to be reconnected. The white rectangle indicates the u/s section of the extant channel which should be blocked with windblown trees and their root plates (ideally), packed into a dense log-jam matrix. Any boulder or rock used to block the paleochannel should be removed with appropriate plant and relocated to augment the log-jam, and encourage return of flow to the paleochannel. As noted earlier from

the LIDAR, even the paleochannel appears to have been straightened in one section (dashed rectangle), so it would be worth investigating this prior to any reconnection and installing some LWM arranged to deflect flow and increase sinuosity – see below. Since the disconnection of the paleochannel seems to have occurred very recently, the idea here is not to ‘rewiggle’ or over engineer *per se*, but to simply block the extant straighter channel and encourage a return to a former course.
