WILD TROUT TRUST

Advisory Visit: River Yarrow

Southport Fly Fishers Club, Sept 2023

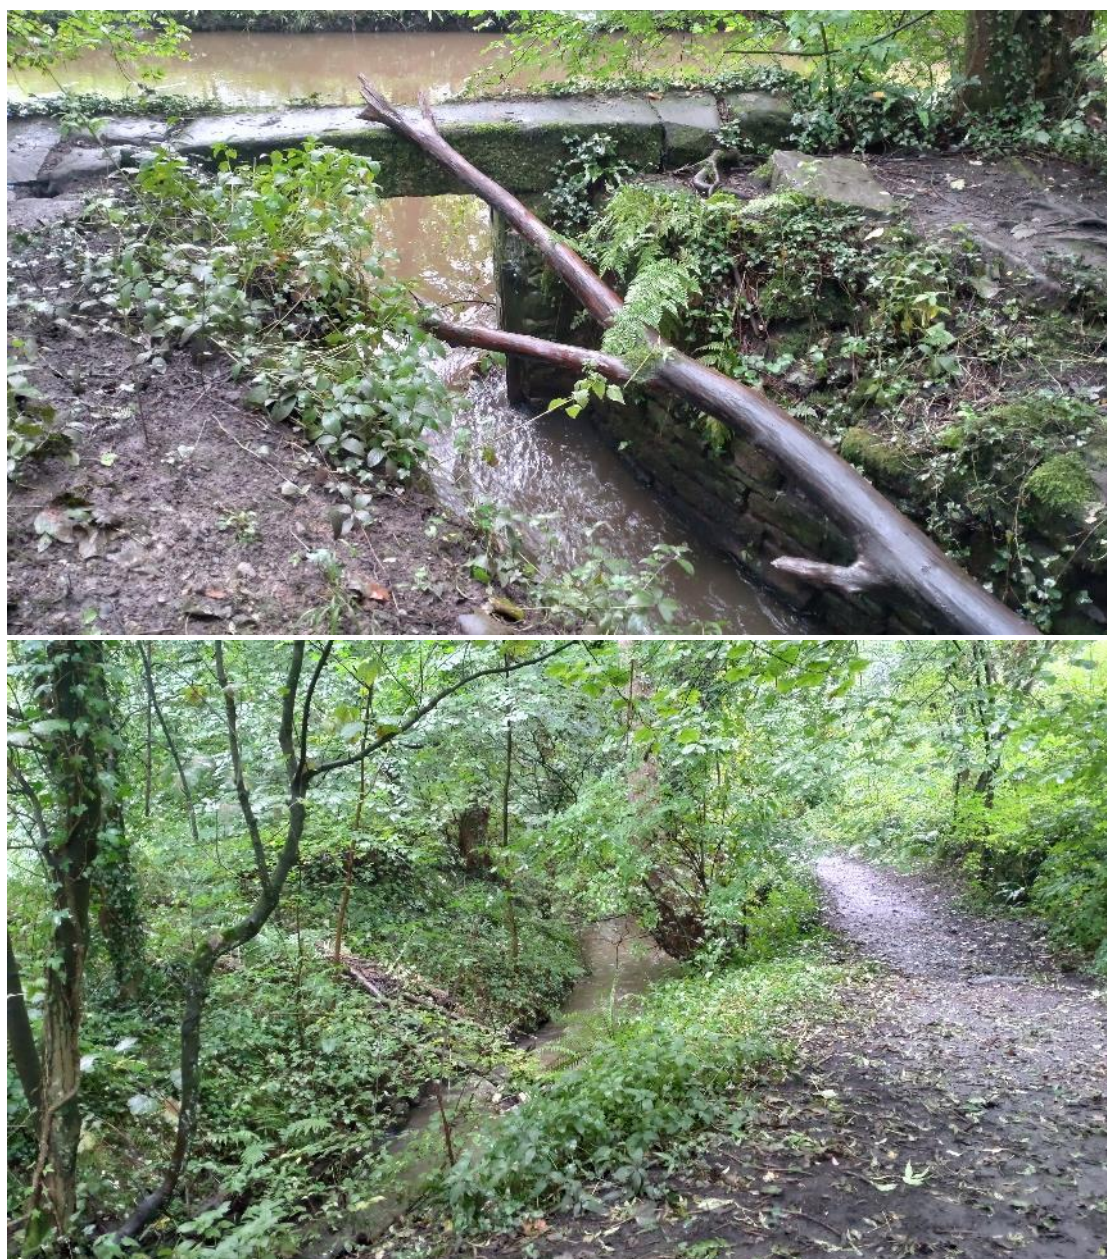
Fig 1. At SD 54790 18010, the u/s extent of the waters and the walkover, the goit associated with the weir was routed from the RB in a heavily incised channel of consistent proportions. Re-naturalisation of the riparian flora had resulted in a native woodland canopy of mixed age, although ground cover was limited due to a relatively dense canopy and the proximity of a popular footpath adjacent.

As with any artificial, relatively straight channel, the goit was heavily incised and dominated by fast riffle habitat but offered potential backwater refugia during main channel spate flows. The goit may also provide spawning habitat but this would have to be assessed under lower flows. Naturalisation of the goit banks with a well-developed native tree flora provided substantial shade; indeed, the ground cover was relatively sparse (ivy, dog's mercury amongst others, as well as Himalayan balsam). Bare earth resulting from shade and/or balsam dieback was compounded by footfall and dog access to the water where the popular footpath was too close to the bank top (Fig 1: lower panel). The consequent issue of fine sediment pollution could be readily addressed using fascines in problem areas.

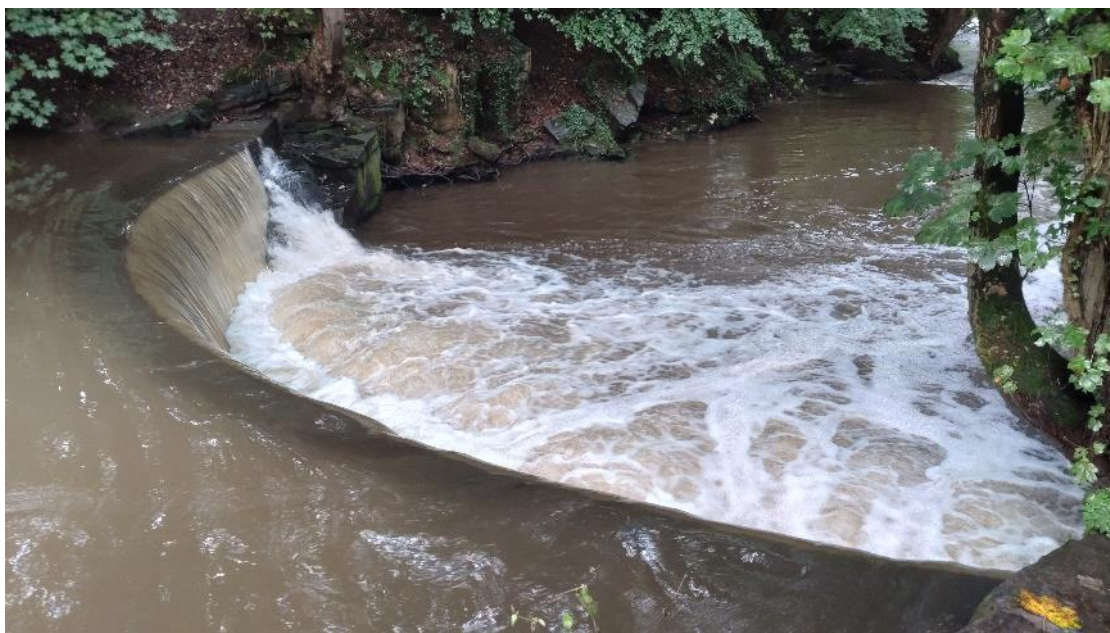
Fig 2. The 1m high, vertical weir had been sited on a seam of bedrock visible on the left bank and was causing impoundment for $\sim 150\text{m}$ u/s. The structure was concave, focussing flow with a slight bias initially to the RB, and clearly an impassable barrier to most fish species most of the time.

The weir was sited adjacent to and presumably also at least partly on a seam of bedrock at a natural pinch-point in the valley (Fig 2). It would clearly be a barrier to passage for most fish species for the majority of the time due to its size and configuration, as well as drowning out natural channel features in the impounded reach for $\sim 150\text{m}$ u/s and trapping sediments. Since construction of the weir, the reaches d/s would have been starved of the resupply of smaller fractions of bed substrate such as gravel, leading to a predominance of large cobble and boulder, and hence a reduced physical diversity with fewer niches for organisms to occupy and reduced opportunities for gravel-spawning fish species.

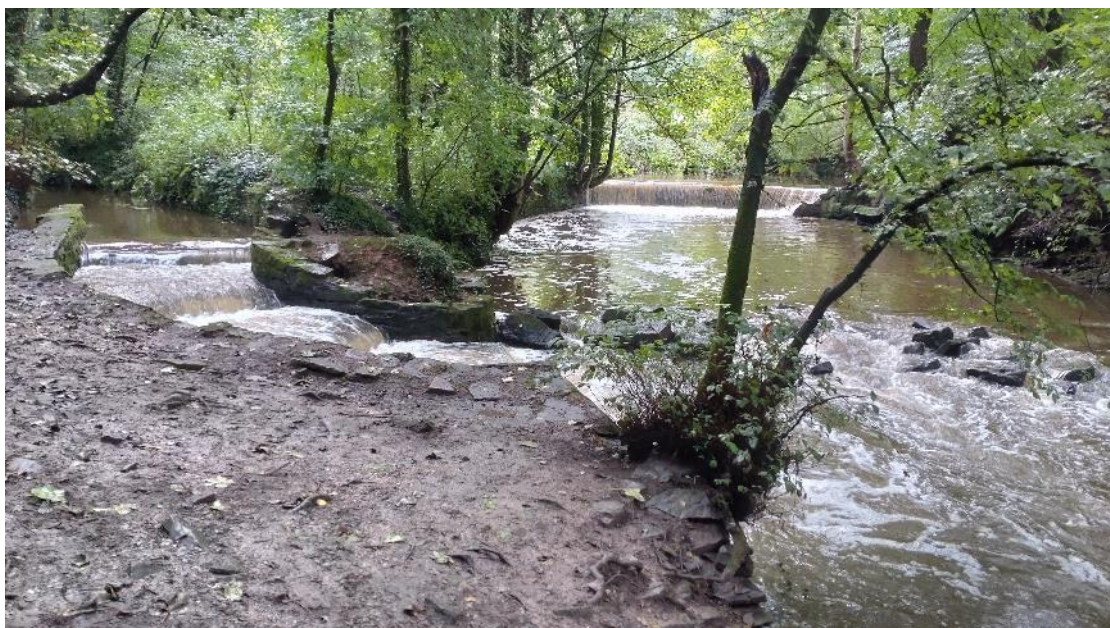
using the exiting goit as a bypass channel (Fig 3&4). Four notched barrages (to simulate a pool-cascade) were placed in sequence close to the confluence to overcome an initial head loss of <1m. Such engineered structures / bypass channels are rarely very efficient for fish passage which is why weir removal should always be the preferred option when possible. Amongst other issues:

- Require sufficient and consistent attraction flow to lead fish to the entrance of the fish pass, and thus are typically co-located with the toe of the weir. In this case, the fish pass entrance was separate and poses a considerable risk of fish missing it and swimming to the 'dead-end' of the weir u/s.

Fig 3. SD54701797: Spatial context of the outflow from the goit, engineered into a stepped fish pass, rejoining the Yarrow from the RB, ~33m d/s of the weir. The ground cover around the fish pass was negligible because of footfall. The foam line from the weir can be seen along the RB u/s of the fish pass but boulder placement (see Fig 4 & 5) seemed to divert flow away to the LB, potentially taking 'attraction flow' away from the fish pass mouth.

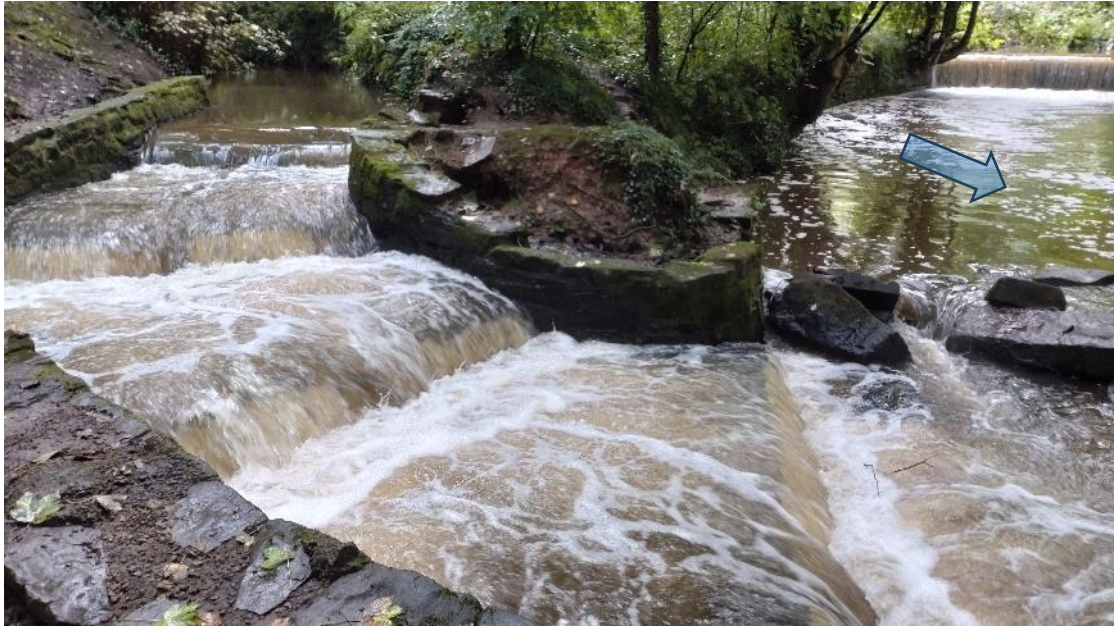
Fig 4. The four steps of the fish pass at the d/s end of the goit where it enters the Yarrow. There appeared to be a series of slightly offset notches to focus flow between the steps under lower flow conditions. NB the diversion of flow from RB to LB u/s of the fish pass on the Yarrow (blue arrow).

Indeed, with those concerns in mind, at the discharge observed on the day, the flow and turbulence between the notched barrages would have required considerable power/burst-speed to overcome, and attraction flow appeared to be focussed to the LB rather than the RB and fish pass entrance, hence luring fish to the weir still (Fig 4&5).

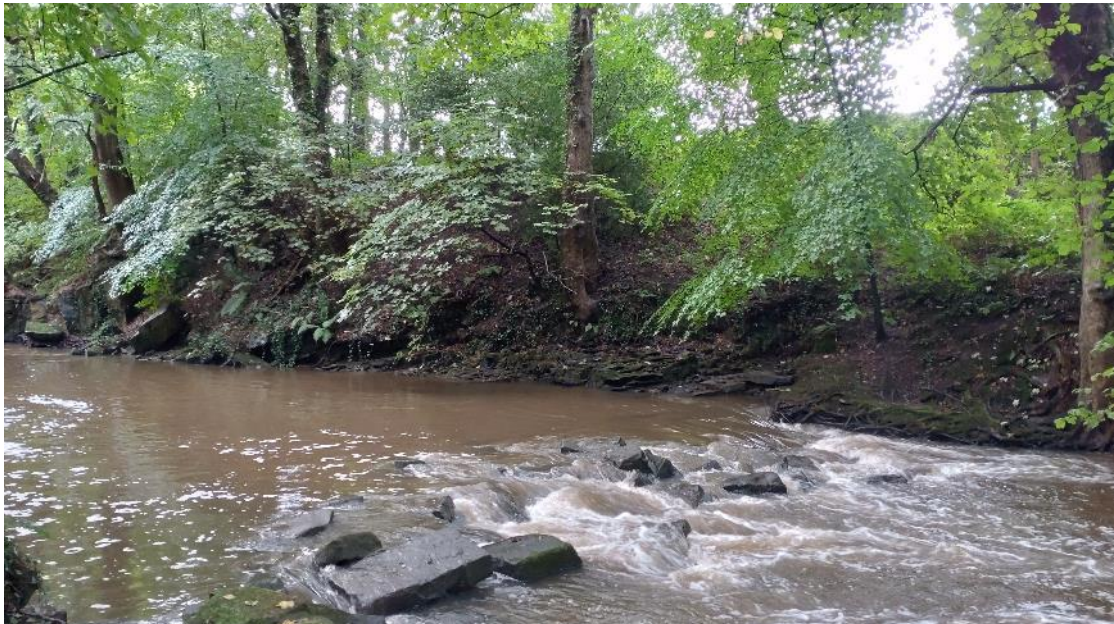
Fig 5. Looking across the Yarrow from RB to LB (from the fish pass; Fig 4) at the redirection of focal flow. This could potentially be more attractive to fish moving u/s, drawing them to the weir rather than the fish pass mouth.

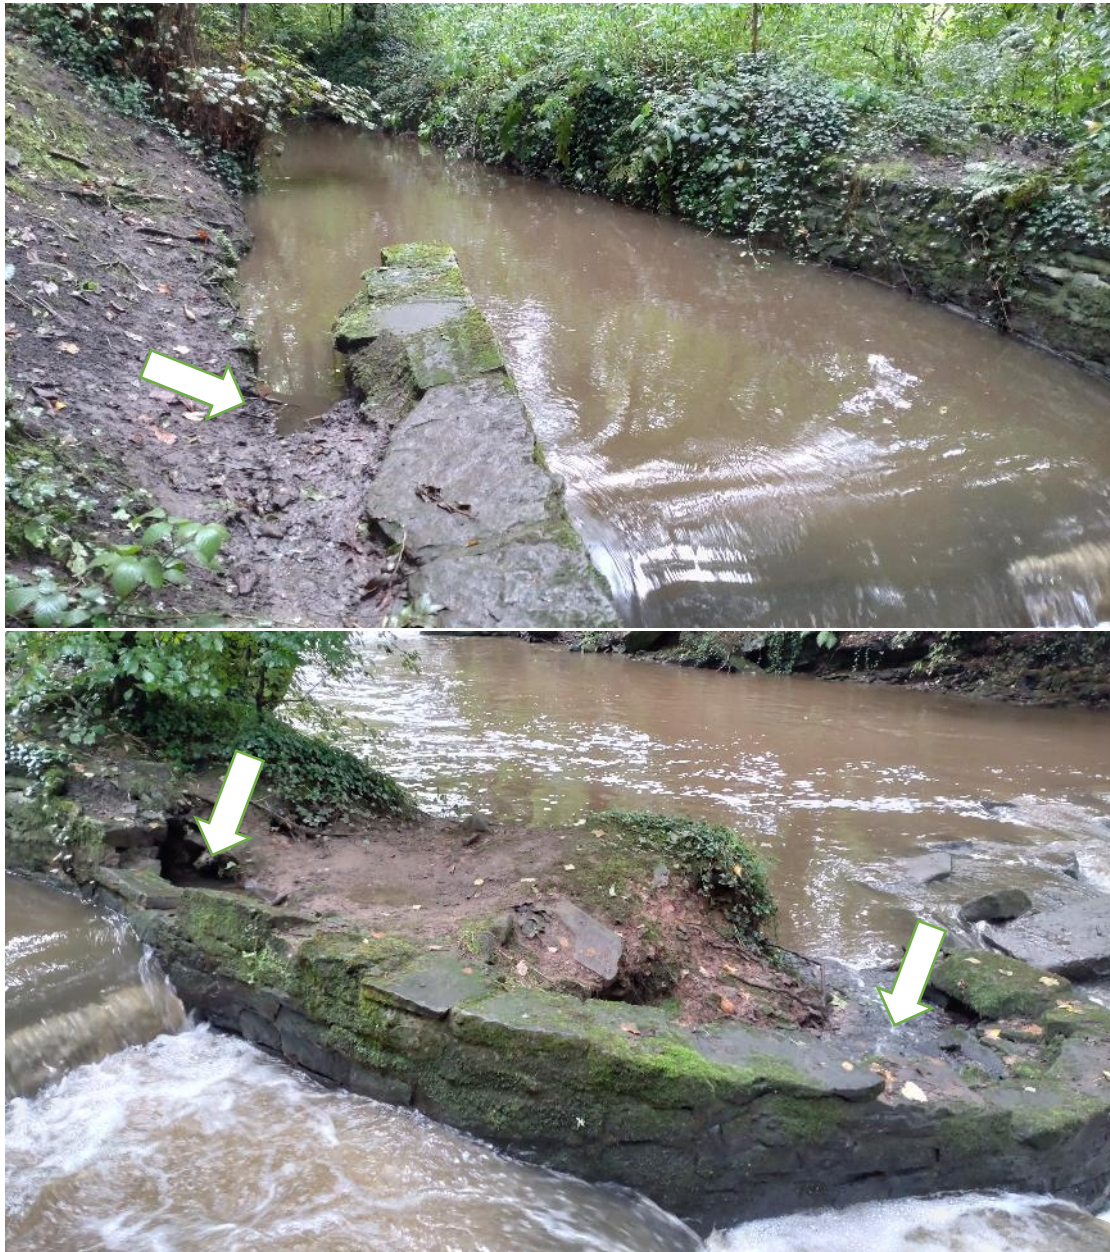
In addition, considerable investment had probably been secured to install the fish passage solution at the tail end of the goit. Yet, erosion and failure of the walling, compounded by considerable footfall and hence maintenance of bare earth next to the structure, was clearly

Fig 6. Erosion detail around the fish pass. Clearly time and expense has gone into the building of this structure, yet it was in a poor state of repair and likely to fail in the near future without a little further investment.

evident and would ultimately lead to its complete failure (Fig 6). Best scenario for the natural heritage of the river would be to remove the weir. In the interim, preventative action to address the issues on both sides of the goit, highlighted in Fig 6, should be undertaken soon.

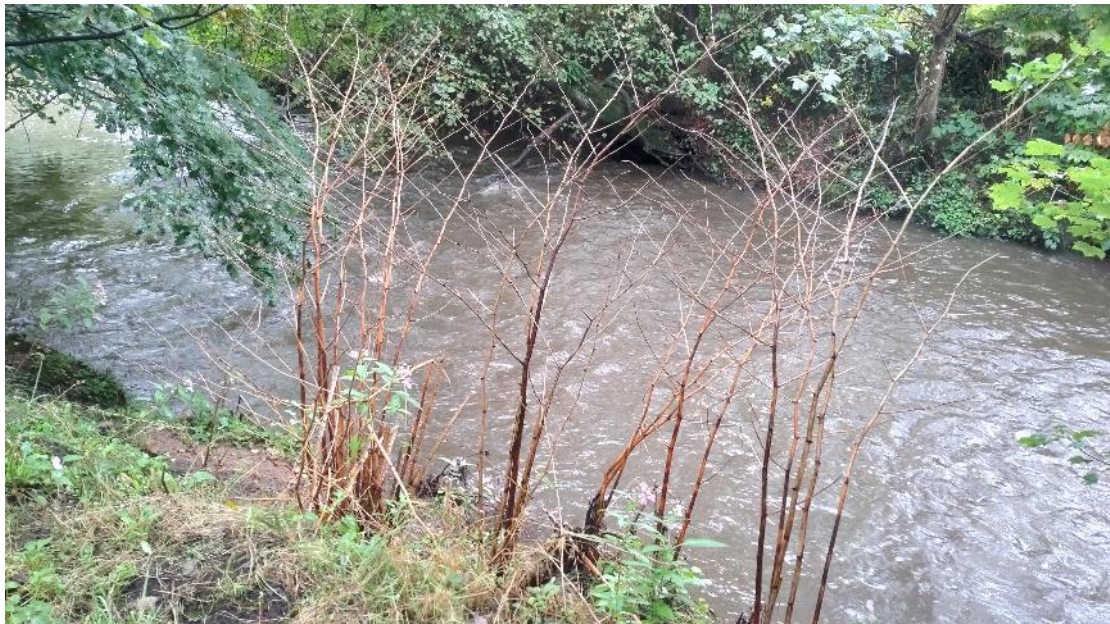
It was noted that amongst the widespread Himalayan balsam, there were also a couple of stands of Japanese knotweed which appeared to have been treated. It is important to monitor this particular invasive, non-native species (INNS; and also giant hogweed – see Fig 19) to prevent it spreading further and taking over the riparian flora.

Fig 7. A small stand of Japanese knotweed which looked to have been treated. Any such stands should be monitored / reported in attempt to eradicate this invasive non-native species (INNS). The image also highlights the incised (steep-banked) and consistently proportioned channel dominated by shallow riffle, typical of the reach between the weir and under the M6 to the footbridge at SD 54233 17948 (Fig 12).

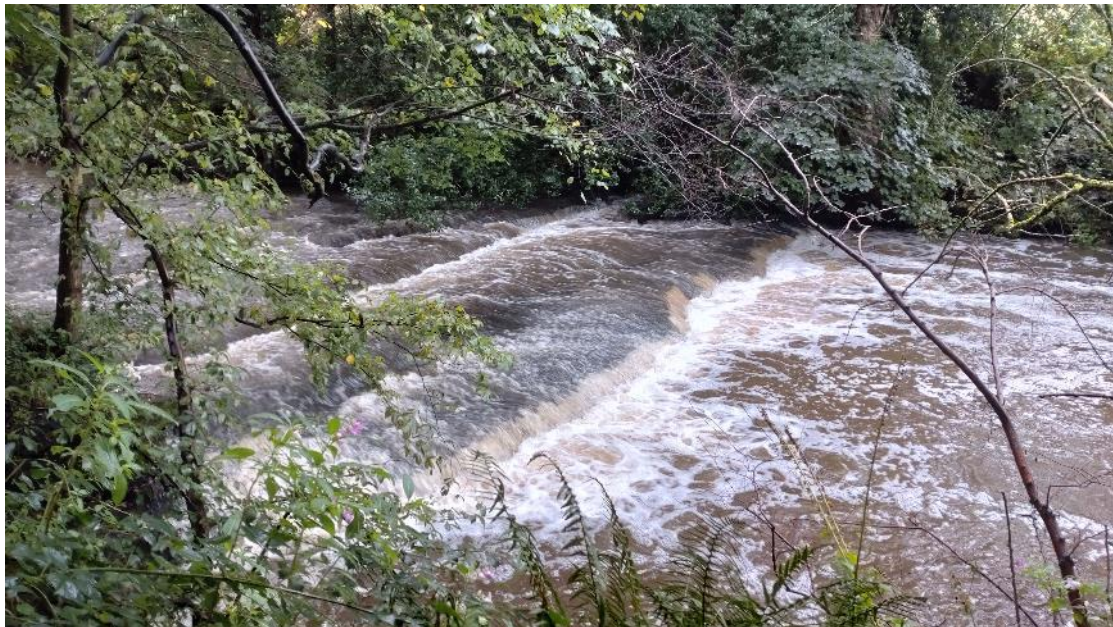
At SD 54619 17993, another weir of very different construction was located, assumed to be block stone arranged in three tiers of broad, shallow steps; the channel was almost twice as wide as elsewhere either u/s or d/s (Fig 8&9). Despite the relatively shallow gradient, the weir would still be impassable to most fish species for most of the time as each step would not provide sufficient depth from which to leap to the next. Like many weirs of 150-250 years old, the structure appeared to be degrading with failed stonework ~75% across from the RB (point of observation), which may provide a focal flow under

lower discharge and improve fish passage marginally. However, it appeared redundant with seemingly no modern infrastructure such as an associated pipe crossing. Consequently, the weir should be investigated for removal to reinstate all the benefits of a free-flowing, connected channel.

Fig 8. SD 54619 17993: three-tiered step weir looked to be degrading at ~75% of the width from the RB which may be improving the situation for fish passage – see Fig 9.

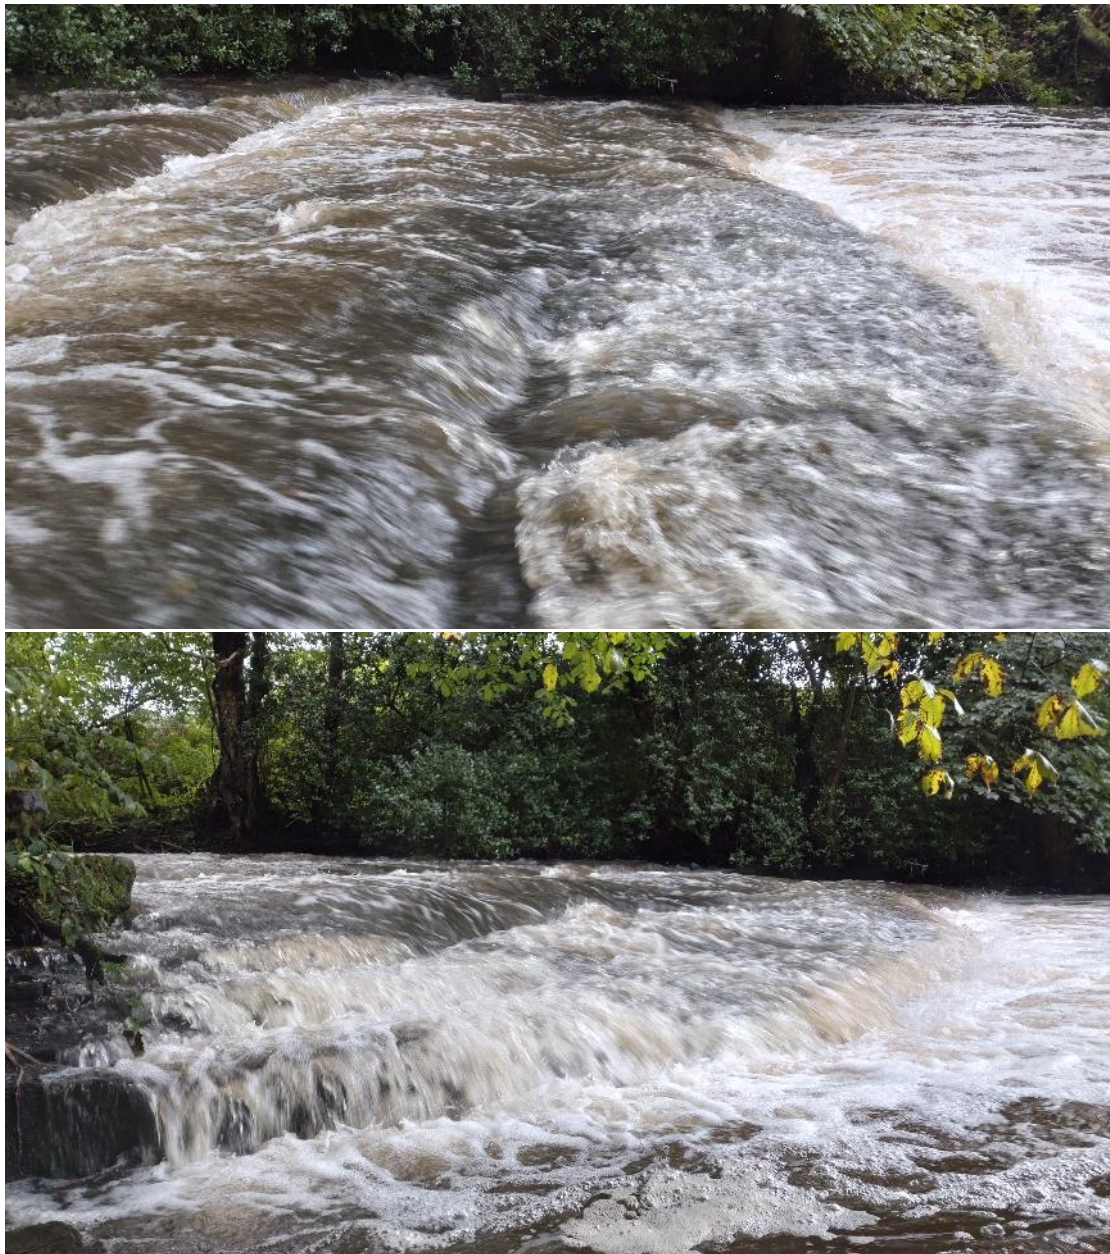
Fig 9. Closer detail of the structure of the weir – broad steps of $\sim 1\text{m}$ base and each $\sim 0.3\text{m}$ high to give a total head loss across the structure of $\sim 1\text{m}$. Impassable to most fish species the majority of the time. Passability is probably further reduced under lower flow regimes as each step will only be covered by a shallow skim of fluming flow.

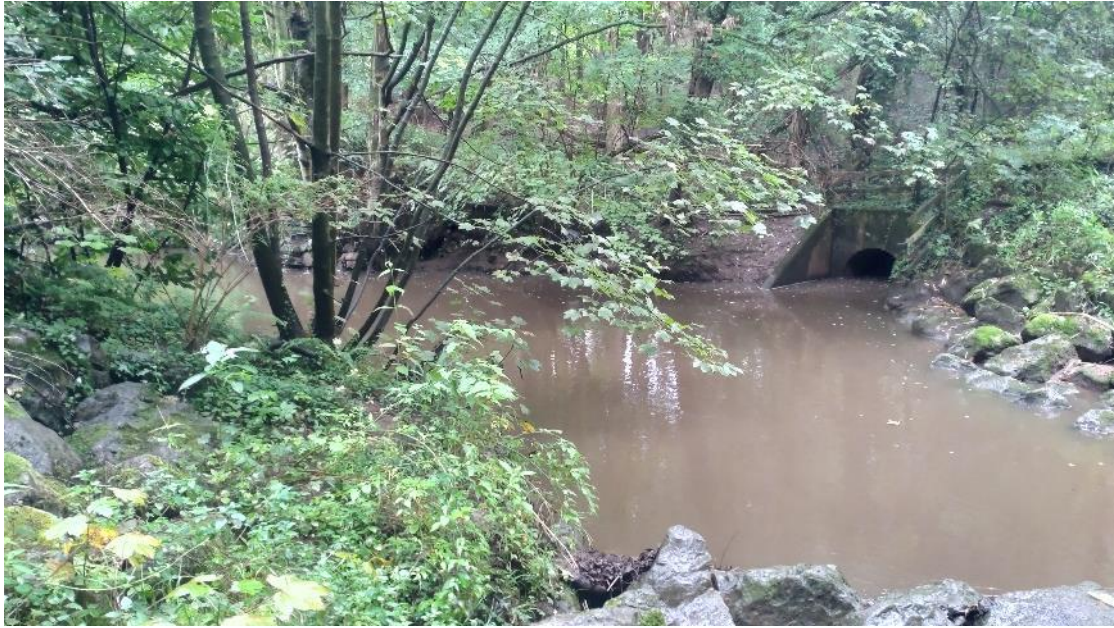
Fig 10. On the LB, u/s of the M6 flyover, a large culvert formalised the flow from a small beck network, seemingly converted to agricultural drains, and presumably with contributions from the motorway which will be a focal point for pollution.

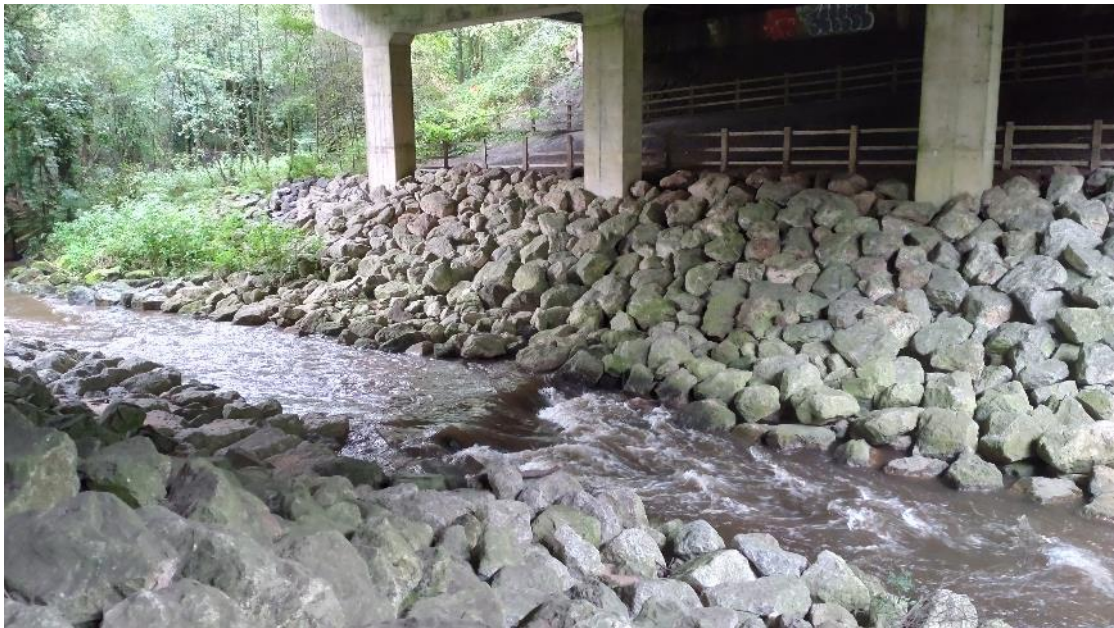
Fig 11. Large boulder revetment underneath the M6 flyover, pinching and straightening the channel, and increasing flow velocity for the span of the bridge.

The pinched channel under the flyover, whilst extremely straight, was also hydraulically roughened by the large boulder revetment and so was probably not particularly challenging for fish passage, although there appeared to be a step at the mid-point (Fig 11). Based on flow patterns around the step, it probably comprised revetment material and hence had focal flow paths over, around and through for fish passage, but should be reassessed under low flow.

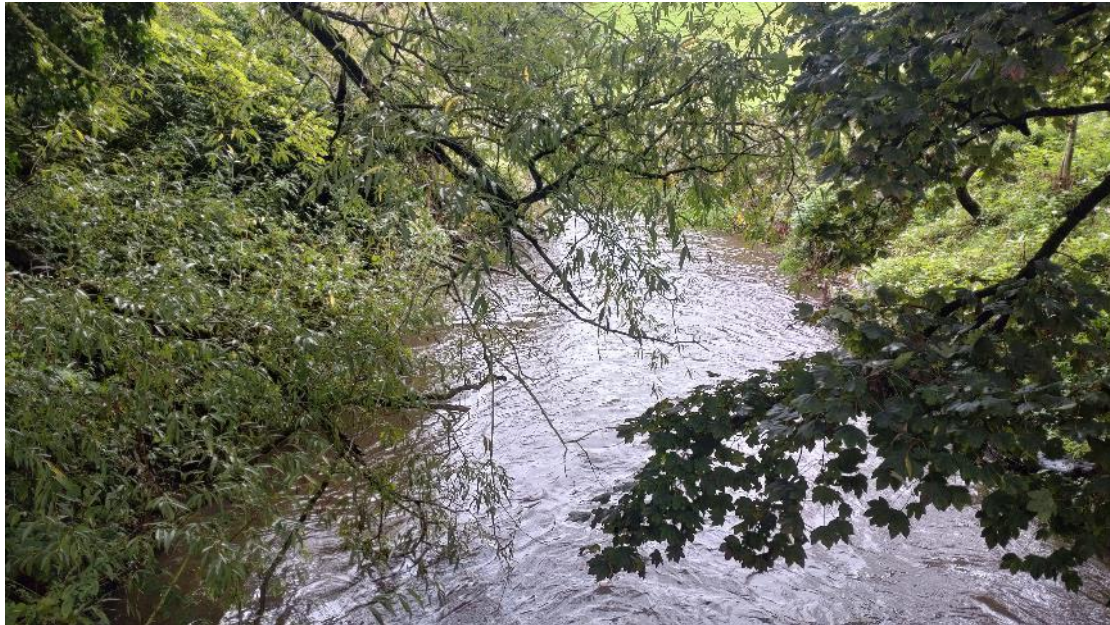
Fig 12. At SD 54233 17948, looking d/s from the footbridge adjacent to a private property that splits the SFFC waters. The field belonging to the property (outwith SFFC influence) was fenced and the riparian zone was as good as could be expected given the straightened nature of the channel. From here in a d/s direction, the channel was more natural in form than the reach u/s to the weir (Fig 3) which had been incised and straightened.

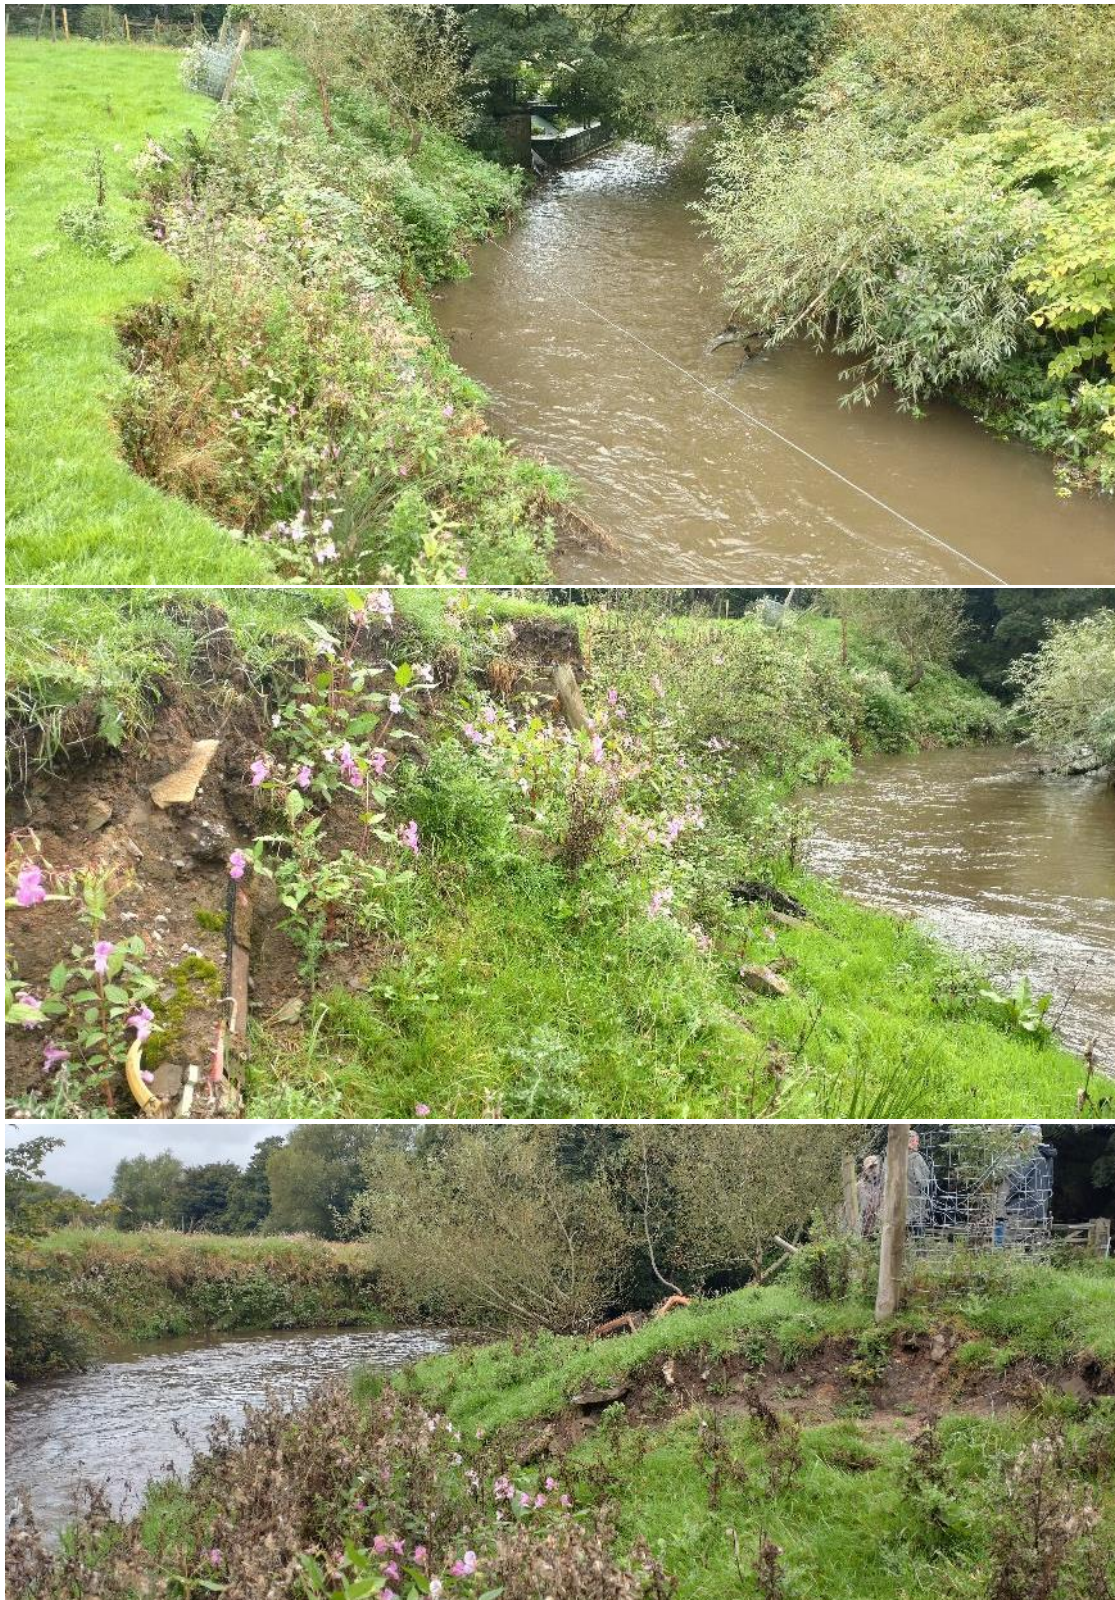
The RB d/s of the footbridge had been artificially raised using building rubble and metalwork amongst other things to create a more level field for agriculture, currently grazed by both sheep and cattle. Buffer fencing was present (to exclude livestock) but had been set too close to the top of the bank and was failing. It is difficult to pin down any one particular cause; the unconsolidated nature of the bank, heavy grazing of grass and therefore little investment in roots, a predominance of balsam on the bank face, and few native herbs and trees that would be present year-round and root deeply (binding the soils and increasing resilience), would all interact to leave the bank susceptible to erosion. Hence, it is important to give sufficient space within a buffer zone to build the resilience required to withstand spate flow. Furthermore, the fencing had been deliberately cut and rolled back in places, thereby rendering the whole scheme pointless. Riparian fencing schemes should include gates or hurdles so errant stock can be removed if required.

Fig 13. At SD 54184 17978, d/s from the footbridge, the RB had been historically raised to form flatter agricultural land but the fencing protecting the bank had been placed too close to the bank top and deliberately removed in places, thereby allowing stock access. A combination of artificial, unconsolidated bank material (building rubble, metalwork etc, evident in middle image), stock access and Himalayan balsam, with a naturally friable sandy soil anyway, rendered the banks susceptible to erosion by both the water and by stock. Note the large stand of Japanese knotweed on the LB that had not been treated (upper panel).

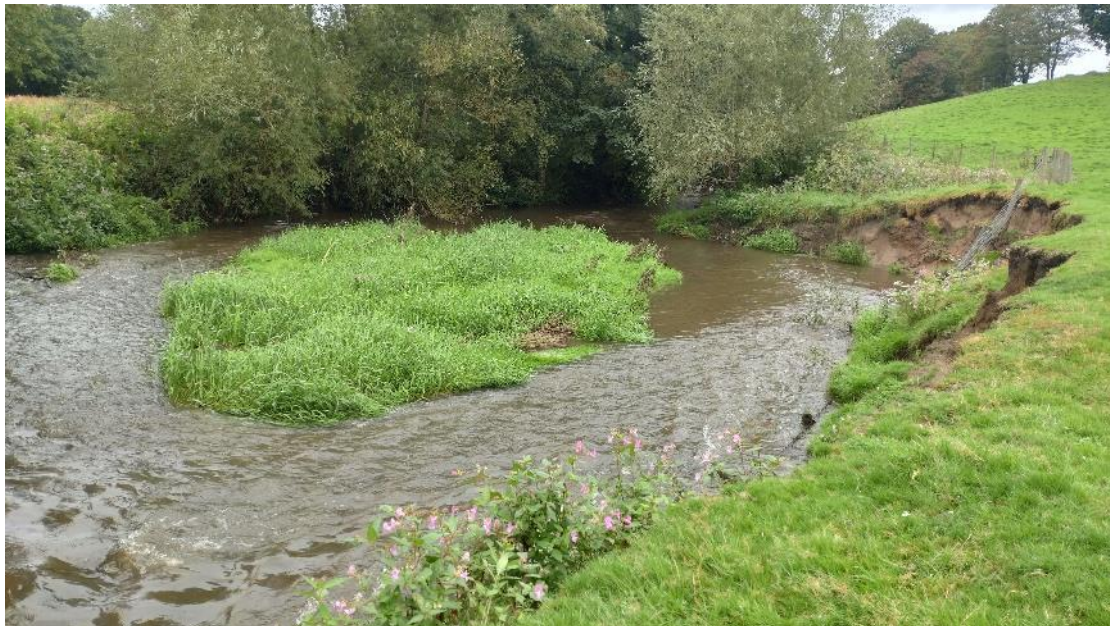
The RB was managed as pasture and erosion into the friable sandy soil was rife (Figs 14-17). Almost the entire length had livestock exclusion fencing, yet that had failed in numerous places, probably due to being placed too close to the bank top and leaving insufficient room for a riparian buffer to develop. It was somewhat confusing to see relatively new fence posts having been installed in various sections (Fig 18) and yet there were clear, unaddressed breaches in the fence being exploited continually by sheep, again rendering the original scheme and the recent investment worthless from an environmental perspective.

Fig 14. SD 54017 17975: Channel diversification providing different habitat types within the two channels around the island. Unfortunately, the riparian buffer fencing had been placed too close to the bank top again and so had failed, exacerbating the potential for erosion into the RB.

To improve the resilience of the RB (whilst simultaneously improving the habitat for fishery benefits) and prevent the inexorable loss of further land, the integrity of the buffer fence requires reinstating with sufficient space for some augmented planting of appropriate tree species. Alder, grey willow, aspen or bird cherry have all evolved to root well in wet soils and provide high quality leaf litter subsidies to aquatic macroinvertebrates; they also benefit terrestrial invertebrates that may end up in or on the water. Whilst there is undoubtedly a natural seed bank available, the predominance of balsam (as well as sheep access) will have impacted upon natural regeneration. Augmented planting kickstarts the process by giving young saplings a competitive edge over balsam, and in time, the new tree canopy should hinder balsam growth. There are various schemes which pay landowners to manage their land in an alternative manner to traditional grazing to offset the reduction in pasture – see Recommendations.

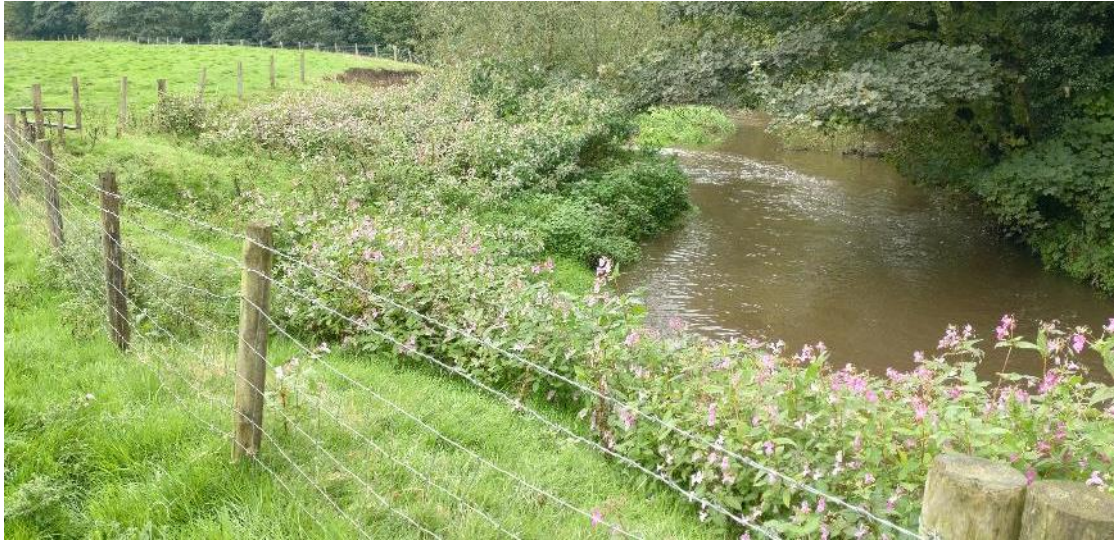
Fig 15. Immediately d/s of the island in Fig 14, just visible, the width of the riparian buffer strip originally afforded was probably sufficient to build resilience but extensive balsam and livestock access at various untended breaches to the fence would leave it susceptible unless both of these stressors are controlled.

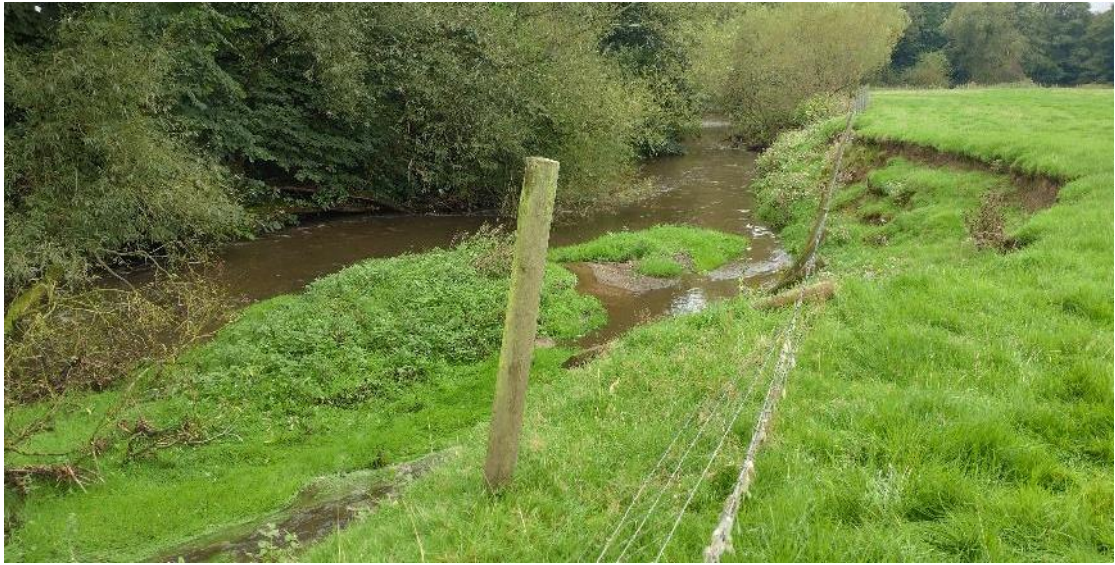
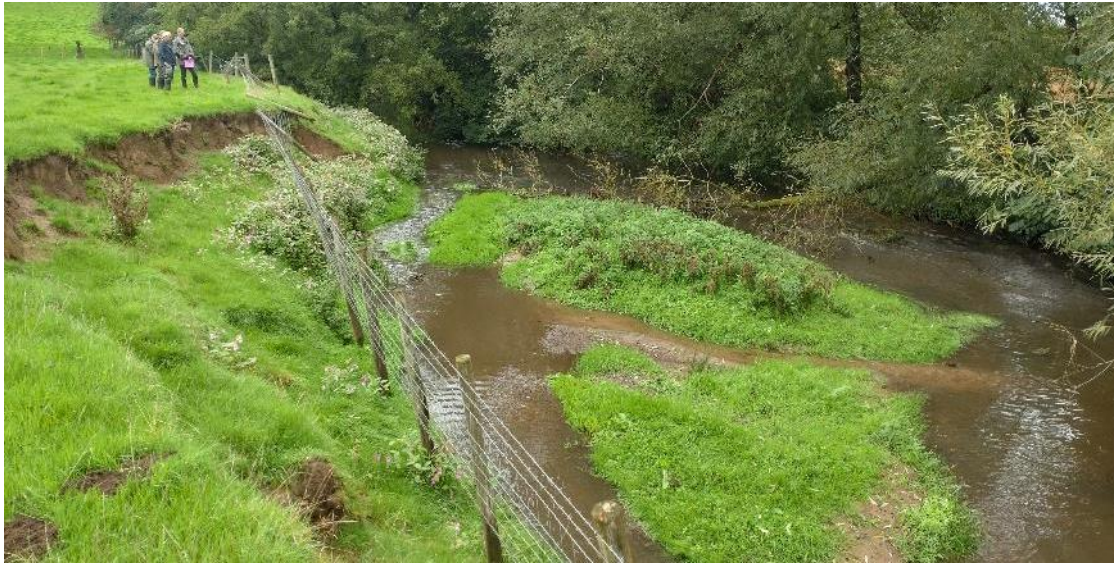
Fig 16. Another failure of the stock-proof fencing because it was placed too close to the top of the bank on an artificially straightened section and the river had undermined the whole lot. A deposition bar had formed within the channel. Note the lack of erosion on the LB afforded a native tree and herb flora in stark contrast to the grazed RB.

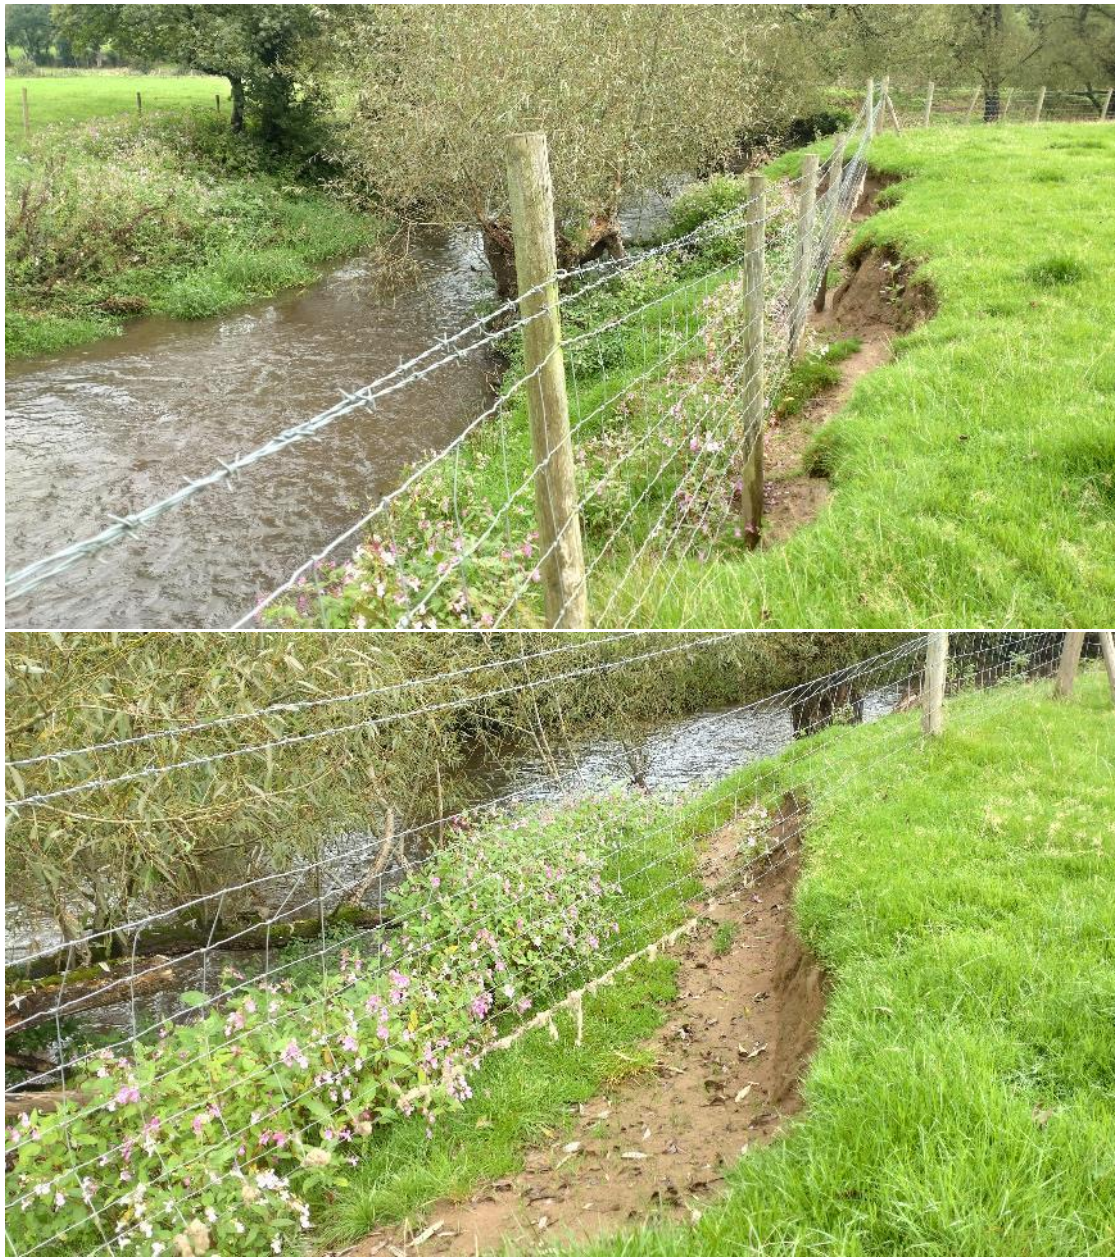
Fig 17. More slumping of the bank where the fence has been placed too close to the top. Sheep were clearly exacerbating these scallops to gain access under the fence, maintaining the area as bare soil and hence increasing the risk of further erosion under spate flow. There was no discernible difference in sward height on either side of the fence, indicating that sheep had unfettered access.

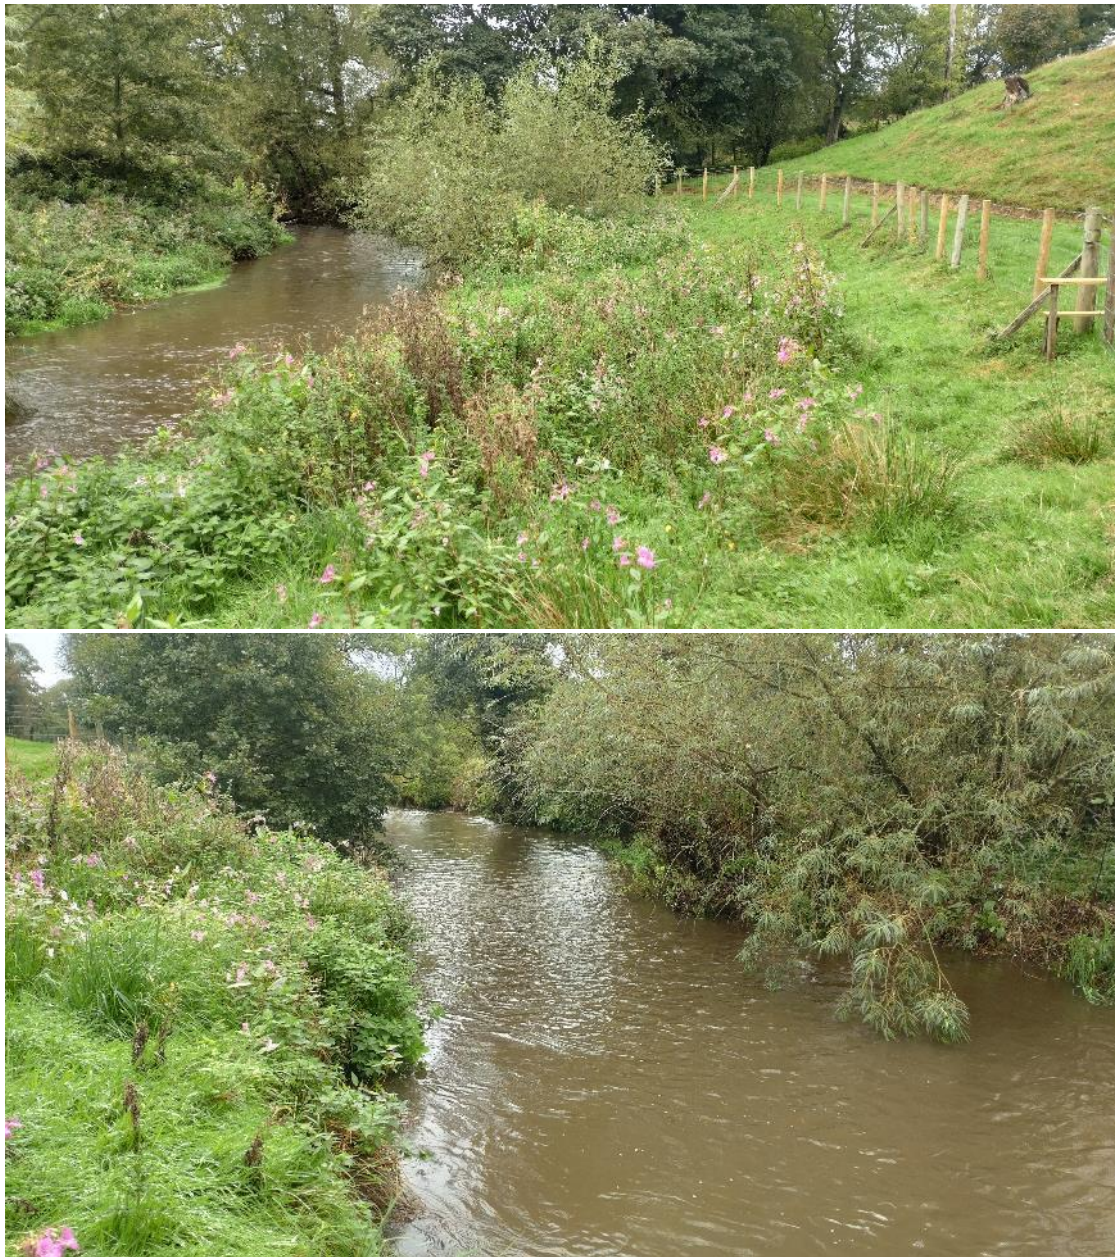
Fig 18. Where the buffer strip was ample with the fence set back 4-5m, there was much less evidence of erosion, despite the presence of balsam. The shallower cross-sectional profile of the bank created naturally by erosion also contrasts starkly with attempting to put fencelines at the top of steep, erodible "cliff" style profiles. However, it was noted that despite investment in replacement posts fairly recently, there were still gaps in the fenceline that the sheep were exploiting.

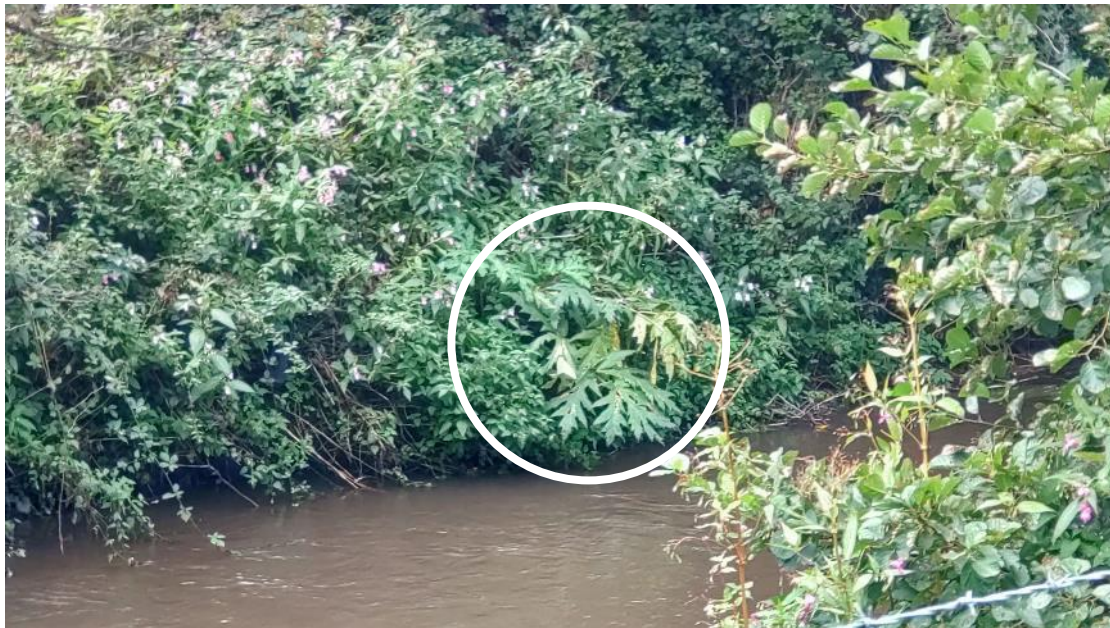
Fig 19. Within 100m of the d/s limit, there was at least one giant hogweed plant on the LB that should be treated as soon as possible, and the area monitored for more.
