WILD TROUT TRUST

Advisory Visit: River Yarrow

Southport Fly Fishers Club, Sept 2023

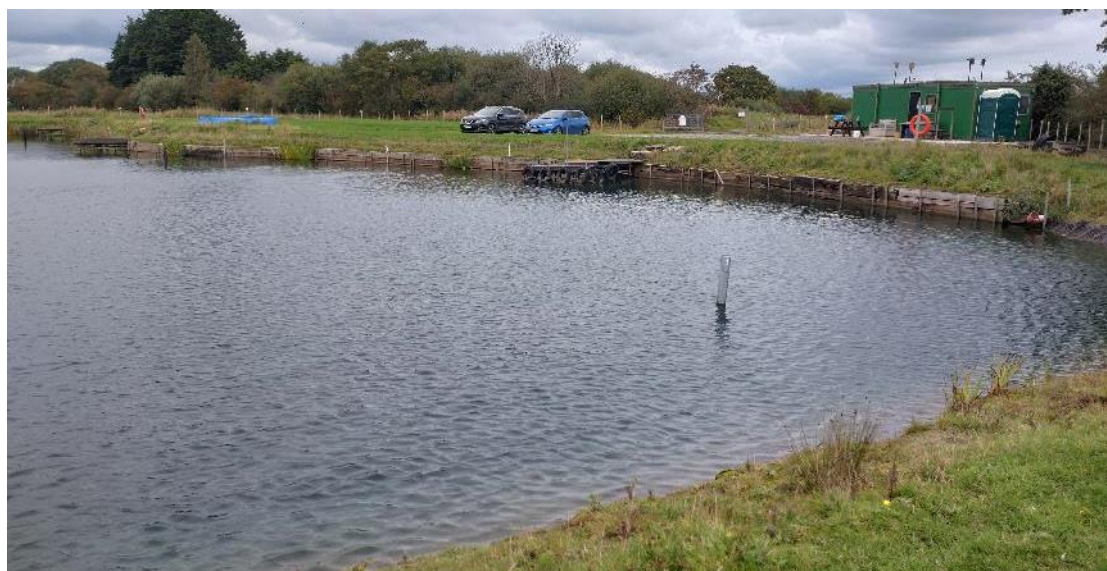
Fig 20. Looking toward the carpark and hut, exemplifying the bare nature of the banks. Sections of the bank had wooden shuttering as well as platforms for casting.

However, the bank areas have been maintained as mown, short-sward grass in a concentric ring around the entire lake (Figs 20-22), causing several issues. In essence, this creates exactly the same problem as livestock grazing along riverbanks. The grass invests all the energy derived from photosynthesis to replace shoot material rather than invest in roots, so there is little root matrix within the soil to bind it together; hence, the erosion and turbidity noted in Fig 21. Repeated cutting maintains a monoculture of grass which provides little diversity of food and cover for terrestrial invertebrates and that community will be depauperate as a result, offering little in the way of fish food subsidy. Furthermore, grazing waterfowl such as Canada geese favour short-sward grasses, and roosting waterfowl also prefer the visibility afforded on short swards. Attracting waterfowl brings associated issues of nutrient transfer into the water, as well as exacerbating erosion at the edges, increasing turbidity through

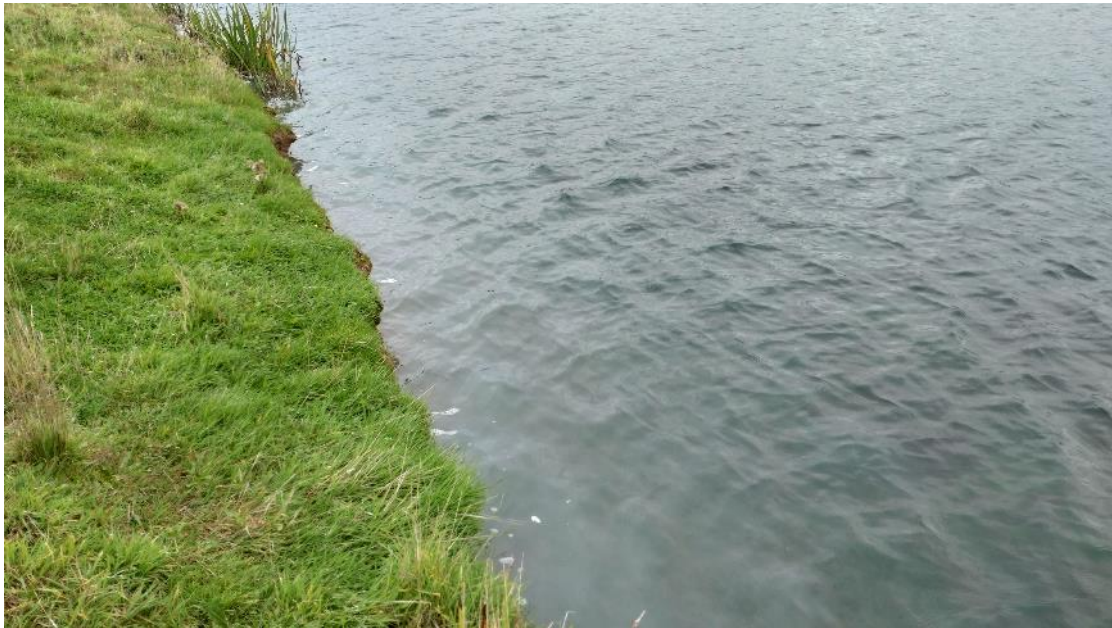
Fig 21. Close up of modest wind action and fetch, yet there was evidence of turbidity from bank erosion along the shoreline. Note that keeping the grass mown as a short sward will exacerbate this problem, as well as make it more attractive for grazing / roosting waterfowl.

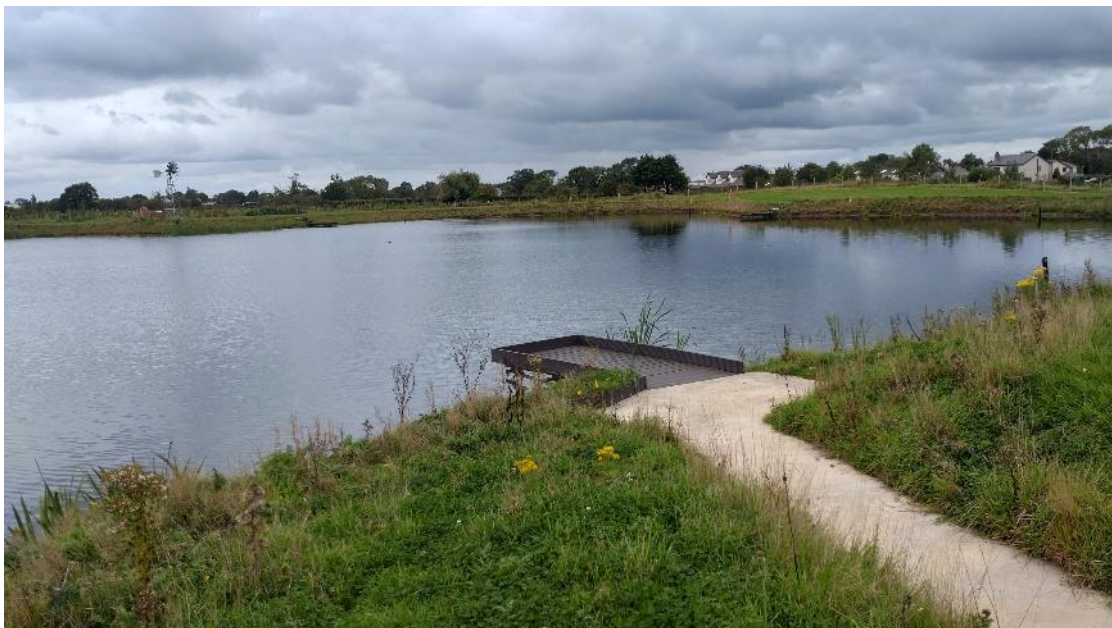
Fig 22. Another perspective of the majority of the lake surface highlighting the generally bare banks although there was clearly some natural seedbank of a more diverse herb flora which could be exploited to diversify the sward and encourage more terrestrial invertebrates that could subsidise fish diet.

The lake would benefit from several low-key measures to naturalise the shoreline, both in and out of the water, which would bring substantial benefits, are not onerous tasks, and would save the club time and funds – see Recommendations.
