Ecclesbourne at Snake Lane Weir Design

Technical Note FINAL

Wild Trout Trust

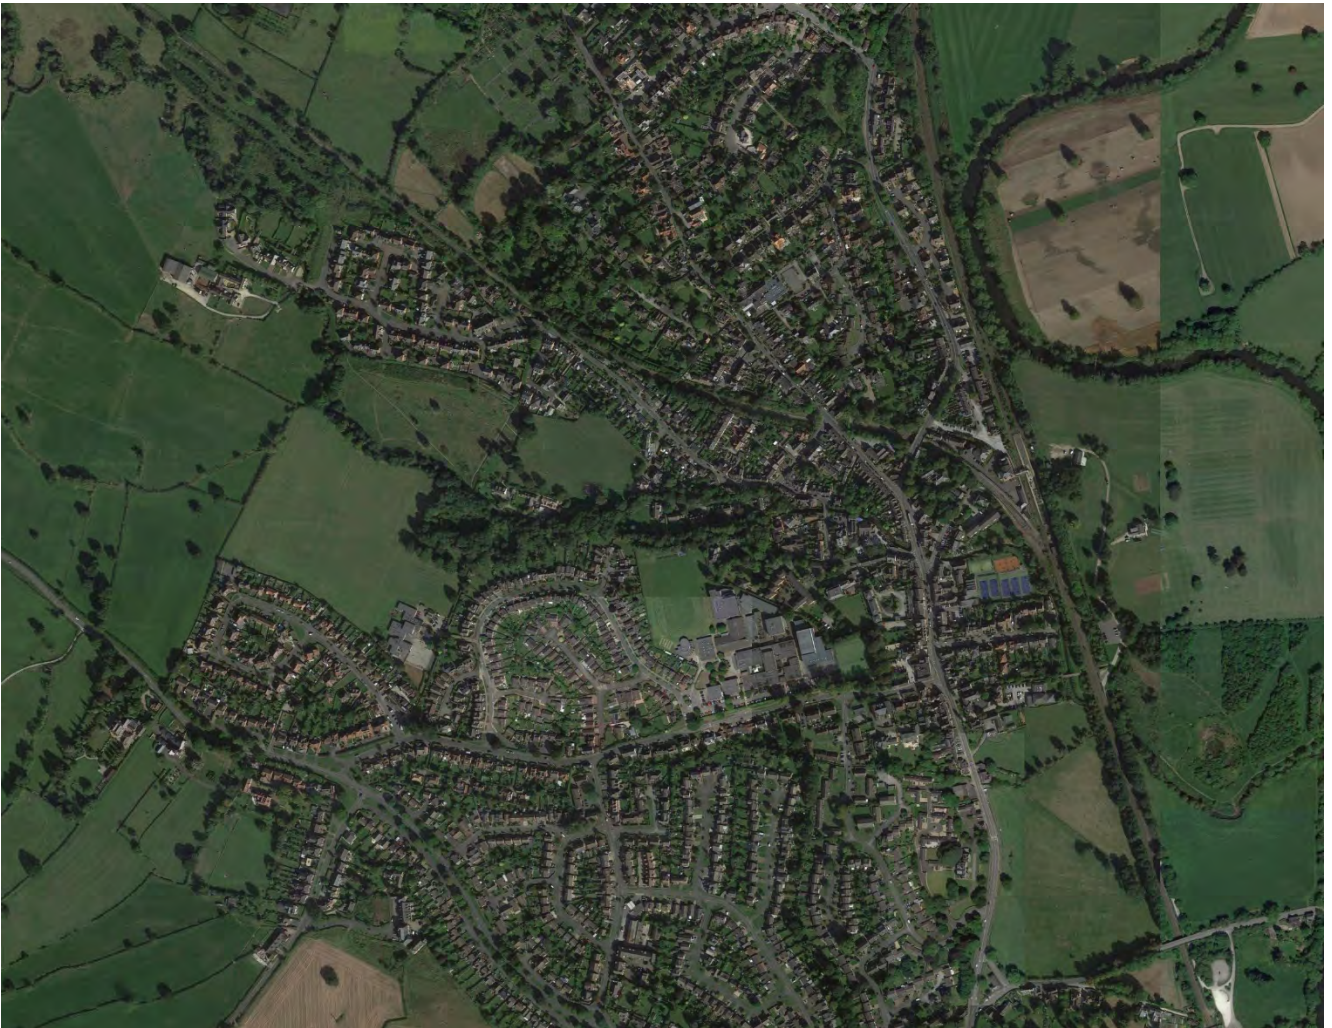
Figure 1.1 Study area of the River Ecclesbourne at Snake Lane, Duffield.

The Wild Trout Trust commissioned AquaUoS to develop a design to provide fish passage at Snake Lane Weir on the River Ecclesbourne, Duffield, Derbyshire. This follows previous optioneering work undertaken by the Wild Trout Trust and Environment Agency. This is to restore fish passage at the weir structure and to enhance the ecological and geomorphological value of the river. The design should build on previous work by the Wild Trout Trust to gather enough information to enable a detailed design to be undertaken for the weir. The study area is shown in Figure 1.1 below.

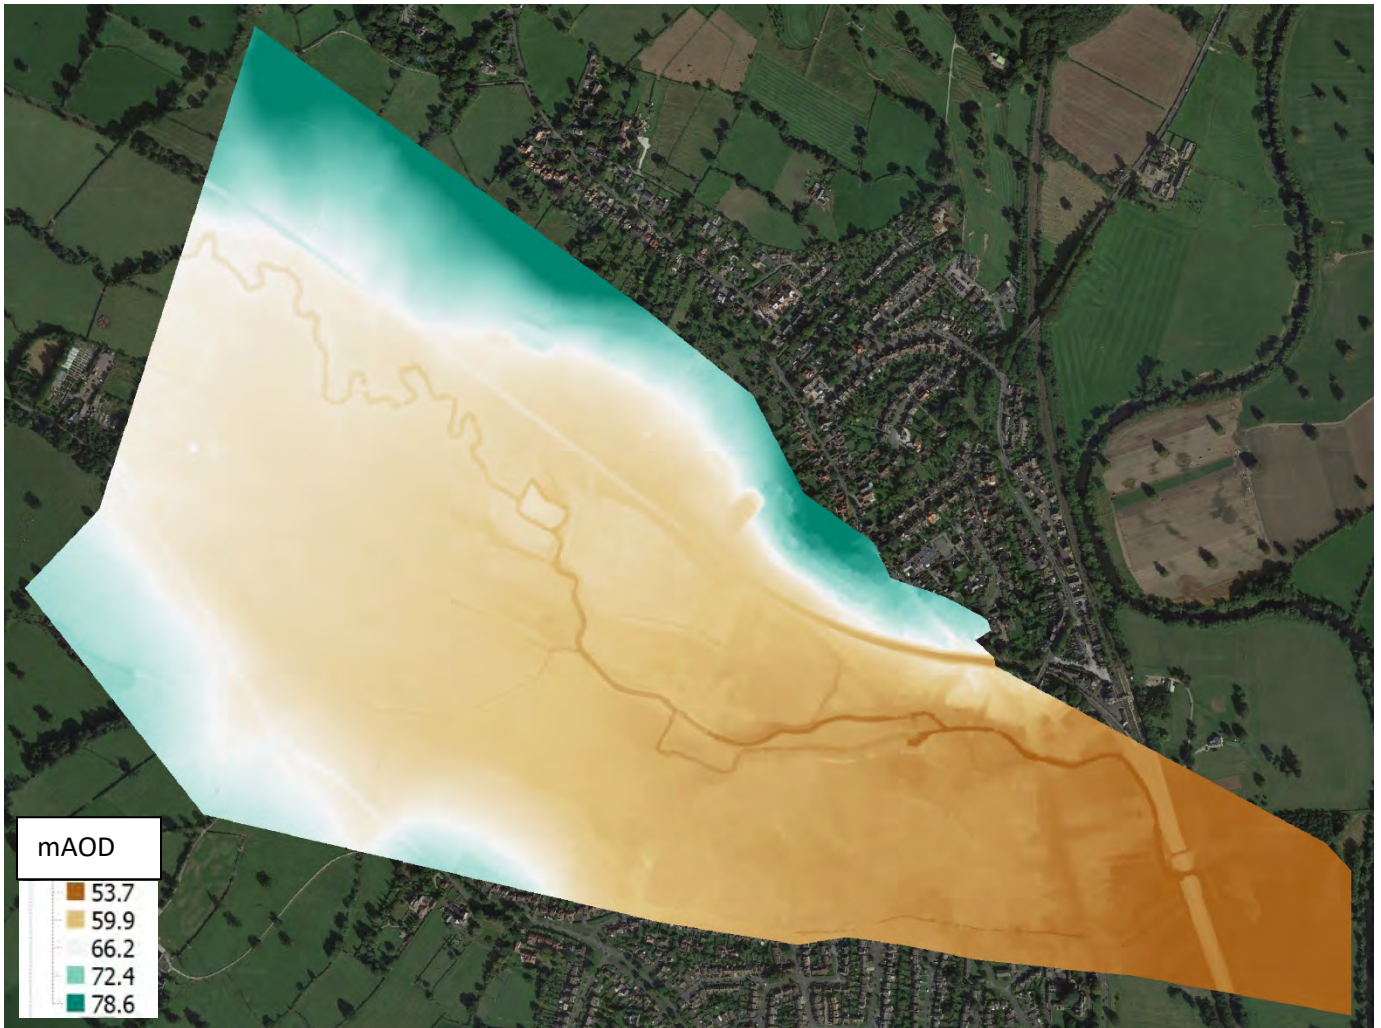
Figure 2.3 General topography in the vicinity of the Ecclesbourne at Snake Lane weir

The watercourse flows over a moderately steep topography with a variably connected floodplain that is generally wider upstream of the study reach and narrower close to Snake Lane Weir. This is the result of significant urbanisation over both banks close to the study reach (Figure 2.3). The highly sinuous former course of the river is visible to the north of the current bifurcating reach suggesting that considerable gradient was added to the reach when it was rationalised, subsequently utilised by the mills through the construction of weirs.

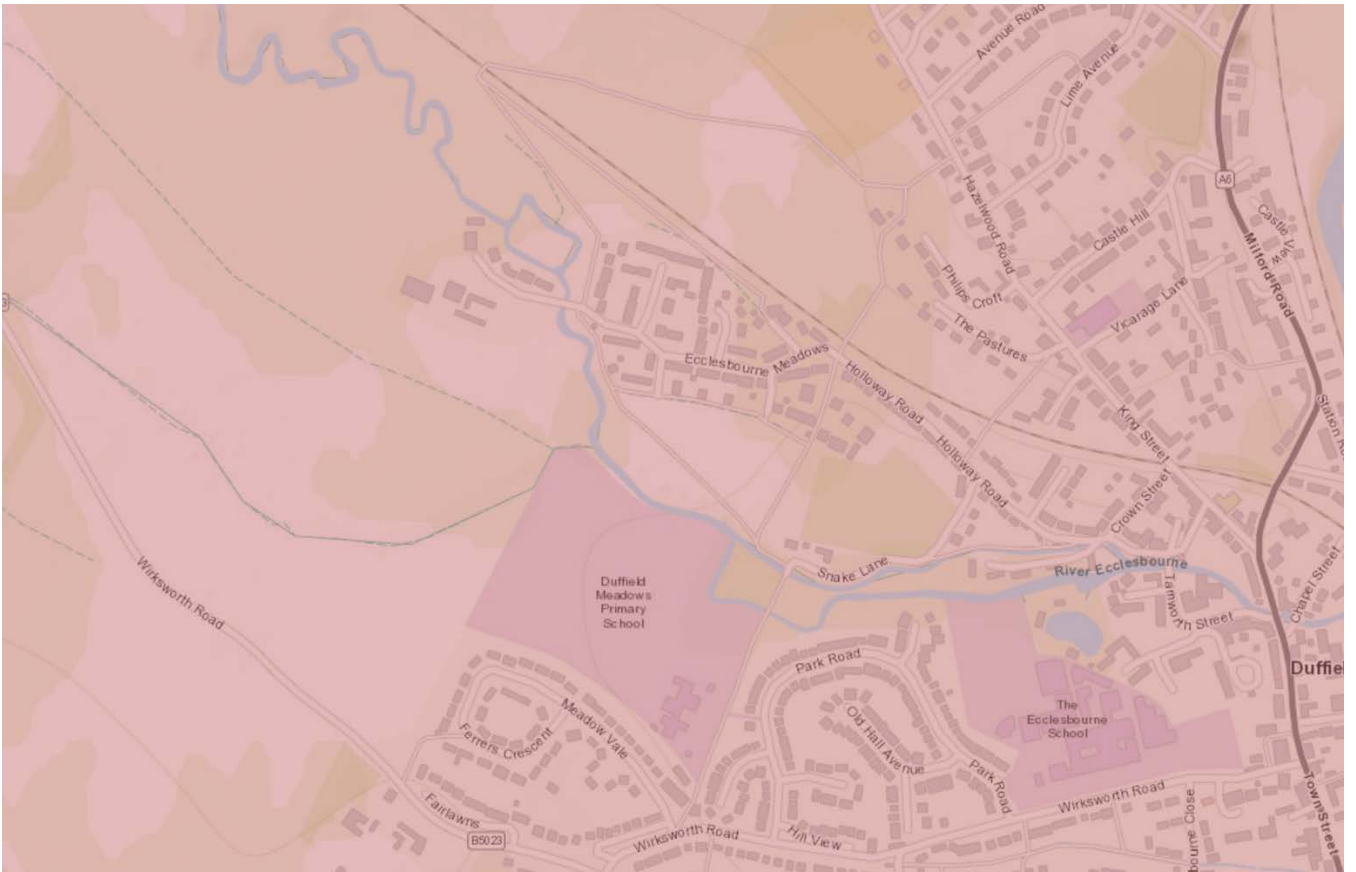
Figure 2.4 Current river course across the study site.

The River Ecclesbourne close to Snake Lane is likely to have been artificially straightened in the past (Figure 2.4), with straightening pre-dating the earliest available maps in 1879 (Figure 2.5 & Figure 2.3) and is likely to have been undertaken through modifications linked to the operation of the various Corn Mills (Figure 2.5) along the reach that also resulted in the creation of the split channel. There is some evidence of relict channels in the floodplain over both banks.

There has been very little change to the planform over the last ~140 years based on analysis of the current and the first epoch Ordnance Survey Map (Figures 2.4 and 2.5). This is mainly a result of the bank protection through the urbanised reach of the Ecclesbourne and subdued flow created behind the weir structures, one of which this project is looking to modify or remove. There is flow in the leat channels that needs to be retained as part of options developed for this project.

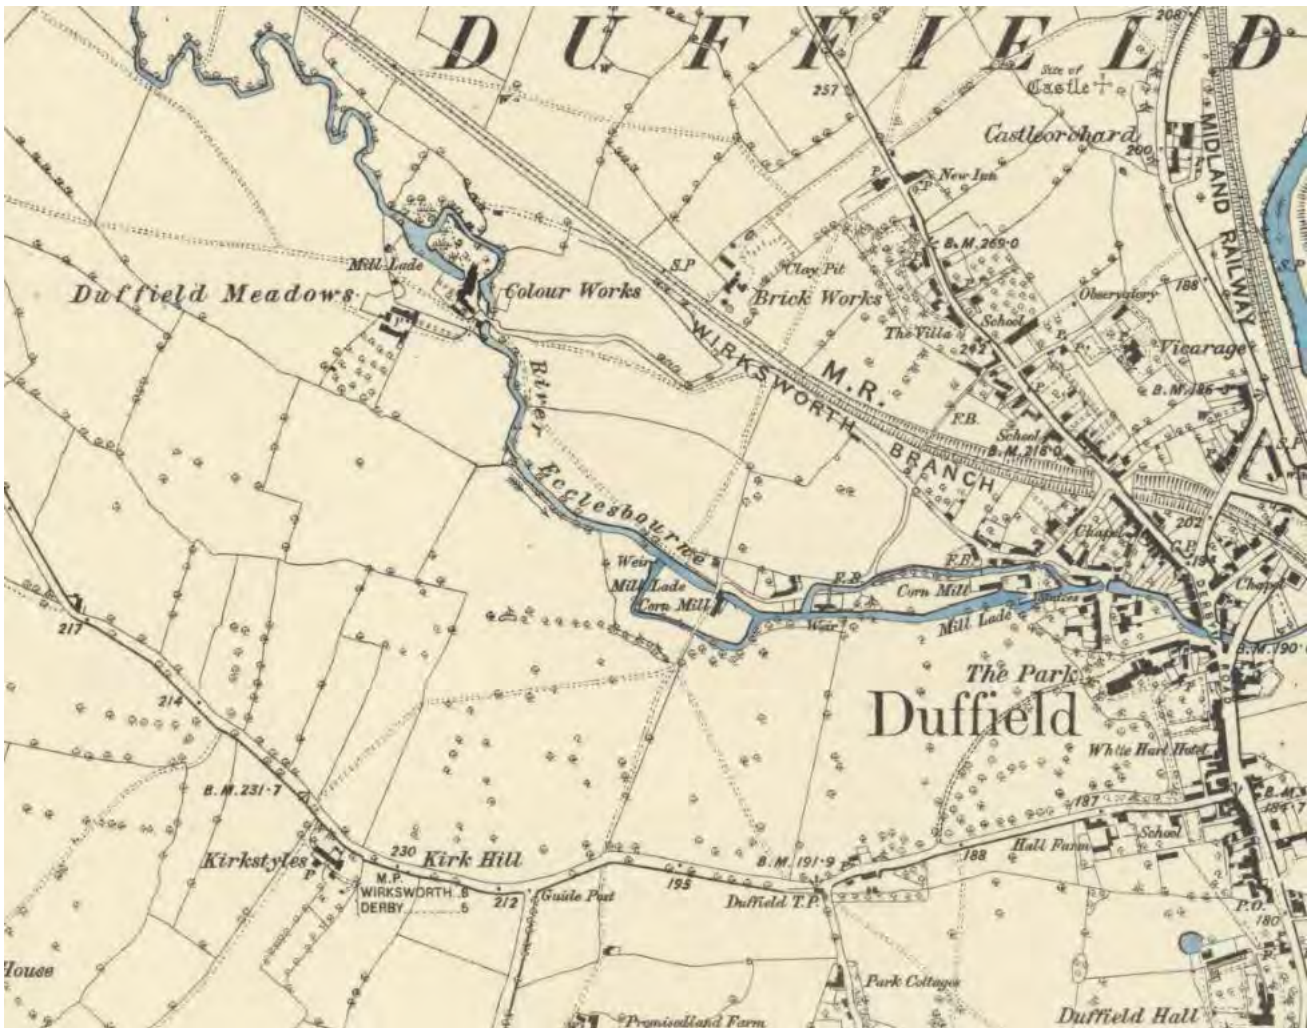
Figure 2.5 Historic mapping of the River Ecclesbourne at Duffield.

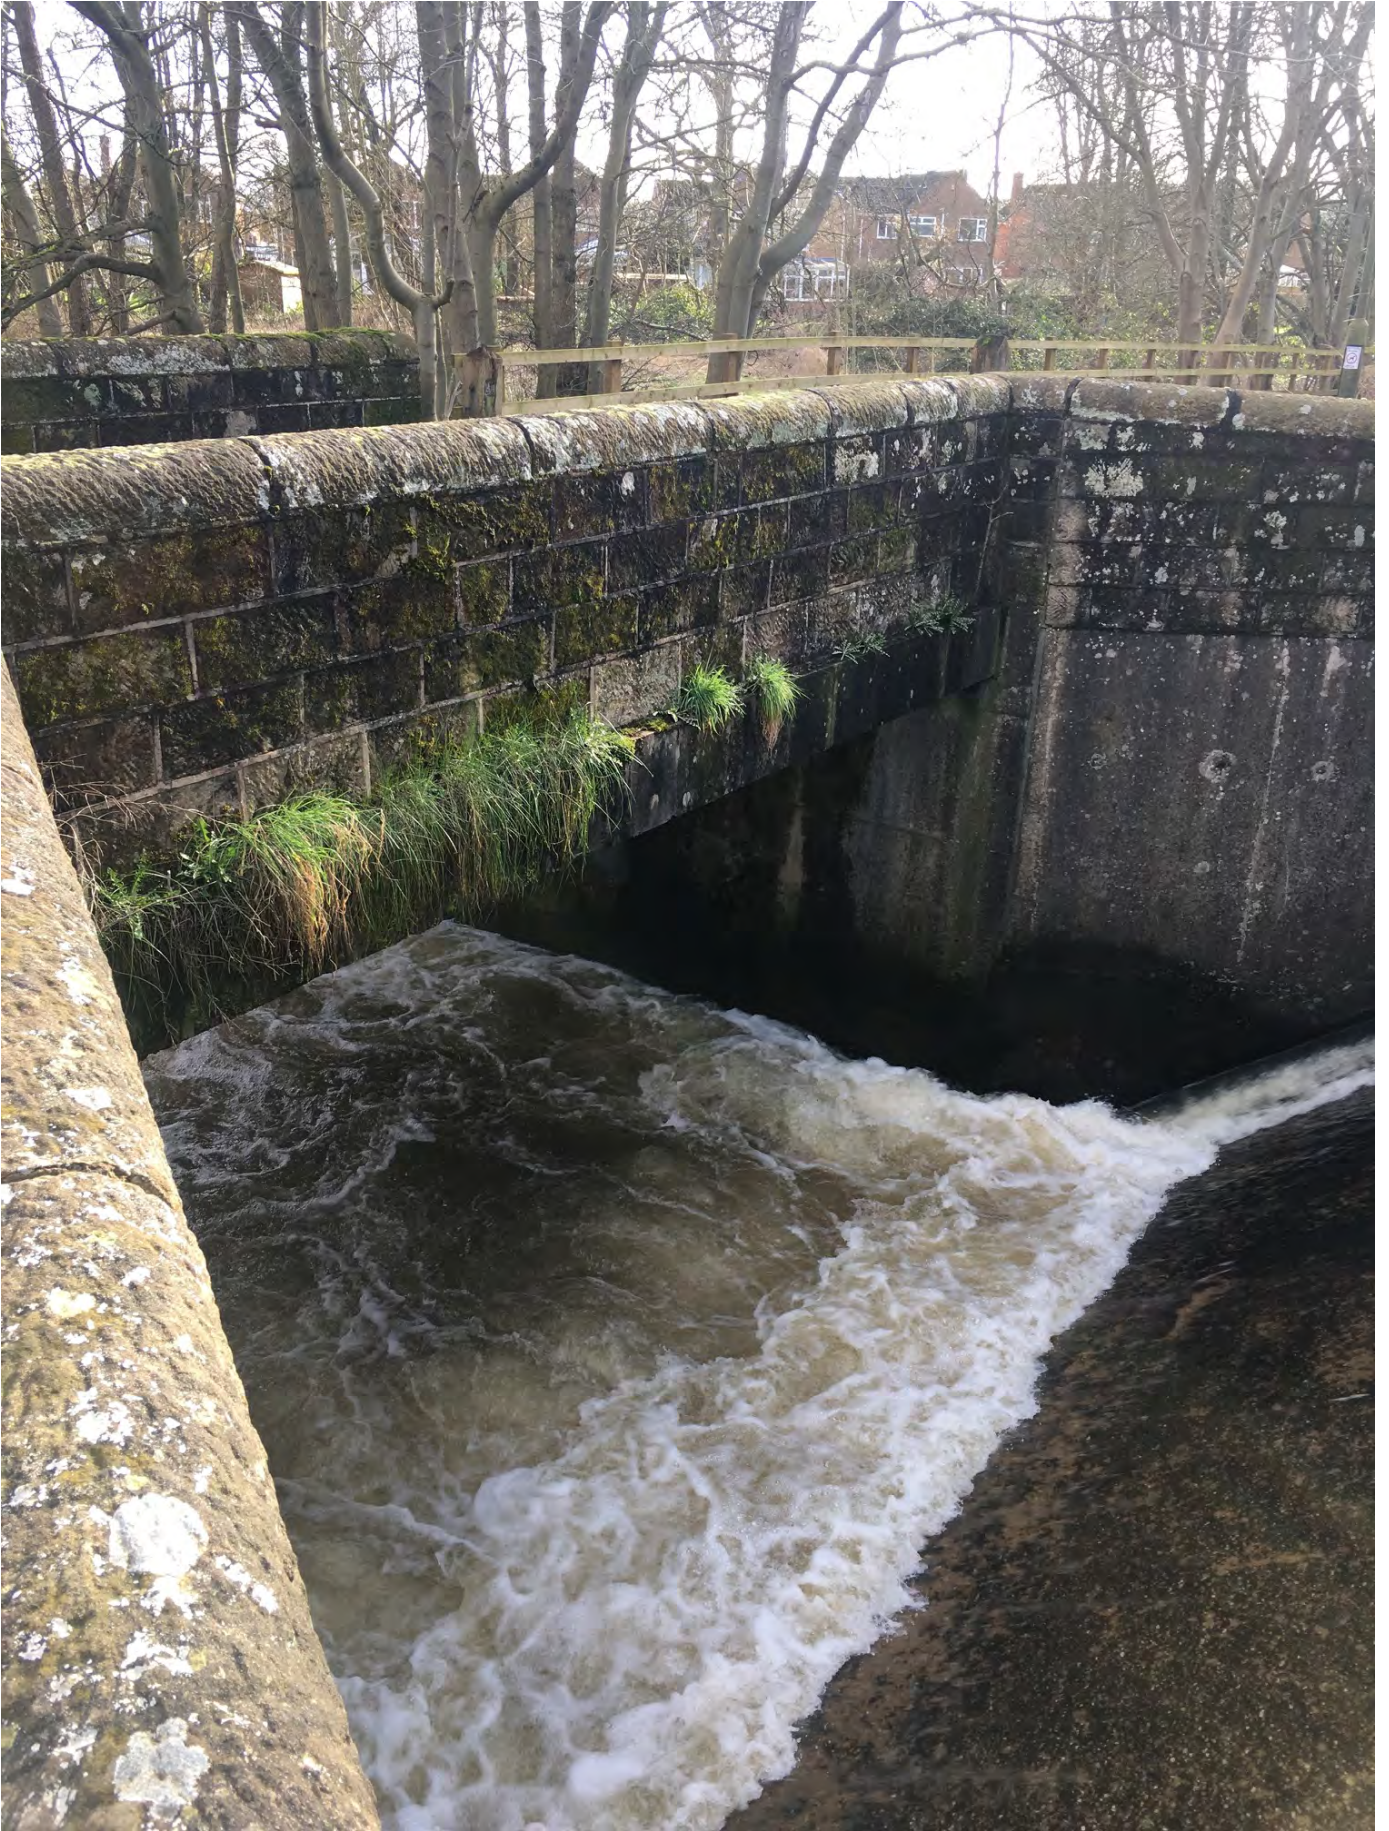
Figure 2.6 Snake Lane weir and access bridge to Duck Island

A field audit was conducted along the study reach of the River Ecclesbourne in Summer 2019 and February 2020. The floodplain zone in the vicinity of the weir is urbanised. The bridge immediately downstream of the weir is used to access the right-hand bank residential properties on Duck Island (Figure 2.6). The weir itself provides a 2m high barrier within the river channel that is completely impassable to fish and significant disrupts the natural flow and sediment regime. The weir is connected to the Duck Island concrete bridge crossing wing walls. No details are available regarding the bridge or weir design, how they are connected and their composition and this needs to be considered in the design process.

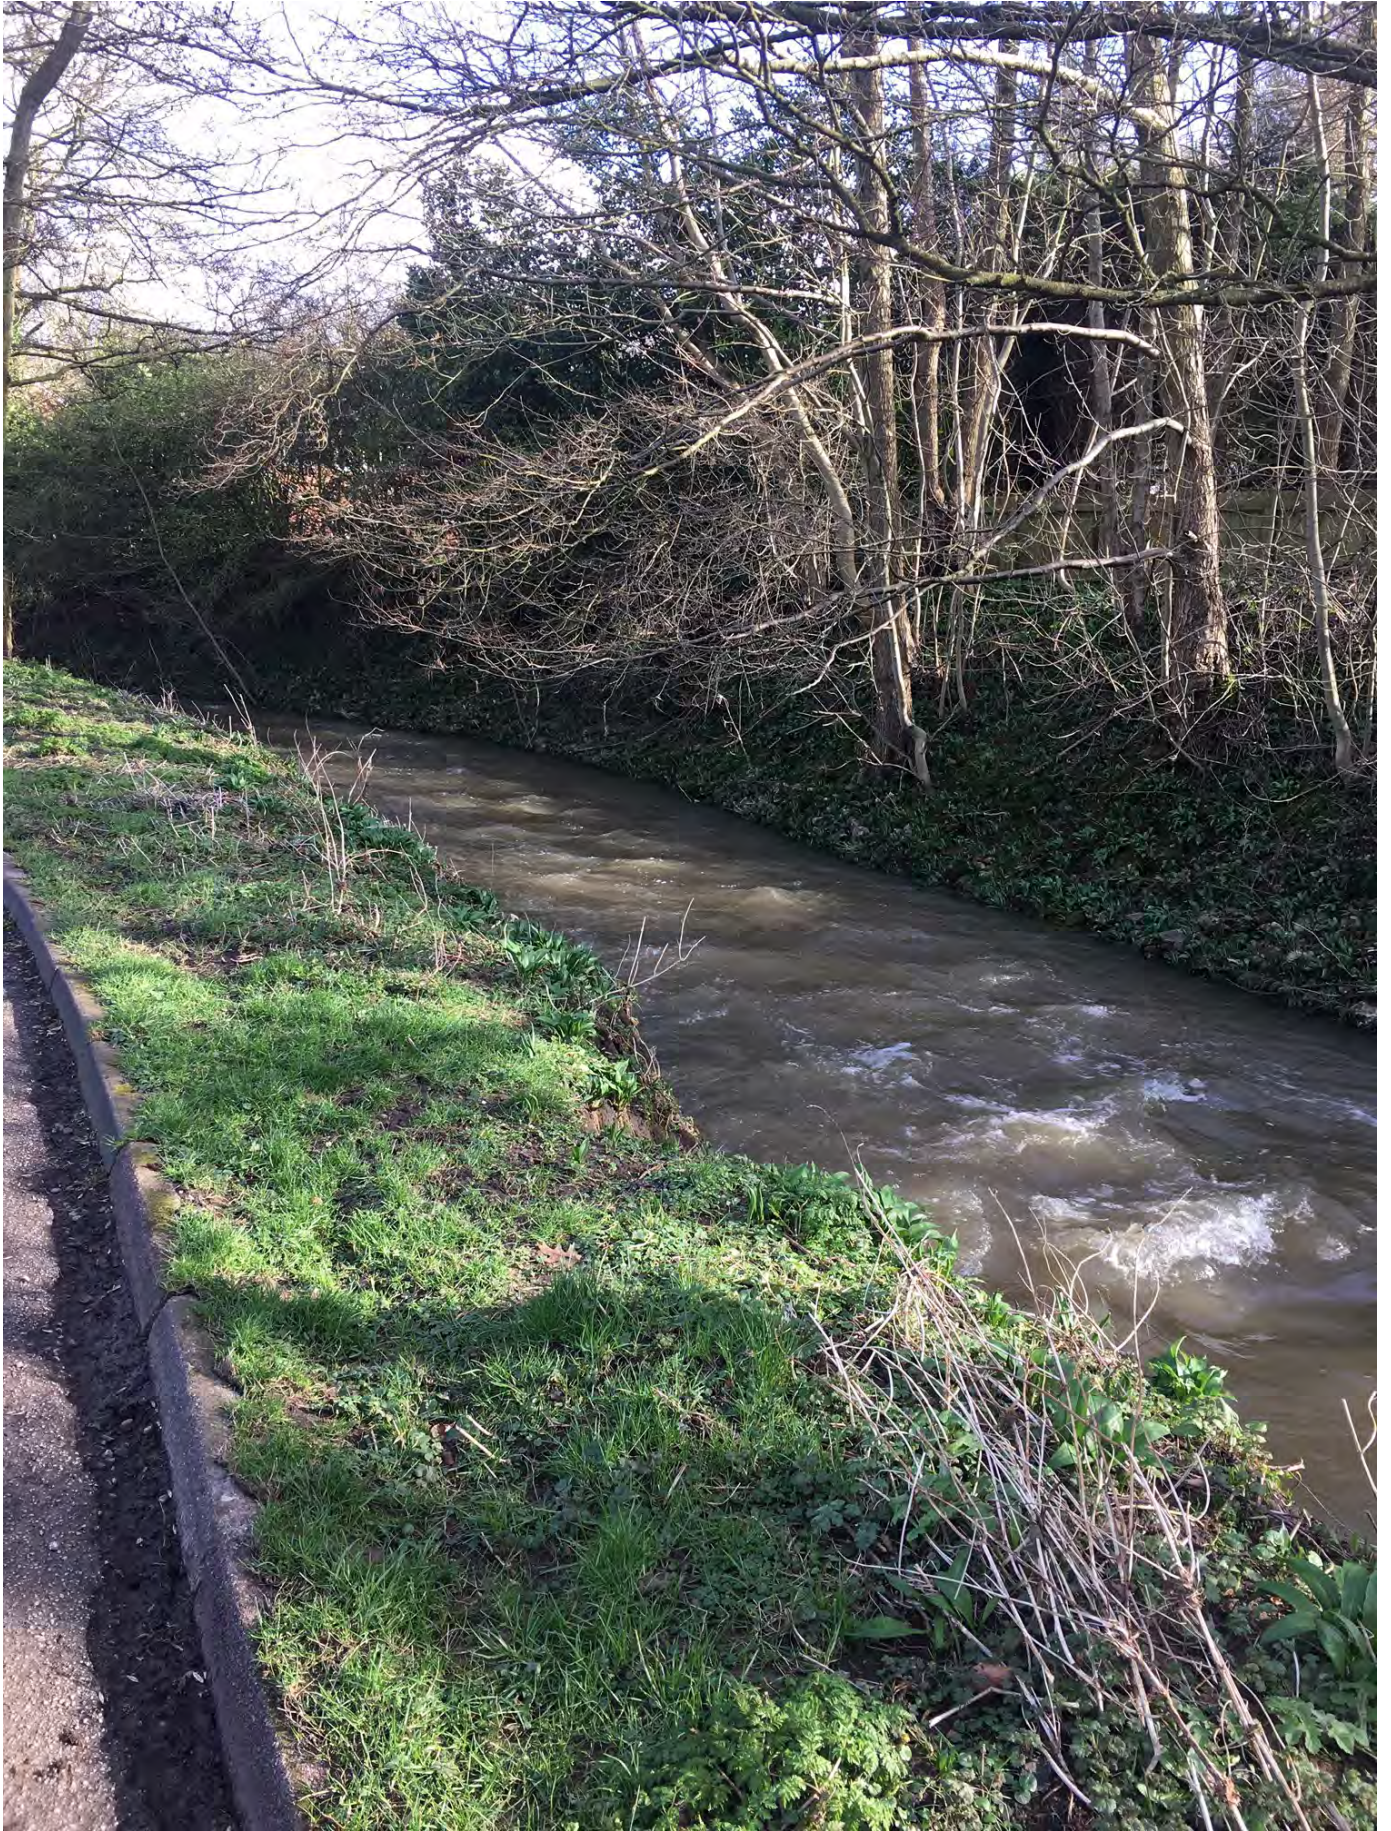
Figure 2.7 High energy flood flows during audit

The watercourse is over-deep (Figure 2.7), displaying width depth ratios <1 confirming the LiDAR evidence, this is likely due to the surrounding urbanisation meaning flood risk protection needs to be maintained through Duffield. Despite being over-deep the bed of the channel displays some morphologic variation beyond the influence of the various weir structures along its course. Gravels and cobbles form the majority of the visible bed material (visibility during the audits was hampered by high river levels) with riffle / rapid type features evident in places, reflecting the relatively high energy flow conditions along this reach outside of the impounding influences of the weir structures. The prevalence of gravel material suggests a strong supply from upstream, which is evidenced by the presence of gravels further downstream within the main town area. Mixed sediment has accumulated behind Snake Lane weir within the impoundment zone, but it is likely this could be redistributed as part of feature creation alongside weir modification options discussed below.

A poorly connected narrow floodplain is present on the right and left banks, reduced in extent by nearby residential property. This creates increased velocities within the channel during elevated flows, as shown in Figure 2.7 above. This needs to be considered in the design of in-channel features, as described in the sections below, to ensure installed features are stable across the flood flow regime. Two outfalls are also present just upstream of the overspill weir (Figure 2.10), these are just beyond the influence of the proposed scheme.

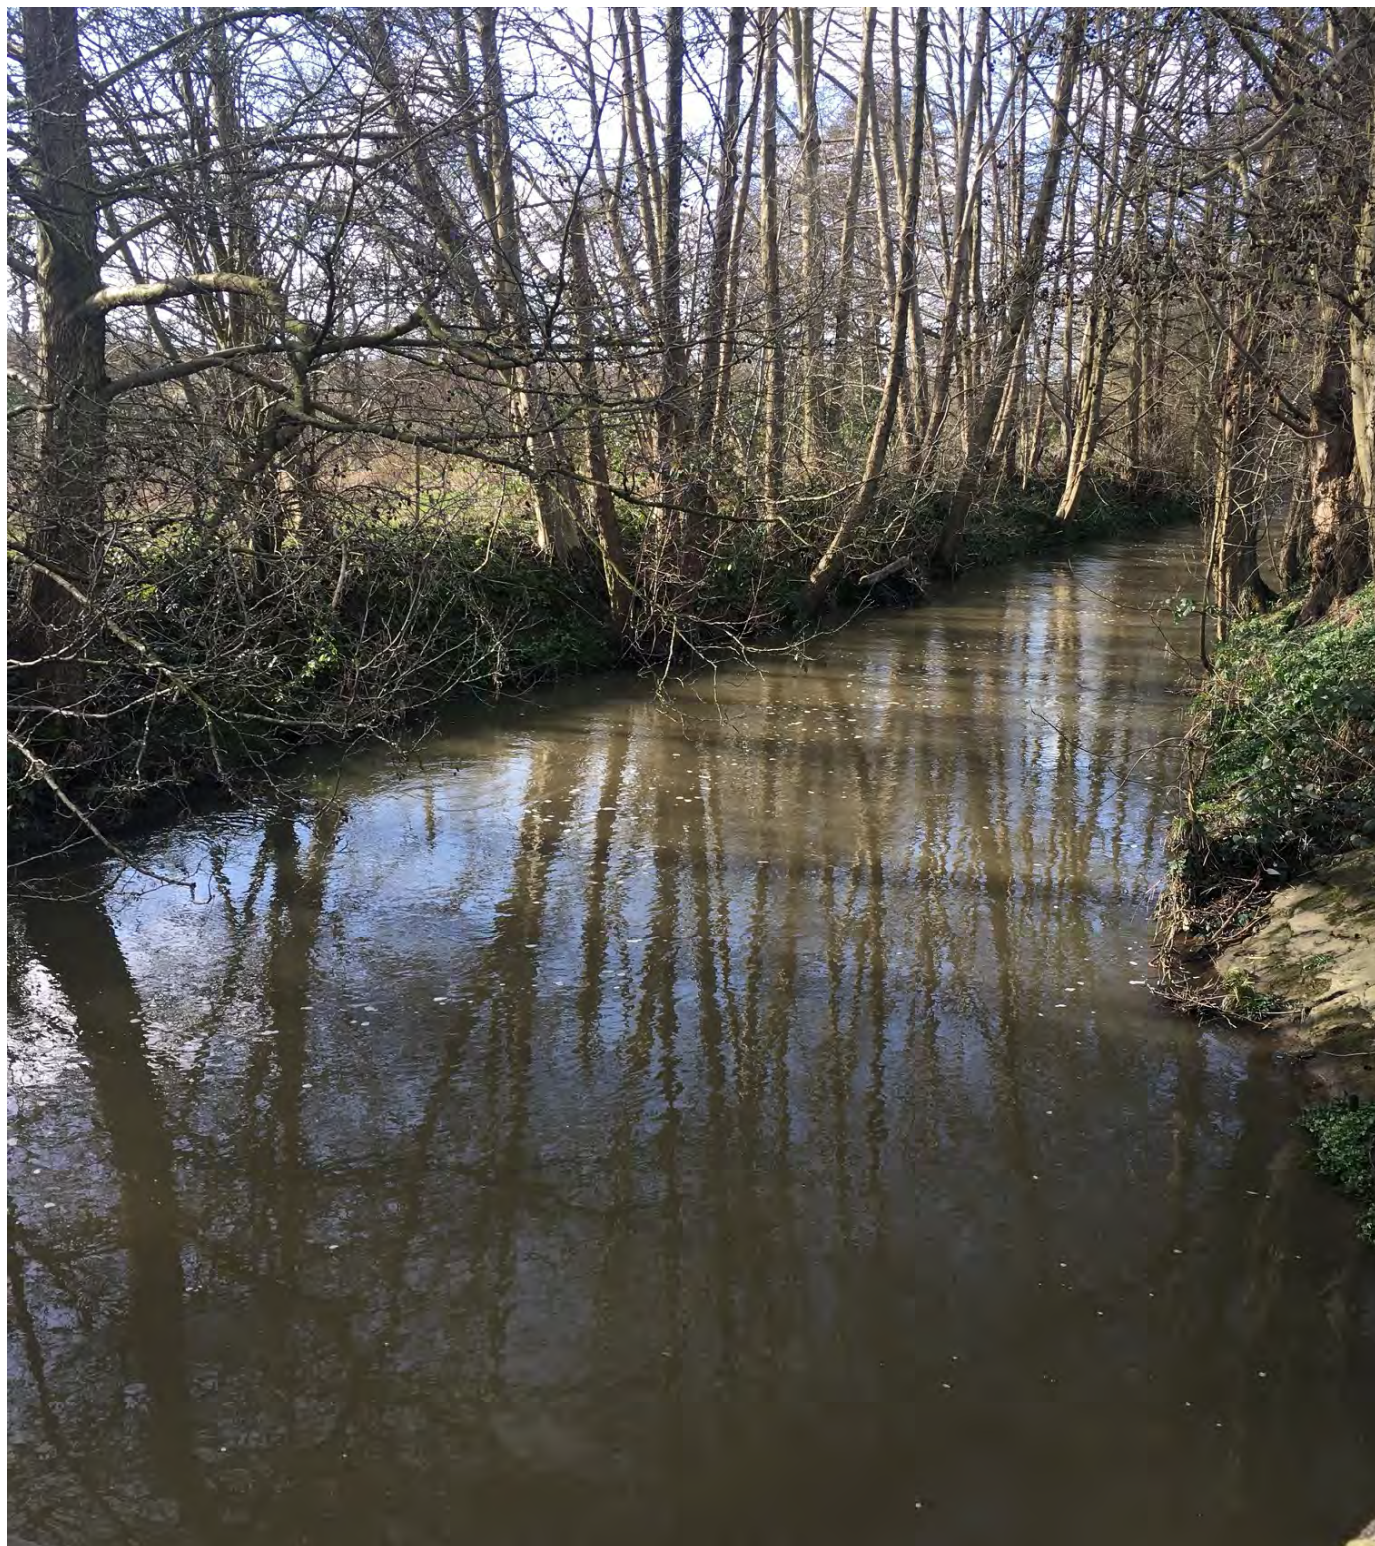
Figure 2.8 Impoundment zone upstream of Snake Lane weir

Flow in the main channel is disrupted by the weir (Figure 2.8) and ponding extends back upstream for around 60 m. Despite this, some bedload now passes over the structure as evidenced by the deposits of mobile sediment downstream within the main town of Duffield. These deposits have been historically removed by the Environment Agency to maintain flood capacity (it is unclear whether this still occurs at the time of writing). Removal of the weir will encourage the transport of sediment through the reach, but will still be interrupted by the further weir structure downstream. As such the deposition in the town will continue with or without the proposed work occurring.

Flow is split around 60m upstream of the Snake Lane weir via a secondary overspill weir into the channel to the south of the main Ecclesbourne channel. Flow into this secondary channel needs to be maintained as part of designs developed for this project. The channel bed and banks are protected in numerous locations along the study reach by hard measures (principally rip rap and walling) due to the close presence of residential properties, footpaths and other infrastructure. A single line of trees also lines the banks along many reaches (Figure 2.8 & Figure 2.9).

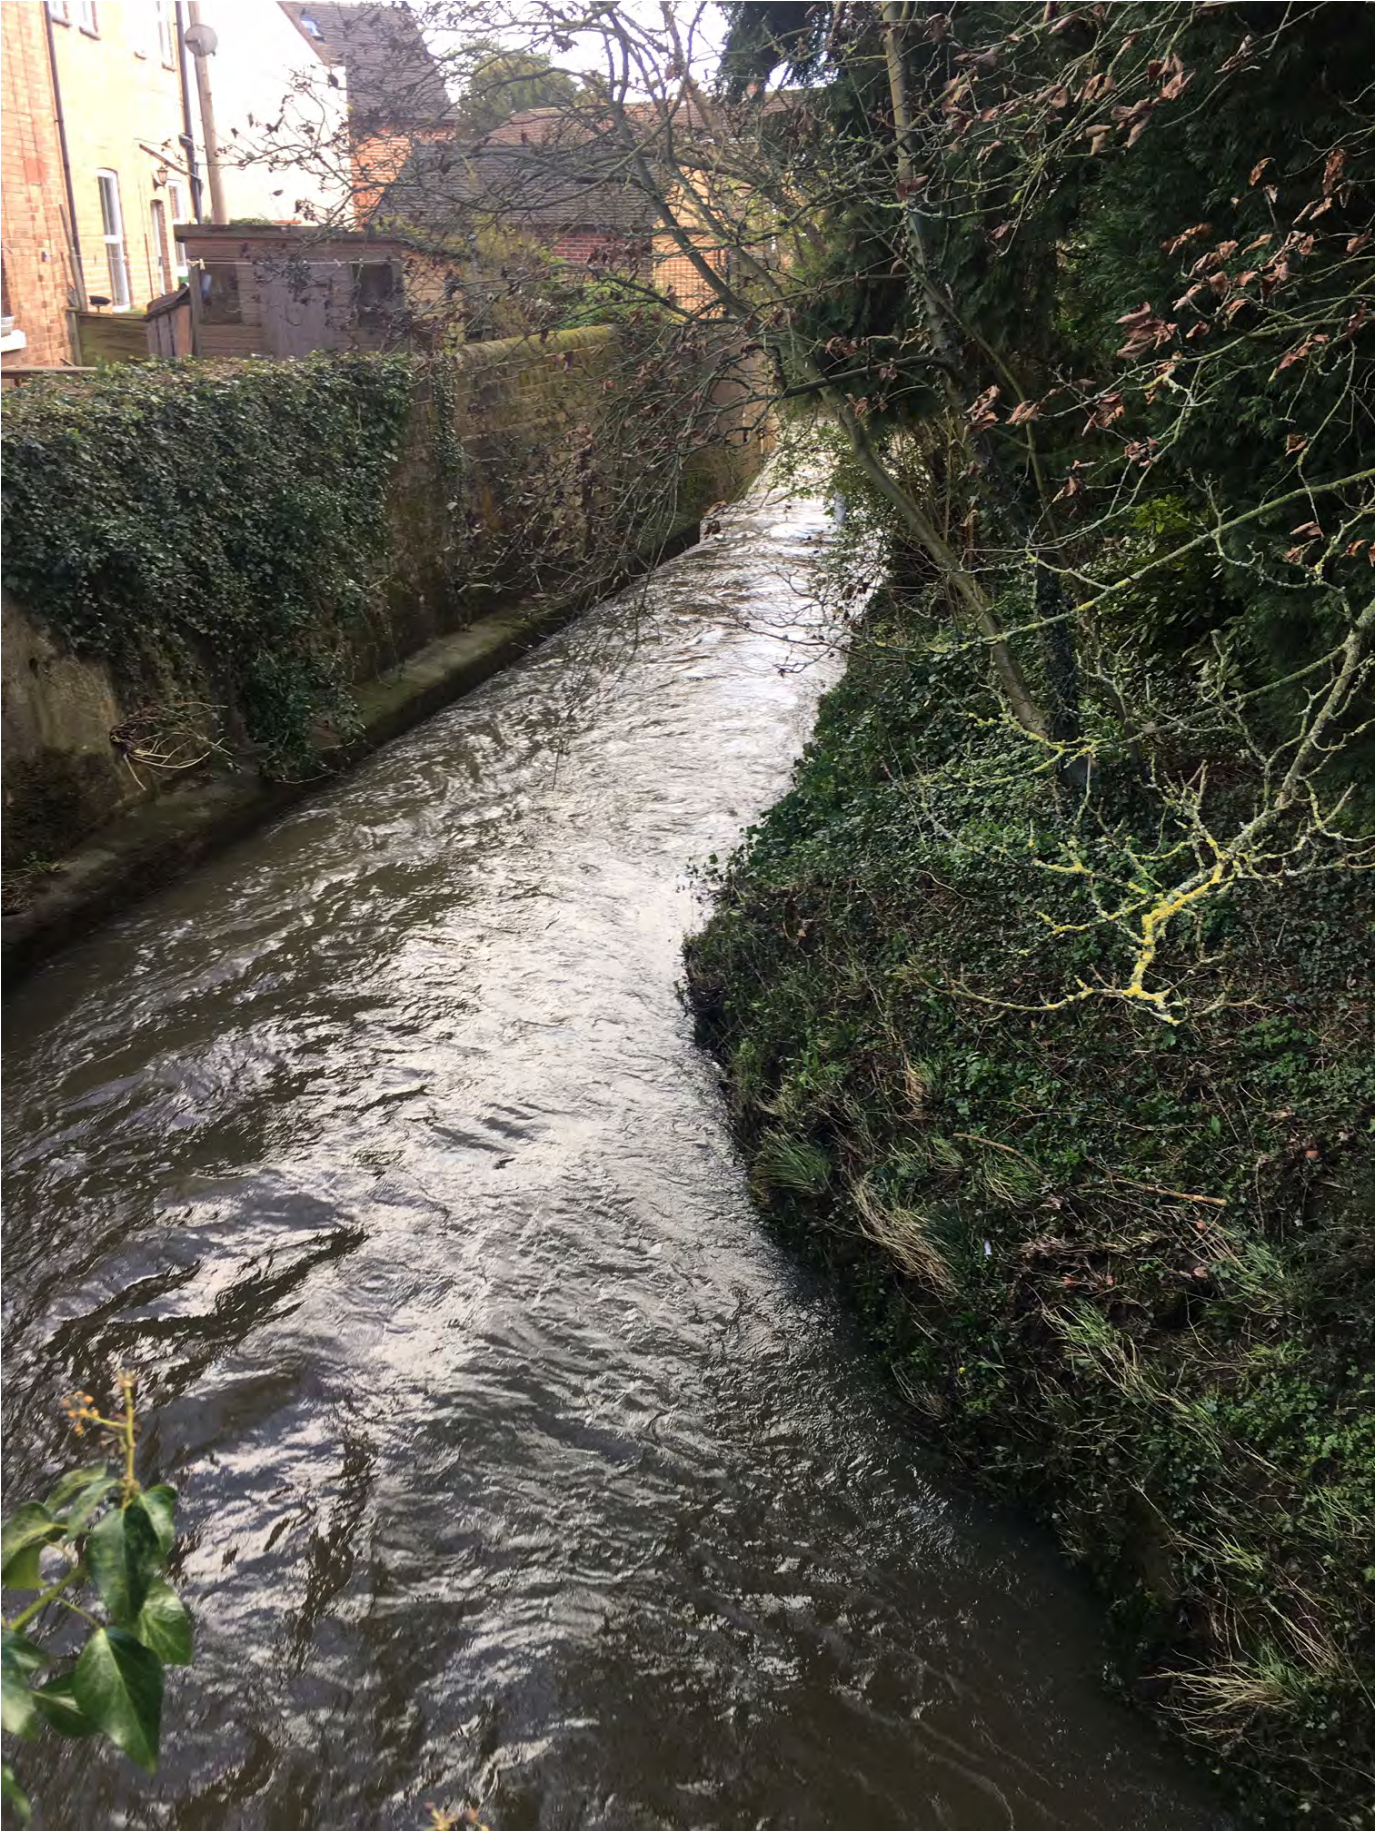
Figure 2.9 Walling lining the river bank

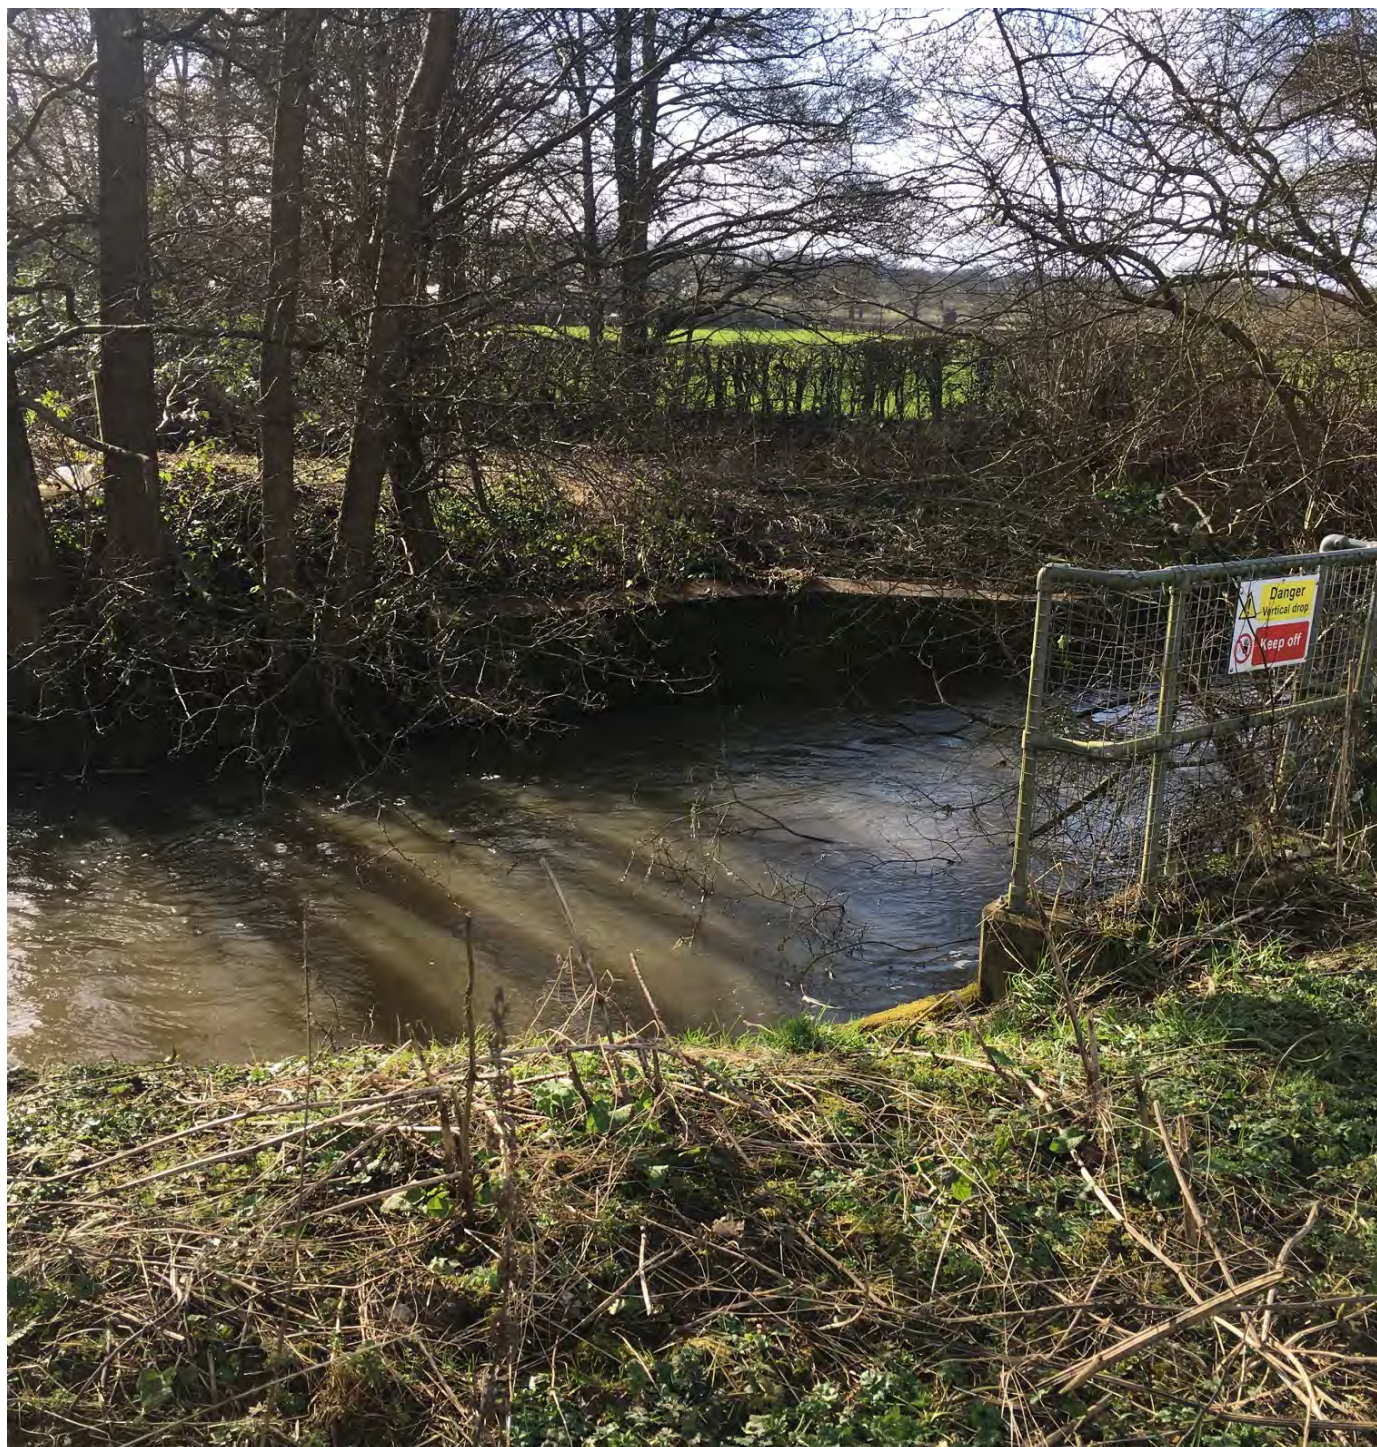
Figure 2.10 Outfall upstream of overspill weir

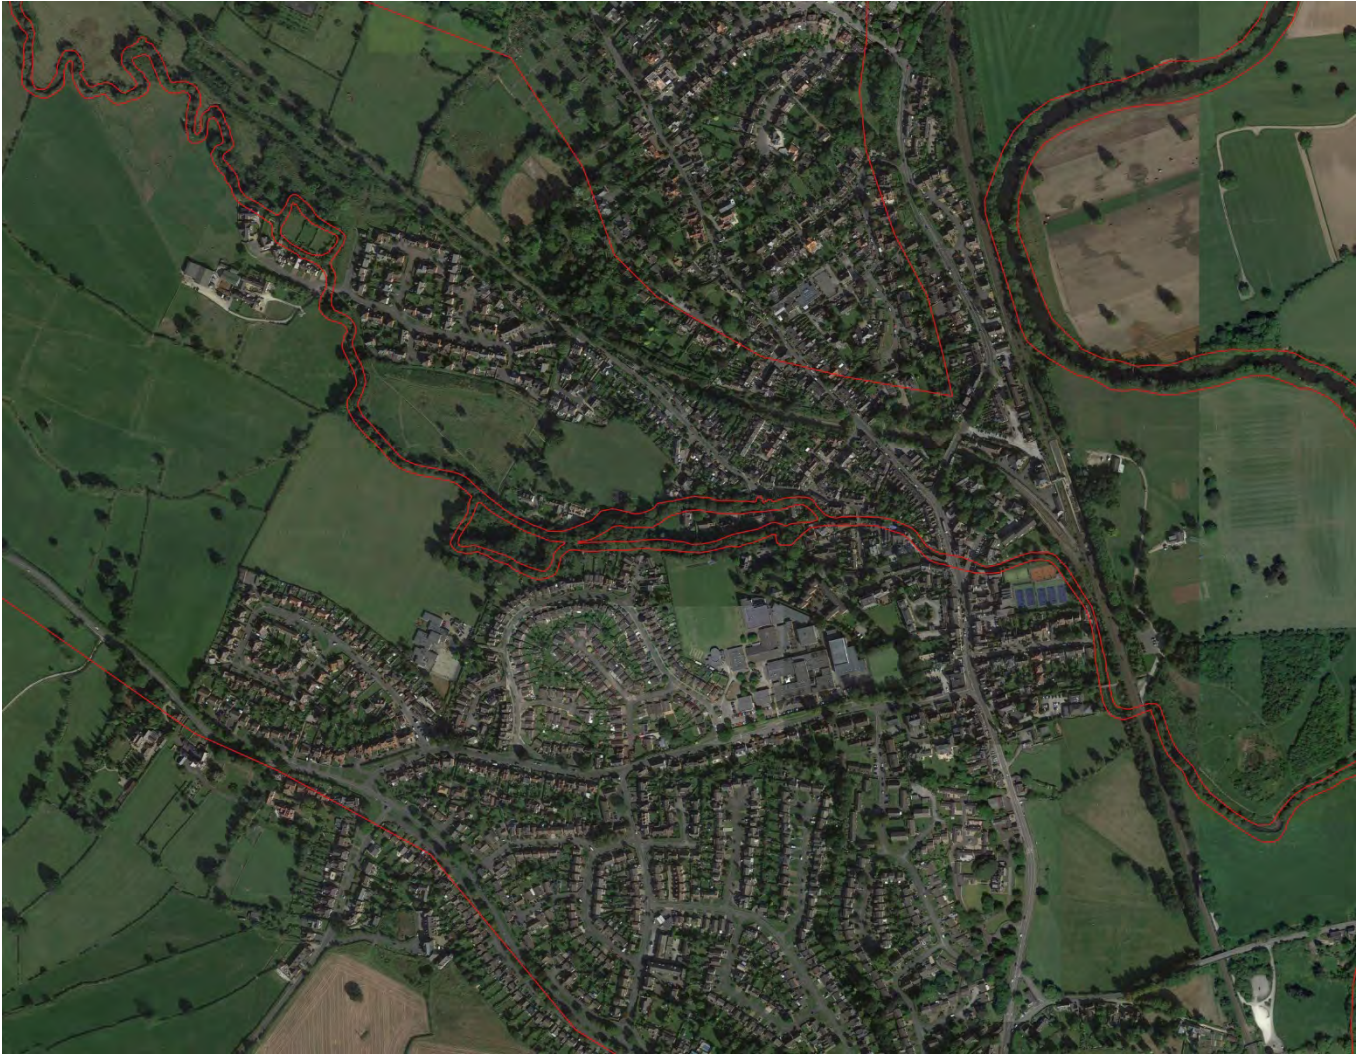
Figure 3.1 1D-2D Model extent (Google Earth base map)

To determine the flood risk impact associated to the preferred option identified from the 2D modelling described above, the supplied 1D-2D Flood Modeller Pro – TUFLOW model of the River Ecclesbourne, supplied by the Environment Agency, was utilised (Figure 3.1). The baseline model was updated with the newly gathered survey to ensure this reflected current channel conditions. This resulted in some minor adjustments to the existing model cross-sections and a minor change to the height of the Snake Lane weir. The 1D model geometry was then modified to reflect the preferred option and run for a variety of return periods to determine the flood risk impact of the scheme.

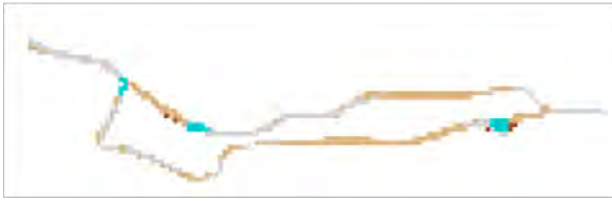
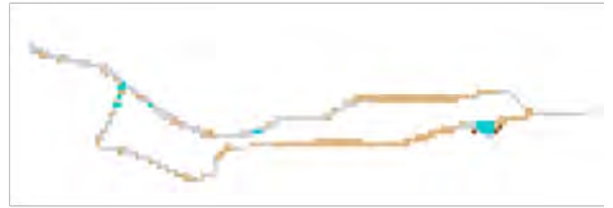
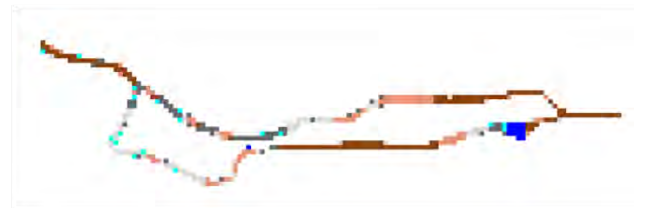
Figure 4.1 Good summer flow (Q95) hydraulic habitat / biotope and depth change compared to baseline for impacted reach of the Ecclesbourne (pie chart size scaled to show area change).

Figure 4.1 shows the hydraulic habitat change, compared to baseline, under good summer flow (Q95) conditions as a result of the proposed weir modification scheme described above to provide fish passage across the Snake Lane weir.

The hydraulic habitat area under the same flow conditions is similar as the overall wetted channel length does not change as a result of the weir option and feature introduction. However, there are expected increases in hydraulic habitat diversity as a result of removing the impounding influence of the weir and introduction of the rapid features within the former impoundment zone. This has resulted in 4% increase in riffle habitat and 9% increase in rapid type habitat, with associated reductions in glide and pool habitat. This is supported by the higher proportion of shallower depth flow associated to these higher energy hydraulic habitat types.

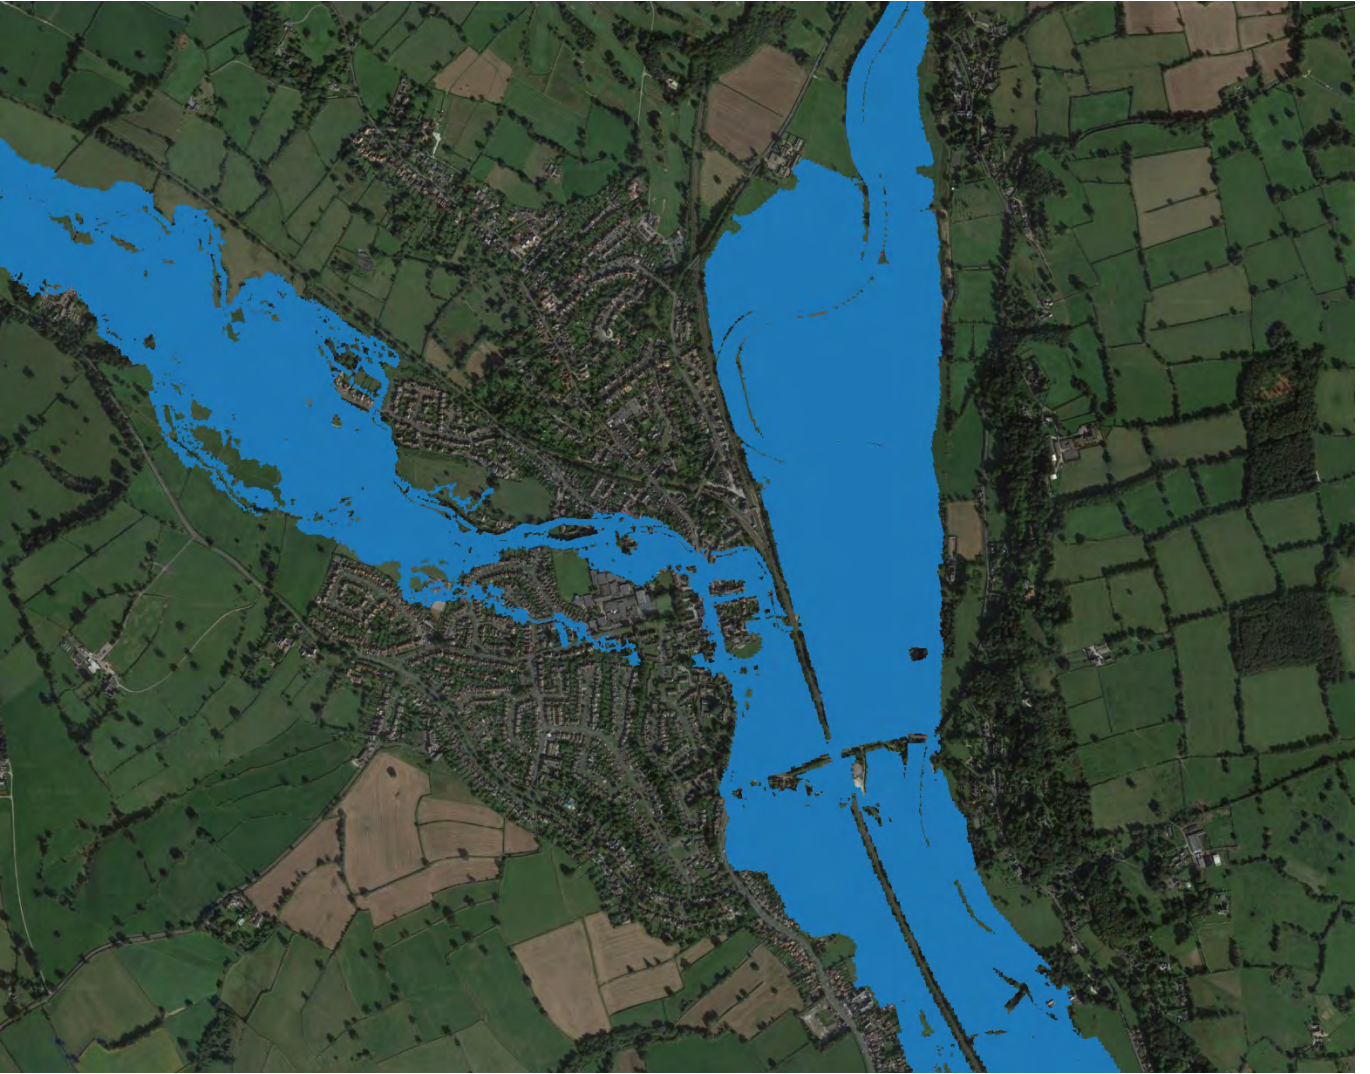
Figure 4.2a 1 in 100yrCC flood extent change, blue = baseline, red = restored (where red is visible indicates flood extent increase).

Figures 4.2 to 4.3 demonstrate the flood extent changes for each of the flood return periods listed above, with baseline shown in blue and the restored scenario shown in red. The 'a' figures show flood extent increases as a result of the restored option for each return period modelled (visible red areas) and the 'b' figures show flood extent decreases as a result of the restored option (visible blue areas). For the 1 in 100yrCC event, there are minor flood extent reductions as a result of notching the weir over the immediate right and left bank close to the weir structure, this is a result of a lowering of the impounding influence of the significant weir structure. There is no flood extent increase associated to this option within model tolerances. For the 1 in 5yr event, there is very little out of bank flow and therefore limited difference between baseline and restored conditions.

The model extends downstream to the Derwent and there are no increases in flood risk down to the confluence with the Derwent for either the 1 in 100yrCC or the 1 in 5yr return period events, as shown in Figure 4.2 and 4.3 above.
