Ecclesbourne at Snake Lane Weir Design

Technical Note FINAL

Wild Trout Trust

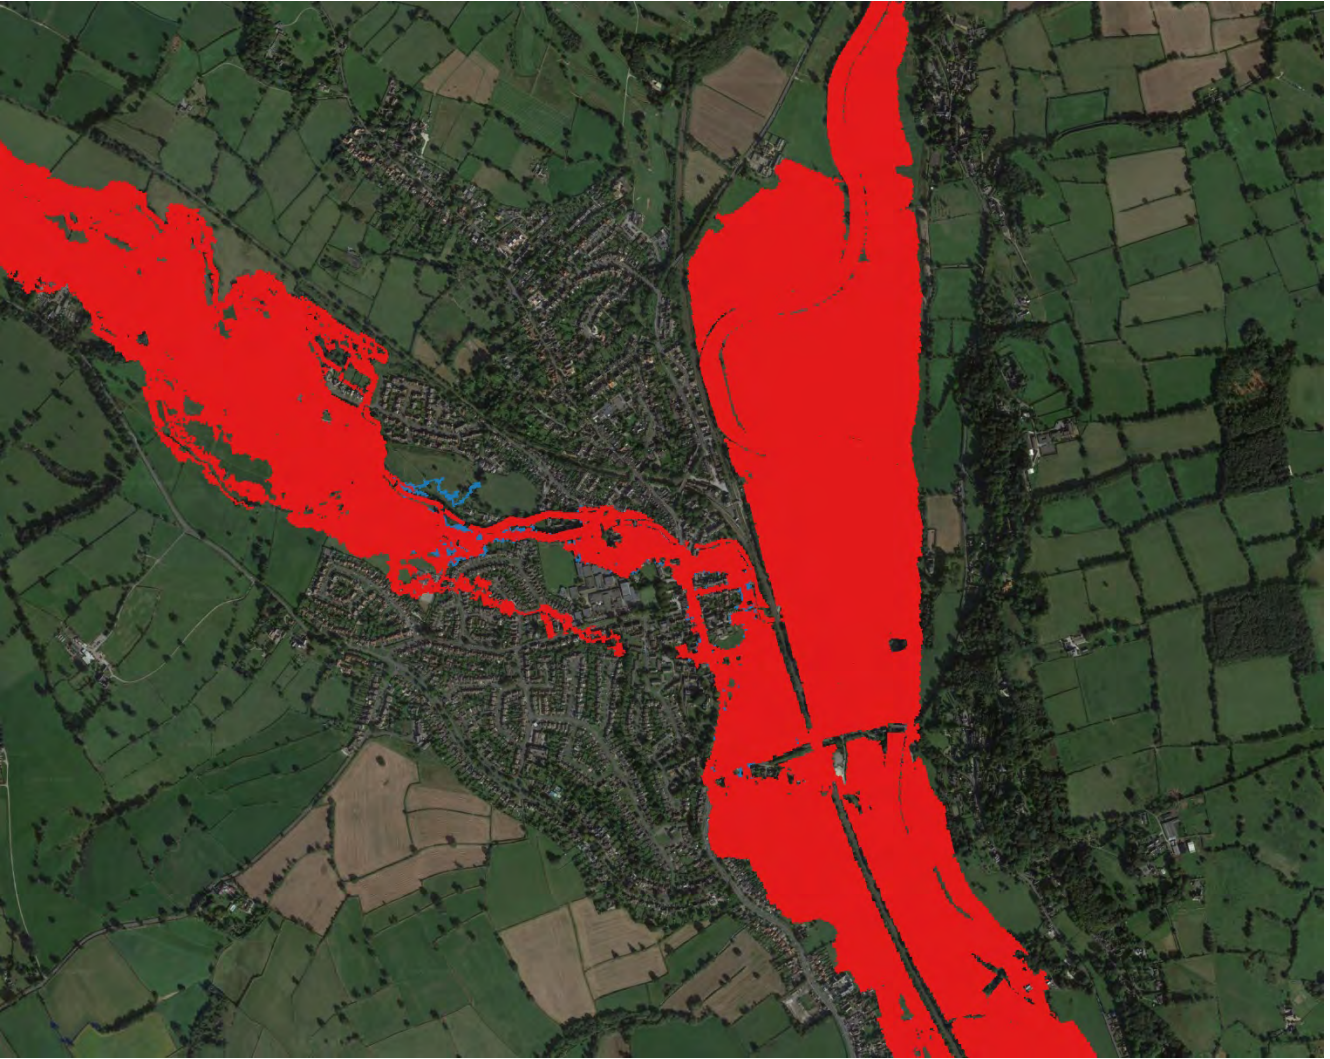
Figure 4.2b 1 in 100yrCC flood extent change, blue = baseline, red = restored (where blue is visible indicates flood extent decrease).

Figures 4.2 to 4.3 demonstrate the flood extent changes for each of the flood return periods listed above, with baseline shown in blue and the restored scenario shown in red. The 'a' figures show flood extent increases as a result of the restored option for each return period modelled (visible red areas) and the 'b' figures show flood extent decreases as a result of the restored option (visible blue areas). For the 1 in 100yrCC event, there are minor flood extent reductions as a result of notching the weir over the immediate right and left bank close to the weir structure, this is a result of a lowering of the impounding influence of the significant weir structure. There is no flood extent increase associated to this option within model tolerances. For the 1 in 5yr event, there is very little out of bank flow and therefore limited difference between baseline and restored conditions.

The model extends downstream to the Derwent and there are no increases in flood risk down to the confluence with the Derwent for either the 1 in 100yrCC or the 1 in 5yr return period events, as shown in Figure 4.2 and 4.3 above.

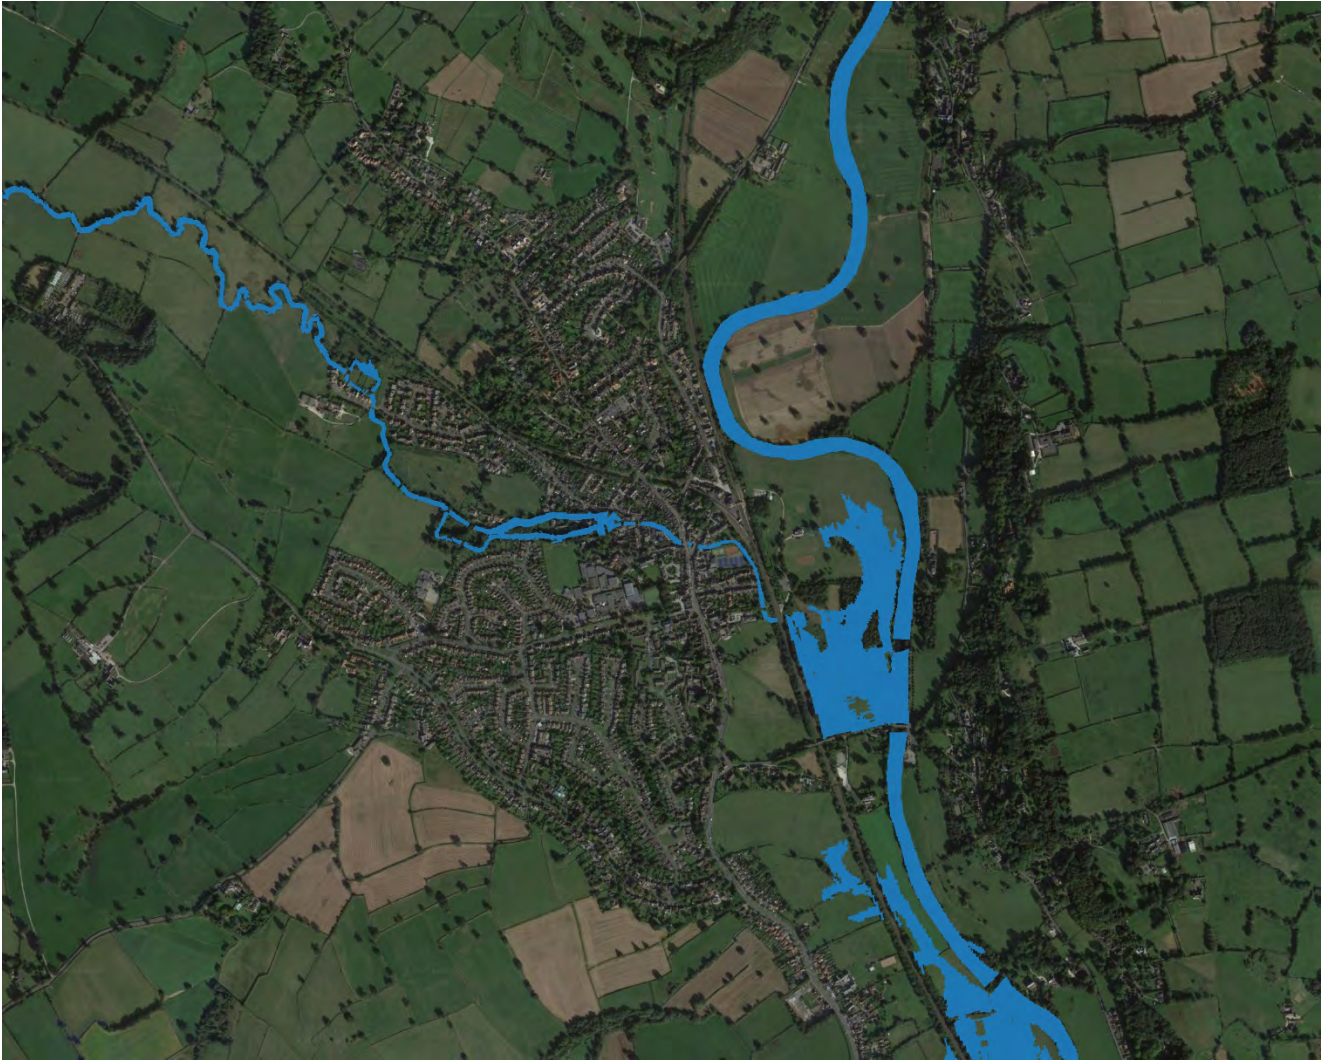
Figure 4.3a 1 in 5yr flood extent change, blue = baseline, red = restored (where red is visible indicates flood extent increase).

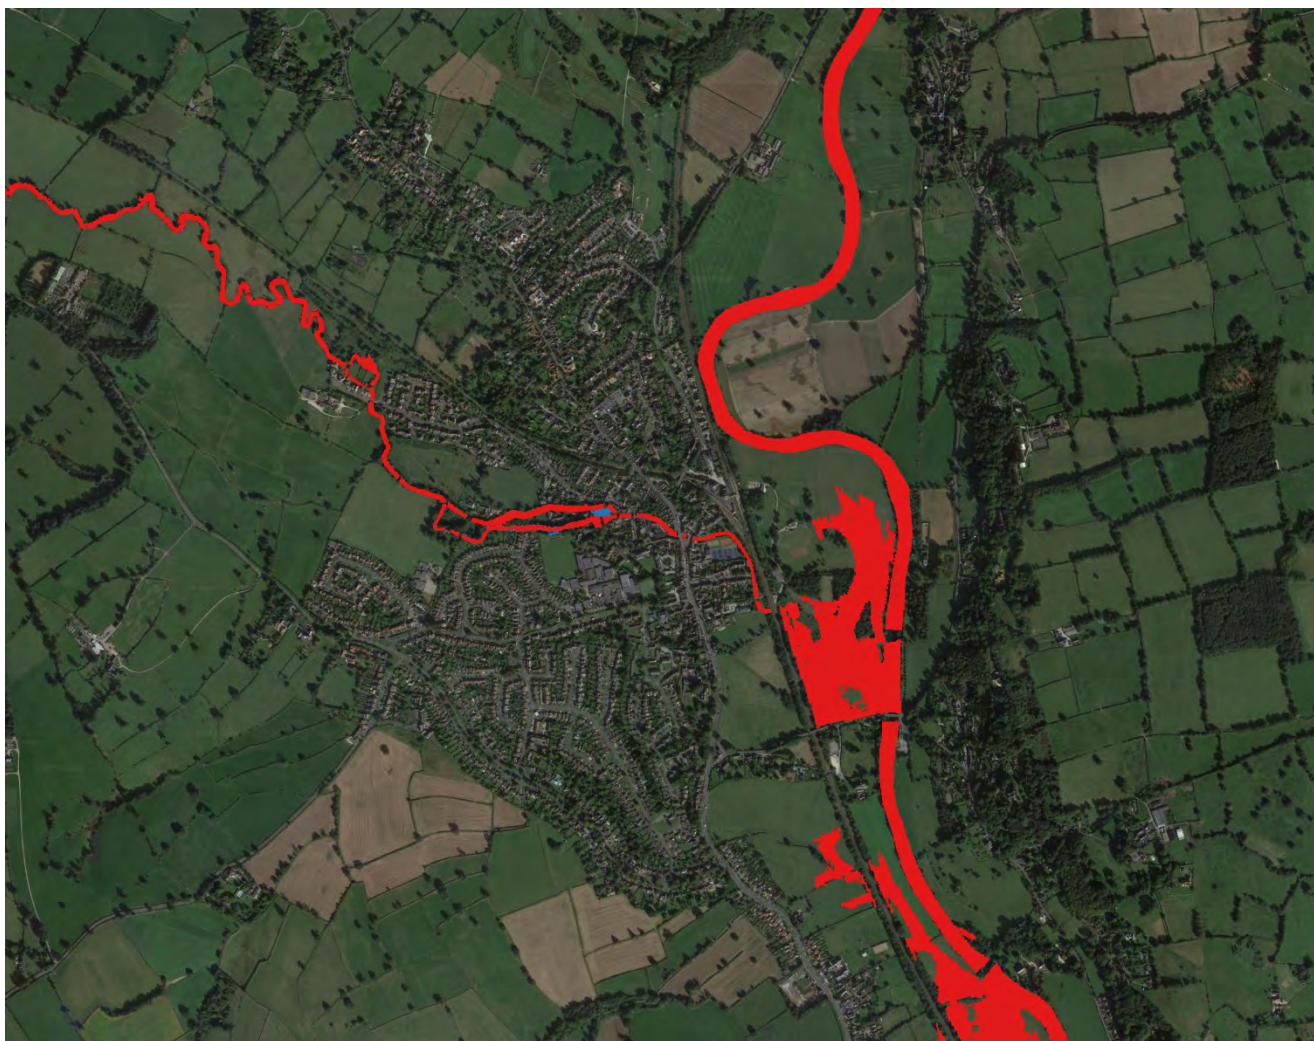
Figure 4.3b 1 in 5yr flood extent change, blue = baseline, red = restored (where blue is visible indicates flood extent decrease).
