# A Cinderella River

## The River Glaven Conservation Group (RGCG) in river habitat improvement 2006.

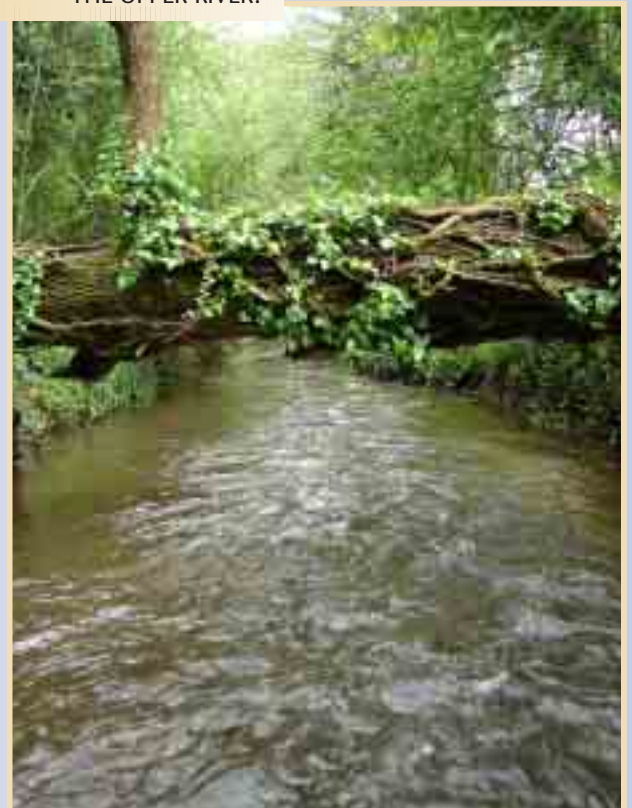
A TYPICAL SECTION OF THE UPPER RIVER.

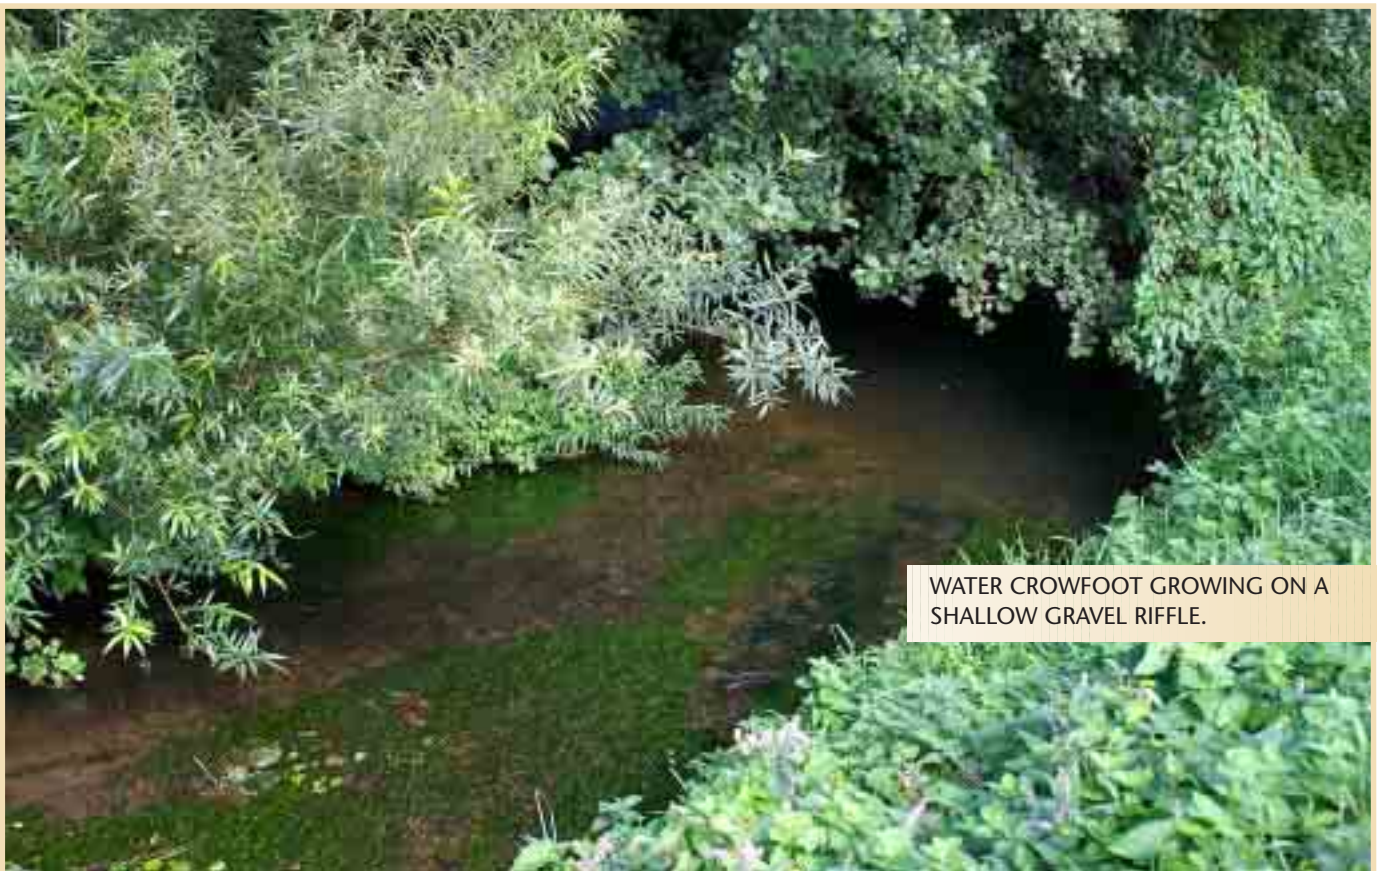
WATER CROWFOOT GROWING ON A SHALLOW GRAVEL RIFFLE.

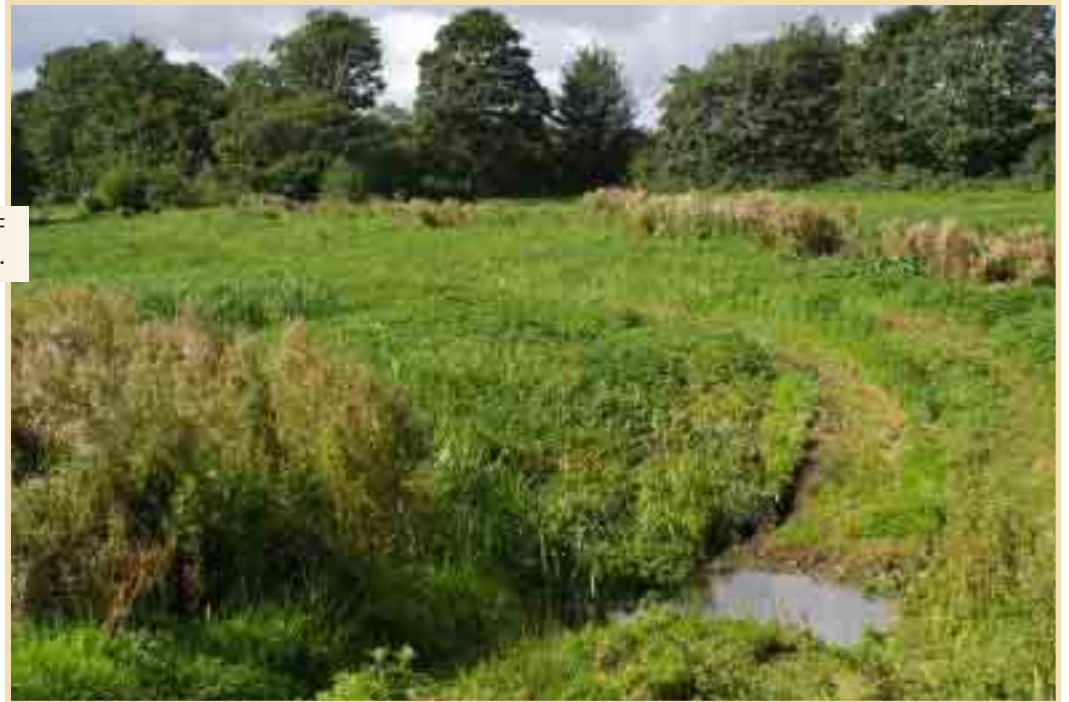
FORD CROSSING OF  
THE RIVER.

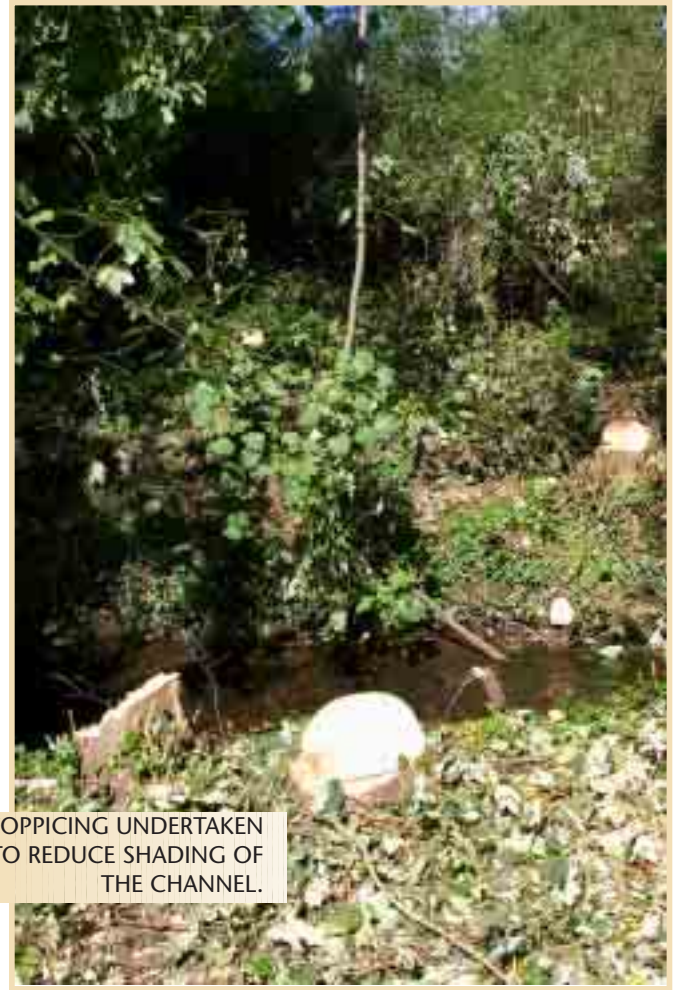
COPPICING UNDERTAKEN TO REDUCE SHADING OF THE CHANNEL.

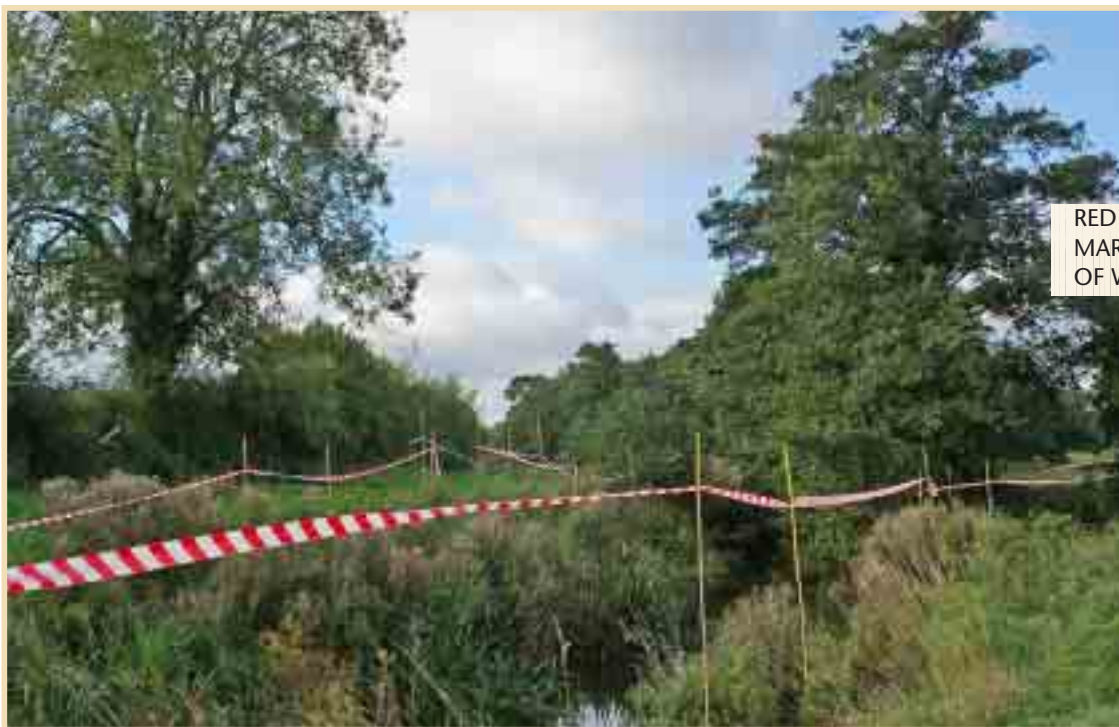
RED AND WHITE TAPE MARKING THE LOCATION OF WATER VOLE BURROWS.

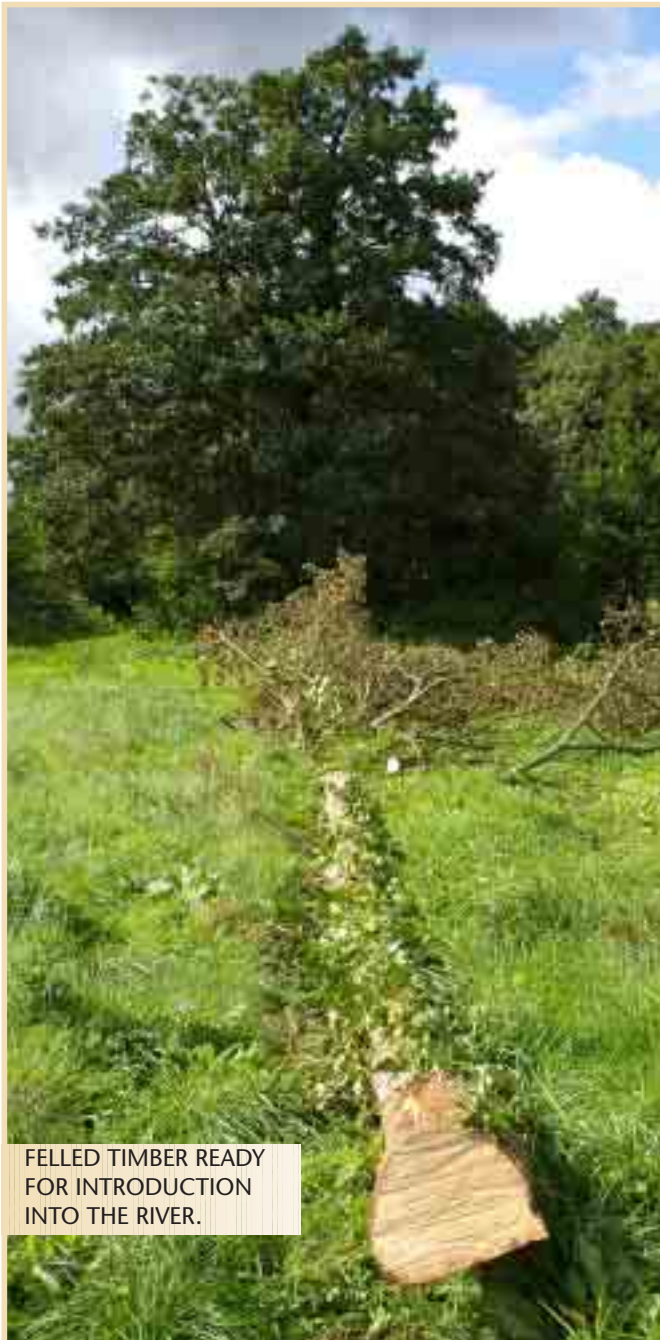
FELLED TIMBER READY FOR INTRODUCTION INTO THE RIVER.

between 1 and 2 feet in diameter. These were used as flow deflectors and one end set in the bank with an up-stream angle of about 30\*. Eight sections were required, and all were drawn from the 6 sycamores that had been felled in the preparation stage.

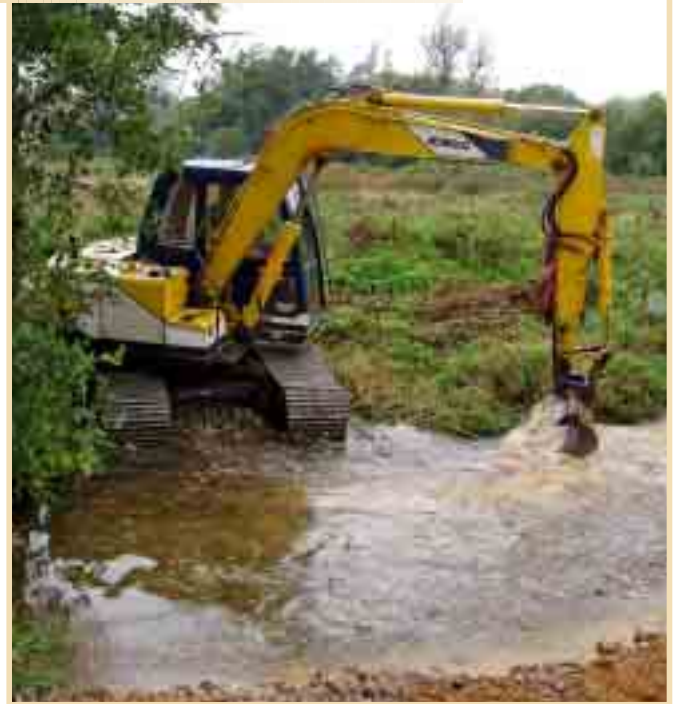
GRAVEL BEING PUT INTO THE RIVER IN ORDER TO CREATE SHALLOW RIFFLES FOR TROUT SPAWNING.

Reject flint from Cemex stacked at the hard surface area was loaded by a digger into a 3t dumper which ferried to the various areas of river bank where it was to be used, and similarly for the gravel. The stone was placed by digger in the river bed to a depth to around 75% of the final level of stone and gravel required. The lengths of the riffles were a compromise between the ideal (15 metres or more) and what could be contained within the project costs, and the material spread by the digger bucket. The stone was followed by the upper layer of 20-40mm gravel, a compromise

between what was best for spawning brown trout and the habitat for the white-clawed crayfish. The weight ratio of stone to gravel was around 3 to 1, but varied with water depth.

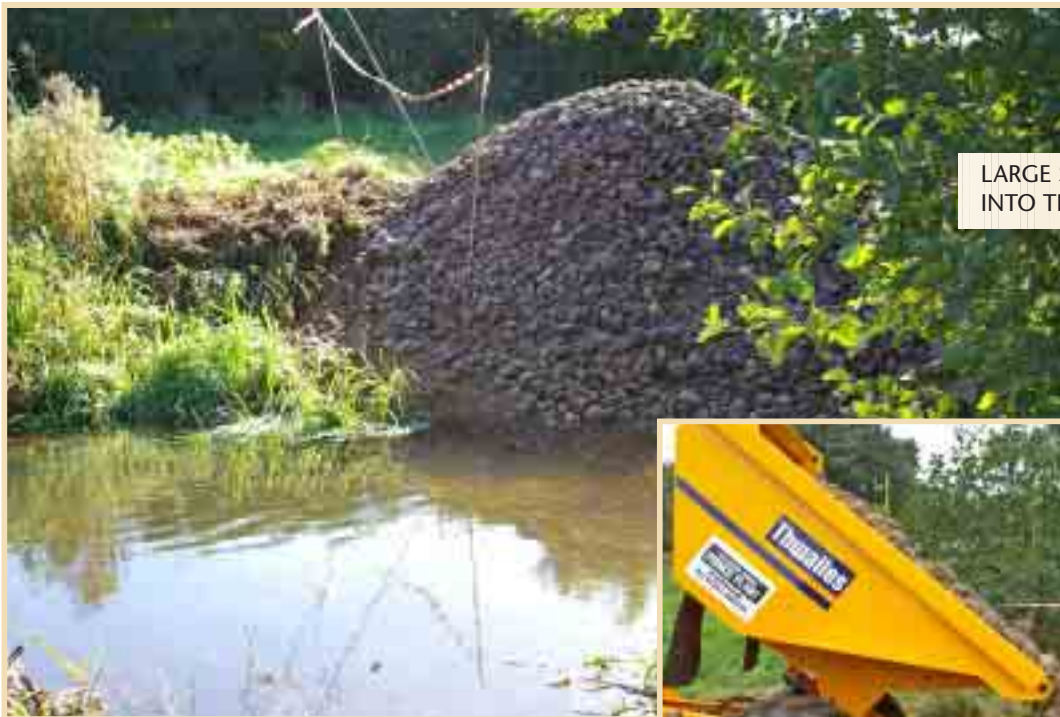
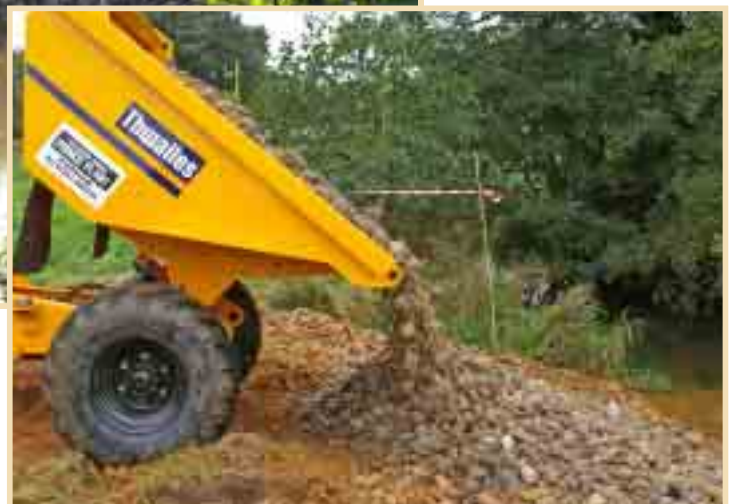
LARGE STONE BEING INTRODUCED INTO THE CHANNEL.

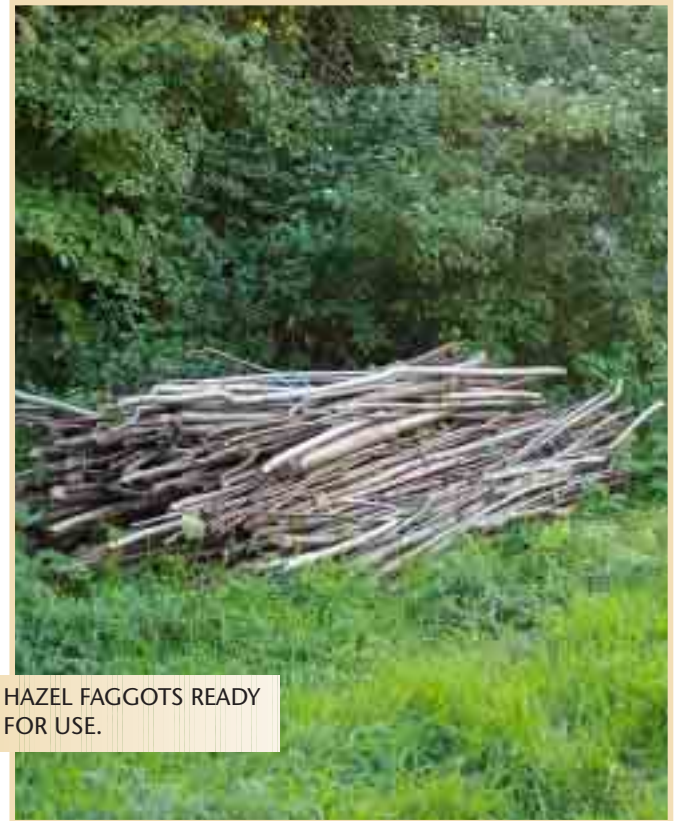
HAZEL FAGGOTS READY FOR USE.

The main wood material used was hazel, and in the plan was to be designated for bank narrowing, with a smaller amount for the island work. As part of the preparations leading up to the work in the second half of September 120 hazel faggots were made from material cut from trees on the Bayfield estate. The bundles were some 7 feet long and 1 foot in diameter.

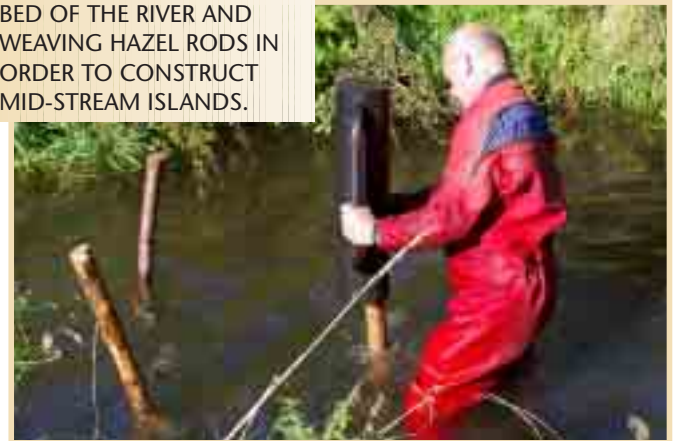
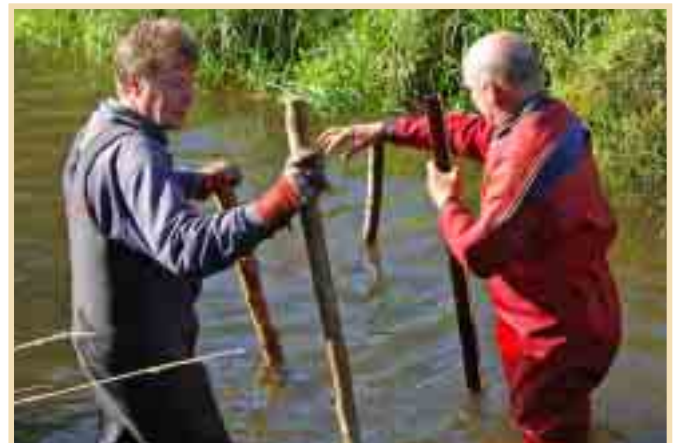
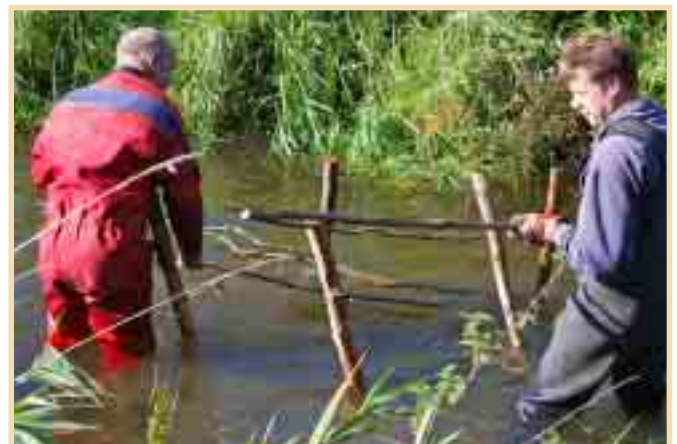
DRIVING STAKES INTO THE BED OF THE RIVER AND WEAVING HAZEL RODS IN ORDER TO CONSTRUCT MID-STREAM ISLANDS.

Three mid-stream islands were constructed near footbridge 1 (see map 2). The method of construction was the same as the river narrowing work, and in time the structures would develop as islands with vegetation. The top level of the islands were planned to be 150-200mm above water level.

Each of the islands formed a point at the upstream end, but set at a slight angle to the river flow. They were 2-3m long and some half metre wide. Each was built around a frame of 7 stakes driven into the river bed. The third island was in a metre of water, and as noted above the other two had been set where riffle 3 was to be placed. The islands quickly collected silt, leaves and much water cress.

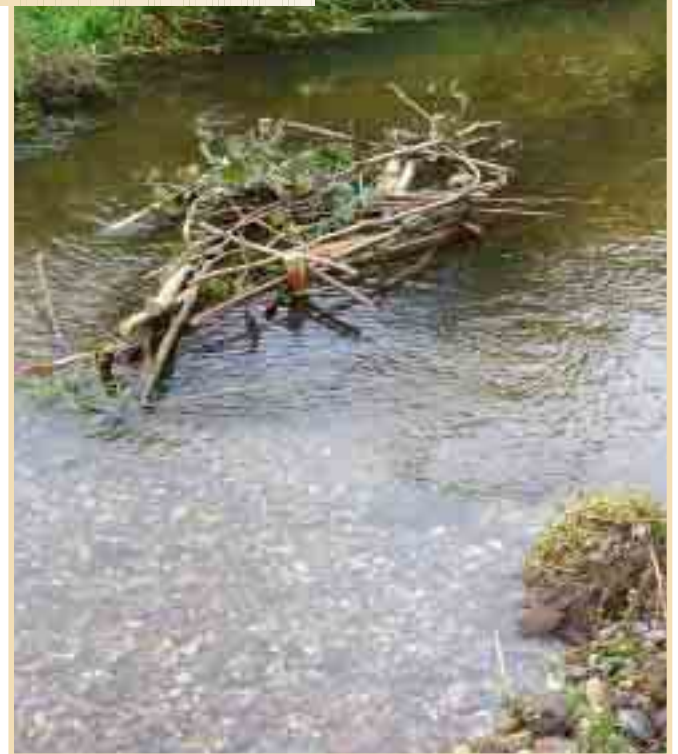
COMPLETED MID-STREAM ISLAND.

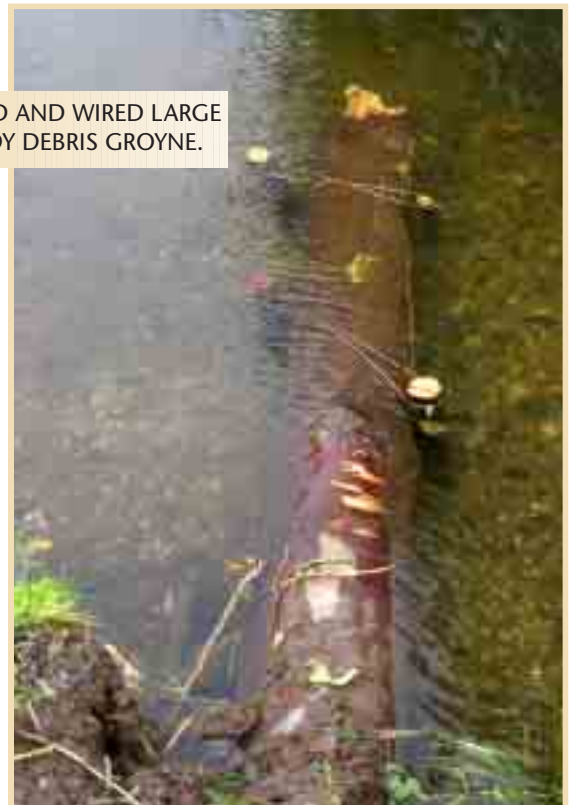
STAKED AND WIRED LARGE WOODY DEBRIS GROYPNE.

Sections of tree trunk were placed in 9 different parts of the river, all in or close to the lower middle reach. The purpose of these is to promote the scouring of the river bed in relatively homogeneous areas, and create high physical diversity within the channel. Past practice of removing all naturally occurring woody debris has an adverse impact on juvenile and adult trout. LWD create simple flow deflectors and provide deeper pools used by adult fish, and smaller pools and shelter areas also. The tree section is orientated to reduce bank erosion and secured by staking and wiring. All sections point upstream.

All nine sections of tree trunk were secured by setting the “downstream” end into the bank to a depth of 2 to 3 feet. The exposed in-river lengths for six of the nine ranged between 1.5 and 2.5m, at an upstream angle of about 55\* to the bank. Six were set on the river bed and submerged by the flow. Three were set across riffles 4 and 5 and broke the surface of the water. One of the trunk sections (LWD 7, 3m) was set in a diagonal from

In addition to anchoring into the bank all sections of LWD were secured by at least two stakes in stream, and the stakes and trunk wired together with fencing wire held by heavy duty staples

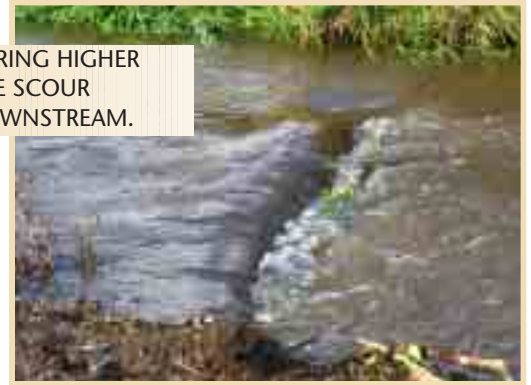
GROYNE DURING HIGHER FLOW. NOTE SCOUR PATTERN DOWNSTREAM.

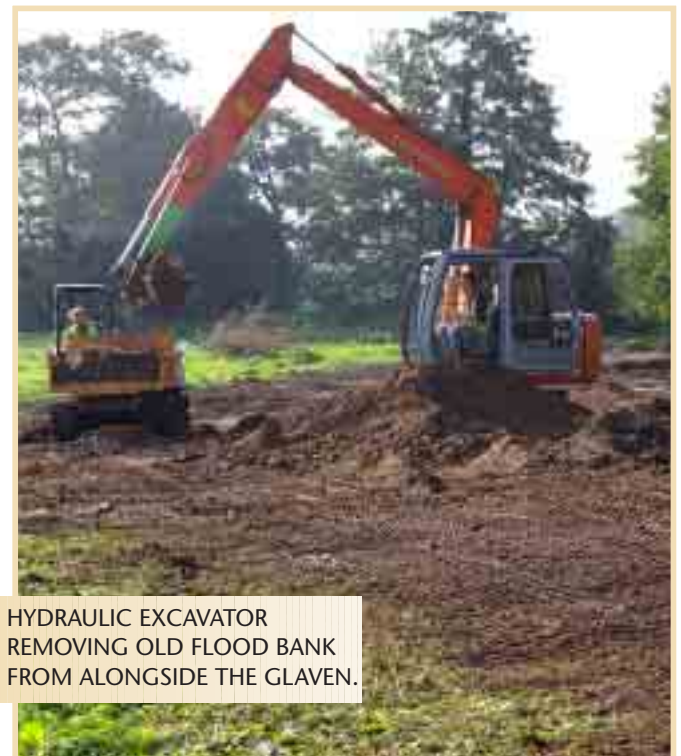
HYDRAULIC EXCAVATOR REMOVING OLD FLOOD BANK FROM ALONGSIDE THE GLAVEN.

Some 700-1,000 tonnes of spoil were removed along a meadow width about 122m. with a tracked digger and two 2.5t tracked dumper trucks, as described in the Logistics section above. The work revealed the sinuous character of this stretch of river, the frontage of the river bank itself extending to some 130m. The re-profiled bank was taken to about 18” above the water line, and 2metres further back it was stepped up another 9” or so to bring the profile to the level of the meadow as a whole.

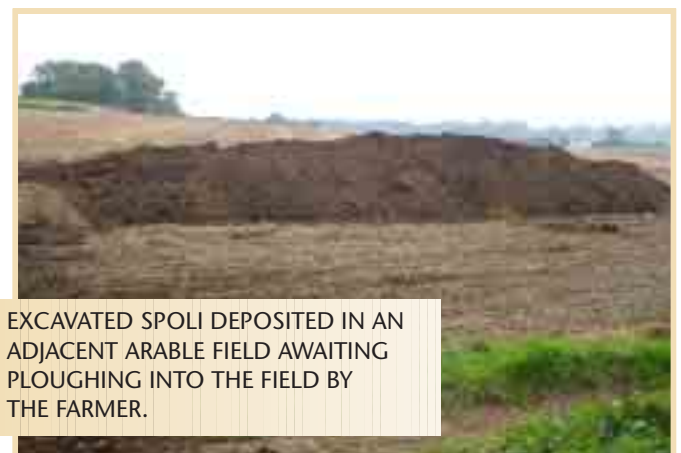
EXCAVATED SPOIL DEPOSITED IN AN ADJACENT ARABLE FIELD AWAITING PLOUGHING INTO THE FIELD BY THE FARMER.

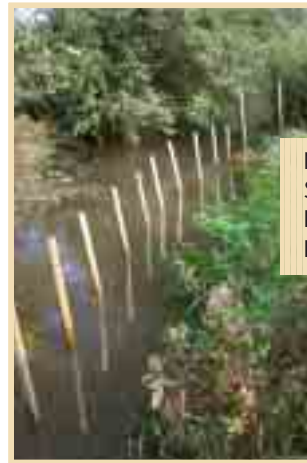
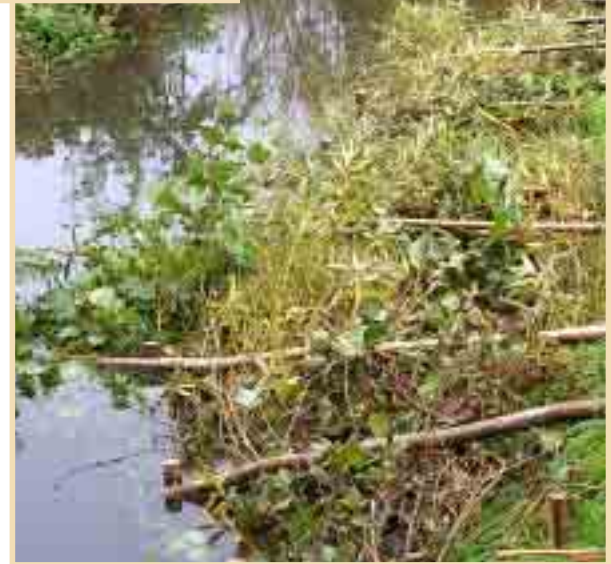
NEW BANK LINE...AND THE SUBSEQUENT GROWTH ON INTRODUCED BRUSHWOOD FAGGOTS.
