Advisory Visit

River Nidd

27 September 2011

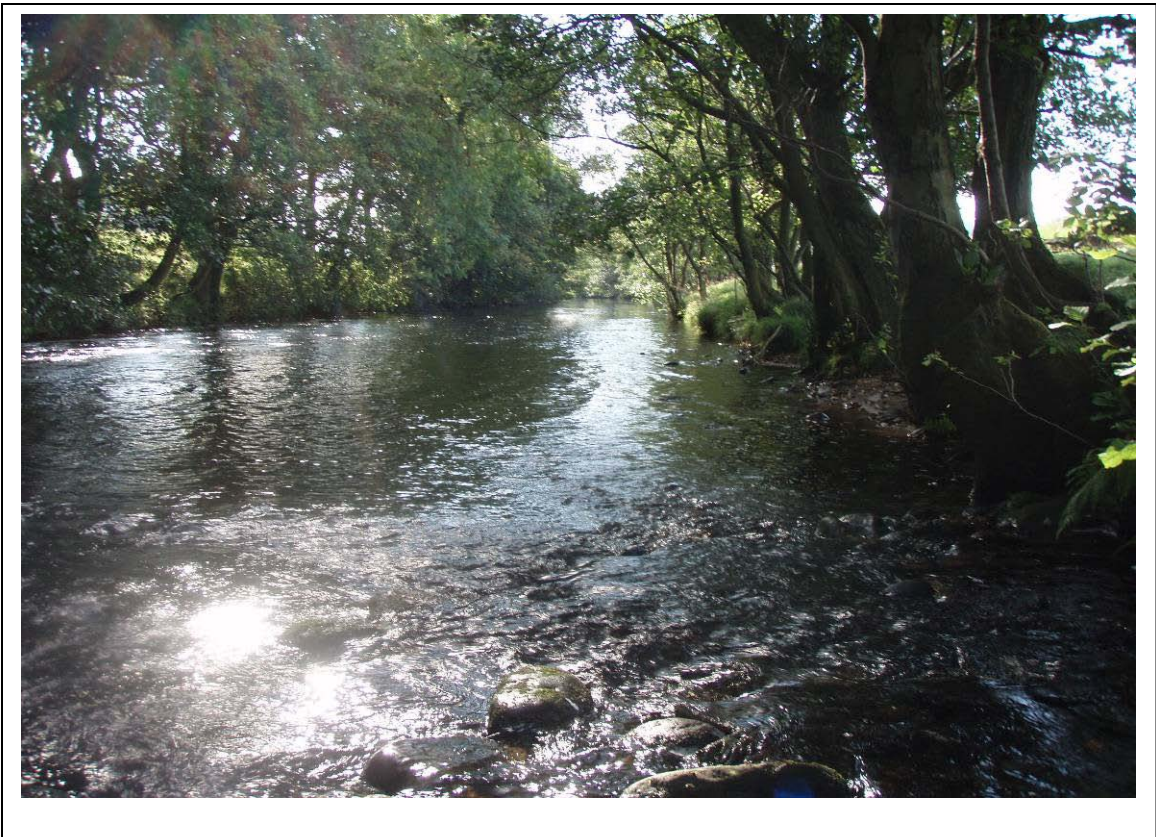
It was noted that in several places, particularly RHB downstream of Foster Beck (Cover photo, SE 15342 66336) and particularly downstream of Glasshouses Bridge LHB (Photo 4, SE 17303 64272), the canopy of the bankside trees had been lifted through pruning and tree management. This, as with the management of woody debris, is something that can have a significant negative impact on the trout habitat and fish numbers within the river. By pruning the low lying and trailing branches most of the cover that trout require for shade and security is removed. Consequently, the habitat in that area becomes unfavourable to trout and often only capable of supporting low numbers of smaller fish. The larger fish often leave in search of better habitat. These areas could be drastically improved by low coppicing to encourage regrowth and replace the cover at water level.

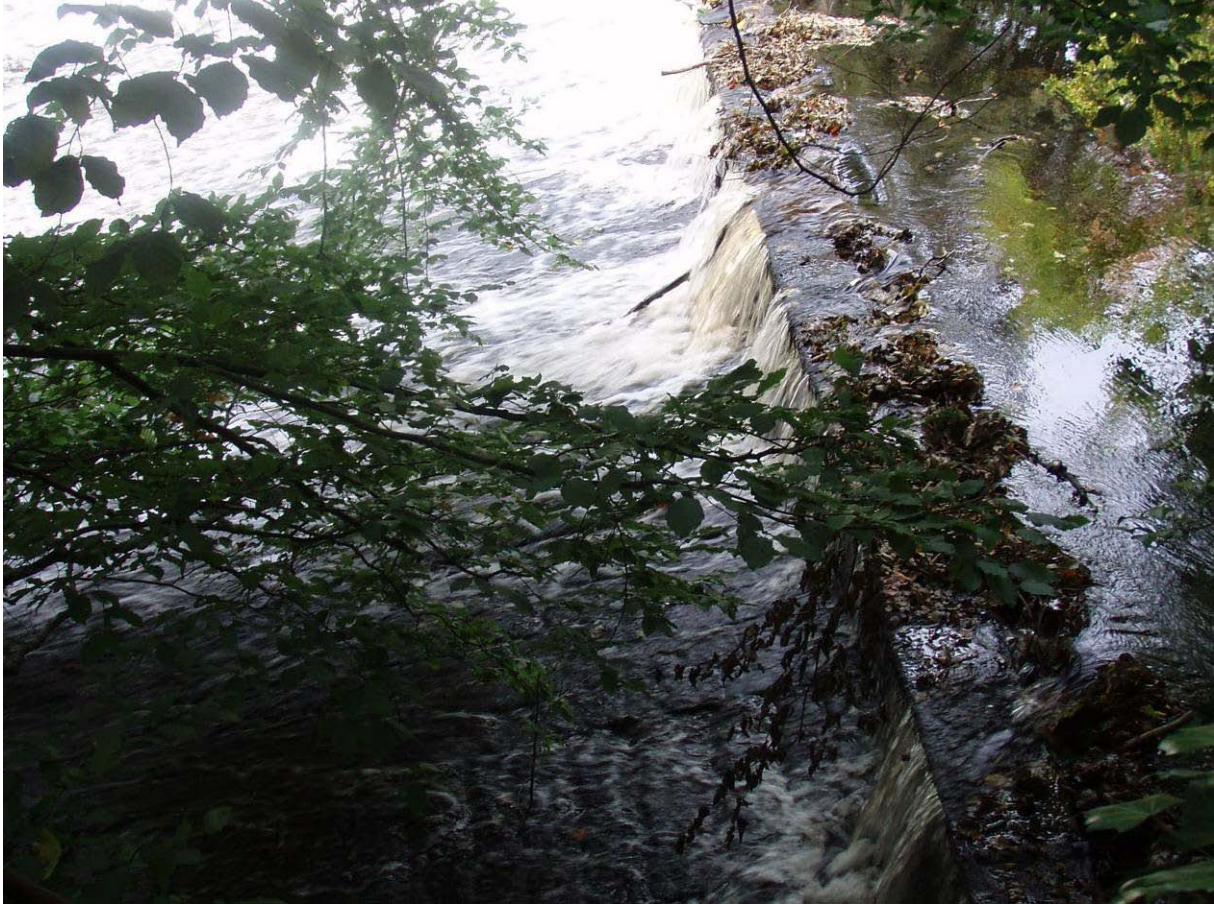
Photo 1 – Weir at the top of Glasshouses mill race. The vertical step at the top makes a difficult weir impassable in all but very high flows. Small fish don't have a chance of ascending it.

Fish access to the appropriate habitat for their life stage could be greatly improved by fish passes or removal of the obstructions. Unfortunately, both of these options have issues and are likely to be very costly due to the scale of work required. There is also the issue that the weirs are likely to have historical significance to Nidderdale as part of the cultural heritage. That said it is still worth the club making contact with local EA fisheries officers to find out what their plans are for improvements to fish passage in the area. The structures are likely to be of medium/low priority currently as being in an heavily modified waterbody, with obstructions up and downstream, but it may be that they would be more likely to undertake improvements if the club had money to enter into a partnership project. This could potentially be the catalyst for creating at least an easement, if not a full fish pass.

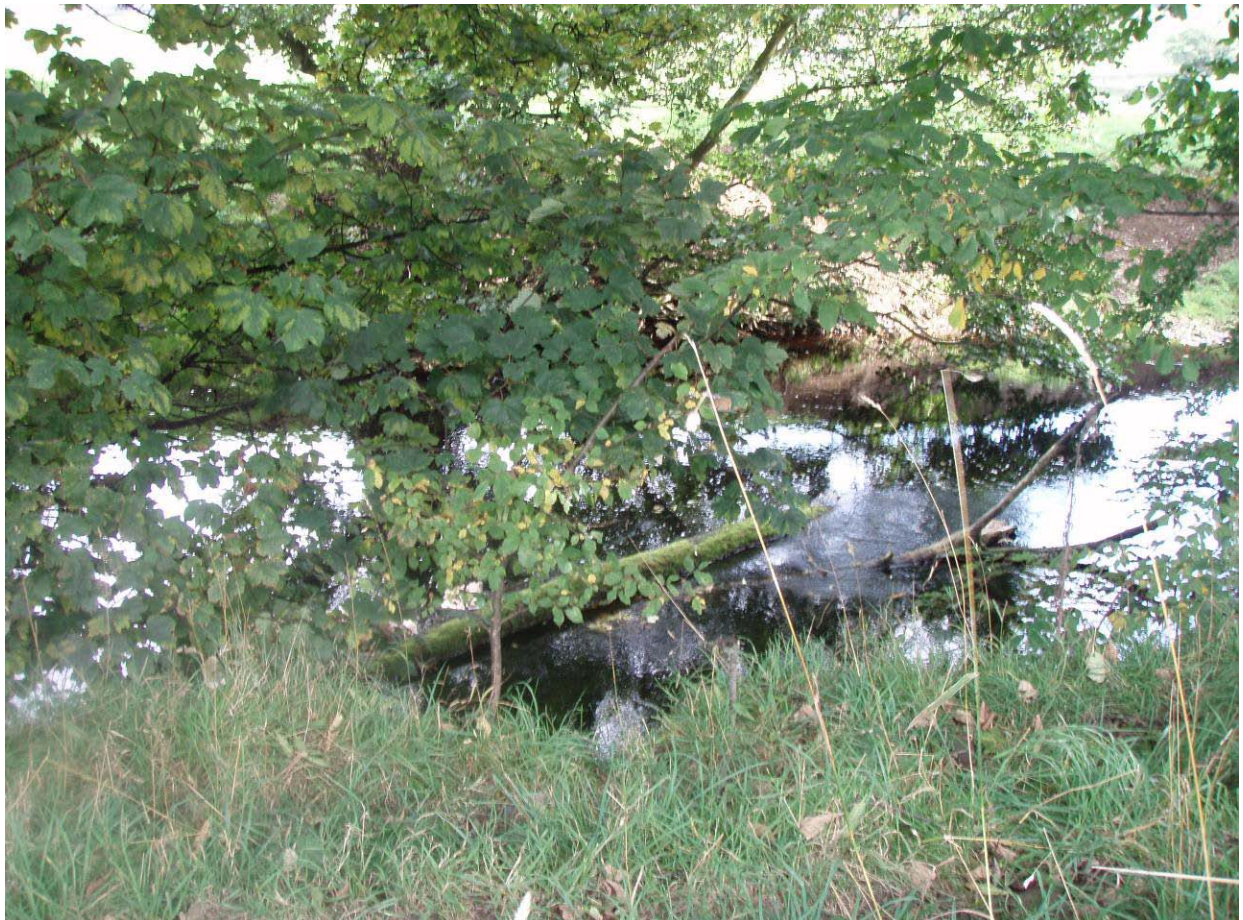
Photo 2 – Woody debris created by a large tree trunk that protrudes across the channel creating good flow diversity and cover. Also note the good length of grass on the bank and good leafy tree cover over the water.

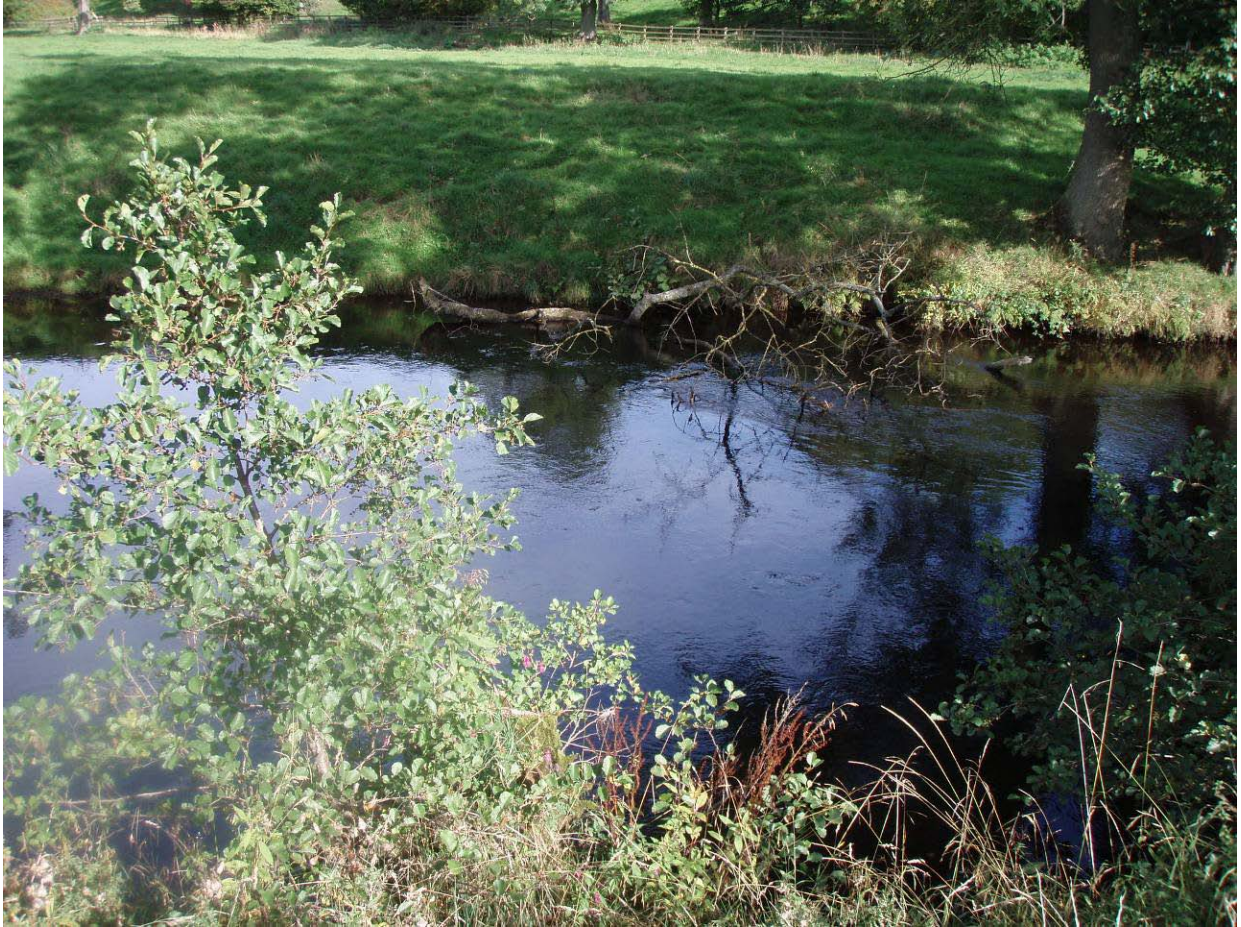
Photo 3 – Good example of smaller natural woody debris on the far bank. Healthy self set alder shrubs can be seen on the near bank, protected from livestock within the buffer fence. A contrasting lack of shrubs and larger vegetation can also be seen on the unfenced far bank.

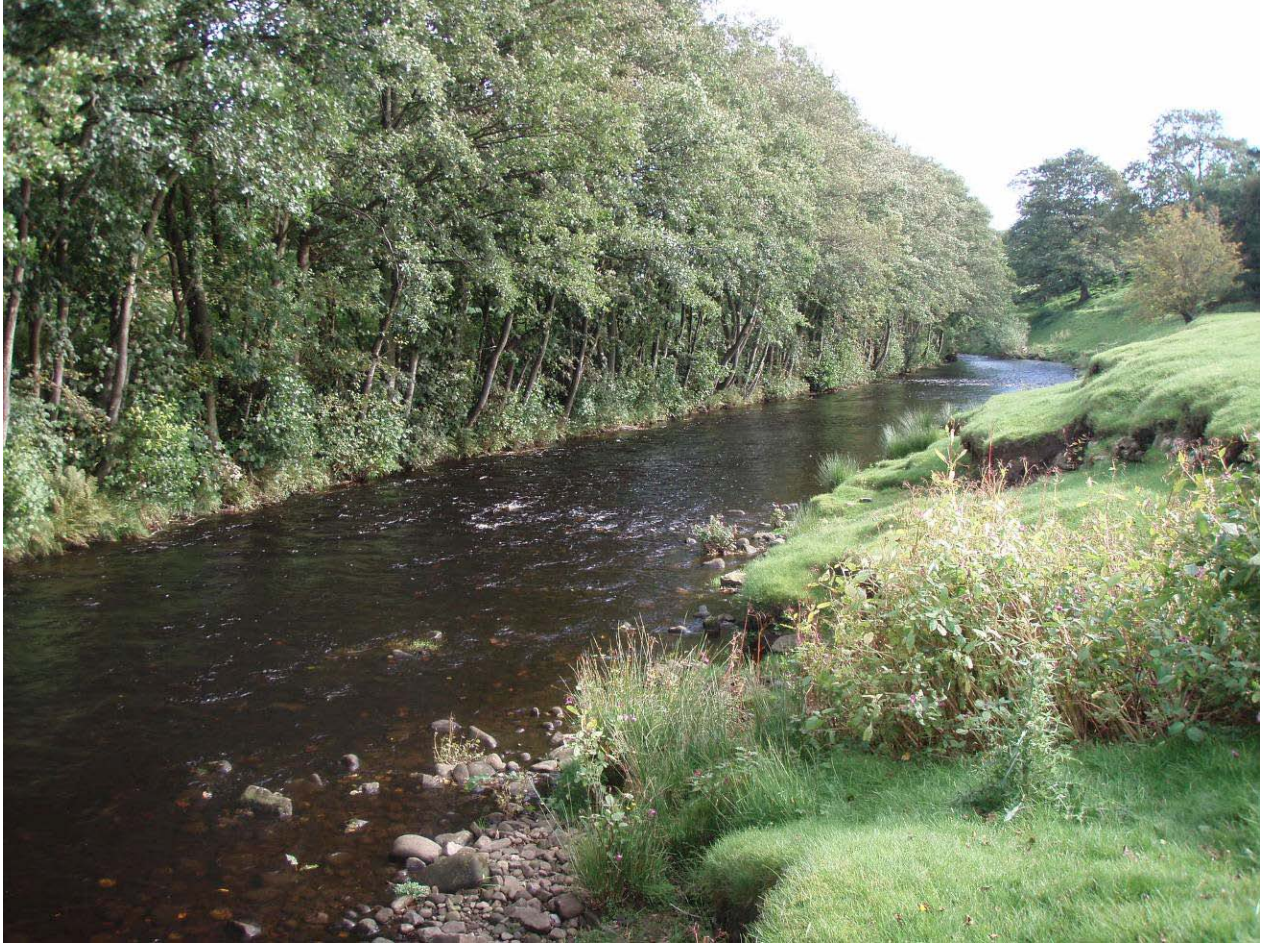
Photo 4 – The tree canopy on the LHB has been lifted way above the river by pruning and provides very little in the way of cover for fish. Coppicing here would encourage low level growth again. Also, note the over grazing on the RHB leading to erosion and a lack of bankside cover.

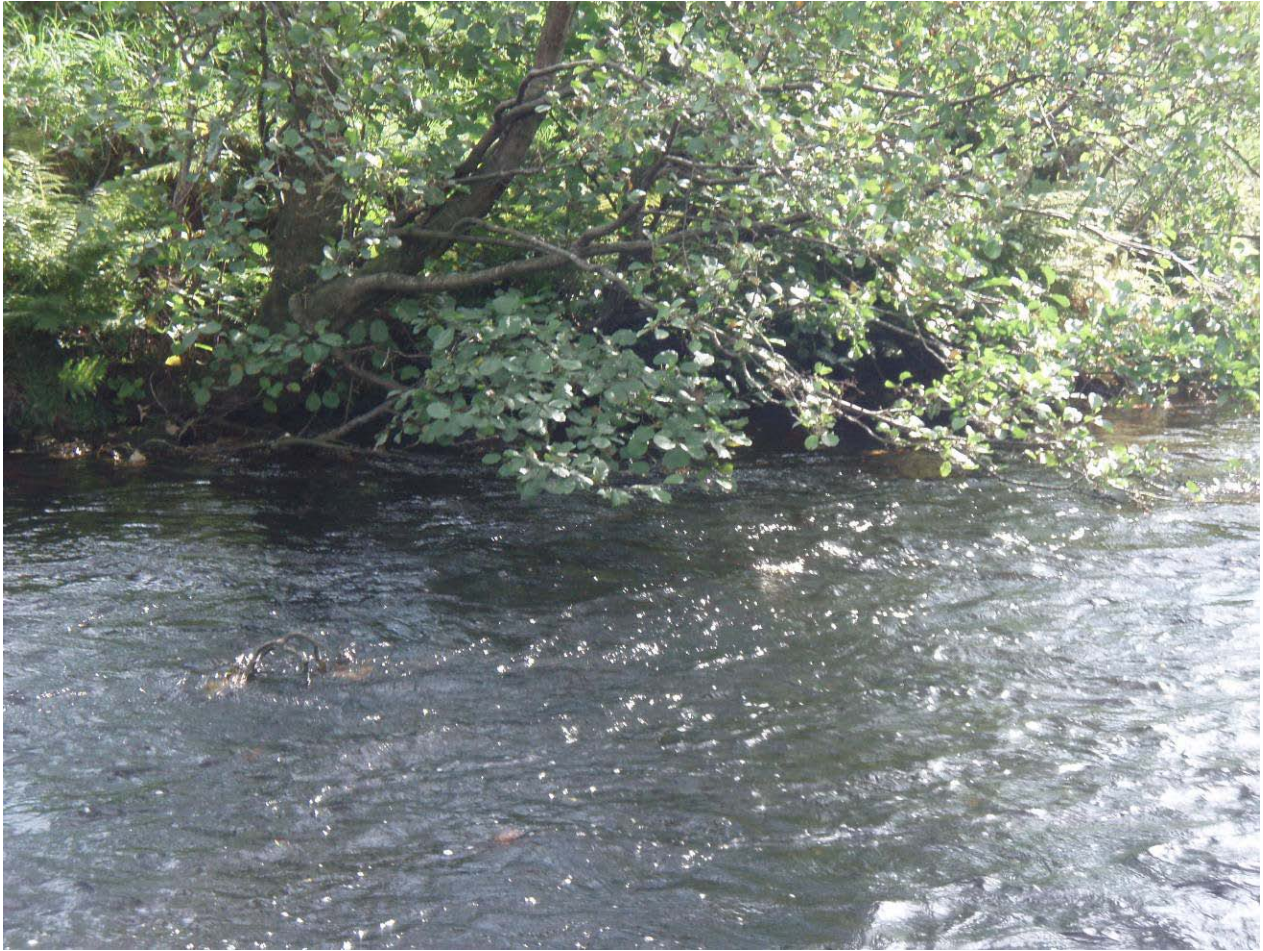
Photo 5 – Low level aerial cover creating ideal trout habitat, particularly when adjacent to riffled water.

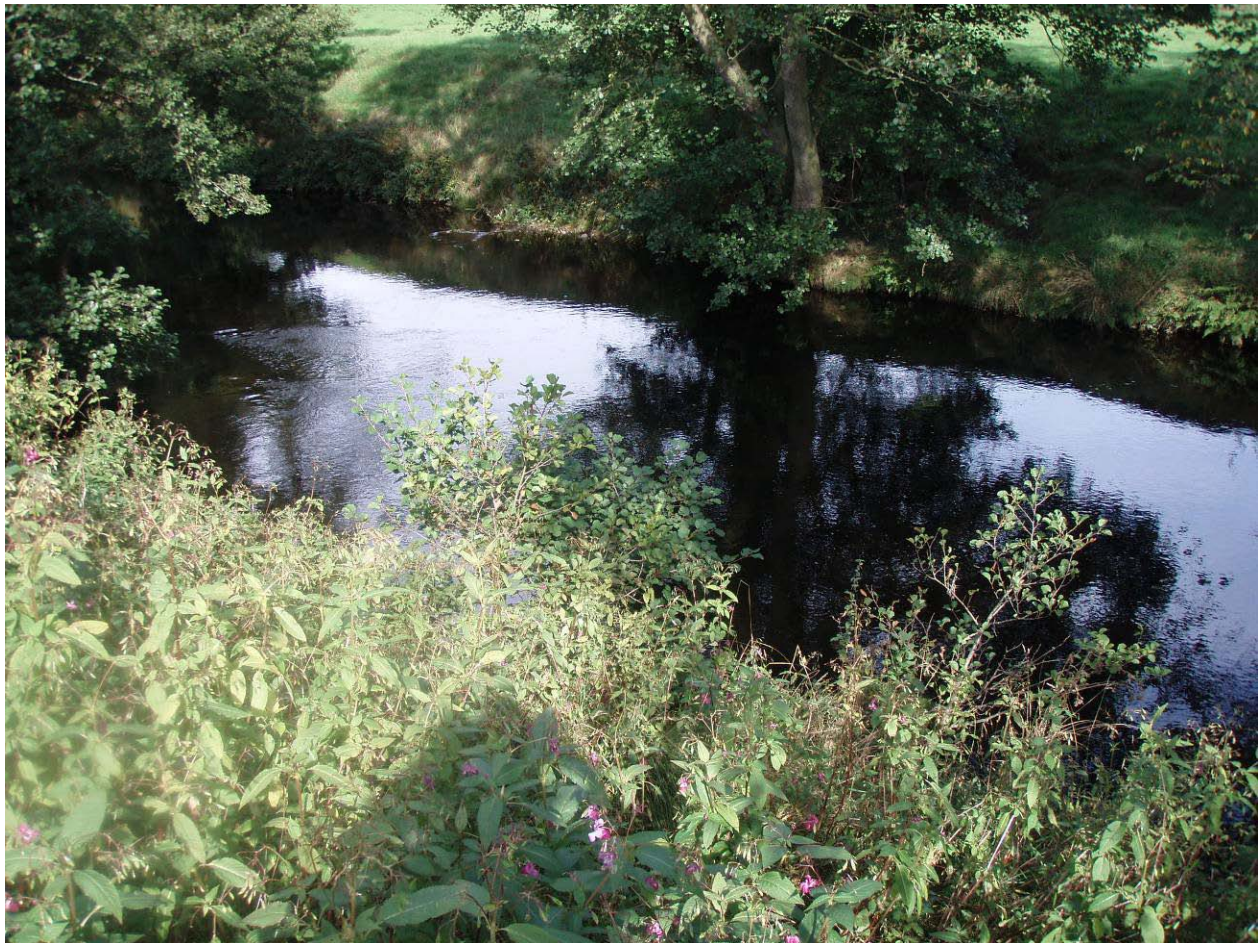
Areas where stock are excluded, like the buffer fencing around Meal Ark (Photo 6, SE14587 67350), had a much healthier and more diverse species mix. The rank vegetation they support not only provides better marginal cover for fish, but also benefits a wide range of other wildlife from invertebrates to small mammals and birds.

Photo 6 – Good growth of self set alder and long grass. In areas such as this it is important to tackle the Himalayan balsam so that it doesn't out-compete the other more valuable native vegetation.

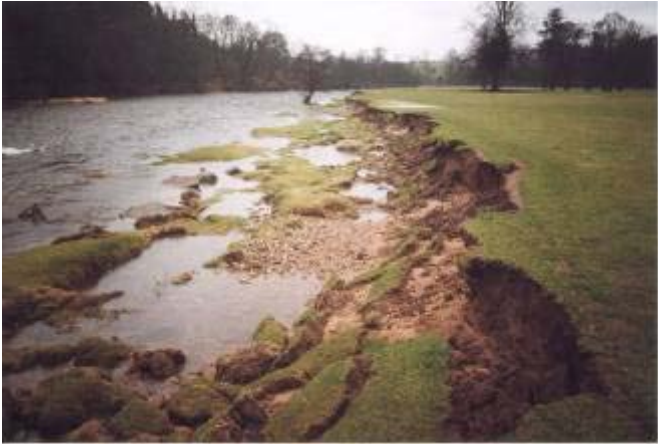
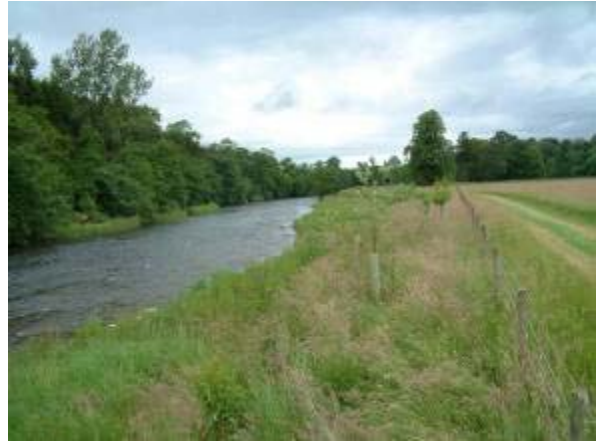
- Examples of fencing projects – before and after

River Eden, Crackenthorpe, November 1998

River Eden, Crackenthorpe, July 2002

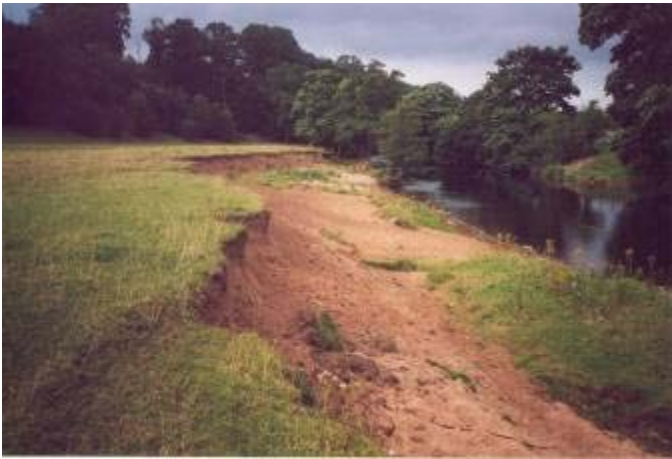
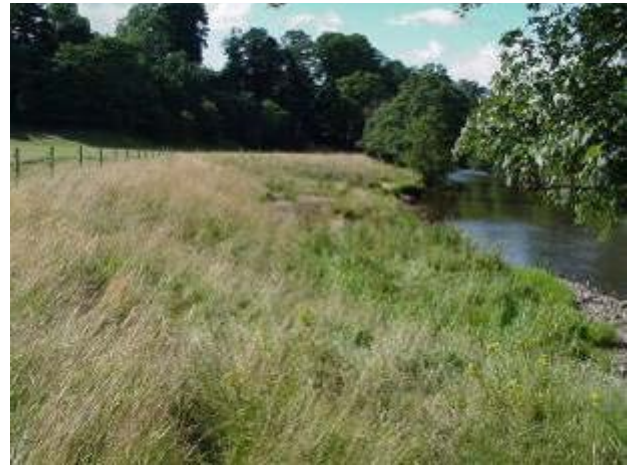
River Eden, Barrowmoor, October 1999

River Eden, Barrowmoor, August 2000

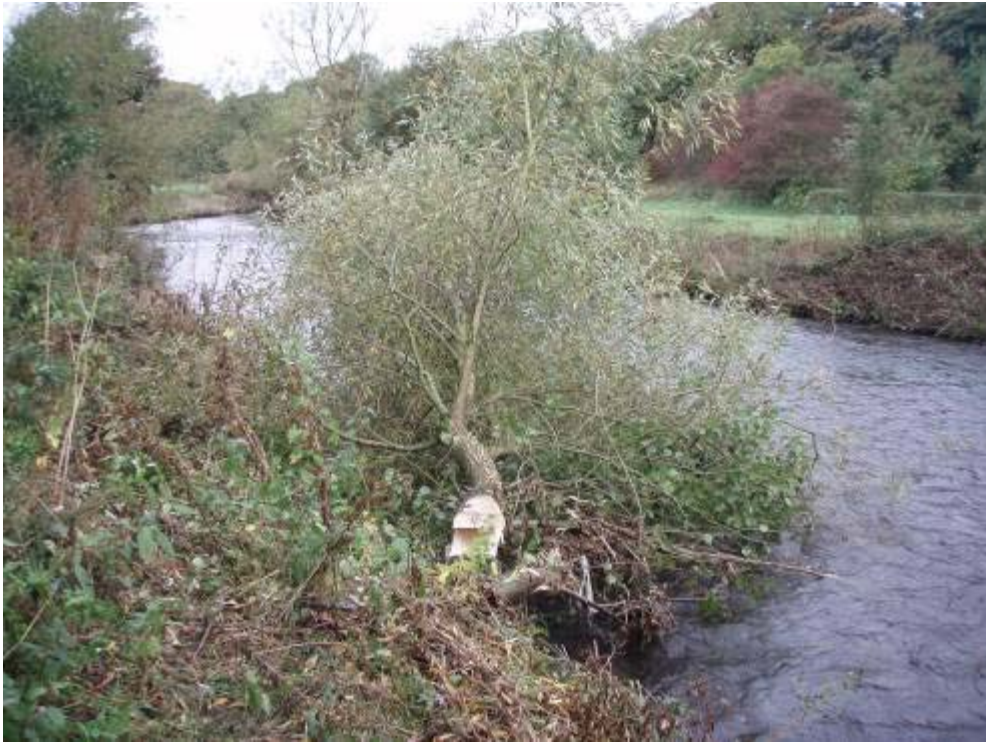
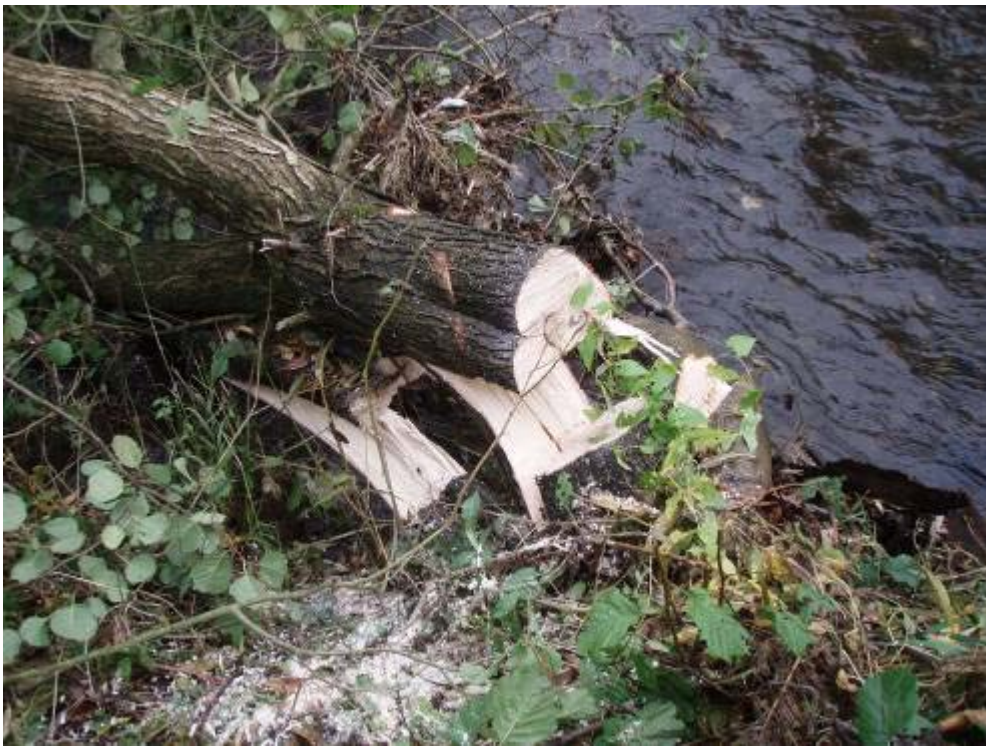
- Introducing low cover by laying willows

Partial cutting and laying of willow (like hedge laying) is a quick way of creating low cover which is firmly fixed to the bank. The willow should root along its length.

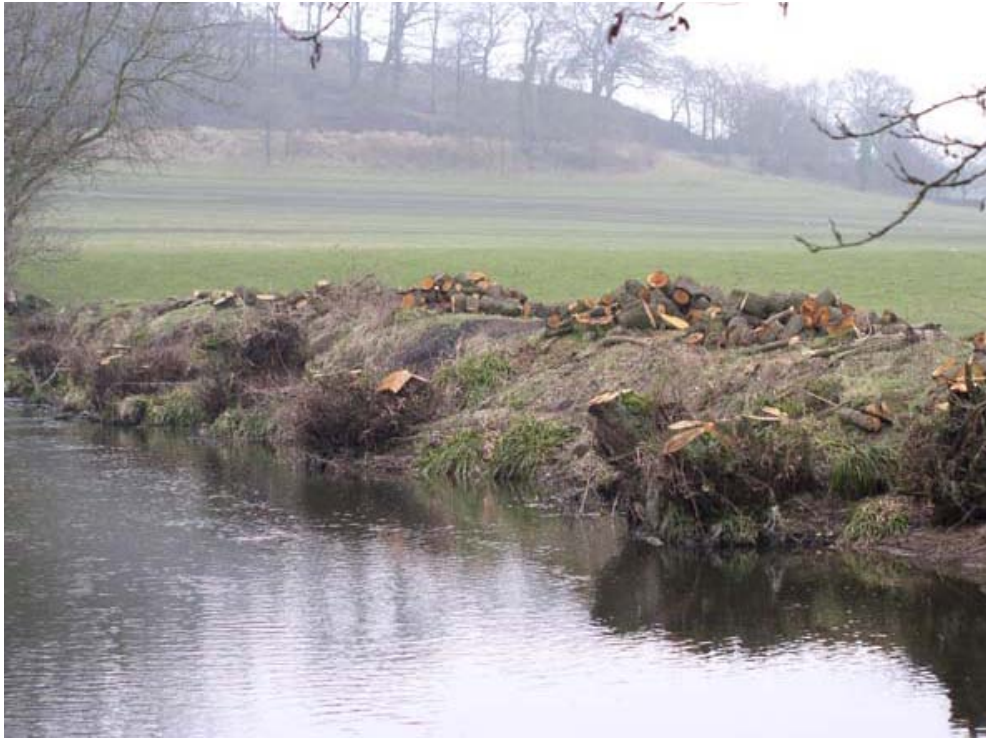
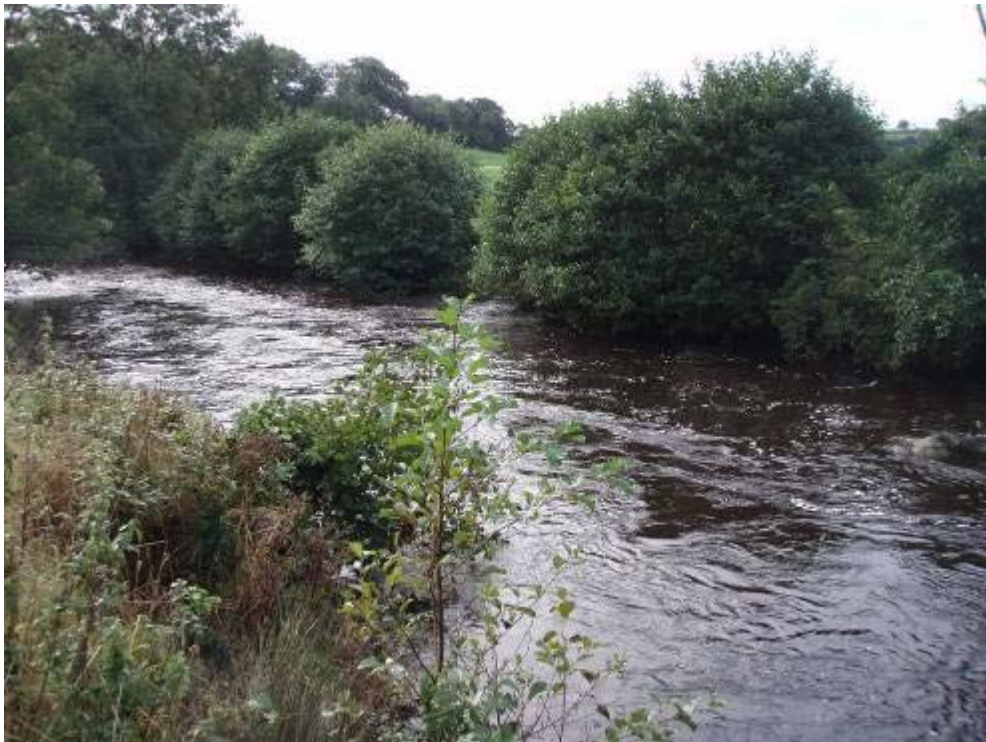
- Coppicing trees

Coppicing trees produces bushy re-growth which creates excellent low cover over the water (if protected from grazing) but doing it all in one go like this produces a uniform size of trees. Better to adopt a rotational coppice to increase variety. The lower picture represents 4 years re-growth (River Dane, Cheshire/Staffs.)
