**River Worth, Keighley (Woodhouse Road to River Aire):
Advisory Visit**

River Worth: Keighley
River	Worth (West Yorkshire)
Waterbody Name	Worth from Bridgehouse Beck to R Aire
Waterbody ID	GB104027062891
Management Catchment	Aire and Calder
River Basin District	Humber
Current Ecological Quality	Moderate
U/S Grid Ref inspected	SE 06009 40209
D/S Grid Ref inspected	SE 07653 42112
Length of river inspected	3km

Wild Trout Trust Report – Following a Site Visit on 27/10/2017

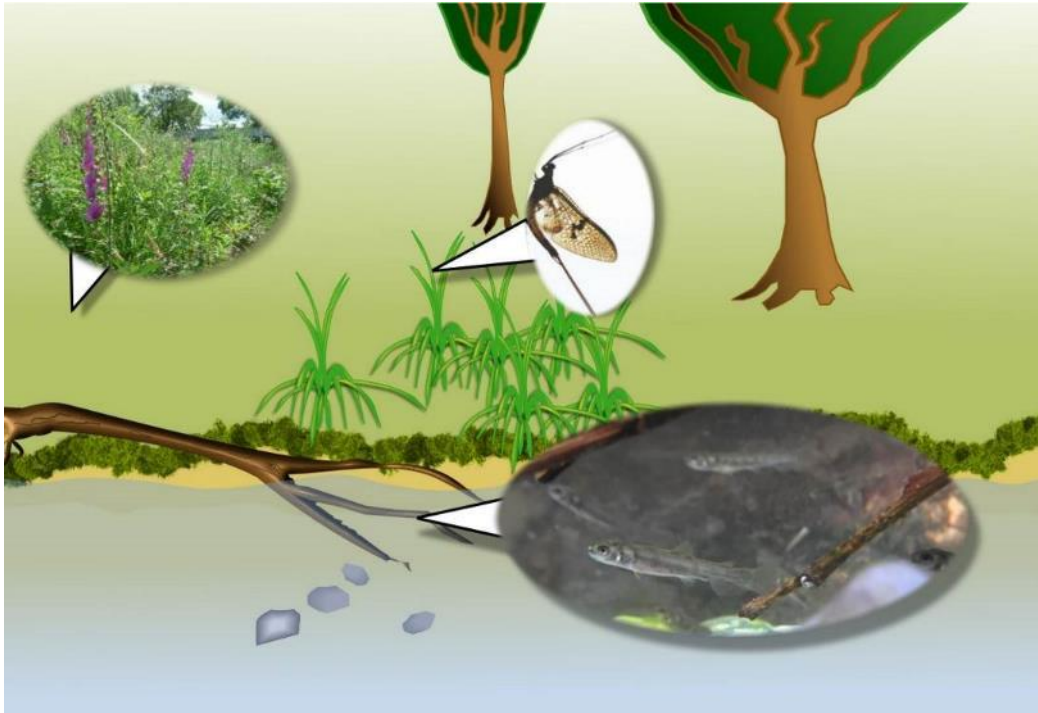
Figure 3: Larger cobbles and submerged “brashy” cover and/or exposed fronds of tree roots provide vital cover from predation and spate flows to tiny juvenile fish in shallower water (<30cm deep). Trailing, overhanging vegetation also provides a similar function and diverse bank-side vegetation has many benefits for invertebrate populations (some of which will provide a ready food supply for the juvenile fish).

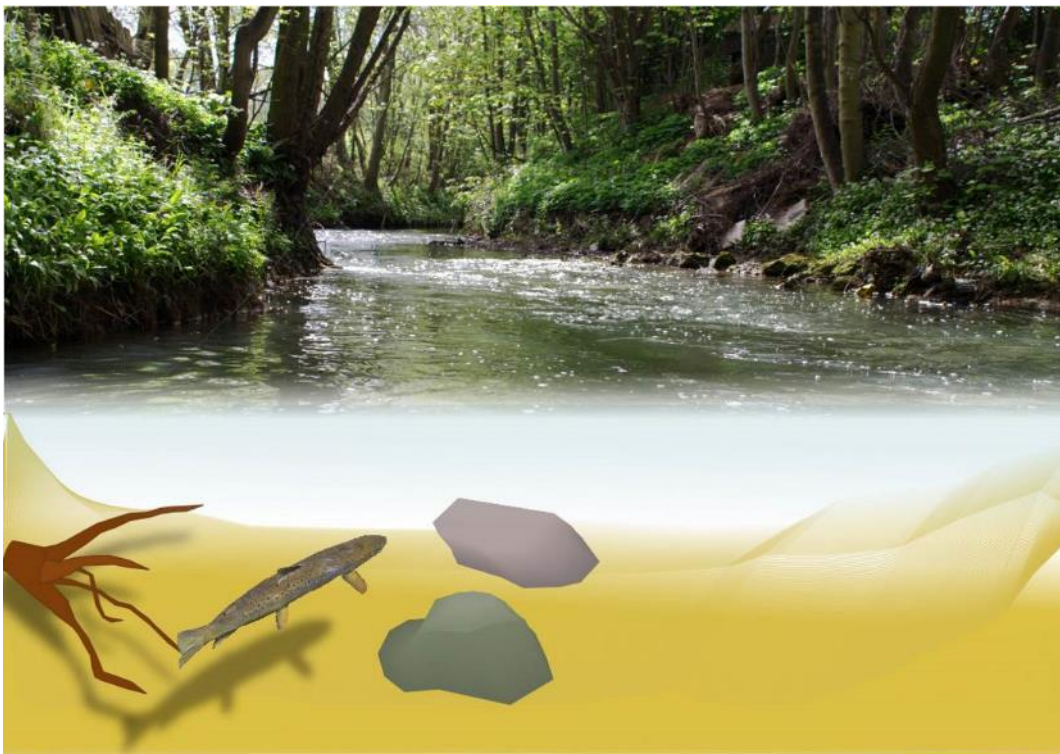
Figure 4: The availability of deeper water bolt holes (>30cm to several metres), low overhanging cover and/or larger submerged structures such as boulders, fallen trees, large root-wads etc. close to a good food supply (e.g. below a riffle in this case) are all strong components of adult trout habitat requirements.

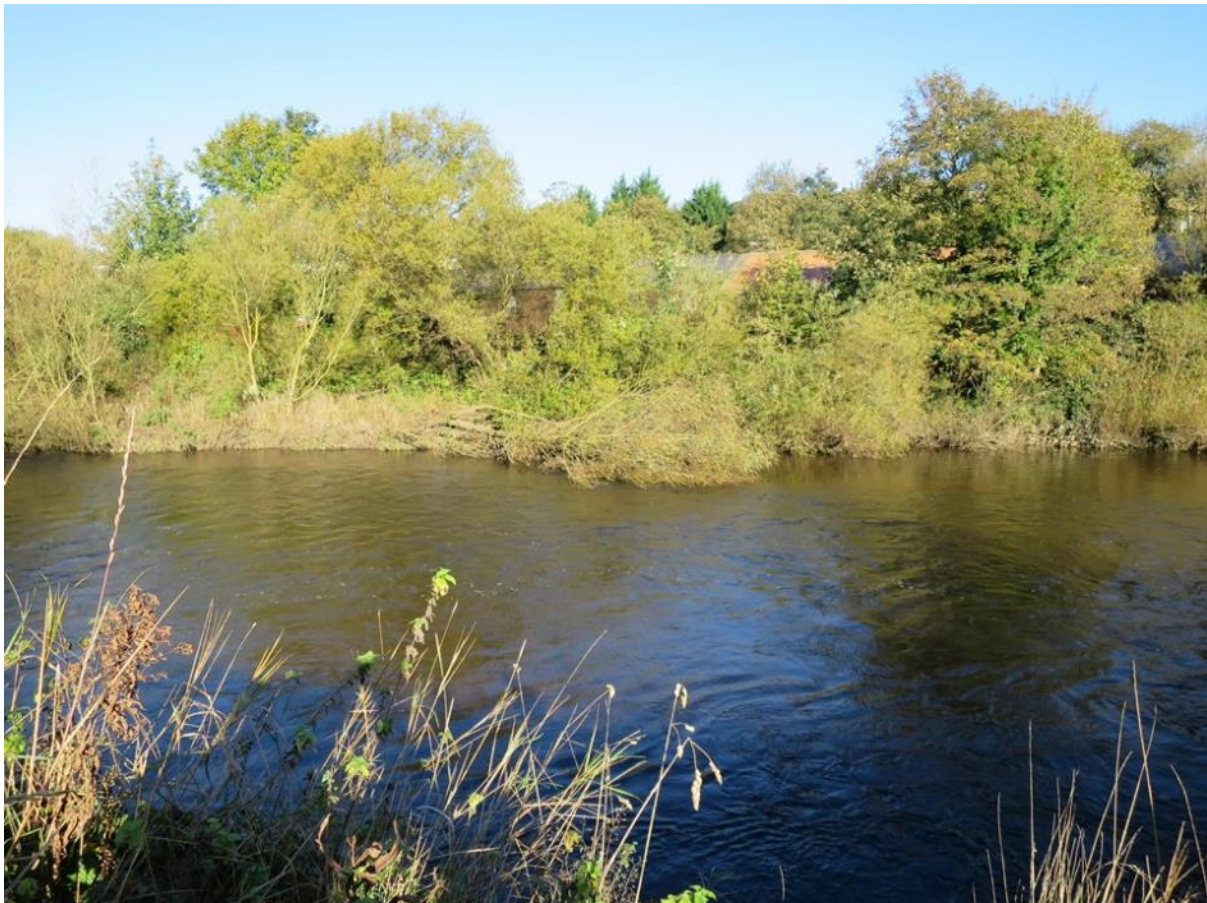
At the downstream limit of this visit (SE 07653 42112), the conditions in the main River Aire were examined below the confluence with the River Worth. The main river is a wide and powerful watercourse at this point. Consequently, the presence of trailing and submerged complex cover are vital factors for wild fish populations – providing respite from spate flows and keeping a healthy balance between predators and prey species. This latter factor was highlighted by the presence of goosander on the reach during the visit (in habitat which is very simple and lacks cover, predators become too efficient and prey populations can crash). For these reasons, the stable woody cover noted is extremely valuable (Figs. 5 and 6).

Figure 5: An example of valuable complex cover and refuge habitat in the form of a fallen tree on the opposite bank. Because it is still attached to the bank at the root-end (and lying roughly parallel to the main flow), this feature provides secure respite from spate flows for fish that will move into the “brashy” matrix of the submerged portions of the crown. With the crown still attached it is extremely unlikely to move and does not present a flood risk.

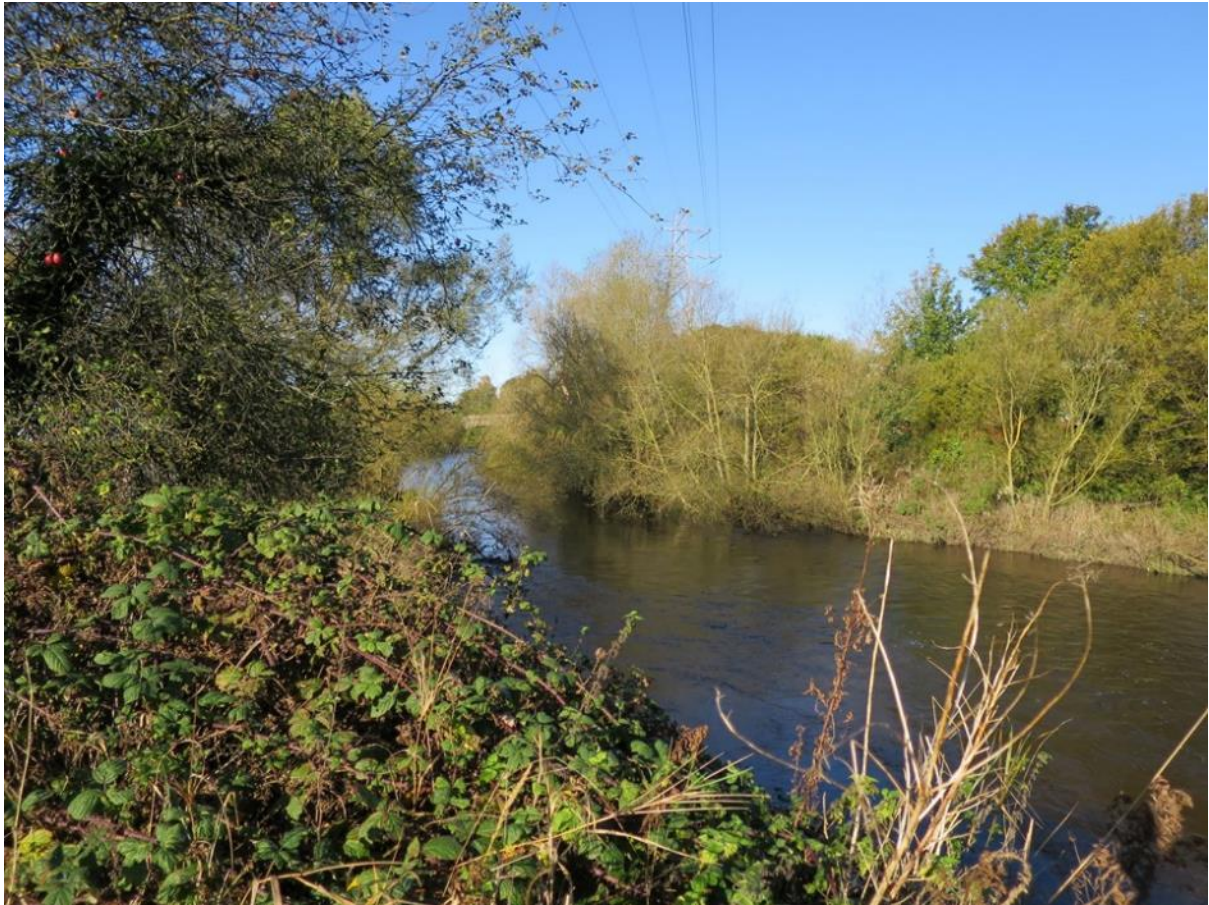
Figure 6: Low-level and partially-submerged bushy vegetation (again on the far bank) providing the same valuable functions as the fallen tree in Figure 5.

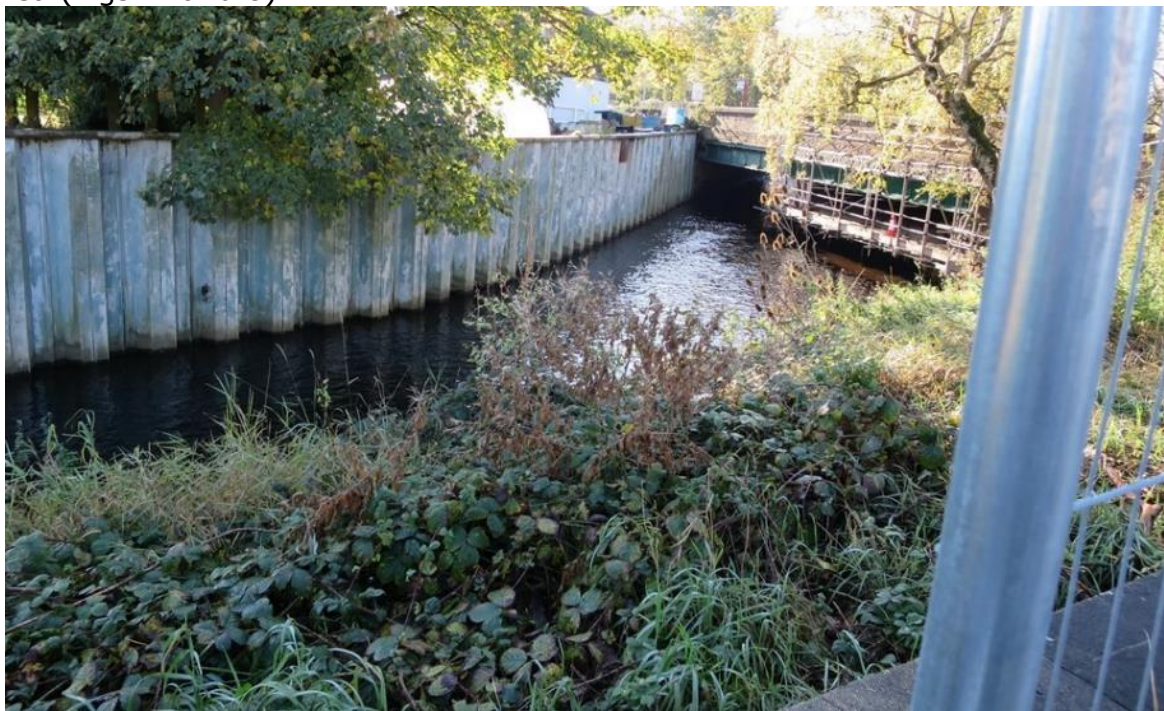
On the River Worth a short way upstream from the confluence with the Aire at SE 07350 41953, repair work to a bridge damaged during a spate in 2015 is visible – as well as the vertical sheet piling used to contain the river within this developed area (Figs. 7 and 8).

Figure 7: Repair work to bridge and vertical sheet-piling revetments.

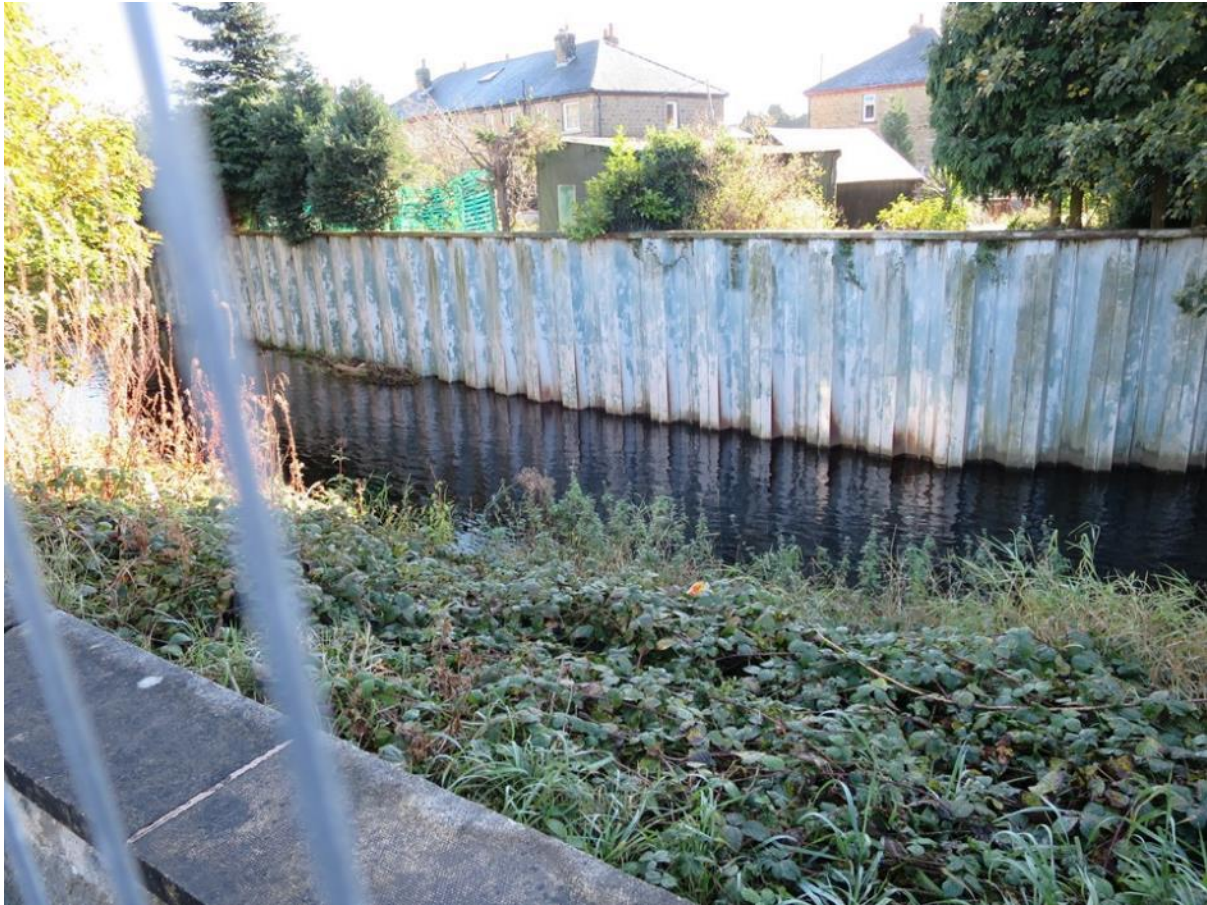
Figure 8: Sheet piling flood defences (showing proximity to housing).

Understandably, property owners and the local council want to prevent the river entering its floodplain at this point (now that it has been developed). The knock-on effect of that situation is that much more powerful flood flows are passed on downstream.

The technical explanation for this is that the shear velocity – which is another way to describe the force that flowing water can exert on a structure experiencing that flow – is greatest under “bank-full” conditions. In a river that is well connected to its floodplain, those bank-full conditions:

In contrast, when that dissipation of force across a wide floodplain is not allowed and, instead, *raised up to a level above the floodplain whilst confined in a narrow chute*; then the destructive power of that water is significantly greater.

These factors (reducing the risk of flood damage and improving conditions for wildlife) provide strong arguments to incorporate greater upstream management of floodwater flows. While it is unlikely that the flood defences could be removed at the location in Figs. 7 and 8, greater opportunities to improve the habitat could still be provided by upstream management of floodwater flow and storage.

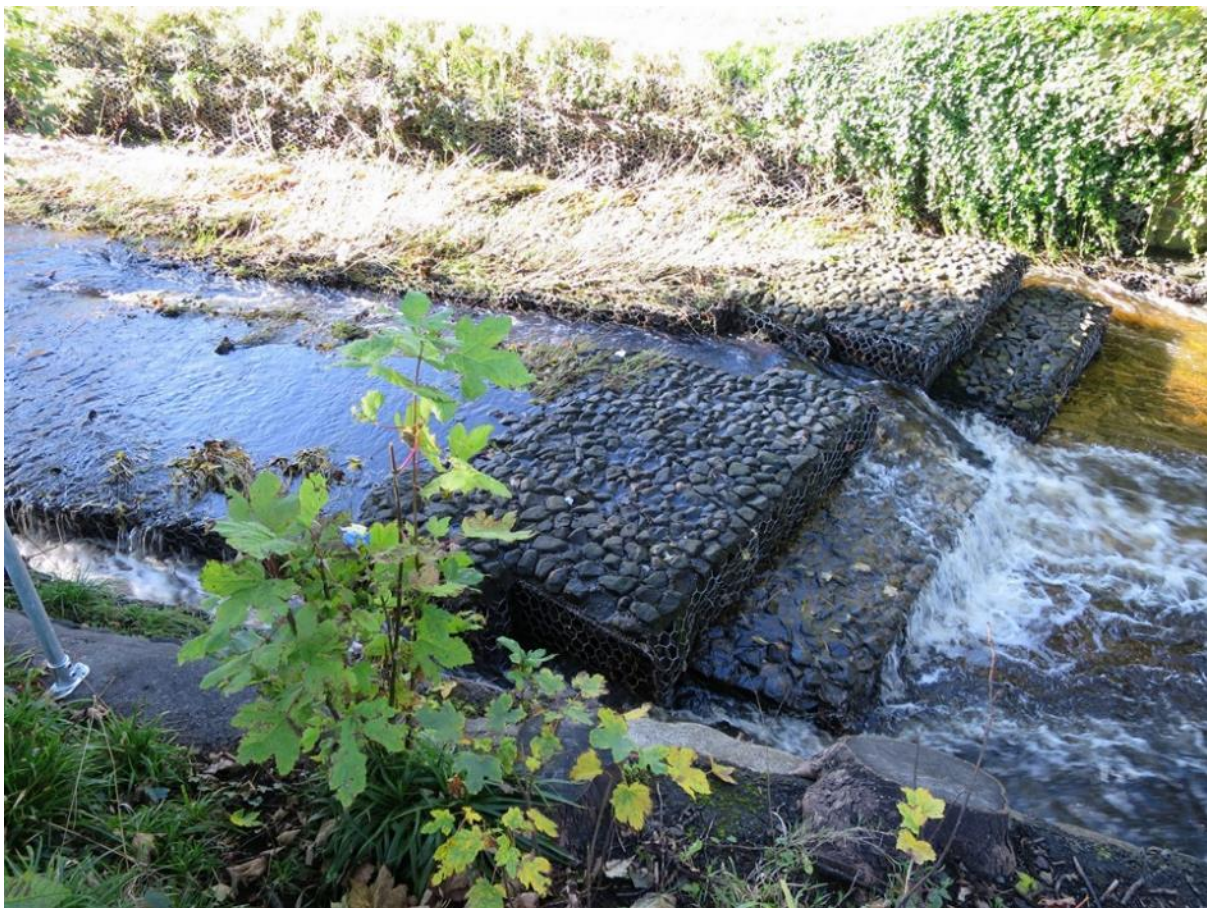
Just upstream of the Aireworth bridge at SE 07347 41859, there is an unusual - and apparently modern - structure in the channel (Figs. 9 and 10). Confirmation through Environment Agency personnel involved in the consenting process for this structure will provide a definitive identification. However, it may have been installed as a kind of 'hydrobrake' in an attempt to protect the damaged bridge downstream from future spate flows.

Figure 9: Modern (gabion) structure which splits low flows into three narrow channels (each impassable in an upstream direction by most fish under most conditions). The first of the three low flow channels one hugs the RB, one runs down the centre and one hugs the LB. All three discharge onto a shallow, smooth concrete apron that is impassable to fish. The gabion mesh is already beginning to degrade and will form a "gill net", a trapping hazard to aquatic life as the degradation progresses.

The structure shown in Figs. 9 and 10 is imposing a significant, negative impact on the biodiversity of the recovering "post-industrial" River Worth. It is impassable to upstream-migrating fish (many species of freshwater fish, including "non-migratory" trout and grayling migrate between different habitats in order to complete their lifecycle). Consequently, it reduces the capacity of the system to be re-colonised following a pollution event. A more subtle impact is the reduced potential for "gene-flow" between members of breeding populations that would, otherwise, be able to mate and produce better-adapted offspring.

Viewed in this light, and with the opportunity to utilise a more biodiverse landscape to achieve upstream controls on floodwater flow to reduce flood risk, it makes sense to examine better options at SE 07347 41859. For instance, replacing the current installation with a roughened “rock ramp” is likely to be more resilient than the currently-degrading gabion structure. As well as being more robust, this would also greatly improve connectivity for aquatic fauna between the main River Aire and the habitat upstream of this point on the River Worth.

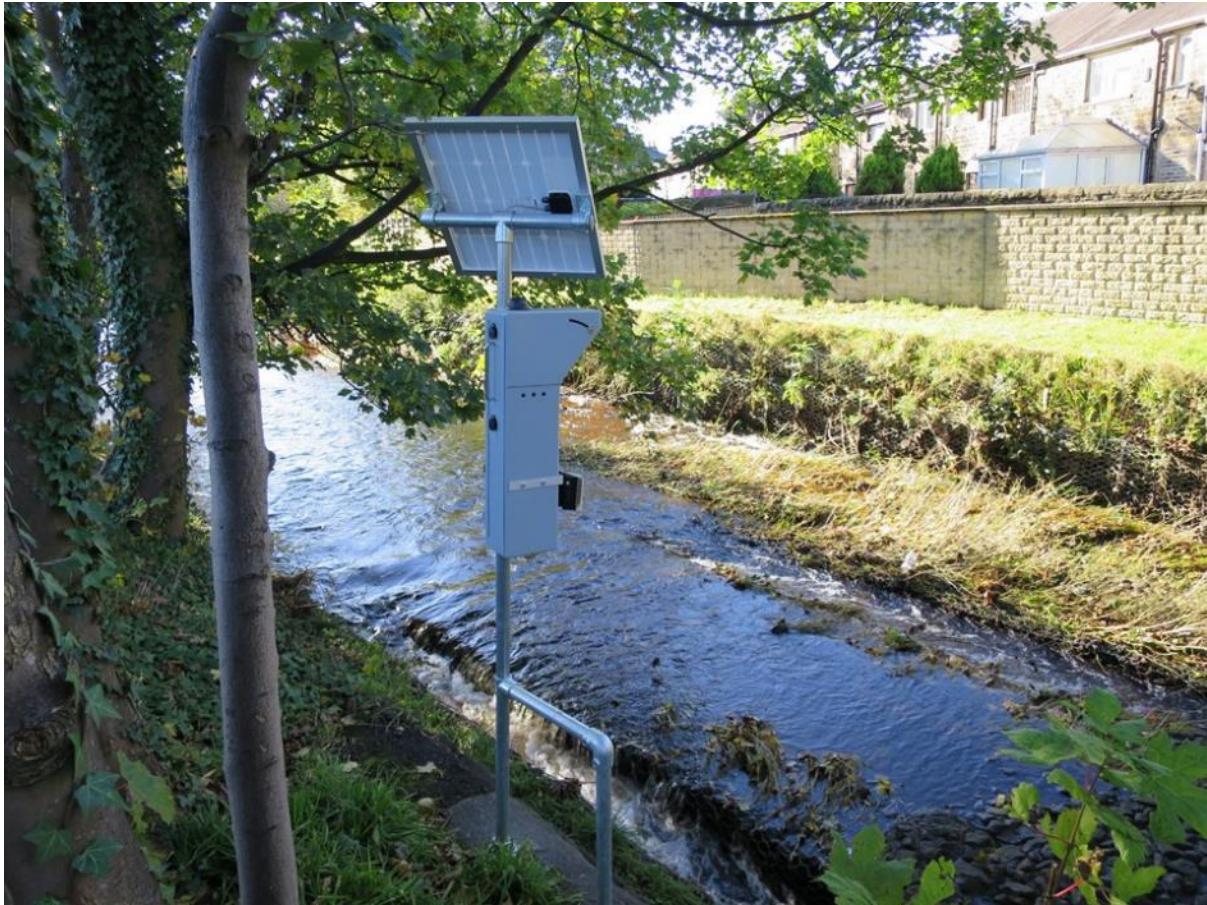
The apparent presence of monitoring equipment (Fig. 10) may support this conclusion, although that would more usually be associated with flow-gauging and data-collection. Overall, it seems likely that the structure is associated with the significant sensitivities to flood risk and associated damage to infrastructure.

Figure 10: Upstream channel and telemetry/instrumentation associated with the structure.

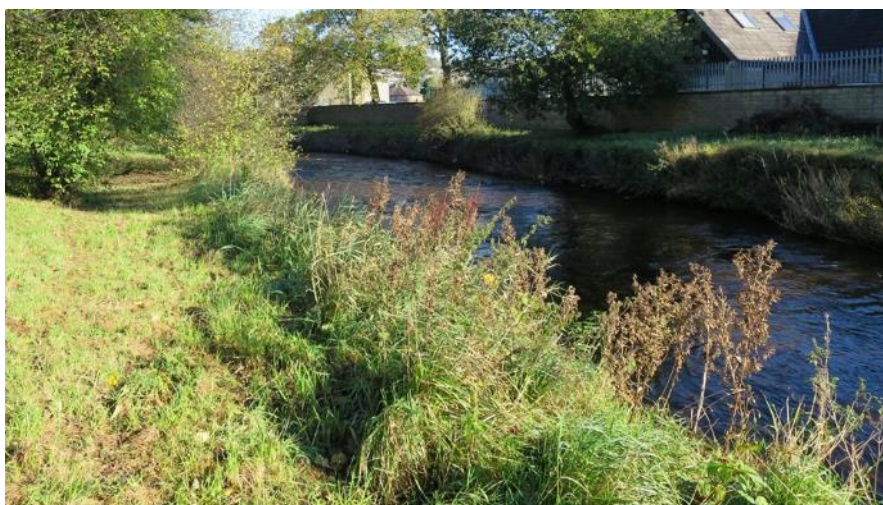
Upstream from this structure at SE 07321 41745 there is a long, relatively shallow run (Fig. 11) that is reportedly favoured by grayling. Although obviously straightened, this is an extremely isolated example within the urban development where the river is actually connected to a small area of floodplain in the form of a grassed amenity area (Fig. 12). The supply of substrate that spans a range of particle sizes from sands, gravels, pebbles cobbles and small rocks/boulders creates potential for structural diversity. It would be beneficial to increase structural variety (section 3. Recommendations) to create the best ecological benefits from the opportunity provided – and to counter unsympathetic dredging.

Figure 11: Gravelly, cobbled run with (rare) connectivity to floodplain. The unmown buffer strip is extremely valuable in biological terms.

Dredging that has been carried out in this section has removed much of what, otherwise, would be providing better in-stream habitat. This is confusing from a flood-damage-mitigation perspective. If the structure directly downstream is designed to slow the pace of water reaching the bridge below – then it appears counter-productive to try to increase conveyance within the section immediately above it which has floodplain storage available.

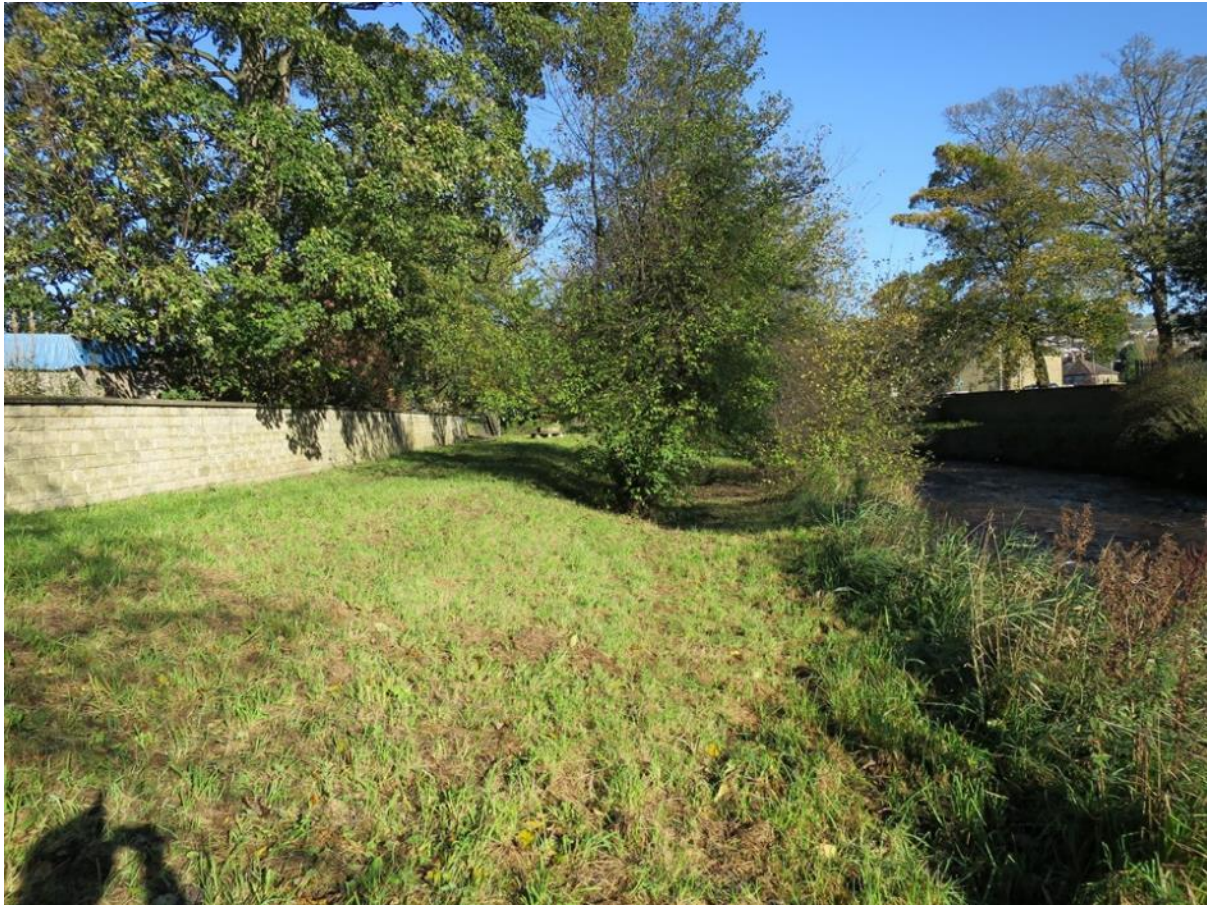
Figure 12: Grassed area enjoyed by local walkers with flood defence wall to the left of the frame and unmown buffer strip to the right. The opportunity for at least some natural over-land flow during spate conditions (and the refuge habitat created by the unmown buffer strip) are ecologically valuable features that should be preserved. The extent and value of the buffer vegetation could be extended by encouraging the wildflower seedbank for a greater proportion of the bank (with a mown ride/path maintained for walkers).

Unfortunately, the larger substrate/boulder habitat removed from the reach below the bridge and pictured in Figs. 11 and 12 is generally too large to be replaced by natural erosion and deposition in the near future.

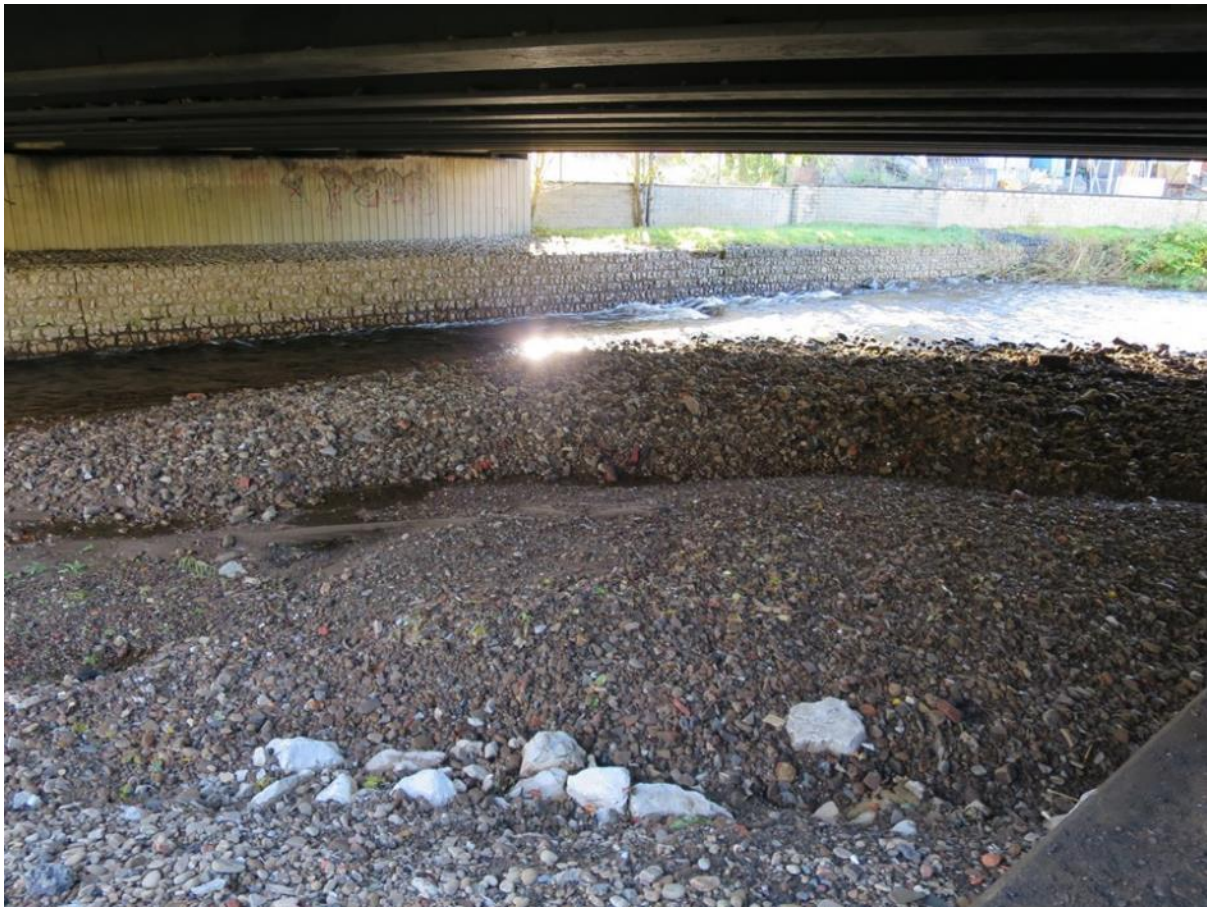
Similarly, although there is likely to be concern within the local community, the dredging directly underneath the A650 bypass bridge will continually be undone by the re-supply of substrate from upstream. There is an inherent overall channel form and capacity that will emerge naturally through redistribution of bed material at this point. Measures that attempt to remove too much of that material will significantly increase the demand for it from the upstream channel – which could have unpredictable destabilising results (example illustrated in scale model which has these exact processes operating in miniature here: https://youtu.be/OAZ_BuyM41s).

Figure 13: Recent dredging has been replaced with gravel and cobbles under the A650 bridge. This is an inevitable consequence on a steep, rain-fed river. As well as the position on a bend (where deposition is favoured on the inside of that bend) it is common to find that the riverbed beneath large bridges has been levelled artificially. This produces a break in the natural longitudinal bed-slope of the river – and the flat “pan” which results acts as a natural sediment trap.

The more cost-effective solution at this location would be periodic management of any vegetation that became established on the deposited material if it began to pose a threat to the stability of the bridge under spate conditions. There may be a degree of natural control on vegetation growth anyway - due to the shading beneath the bridge. Consequently, any interventions should be needed less

frequently (and at a cheaper, less extensive scale) than the dredging which accelerates the demand and replacement of existing material.

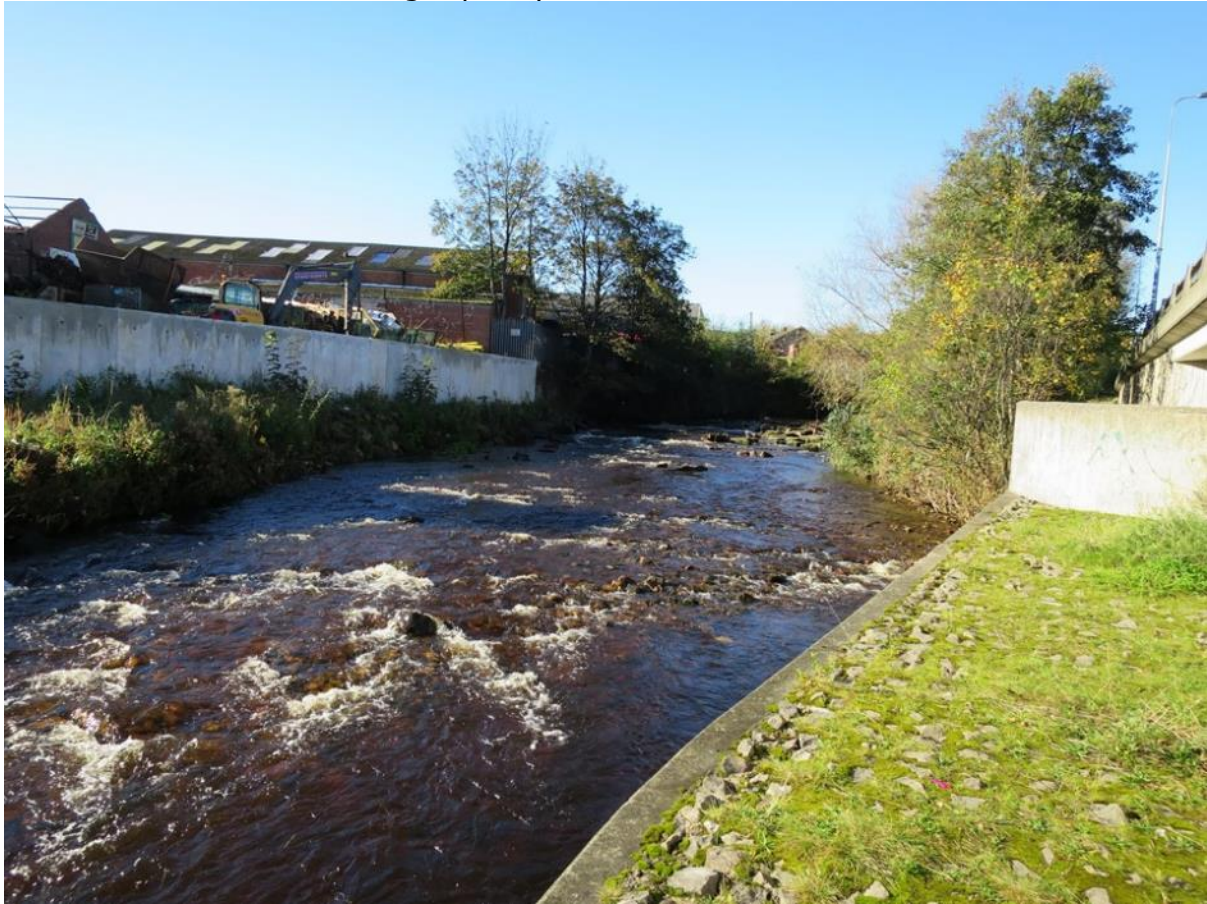
The boulder and cobble substrate directly upstream of the A650 bridge - combined with relatively steep gradient - creates variation in current pace and depth at different points over the channel cross-section. There is a general lack of trailing, overhead and partially submerged brash or vegetation cover. However, this is partially mitigated by the presence of a variety of cobbles and boulders that break up the flow and also create some “bolt holes” in the form of gaps between their undersides and the river bed (Fig. 14). In the background of Fig. 14, the gradually-collapsing weir at SE 07216 41705 is visible.

While the crest of the weir was still intact (and despite technical difficulties with stabilising stone on steep, smooth substrate in powerful flows), the older “rock-ramp” structures designed to ease fish passage (Fig. 16, left of frame) would have been an important measure to limit (but not erase) the negative effects of this “impoundment”.

Figure 14: Unimpounded and higher quality habitat downstream of the collapsing weir (background) compared to the impounded section upstream (Fig. 15).

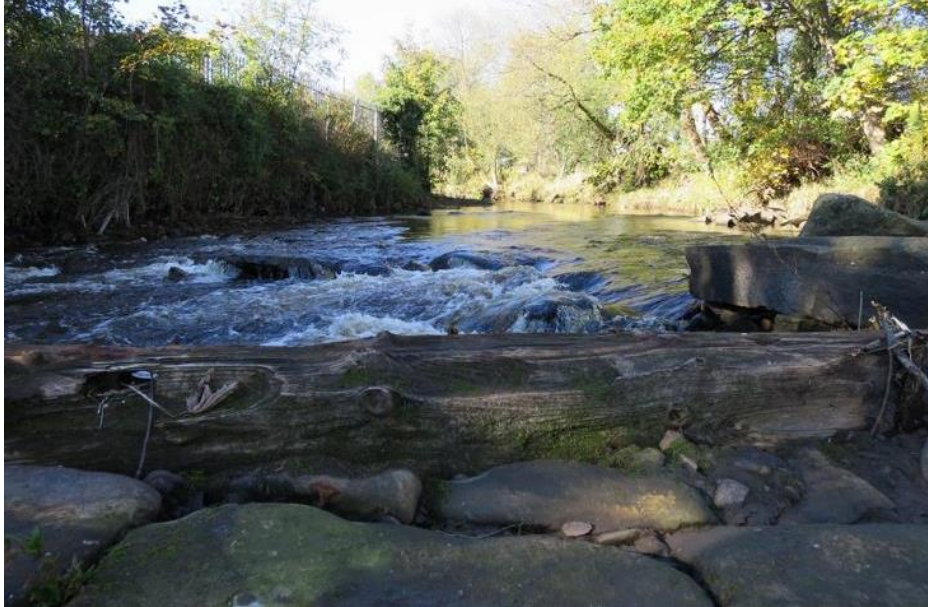
Figure 15: The impounding effect of the weir at SE07216 41705 is reducing as the weir gradually collapses. Habitat in the upstream reach is beginning to improve (note the deposited cobble “point bar” towards the upper, middle part of the frame on the RB).

Although there is still an impounding effect evident, the collapsing weir (Figs. 15 and 16) is now enabling some recovery to the upstream habitat. The longitudinal slope of the riverbed will gradually re-grade while the increase in erosion and deposition processes in the previously-impounded reach create more varied habitat.

- Produce and share materials (and consider the creation of interpretative signage) to de-mystify, reduce apprehension to, and explain the benefits of weir degradation/weir removal in terms of BOTH habitat creation and perceived flood risk. Only after highlighting those issues should fish passage be introduced as an accompanying benefit.
- Consider guided walks on this topic – linked to wildlife-spotting and activities such as Riverfly sampling.

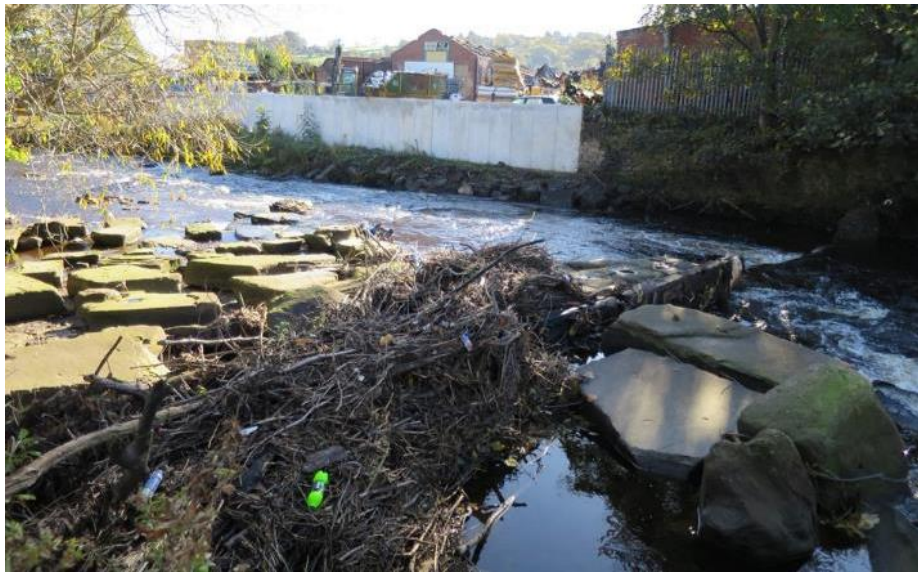
Figure 16: The wooden boards indicate the previous height of the weir crest. Note the brash accumulation at what was previously the entrance to the rock-ramp fish pass on the LB (left of frame).

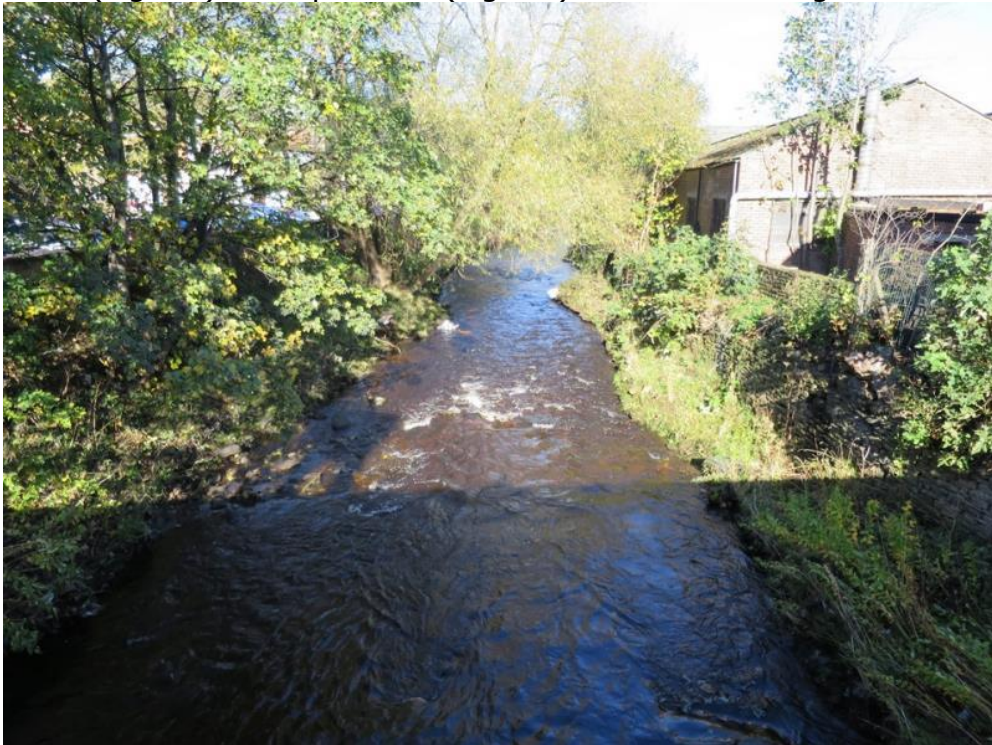
Further upstream at SE 07060 41491 the straightened-nature of the river is visible downstream (Fig. 17) and upstream (Fig. 18) of the road bridge on Dalton Lane.

Figure 17: Facing downstream, the high-vertical walls constrain the river to accommodate surrounding development. The high gradient of the river (which is amplified, by straightening since the same vertical change in elevation occurs over a shorter path-length) and development of marginal vegetation help to create slightly more varied habitat than would occur in impounded reaches. The effective increase in gradient by straightening (in an already steep catchment) is one of the factors contributing to the difficulty in managing flood risks at downstream bottlenecks.

The bridge, high walls, steep gradient and straightened nature inevitably create a flood risk scenario that is difficult to manage at this location. The hydraulic limit imposed by the bridge and the straight, steep channel, with walls that increase the bank-full depth to a level above the floodplain all combine to produce hazardous conditions during high spate flows.

Consequently, there is a huge opportunity to increase the effectiveness of existing hard defences – while at the same time also increasing the potential to accrue benefits from wider ecosystem goods and services. The use of what are often termed “natural flood risk management” technique

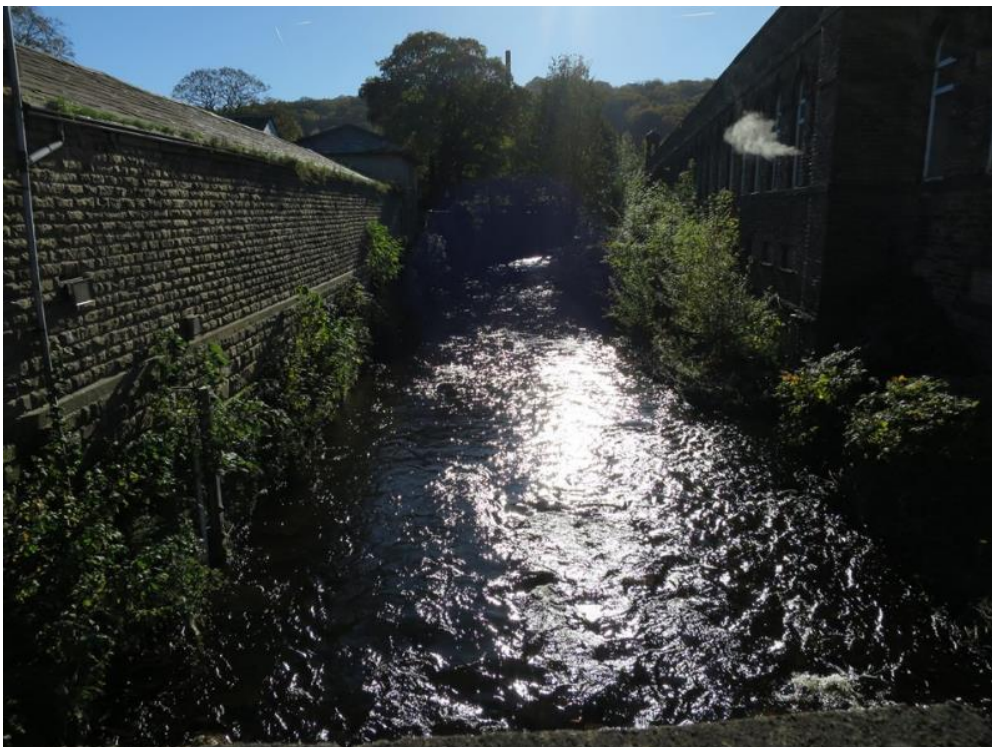
Figure 18: Although facing into the sun, it is possible to see the straightened and constrained character of the river.

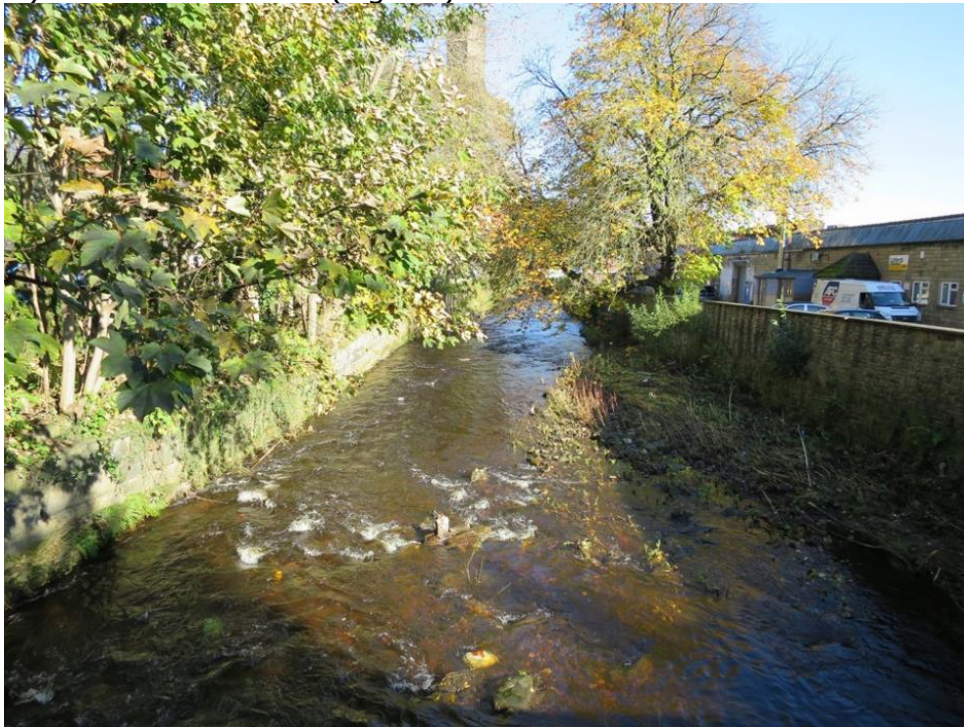
The Dalton Mill buildings make channel access more difficult in the section directly upstream of the bridge on Dalton Lane. However, access at SE 06959 412 directly upstream of the mill revealed a shallow point-bar depositional feature within the straightened channel (Fig.19) and mid-channel bar formation associated with (coppiced) mid-channel trees (Fig. 20).

Figure 19: Photo facing downstream at SE 06959 41266. The point bar on the RB (right of frame) is supporting some marginal vegetation growth – which in turn helps to consolidate the depositional feature. This also creates an increase in depth towards the LB (left of frame) by encouraging bed-scour. The result is at least a limited degree of meandering flow within this straightened/walled section of river.

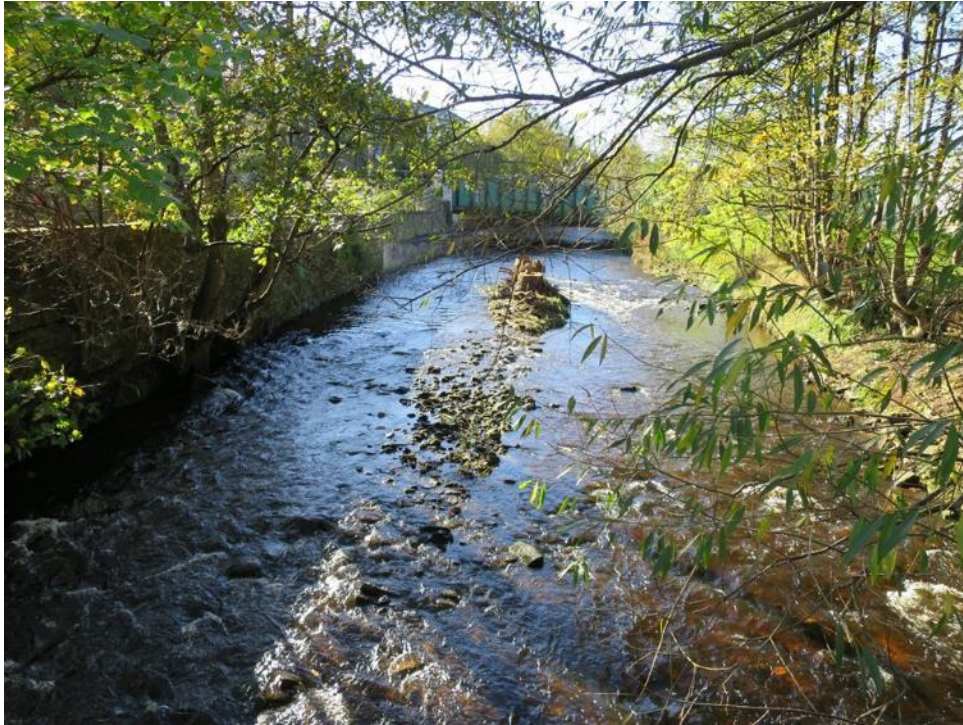
The straightening of the channel (in combination with banks that are defined by stonework) is limiting the potential for meandering flow and depth-variation across the channel. Nevertheless, some geomorphological processes can still act to produce a limited amount of variation in depth and velocity throughout the cross-section. Tree roots – whether growing in the margins or the centre of the channel – act to retain more bed material and cause the localised formation of depositional features (Fig. 20).

Figure 20: Flow being split to the left and right of the channel, while the tree-roots also favour deposition of substrate in the water that is slowed in the lee of those roots down the centre of this reach. This central ridge, with deeper and/or faster-flowing water on either side, is an excellent example of trees generating much more physical variety in river channels.

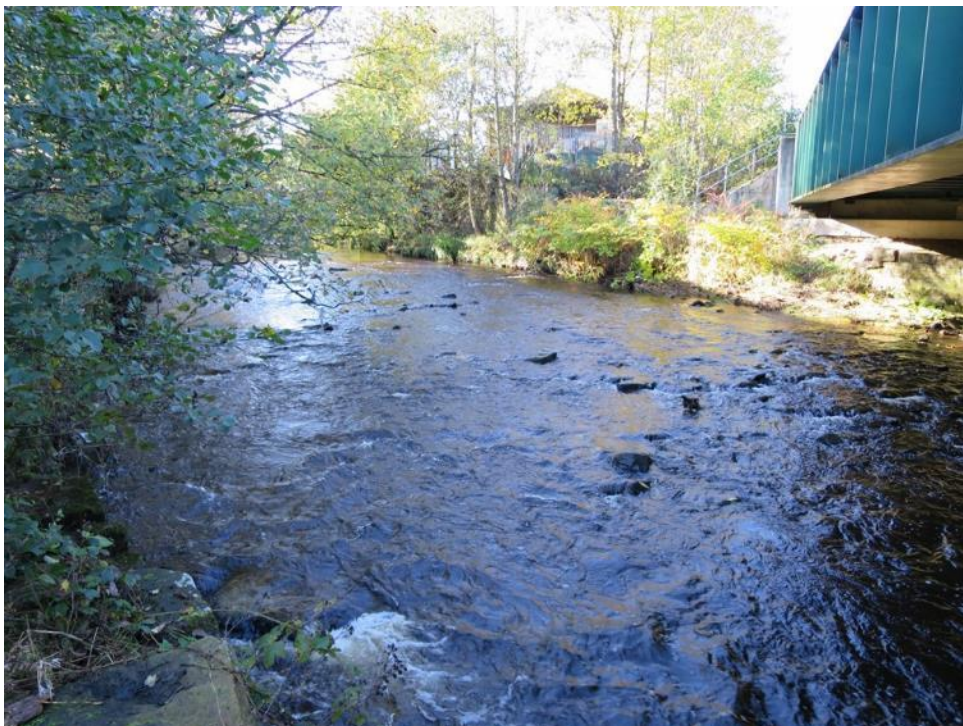
Figure 21: Streamy, cobbled run at SE 06907 41204 (reported to be favoured by the local dippers).

With one spotted on the day, the reports of this section being very good for dipper sightings are clearly well-founded. The shallow, streamy water and cobbles/small boulders that dot the channel look to be ideal habitat for a variety of aquatic invertebrates. The depth and pace of water, along with multiple fishing perches on rocks, are very typical of the feeding grounds favoured by dipper. Again, the very straight nature of the channel means that it is advisable to explore opportunities to re-introduce a degree of meandering flow.

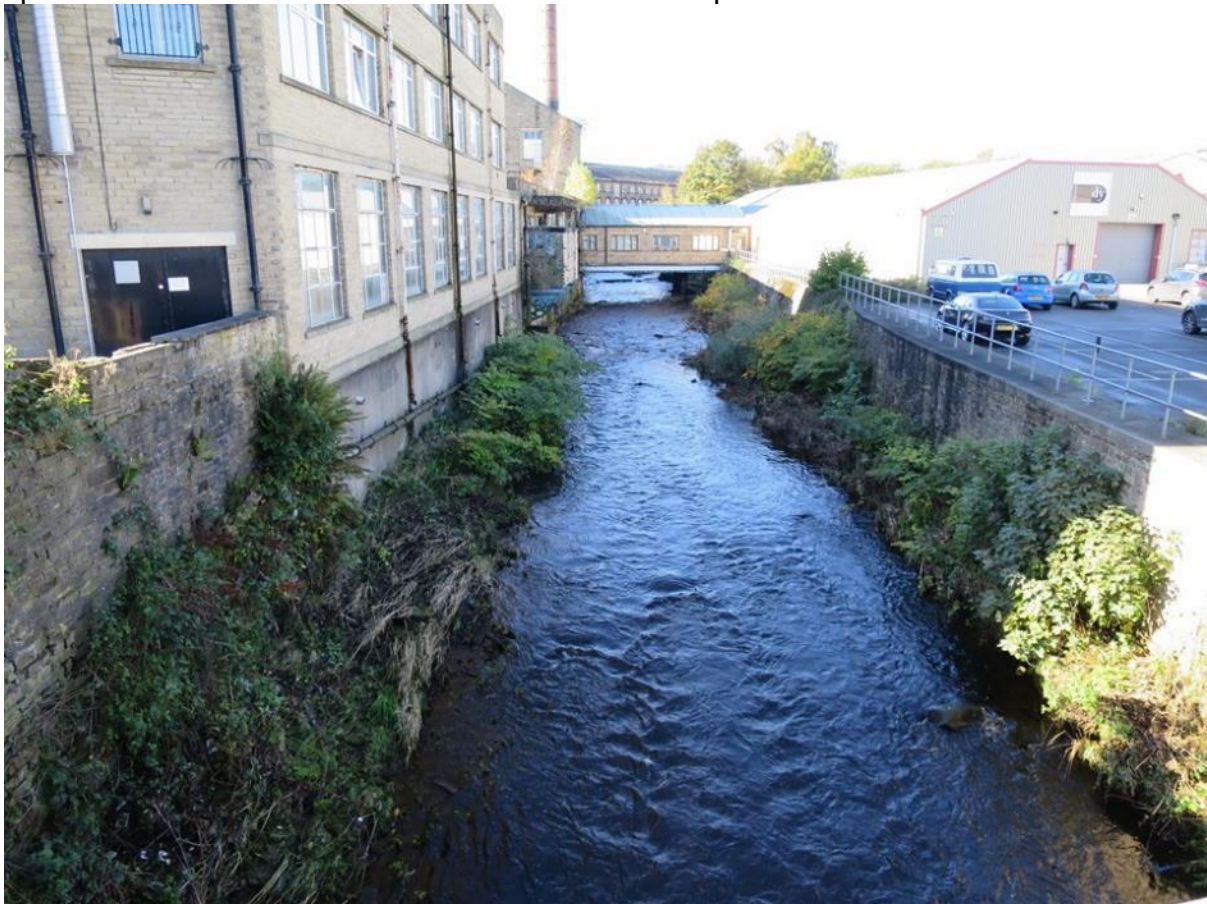
Stands of Japanese knotweed (invasive, non-native species) were noted from the bridge at SE 06817 41153 (Fig. 22). Each plant has a root system that can spread over approximately a seven-metre radius. Additionally, the plants and their roots are adapted to growing in volcanic rock within their native range. Because of these characteristics Japanese knotweed can cause significant damage to walls and foundations. It is also associated with reduced native floral and faunal diversity due to its aggressive competitive ability which eventually ousts almost all growth of native plant species. In turn, the fauna that depends on those native plant species are also lost from areas infested with Japanese knotweed.

Figure 22: Japanese knotweed on the LB (right of frame). In common with all of the sections found in the developed reaches of the river, an artificially-straight channel is reducing some of the structural variety that would otherwise be naturally produced by substrate deposition and erosion.
