**River Worth, Keighley (Woodhouse Road to River Aire):
Advisory Visit**

River Worth: Keighley
River	Worth (West Yorkshire)
Waterbody Name	Worth from Bridgehouse Beck to R Aire
Waterbody ID	GB104027062891
Management Catchment	Aire and Calder
River Basin District	Humber
Current Ecological Quality	Moderate
U/S Grid Ref inspected	SE 06009 40209
D/S Grid Ref inspected	SE 07653 42112
Length of river inspected	3km

Wild Trout Trust Report – Following a Site Visit on 27/10/2017

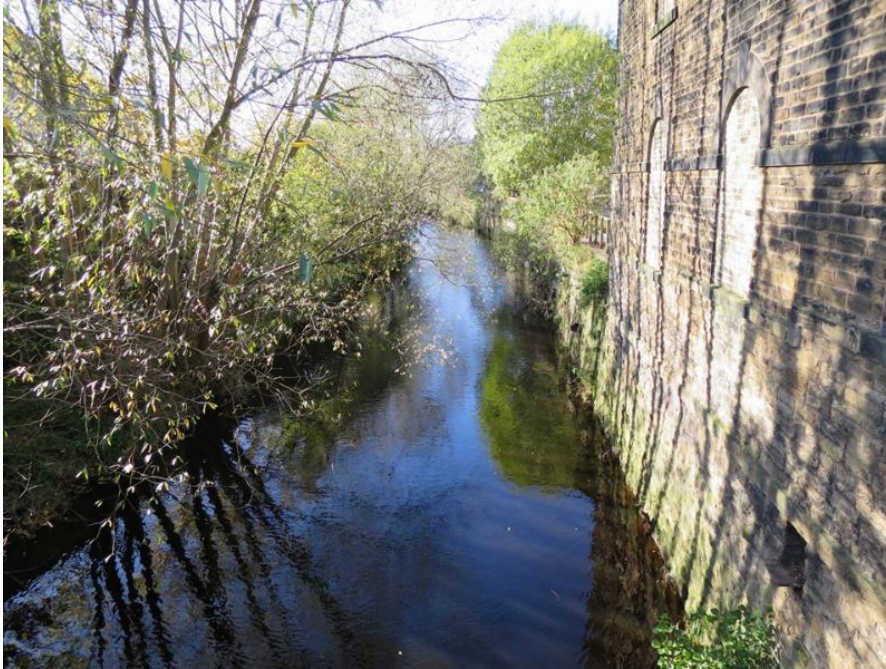
Progressing upstream to a vantage point at SE 06641 41169 revealed an impounded, straightened and over-wide river (Fig. 23). This is reported to be very similar to the situation that previously existed upstream of the collapsing weir pictured in Fig. 16. Where weirs are large enough to produce a really extensive impounding effect, the dramatic simplification of the habitat is easy to see.

It is that simplification which is associated with excessive efficiency of mobile predators (in turn associated with fragile “boom and bust” dynamics for both prey and predator populations). Also, the homogenous conditions will favour a much less diverse range of species compared to physically varied habitat. These factors are compounded by the previously-highlighted problems with downstream salmonid fish migration and bed-material transport.

Figure 23: An extensive impounded reach photographed facing upstream at SE 06641 41169. Due to the overall high-gradient of the natural riverbed, a relatively large weir structure is probably responsible for such a large impounding impact.

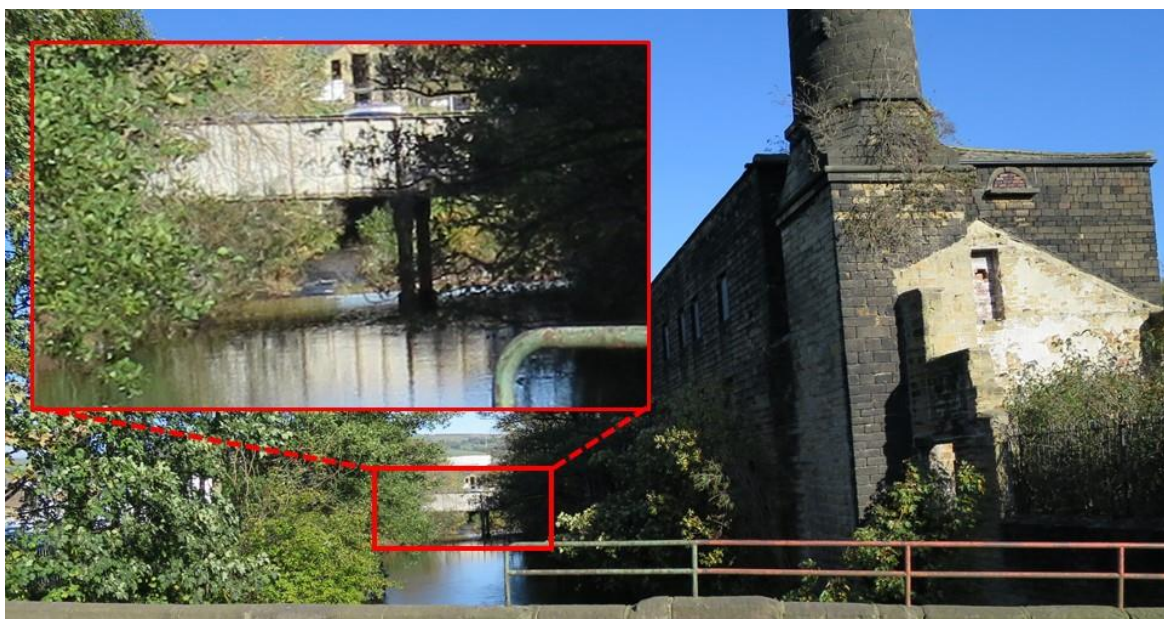
The expectation that a substantial weir would be required to impound the length of channel shown in Fig. 23 appears to be supported judging by what is visible of a structure downstream (Fig. 24).

Figure 24: Continuation of impoundment downstream from photograph in Fig. 23. The crest of a large weir is just visible beneath the bridge towards the lower/centre of the frame in the far background (enlarged in the inset). The height-difference between the flat, reflective water at the crest and the more broken water below is substantial.

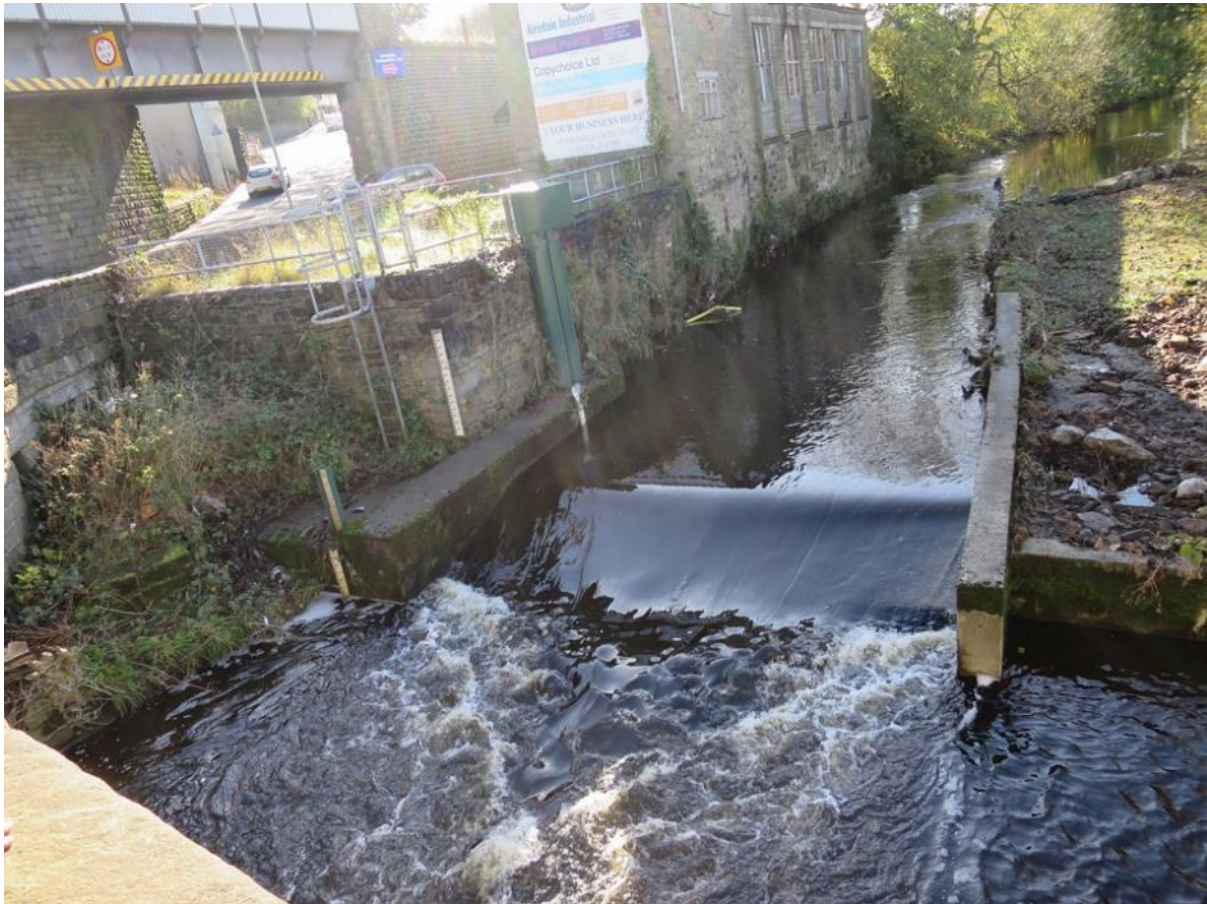
Continuing upstream to the bridge at SE 0637140877, a weir structure which seems to have been previously associated with an adjacent pond (now filled in) has been fitted with gauging instrumentation (Fig. 25). The glassy, powerful (and shallow) flow down the steep face of the weir will be completely impassable to most fish species under almost all conditions.

Figure 25: Weir fitted with gauges visible on the RB (left of frame). This installation is probably formally incorporated into EA river levels monitoring. To the right of the frame there appears to be a back-filled lagoon/mill pond which may have been altered to facilitate calibration of flow-gauging. The power of the laminar flow of water over the weir itself is a severe barrier to upstream fish migration.

There are precedents to refer to where fish-passage easements have been incorporated (with attendant re-calibration of gauging equipment). The WTT can offer some guidance on beginning to pursue that course of action as appropriate.

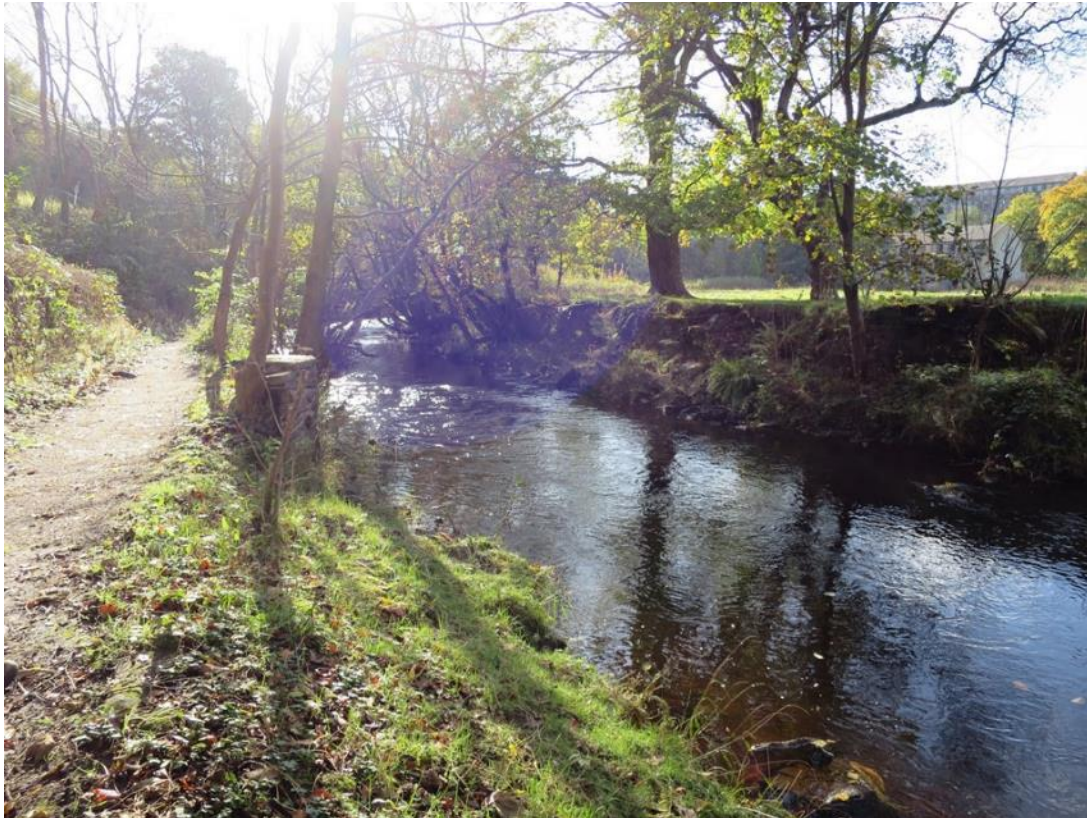
Figure 26: Still a modified channel, but some increased vegetation and bank-full depth that is closer to the level of the floodplain (though the channel is quite "incised" and generally lacks good connectivity to surrounding floodwater storage)

The trees are generally present as a narrow, single file (i.e. Fig. 26) that line the banks and create a canopy of quite uniform height and density. A dual benefit to in-stream structural diversity and also light/shade regime could come from the installation of stable tree “kickers”. This is where the crown of a coppiced tree is cabled securely to its own stump and allowed to swing in-line with the current against the riverbank. This produces the same valuable refuge habitat that is created by natural dead-fall of trees into rivers. However, there is an advantage in being able to reliably anchor that woody material so as to avoid increased risk of debris blocking structures downstream. It also helps to offset both the general reduction in natural tree-cover in many rivers systems – as well as the tendency for fallen wood to be removed from channels when it does arise naturally. Section 3 (Recommendations) includes more information on this simple and cost-effective intervention.

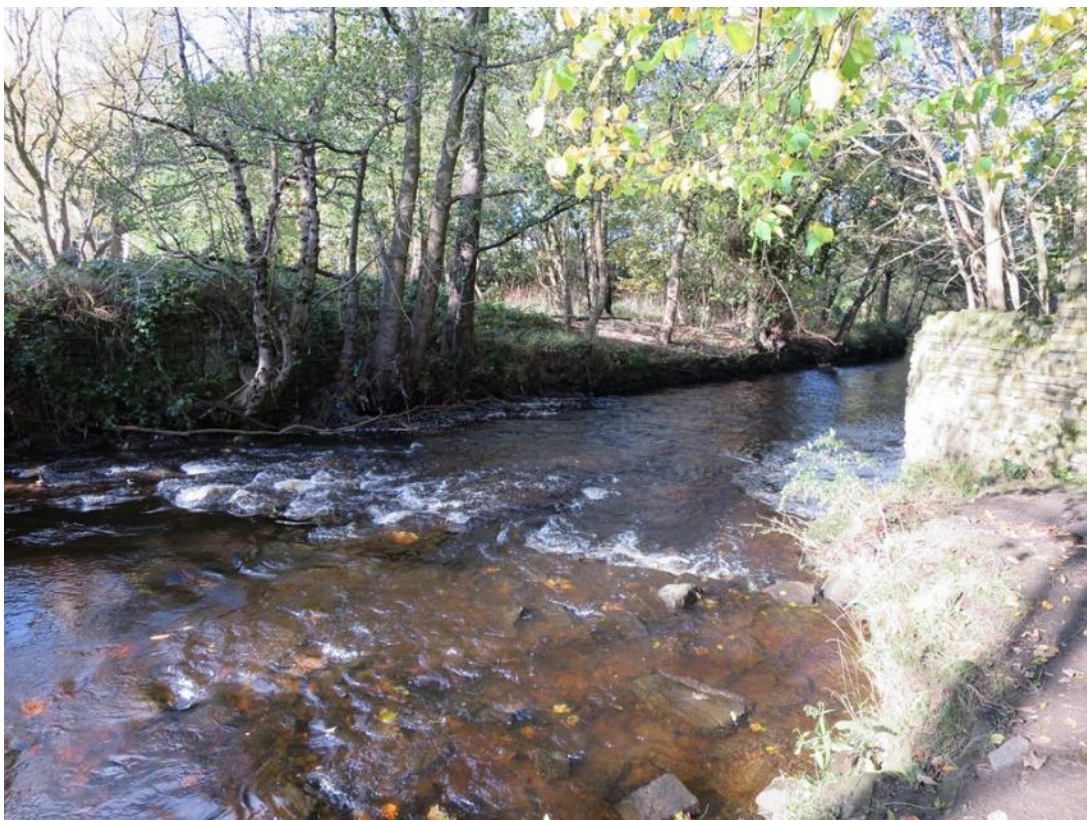
Figure 27: Probably the site of an old weir structure that has degraded over time or been demolished in the past.

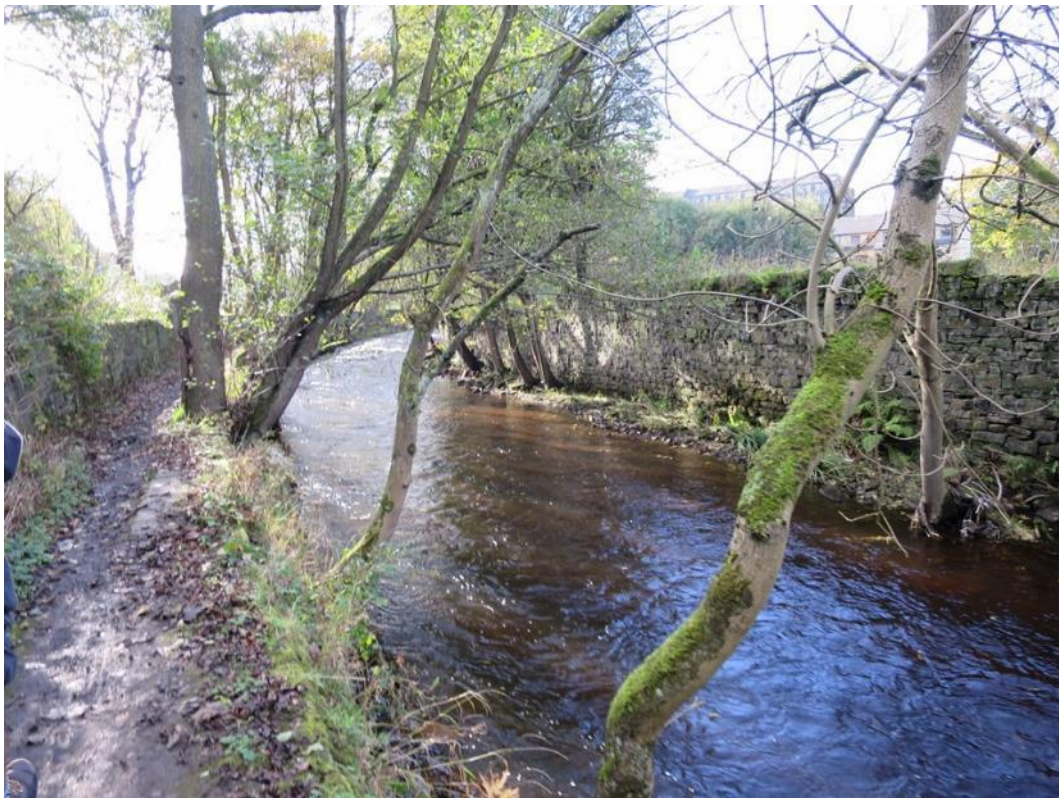
There are multiple opportunities throughout the reaches upstream of the gauging weir pictured in Fig. 25. A typical example of these opportunities is given in Fig. 28. Installing a scattered arrangement of tree kickers throughout the reach would be a low-cost and low-tech improvement to the habitat.

Figure 28: Opportunities for tree kickers to increase structural and light-regime variation at SE 06133 40376.

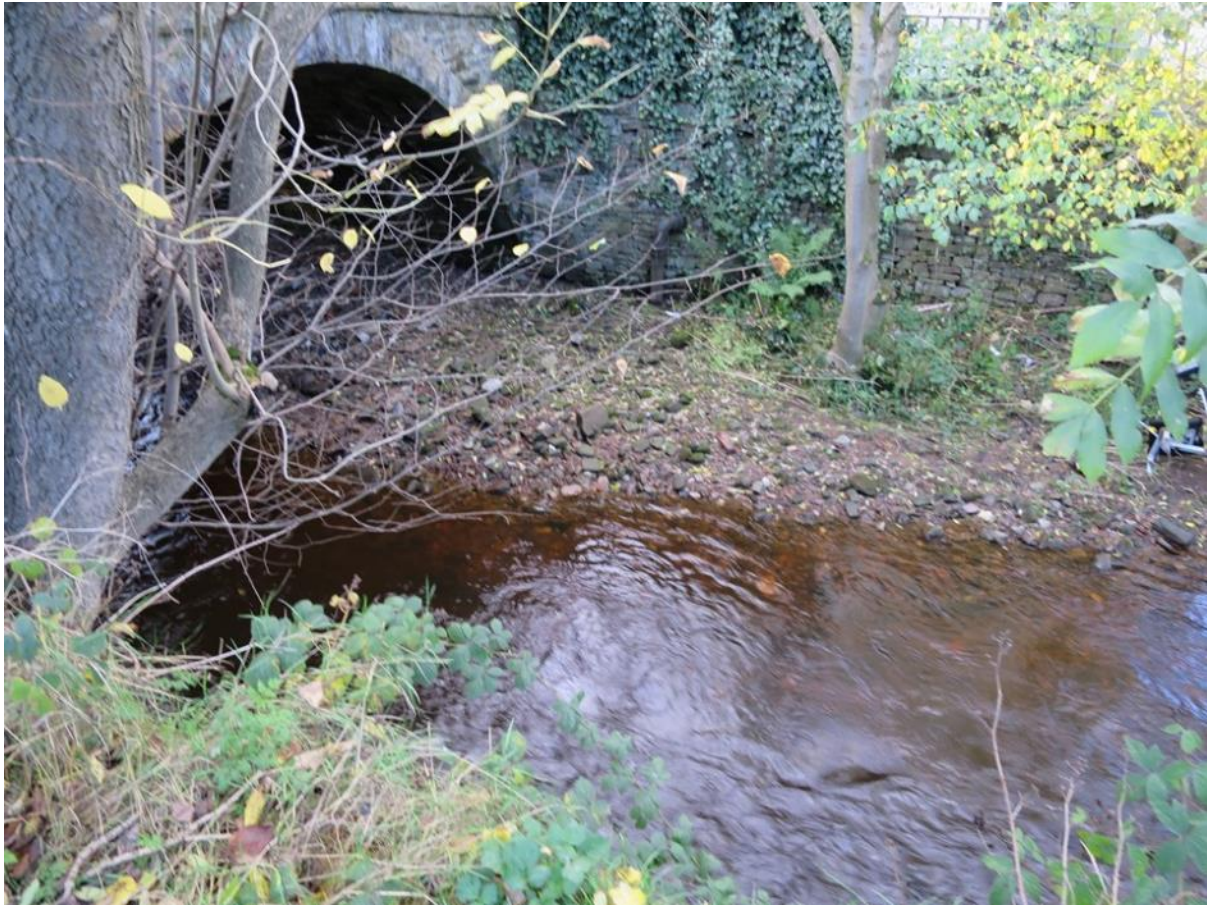
There are also examples of naturally-arising variety in cross-sectional depth and current velocity. These create a wider variety of niche habitats, which in turn provides opportunities for a wider range of species. The deposition of a cobble “point bar” at SE 06025 40213 is an excellent example of this (Fig. 29). These features naturally form at – and in fact fundamentally create – the inside edges of natural meanders. The deposition of material in this way can, in some cases (i.e. the Sheffield Don tributaries following the 2007 floods), cause concern where any material is seen as a potential blockage to the conveyance of floodwater. However, just as with the removal of material deposited in the flat “pan” below

Figure 29: Cobble, gravel and small boulder "point bar" depositional feature creating varied depth and current speed over the cross-section of the channel at SE 06025 40213.

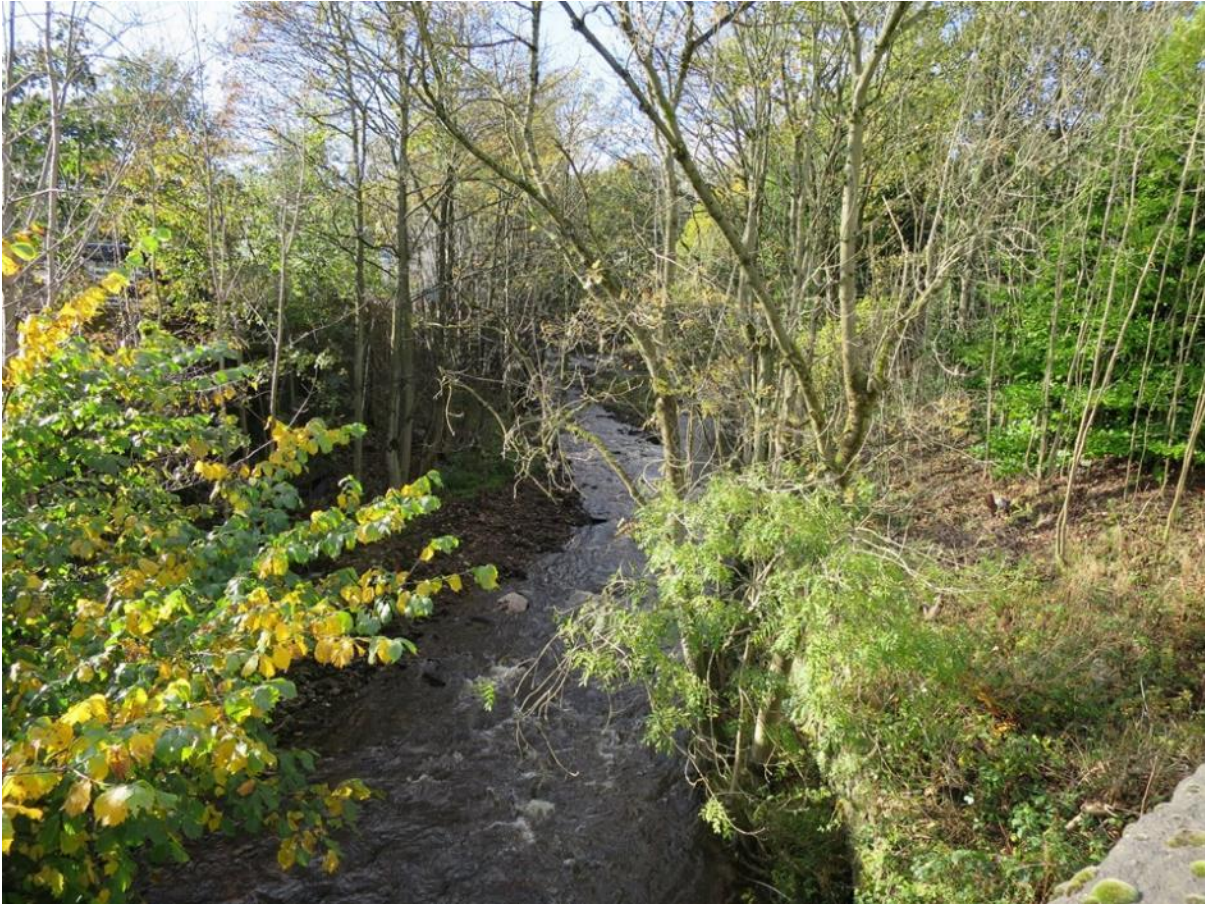
Figure 30: Upstream limit - more extensive riparian woodland and varied geomorphology.
