The River Peffery Restoration Project

PHASE TWO, 2012

Marcus Walters of the Moray Firth Sea Trout Project reports

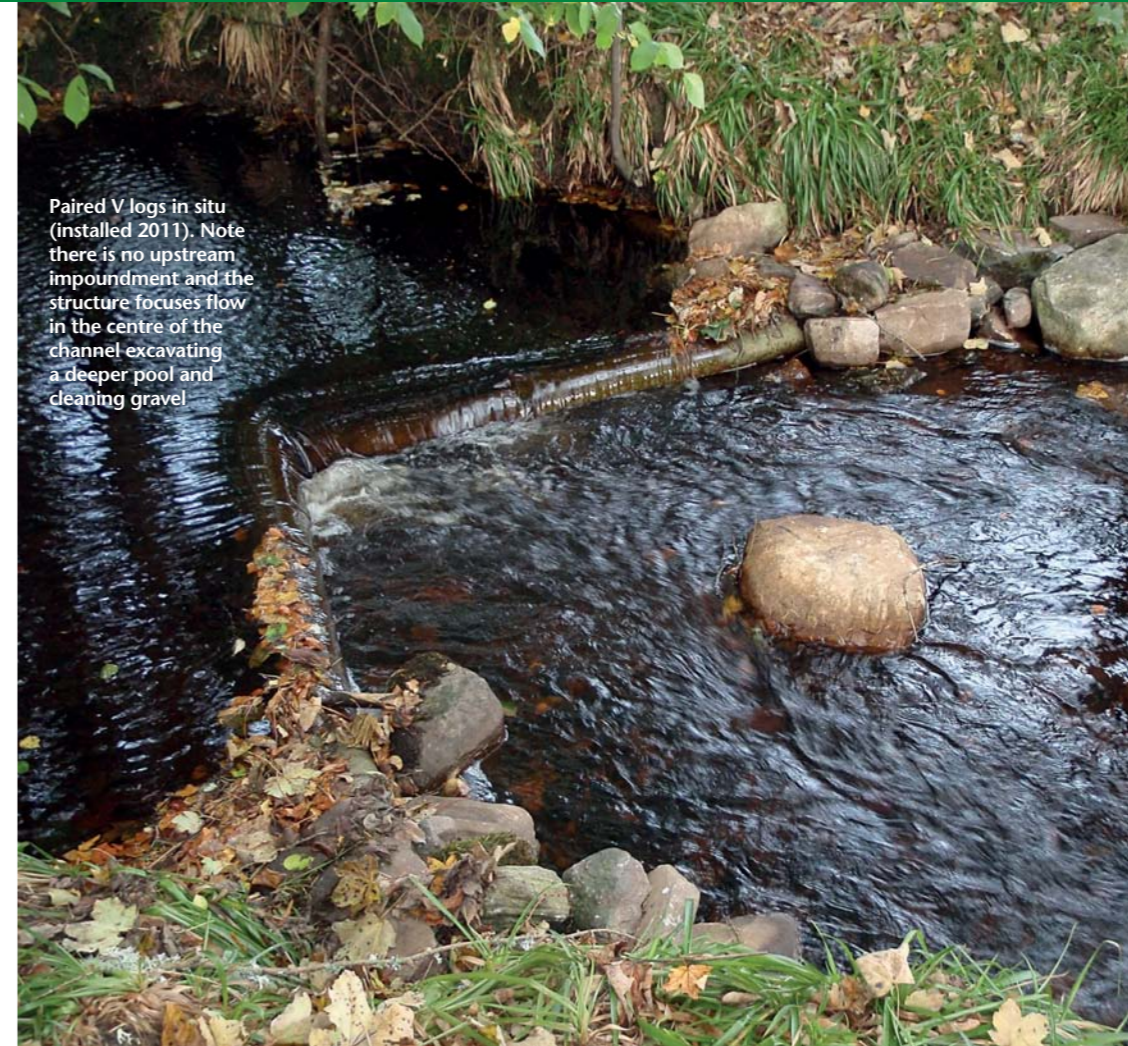
Paired V logs in situ (installed 2011). Note there is no upstream impoundment and the structure focuses flow in the centre of the channel excavating a deeper pool and cleaning gravel

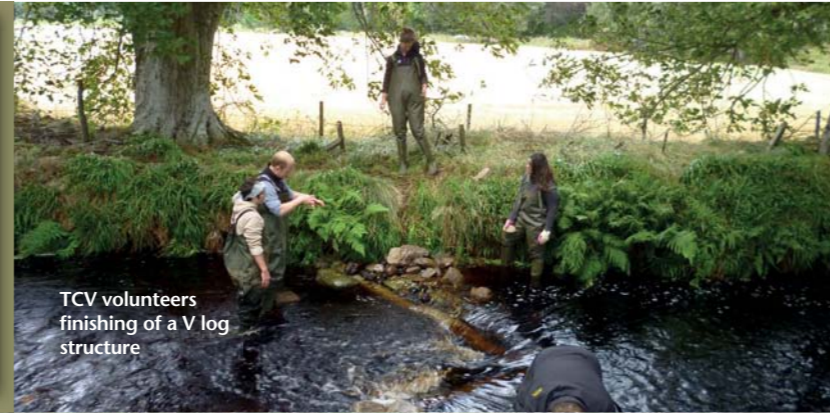
TCV volunteers finishing of a V log structure

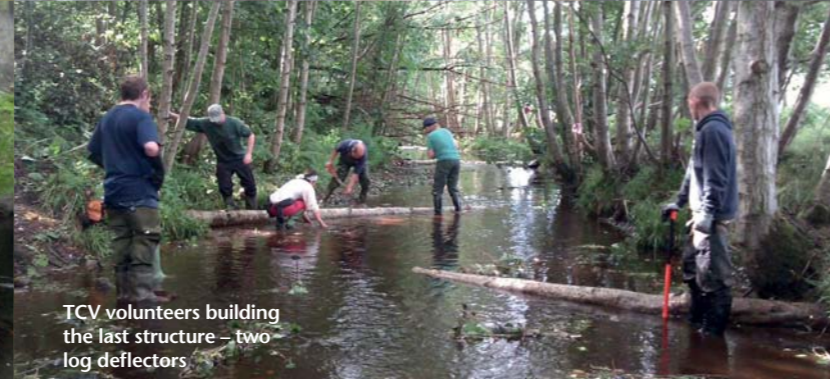
TCV volunteers building the last structure - two log deflectors

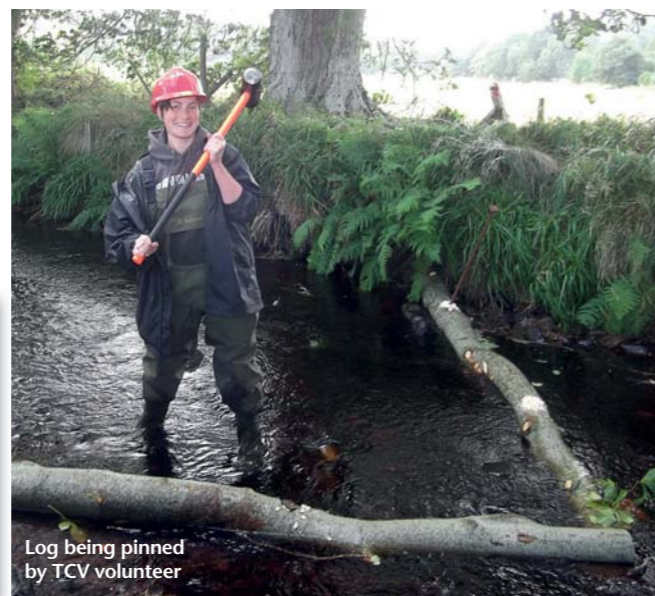
Log being pinned by TCV volunteer

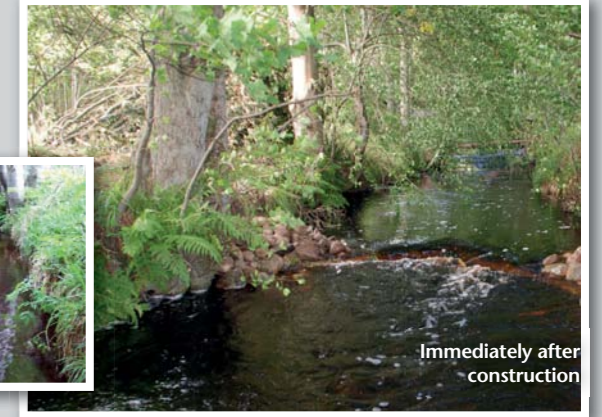
Immediately after construction

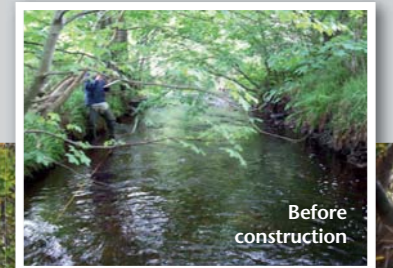
EXAMPLE 2 TYPE OF STRUCTURE: THREE ALTERNATING STONE DEFLECTORS

Before construction

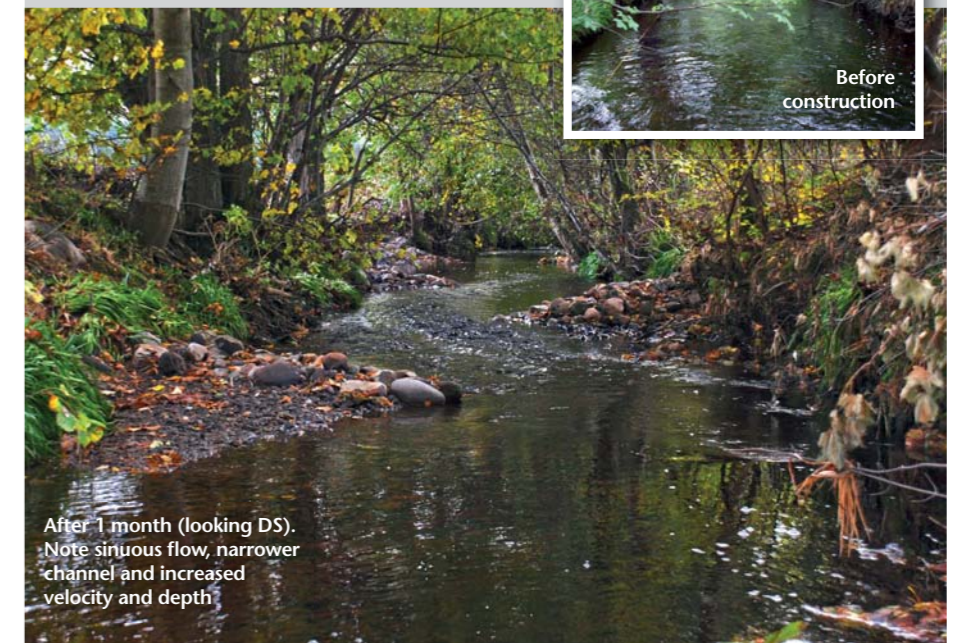
After 1 month (looking DS). Note sinuous flow, narrower channel and increased velocity and depth
