WILD TROUT TRUST

**River Bain**

(River Witham Catchment)

October 2023

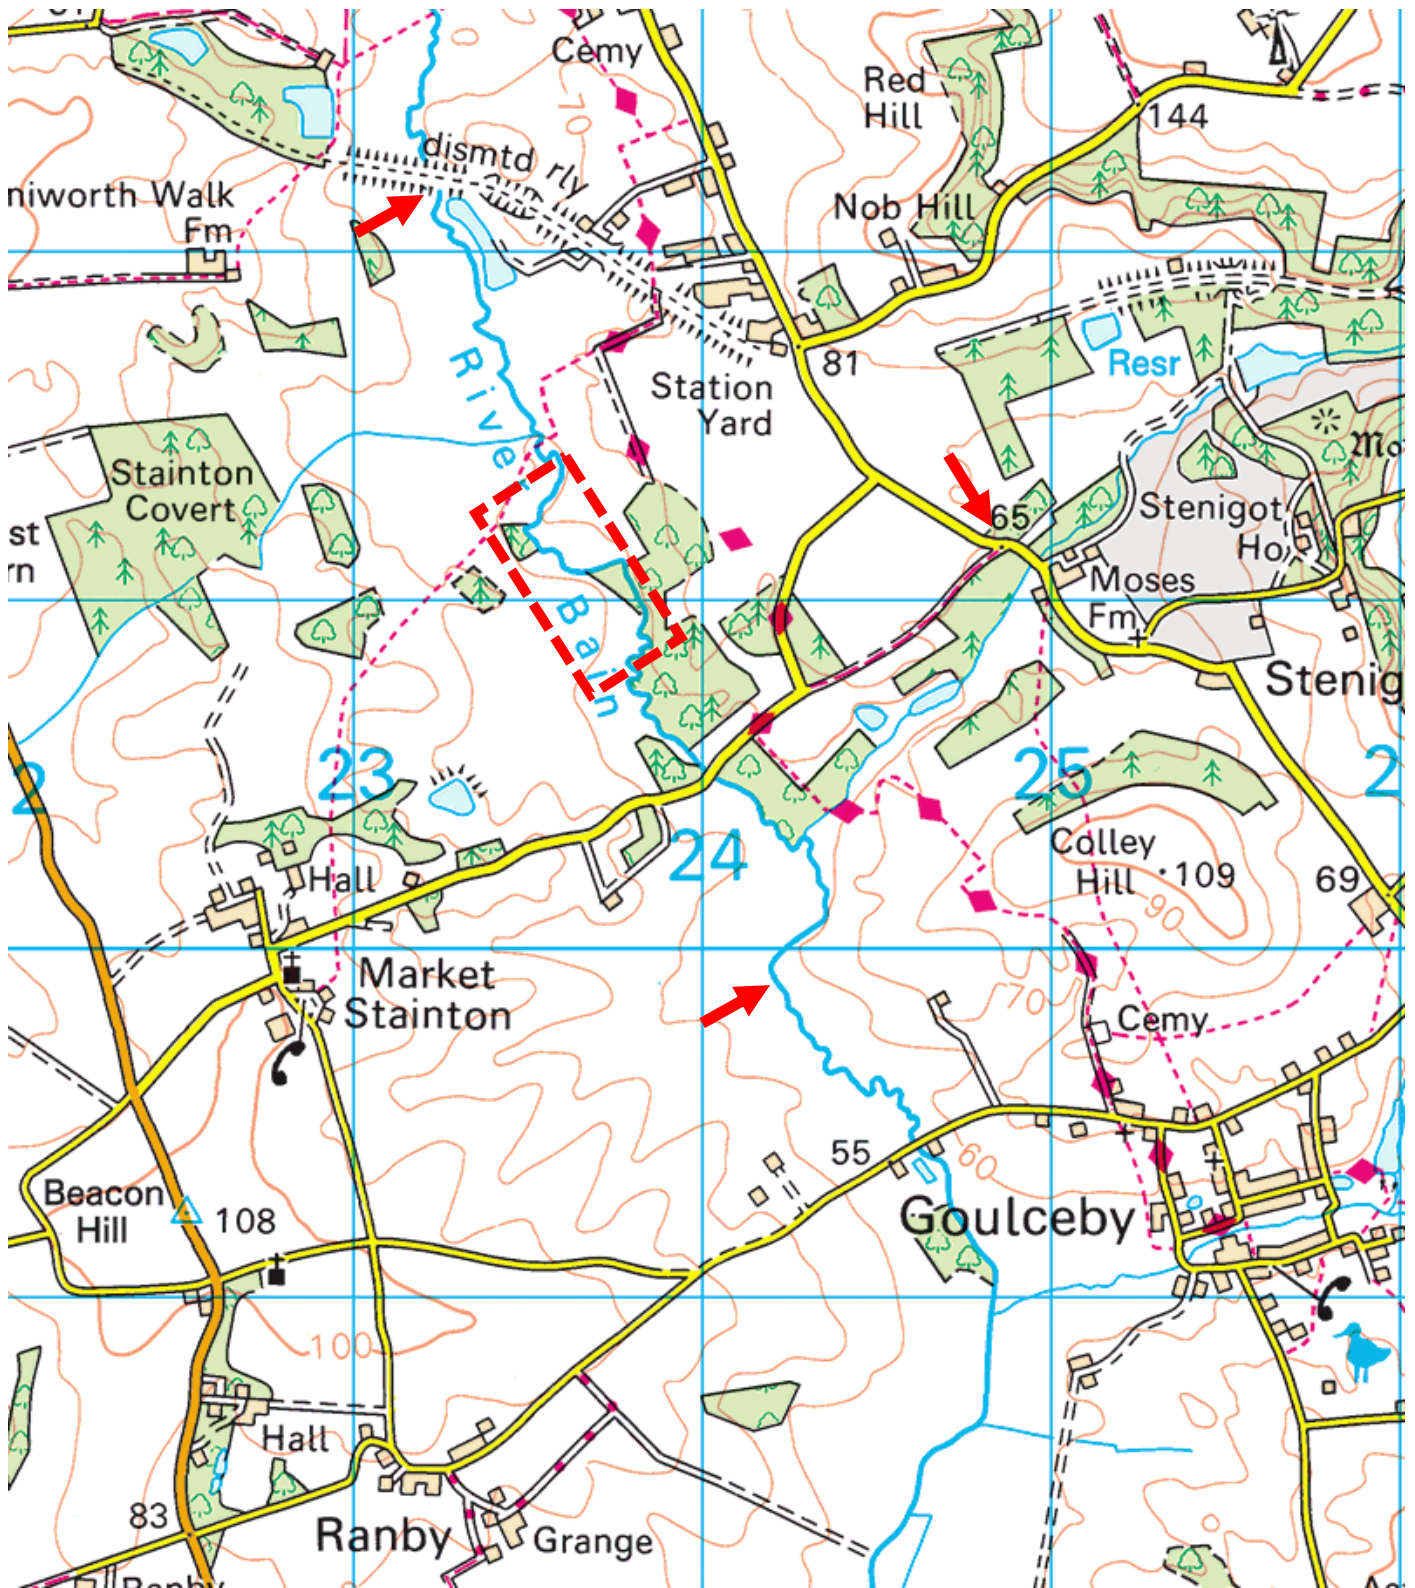
Figure 1 Extent of rivers inspected (red arrows). Area within the dashed box not inspected due to limited access. (1:50000 OS Map, [www.streetmap.co.uk](http://www.streetmap.co.uk)).

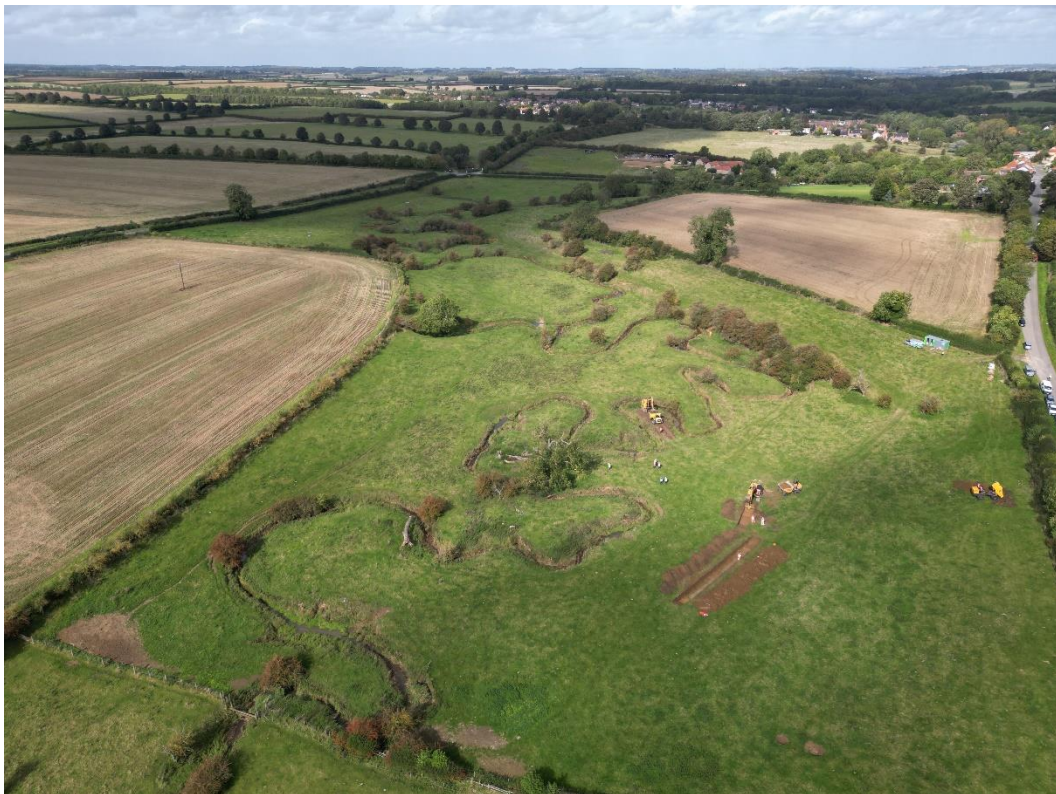
*Figure 32 Upper Witham, Colsterworth, pre-project. A sinuous but deeply incised channel disconnected from its floodplain.*

In addition to the above, seepage ponds and scrapes could be excavated at the base of valley slopes. Figure 32 - Figure 34 illustrate some of the described features at a recently completed project at Colsterworth on the Upper Witham.

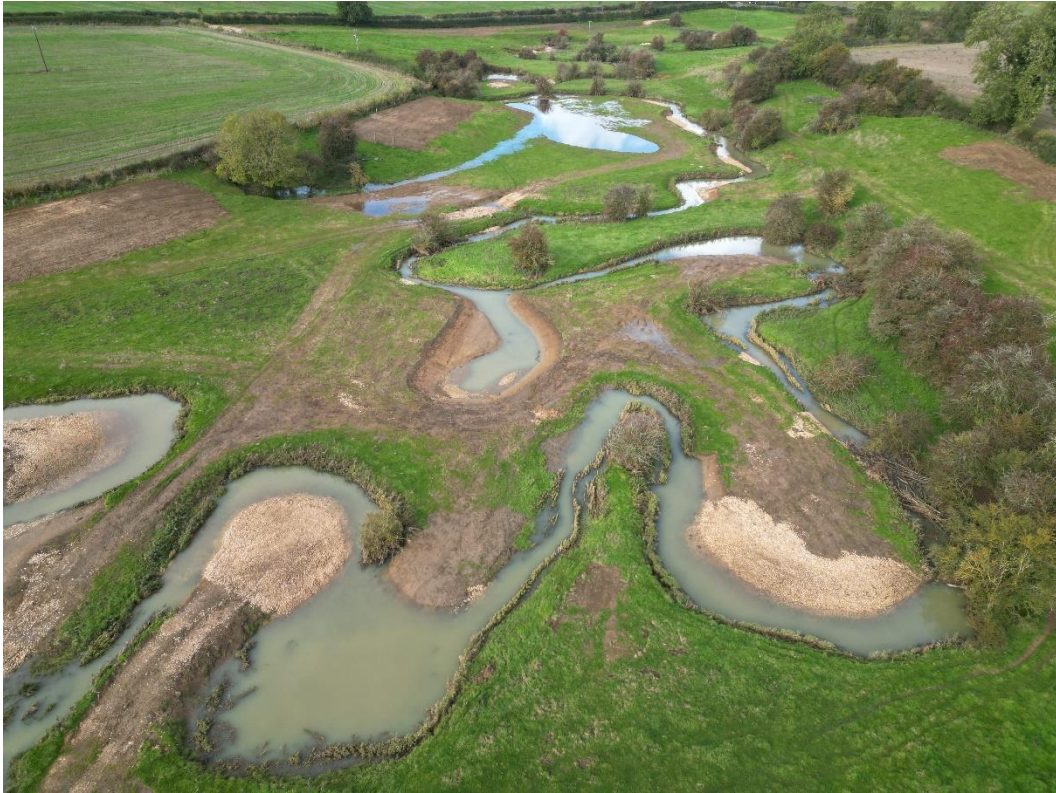
*Figure 33 Colsterworth post-project showing bank-reprofiling (inside of meanders), gravel introduction, backwater creation. River flow is away from camera.*

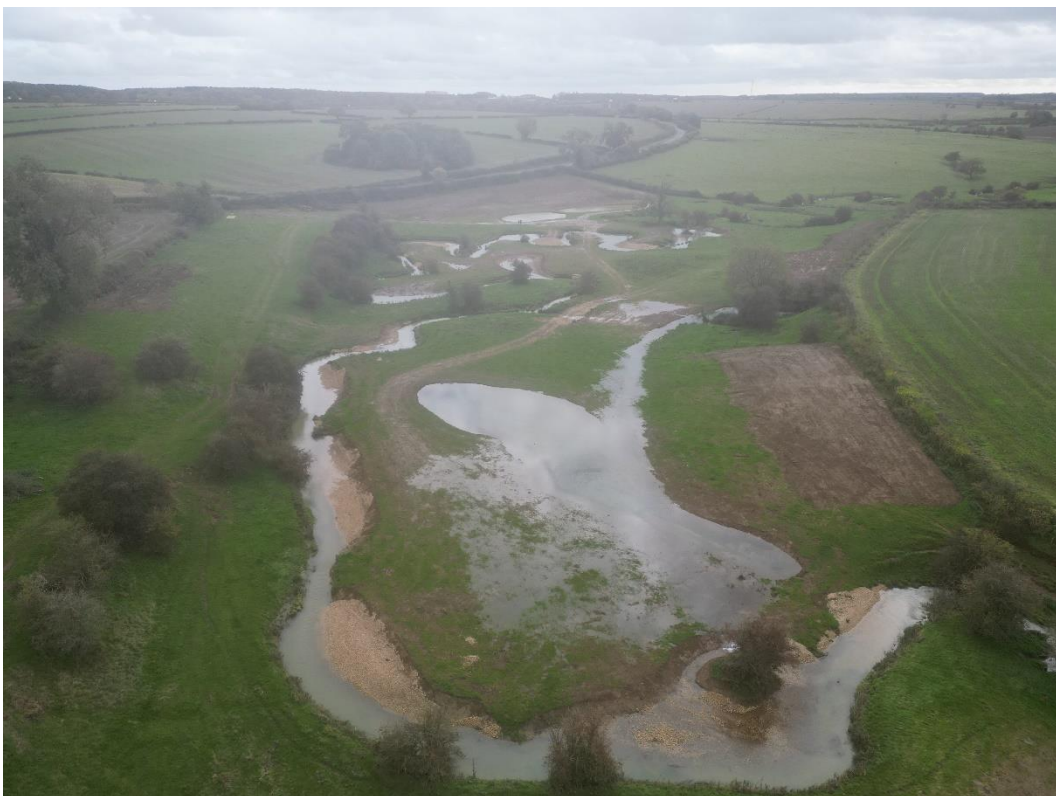
*Figure 34 Colsterworth post-project showing wetted floodplain from an intercepted spring, but equally this could be created by encouraging the river to spill onto and off the floodplain. River flow towards camera.*
