WILD TROUT TRUST
wildtrout.org

Advisory Walkover, Nov 2023

R Aire (Newfield): [GB104027063100](https://www.gov.uk/land-registry/GB104027063100)

Prof J Grey (jgrey@wildtrout.org)

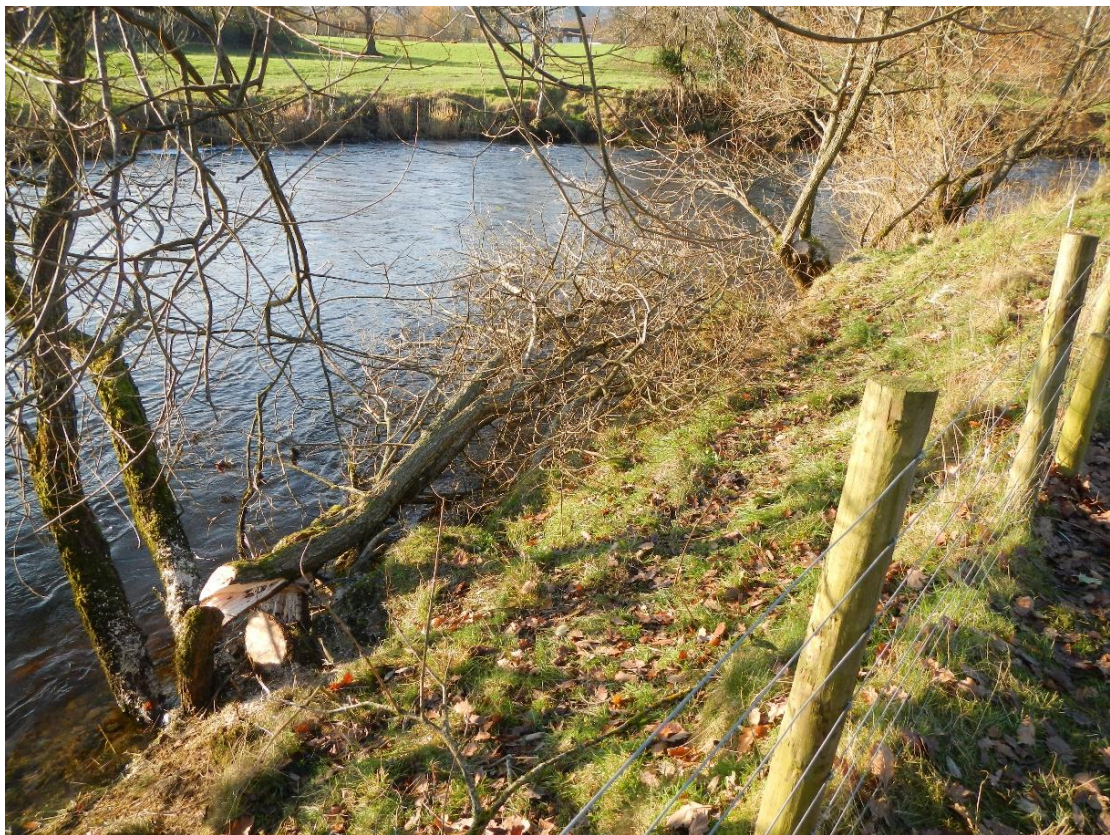
Fig A1. Two stems from a previously coppiced and hence multi-stem crack willow laid into the channel and aligned close to the bank to provide low / submerged cover. The living upright stems on the u/s side protect the hinge.

Tree-kickers simply emulate the fall and retention of natural woody material but can be used where there has been historic removal or where a river system has been too heavily modified to retain material safely (ie risk of dislodged material blocking man-made pinch-points like bridges). It is a step further than simply laying or hinging stems into the channel whereby the material is retained via a living hinge (Fig A1). This can be done with pliant, living species but larger and/or dead trunks and many species are not suitable.

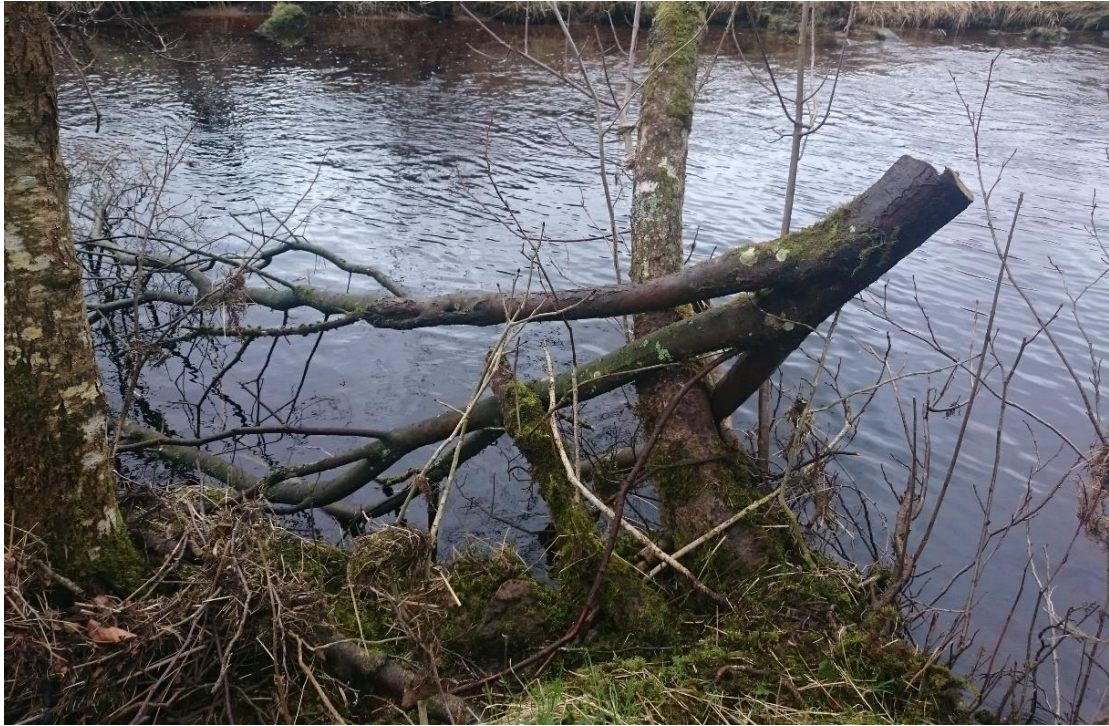
Fig A2. Simple lodging of material if there is the structure, in this case the fork, to make it work.

Ideally, if the trunk can be retained without a tether, eg by lodging around or opposing forces between living trunks (Fig A2) as a tree-hanger, then that reduces the amount of non-natural material used. If not, or to minimise risk, appropriate gauge stainless steel cable (6, 10 or 12mm equivalent to 3, 6.5 or 9.4 tonne breaking strain) and wire rope clamps should be used (Fig A3).

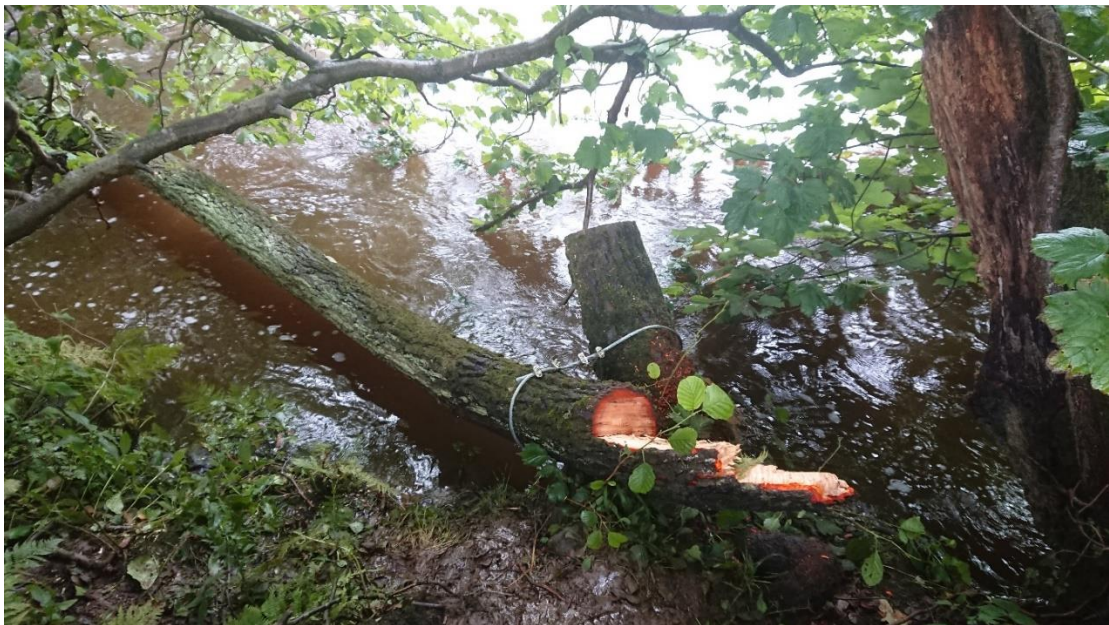
Fig A3. Alder of ~350mm girth felled and cabled back to the living stump as a tree-kicker. The coppiced stump will regrow vigorously, providing further low cover and screening of the cable.

Uprooted trees or individual trunks can be retained *in situ* or nearby by winching and cabling to an appropriate living anchor. If none are nearby, consider the use of a ground anchor, eg <https://platipus-anchors.com/>
