Advisory Visit

River Manifold, Staffordshire

25th March, 2019

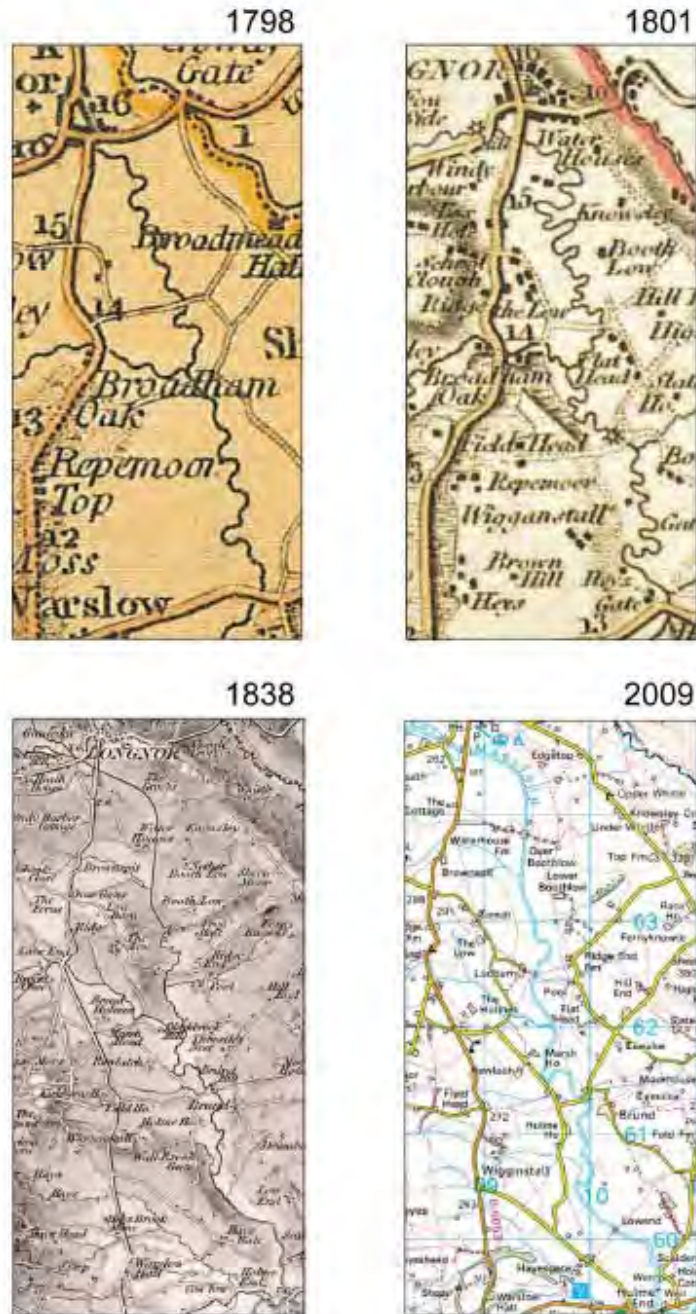
Figure 6.6 Straightening of the River Manifold downstream of Longnor

Extracts from four maps which isolate the date of straightening to sometime between 1801 and 1838:
 Yates' 1798, Smith 1801, OS first edition 1838, OS 1:50 000 2009.
