WILD TROUT TRUST

Advisory Walkover, Nov 2023

Snaizeholme Beck: [GB104027069350](https://www.gov.uk/landranger/view/GB104027069350)

Prof J Grey (jgrey@wildtrout.org)

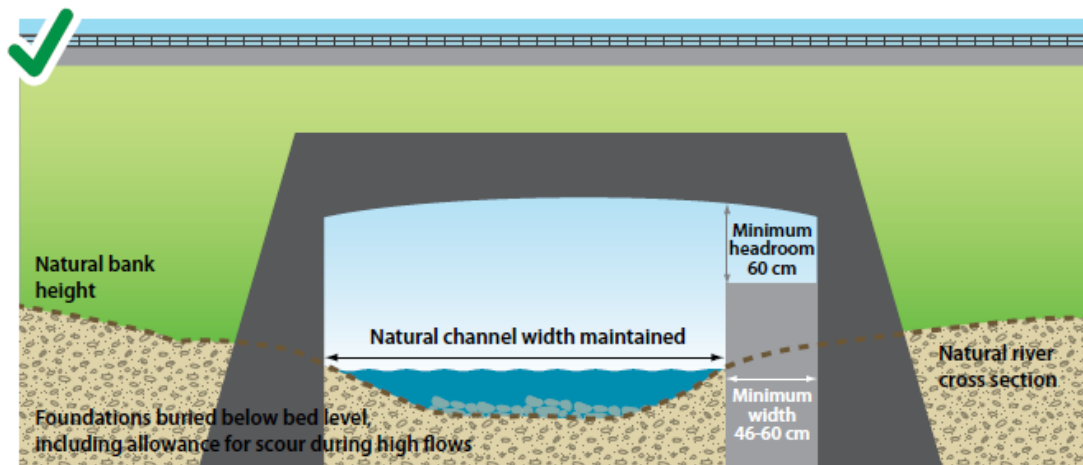
Fig 15. Figure (35) extracted from the SEPA good practice guide ([Engineering in the water environment: River crossings](#)). A structure should span the entire wetted width of the channel and accommodate spate flows, ideally with some natural bank on either side to facilitate mammal movement.

Examples of best practice can be found within the SEPA publication – see Fig 15.
