WILD TROUT TRUST

Advisory Visit: River Yarrow

Southport Fly Fishers Club, Sept 2023

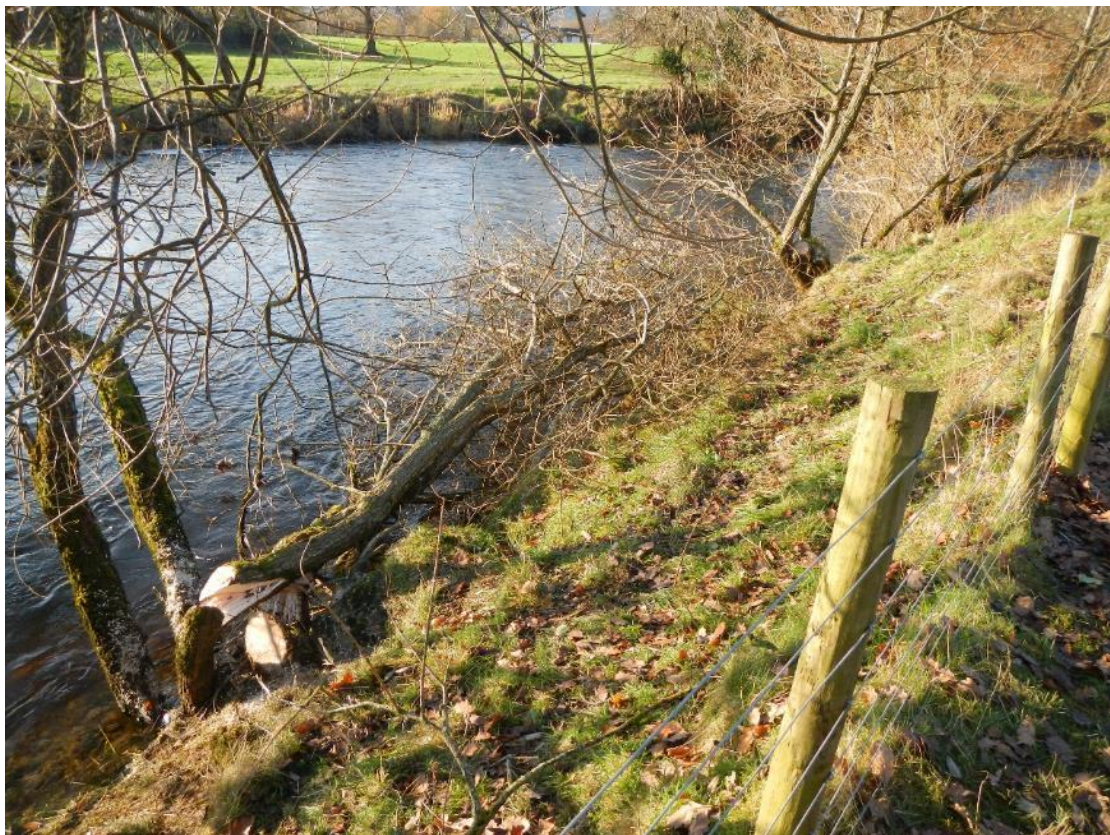
Fig A1. Two stems from a previously coppiced and hence multi-stem crack willow laid into the channel and aligned close to the bank to provide low / submerged cover. The living upright stems on the u/s side protect the hinge.

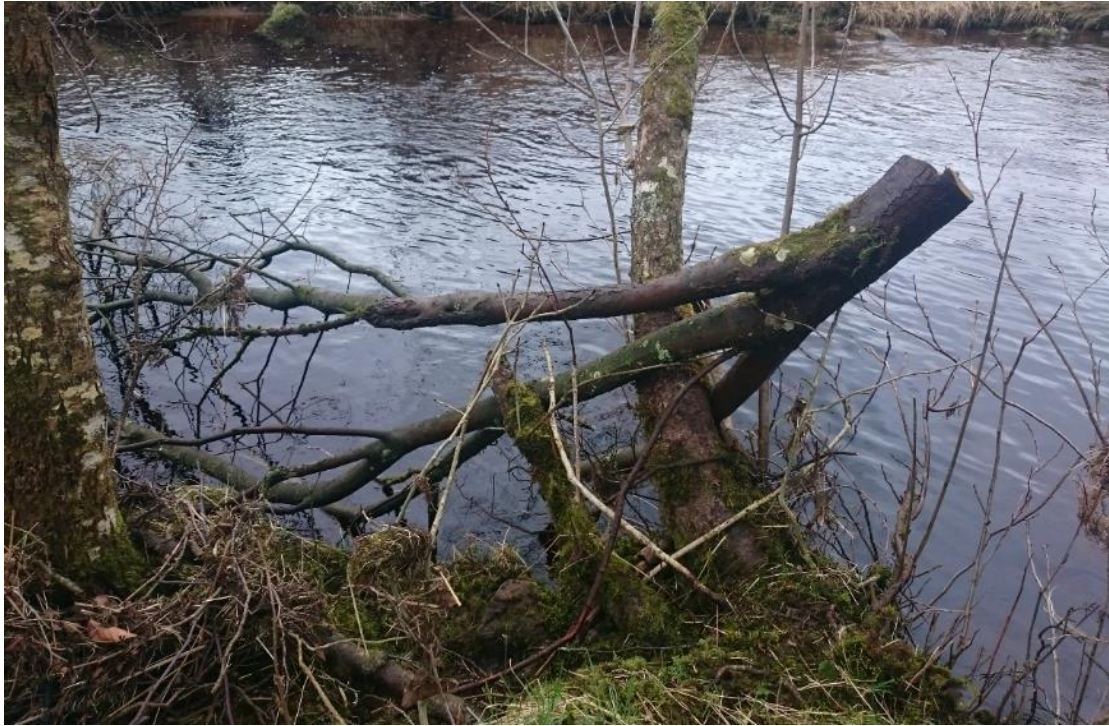
Fig A2. Simple lodging of material if there is the structure, in this case the fork, to make it work.

Ideally, if the trunk can be retained without a tether, eg by lodging around or opposing forces between living trunks (Fig A2) as a tree-hanger, then that reduces the amount of non-natural material used. If not, or to minimise risk, appropriate gauge stainless steel cable (10 or 12mm equivalent to 6.5 or 9.4 tonne breaking strain) and wire rope clamps should be used (Fig A3).

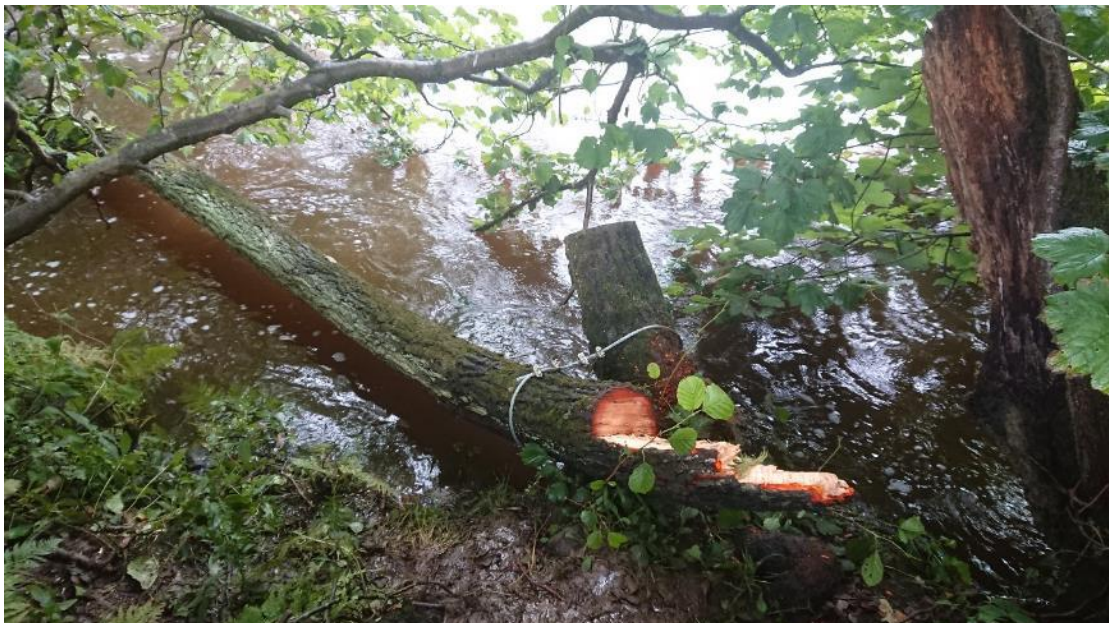
Fig A3. Alder of ~350mm girth felled and cabled back to the living stump as a tree-kicker. The coppiced stump will regrow vigorously, providing further low cover and screening of the cable.
